Christchurch City Council  
PRK\_1415\_BLDG\_001 EQ2  
Old School Reserve - Toilets  
172 Major Hornbrook Road

QUALITATIVE ASSESSMENT REPORT

- Rev B
- 23 May 2013

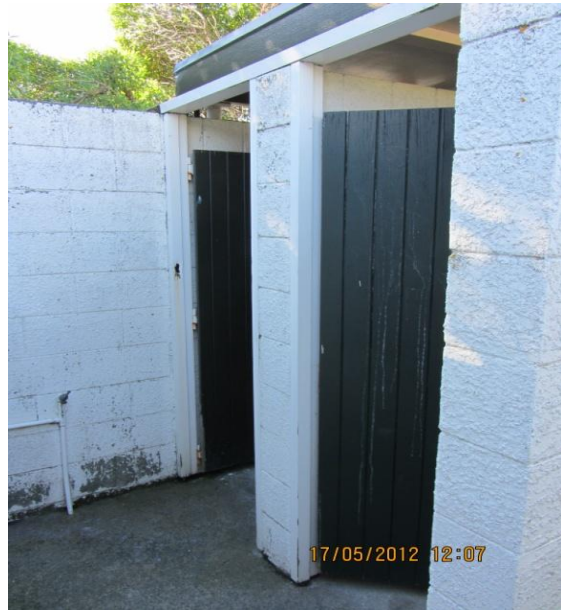
- 1) The northern womens toilet cubicle has a rotten timber frame, with rust stains seeping out (corrosion damage).
- 2) 0.5mm crack in pavement inside the womens toilet (appears to be caused by shrinkage movement and likely to pre-date recent earthquakes).

Photo 7: Women's toilet cubicle

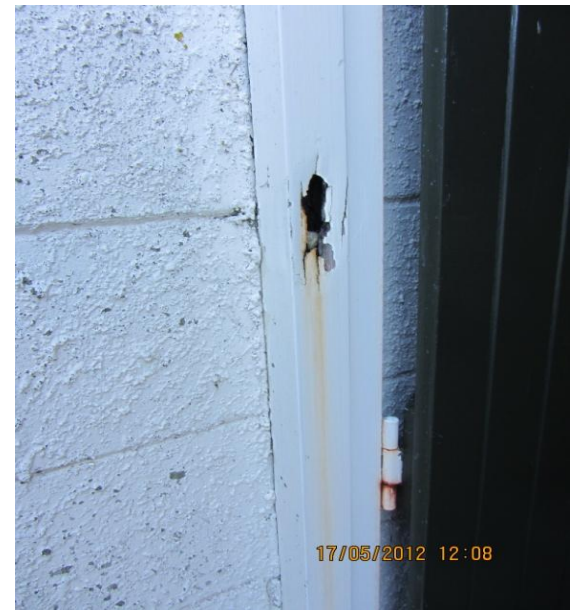
Photo 8: close up view of rotten timber framing

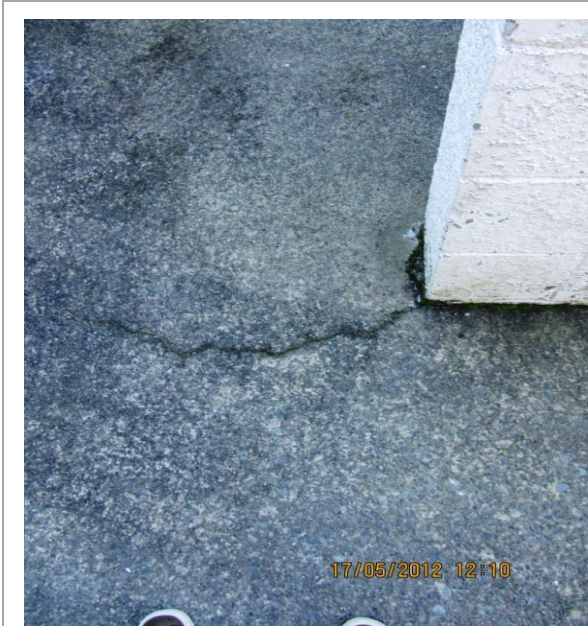
Photo 11: Crack in pavement in women's toilet

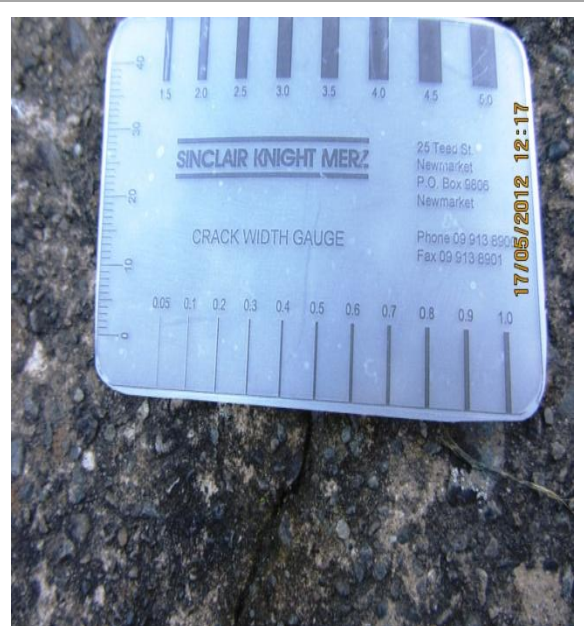
Photo 12: Close up view of photo 11 showing 0.5mm crack

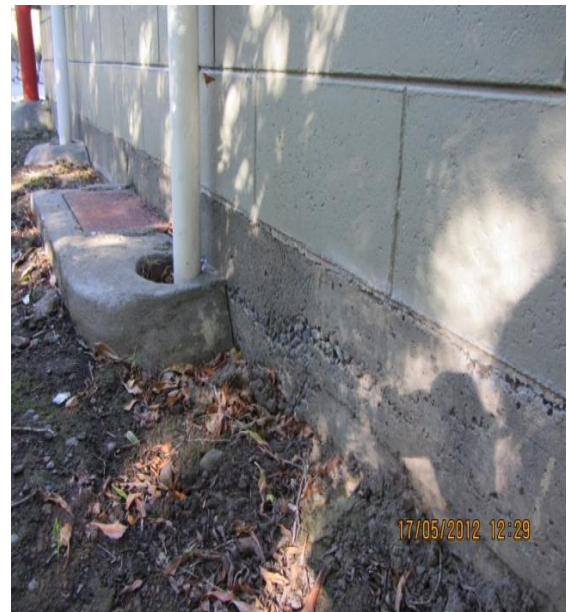
Photo 16: North east elevation showing 250mm of foundation slab above ground

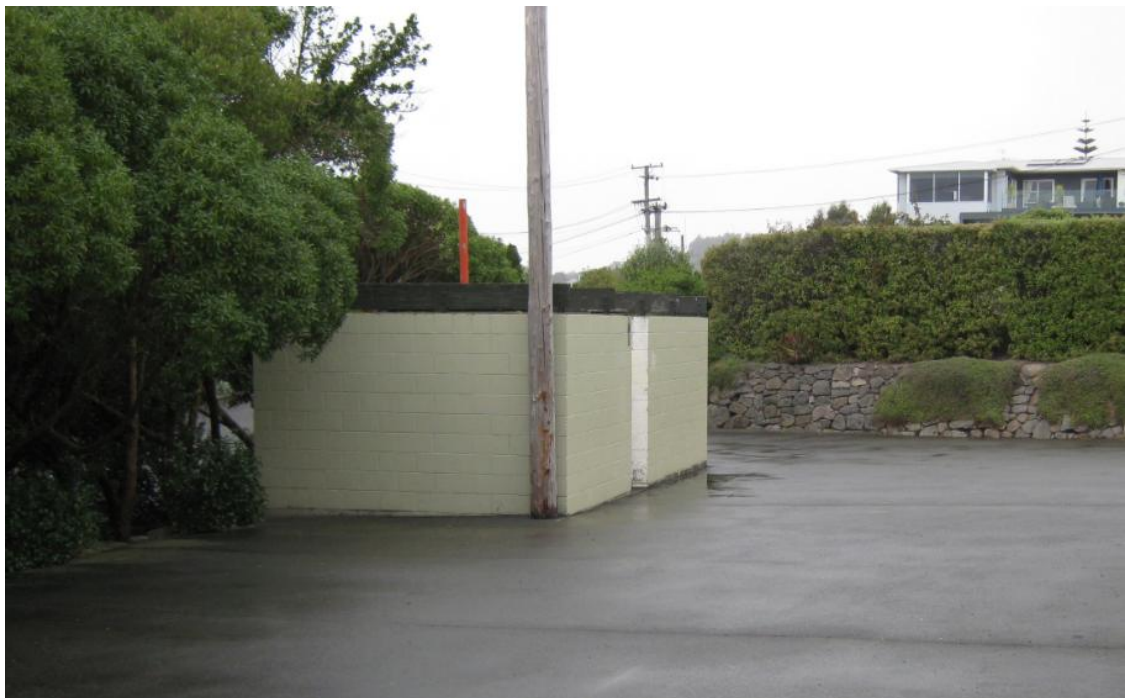
Very little damage could be seen on the toilet buildings on site, with minor hairline cracks in the foundation. Nearby buildings also exhibit very minor damage.

■ **Figure 6** Toilet block at Old School Reserve.

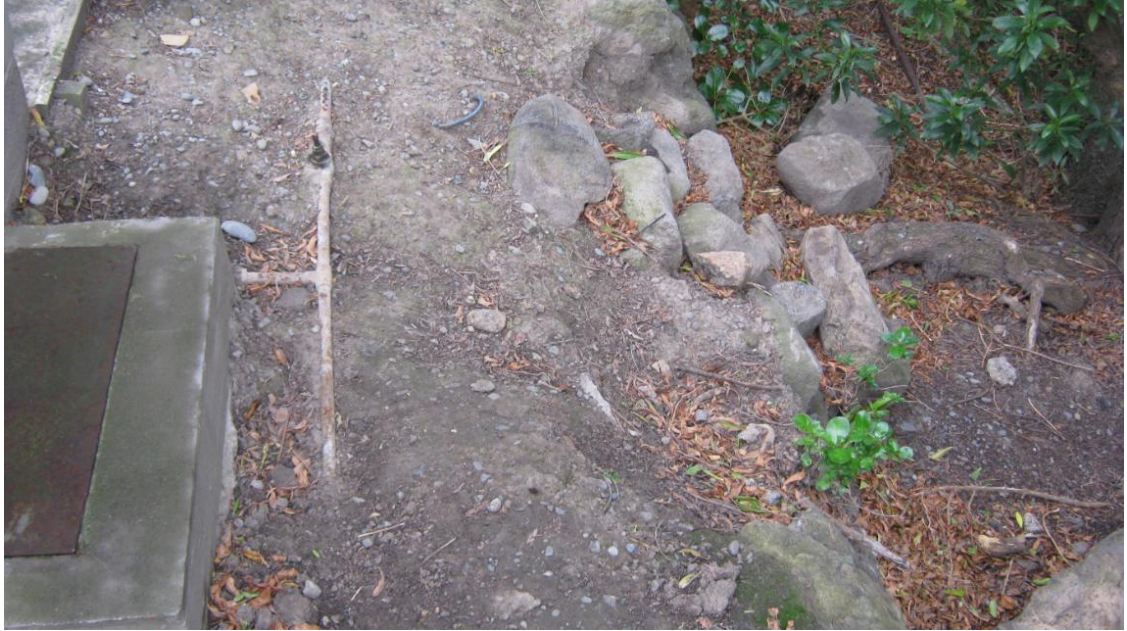
■ **Figure 8** Failed dry stack garden wall behind the toilet block
