Norman Kirk Memorial Pool - Ladies' Change Room Detailed Engineering Evaluation BU 3513-002 EQ2 Qualitative Report

Prepared for Christchurch City Council (CCC)

By Beca Carter Hollings & Ferner Ltd (Beca)

12 July 2013

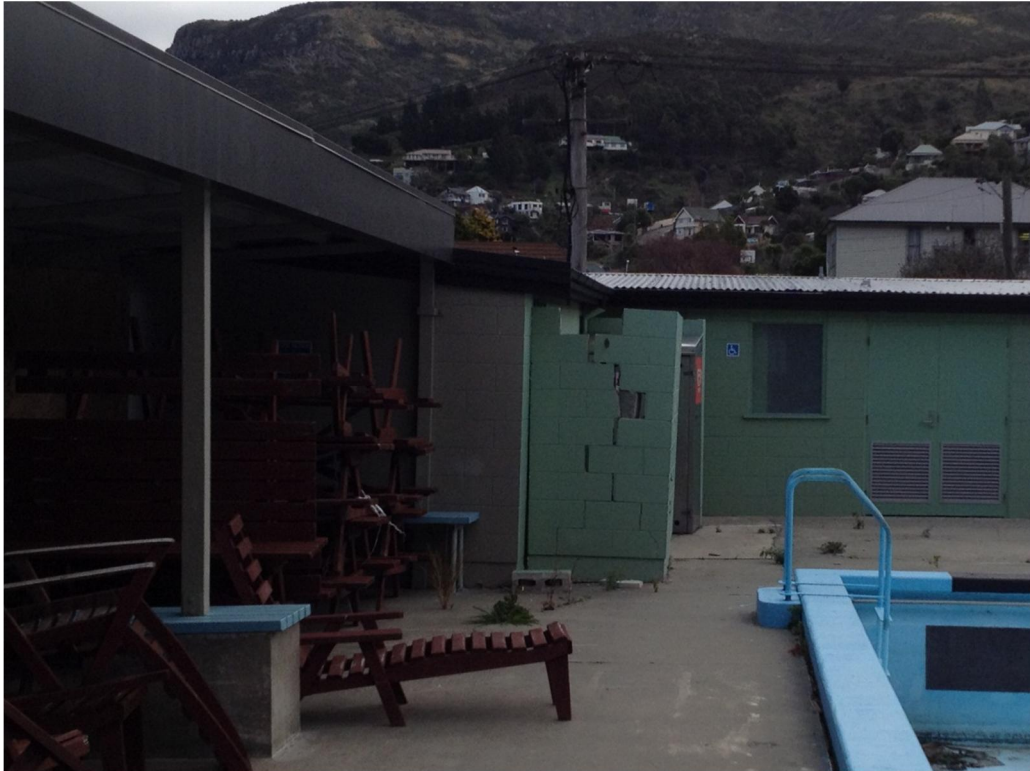
Photo 1: External view of the Ladies' Change Room (view from east).

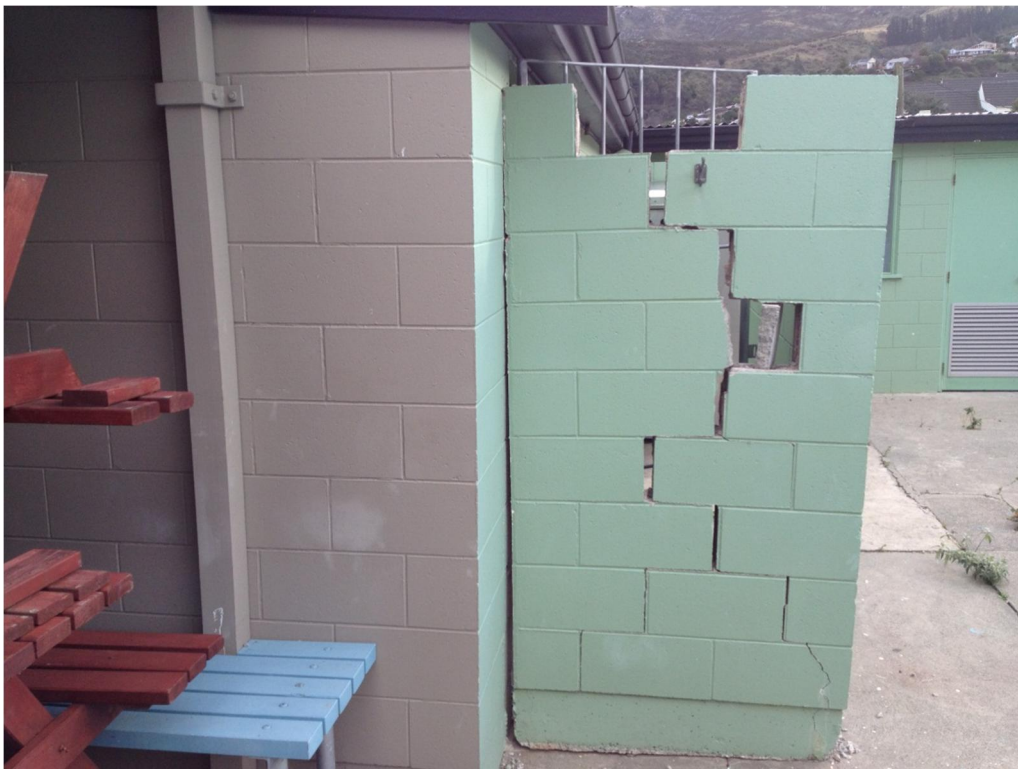
Photo 2: Entrance privacy wall of Ladies' Change Room.

- n Extensive cracking, dislodgement and separation of concrete masonry blocks at entrance and tilting of privacy wall.
- n Separation/movement between walls.
- n Stepped cracking in blocks and mortar joints in internal and external concrete masonry block walls throughout.
- n Cracking in concrete pavement near entrance.
- n Cracking in concrete retaining wall beneath south wall of building.
- n Horizontal cracking/opening of joint between concrete masonry block wall and concrete retaining wall on southern side.

No Critical Structural Weaknesses were identified for the Ladies' Change Room main building structure, however the entrance privacy wall appears to be of unreinforced concrete masonry construction.

Damage Description: Failure of wall, rotation/tilt.

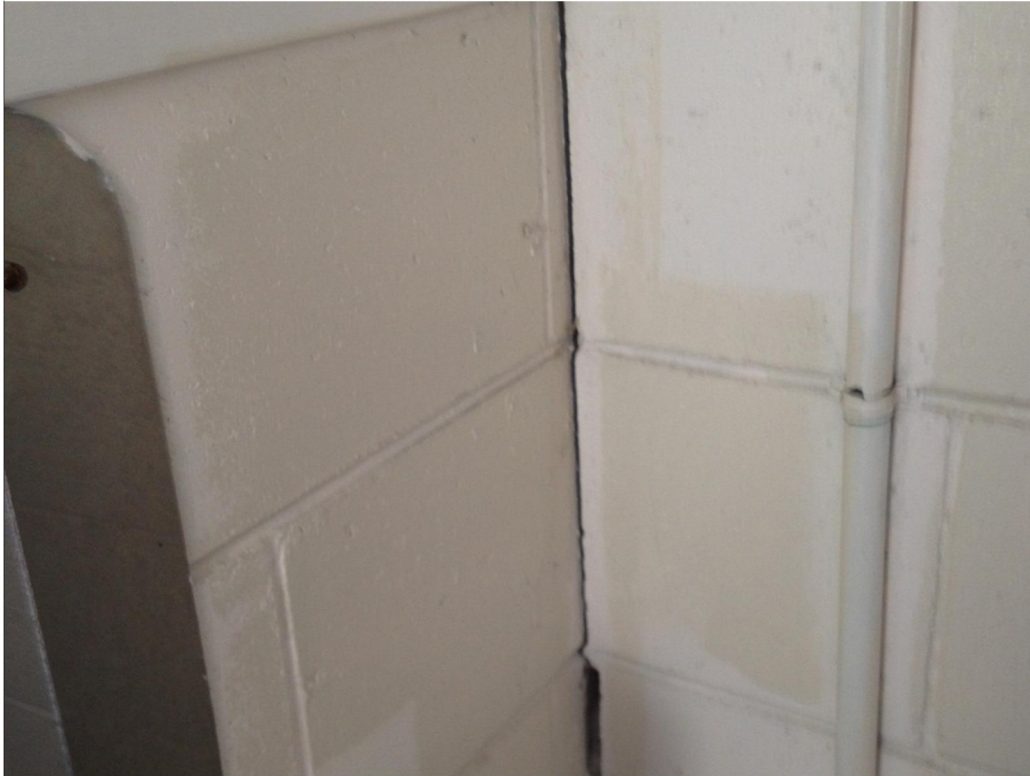
Photo 3: Adjacent internal walls.

Damage Description: Mortar cracking and separation of adjacent walls.

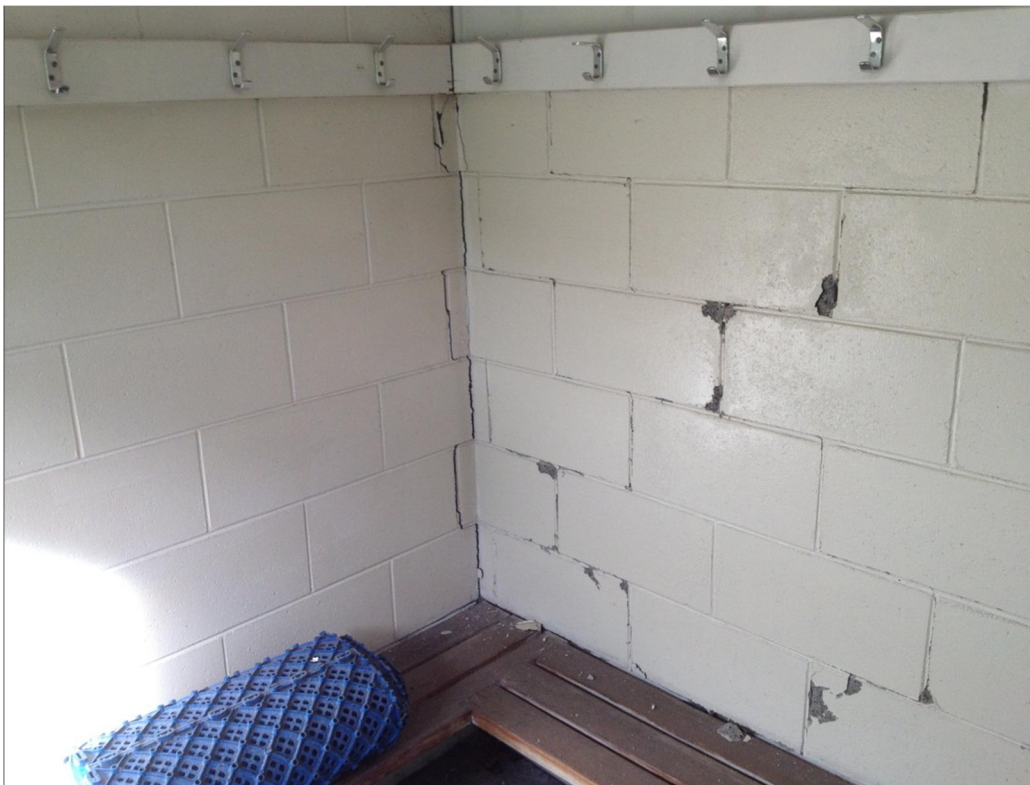
Photo 4: Change room internal walls.

Damage Description: Separation between adjacent internal walls, and stepped mortar cracking.

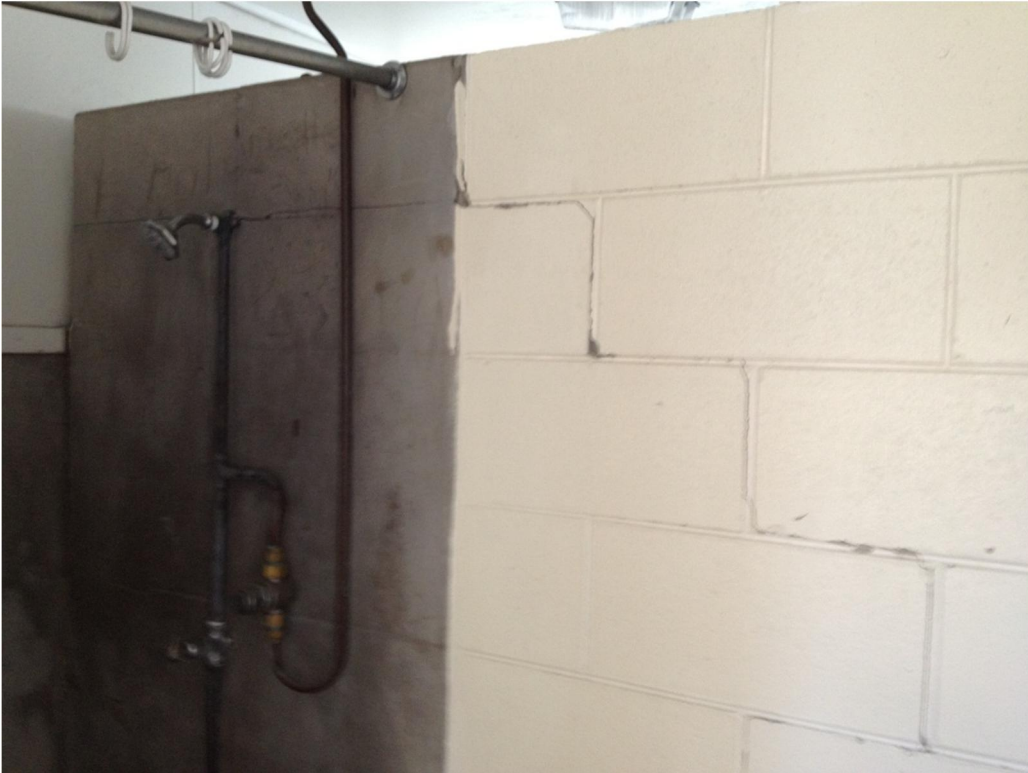
Photo 5: Internal partition wall.

Damage Description: Stepped mortar cracking of concrete masonry walls.

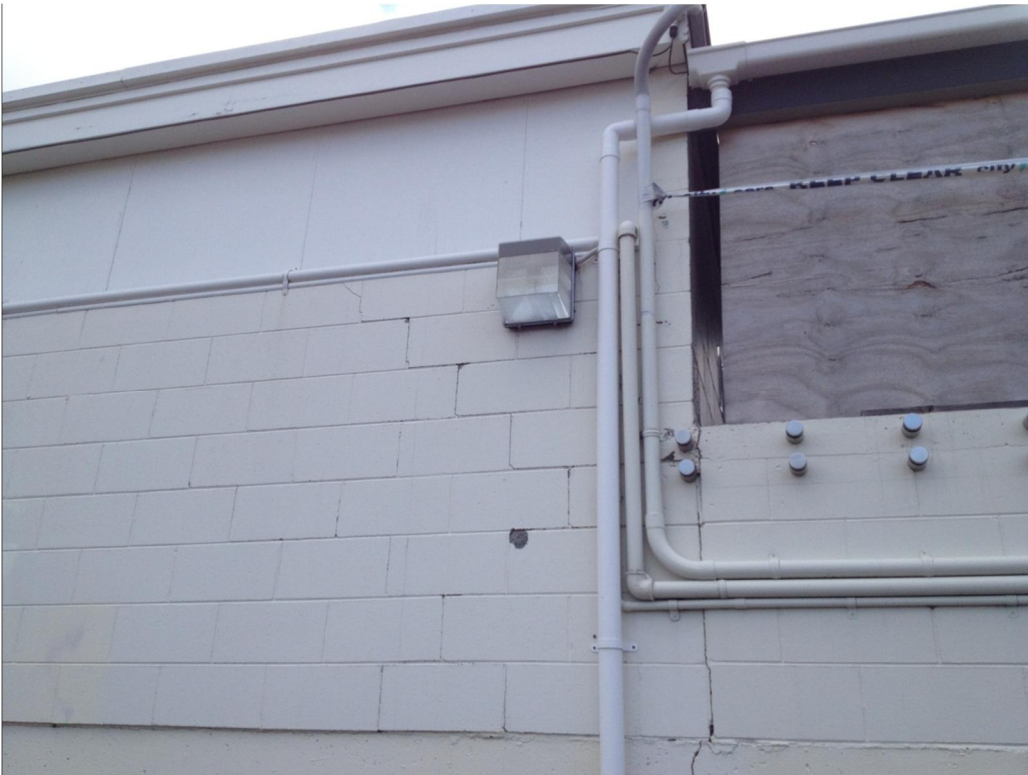
Photo 6: Southern concrete masonry block wall.

Damage Description: Cracking of mortar and concrete masonry block wall.

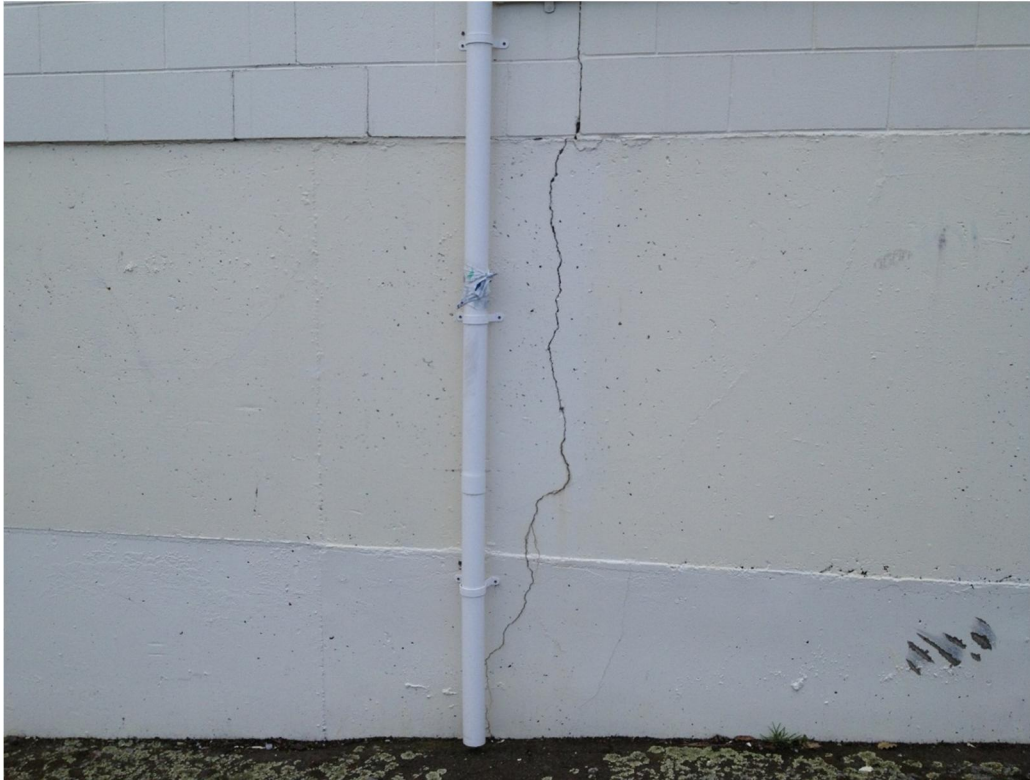
Photo 7: Concrete retaining wall on southern side of Ladies' Change Room.
Damage Description: Cracking of concrete retaining wall and concrete masonry mortar.

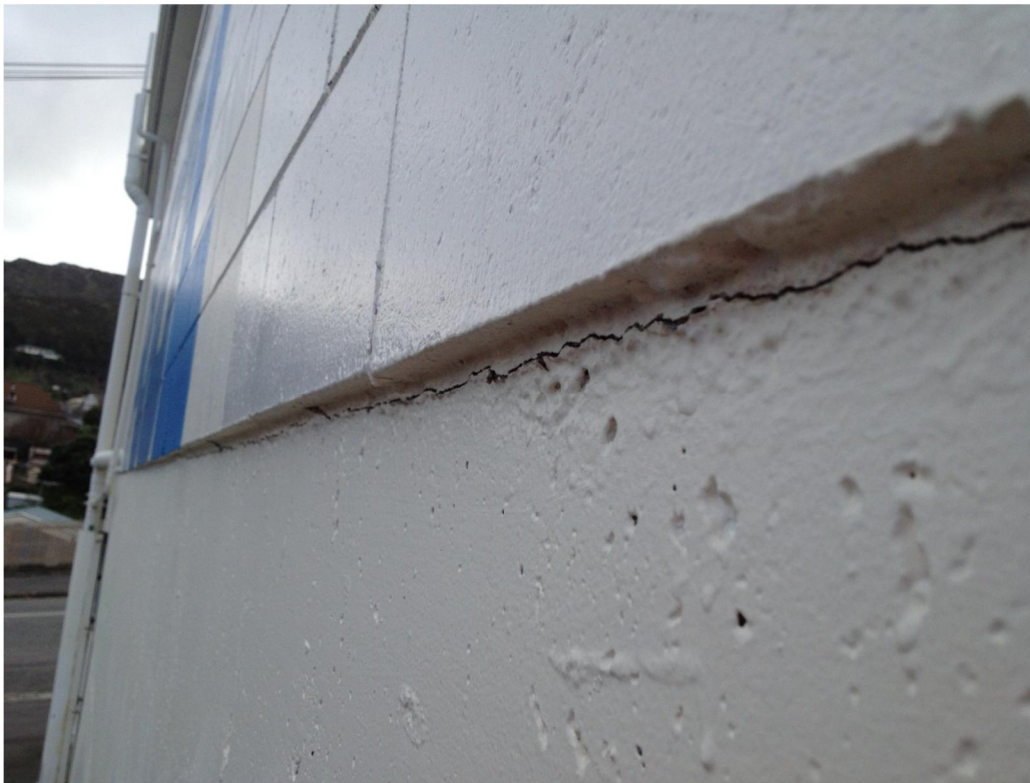
Photo 8: Junction between concrete retaining wall and concrete masonry block wall.
Damage Description: Cracking between masonry and concrete retaining wall on southern side.

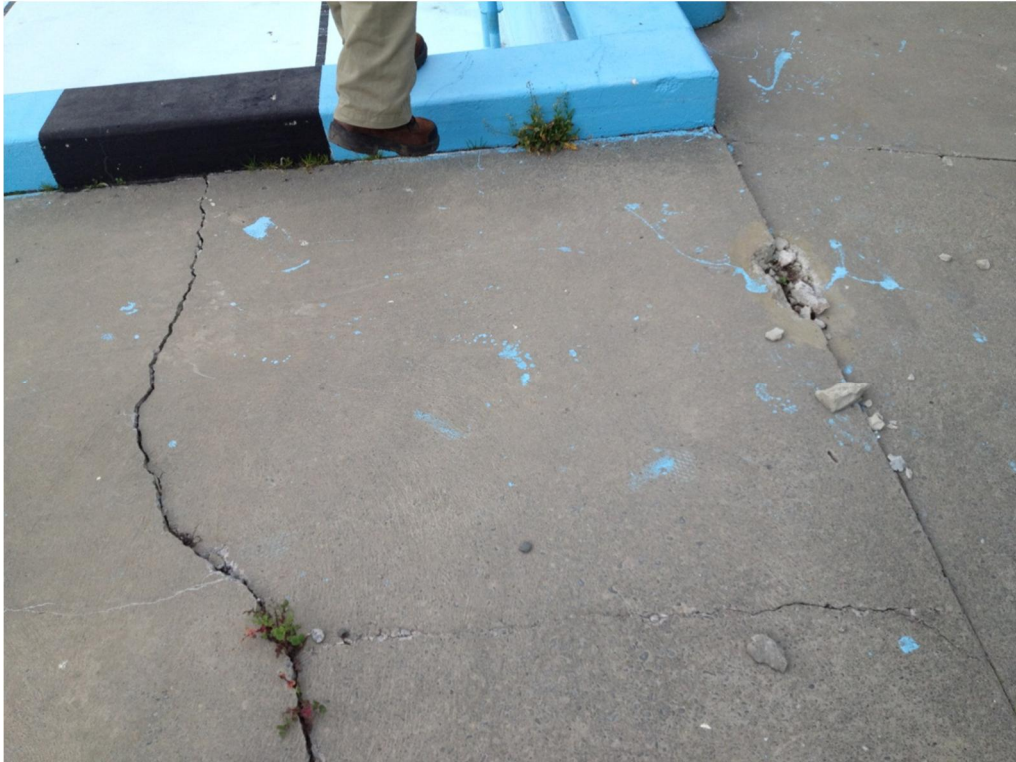
Photo 9: Pavement near Ladies' Change Room.
Damage Description: Cracking in concrete pavement.

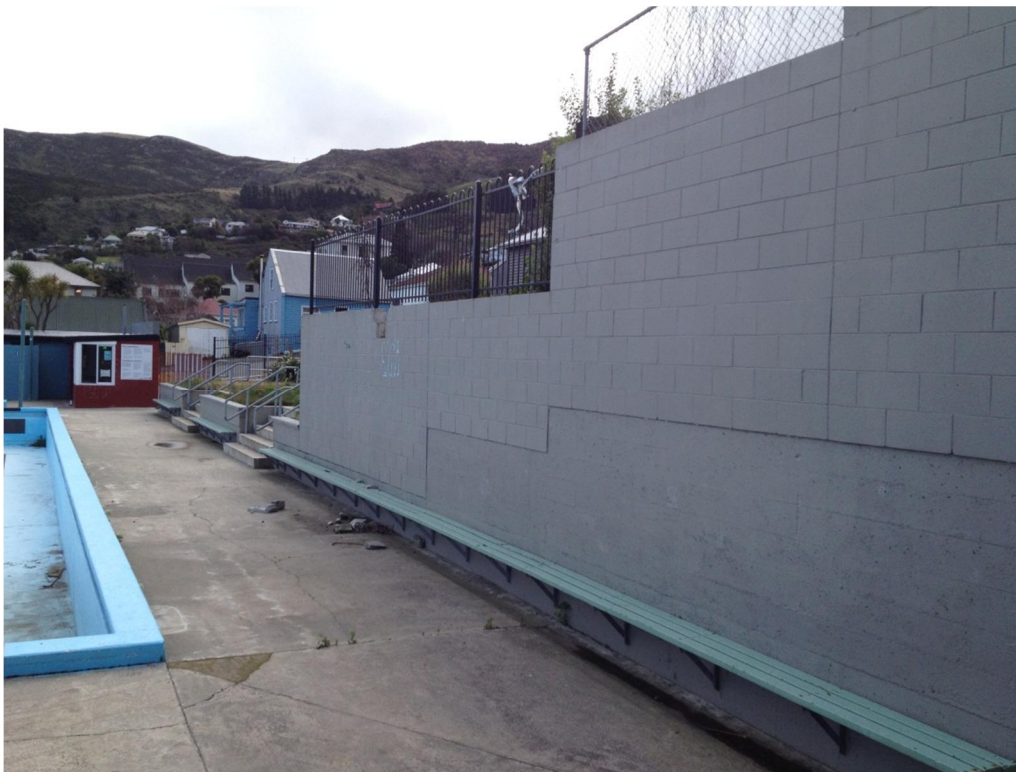
To the north side of the pool is a concrete retaining wall approximately 2m high with a 2m high concrete masonry block fence on top that is significantly damaged (refer Photo 10 and Photo 11 in Appendix A). The block fence section appears to be very lightly reinforced and has minimal fill. It appears likely that the block fence will need to be demolished and reconstructed with an appropriately engineered replacement.

Photo 10: Concrete retaining wall and concrete masonry block fence to the north of the pool (view from south-east).
Damage Description: Cracking and differential settlement of concrete masonry block wall.

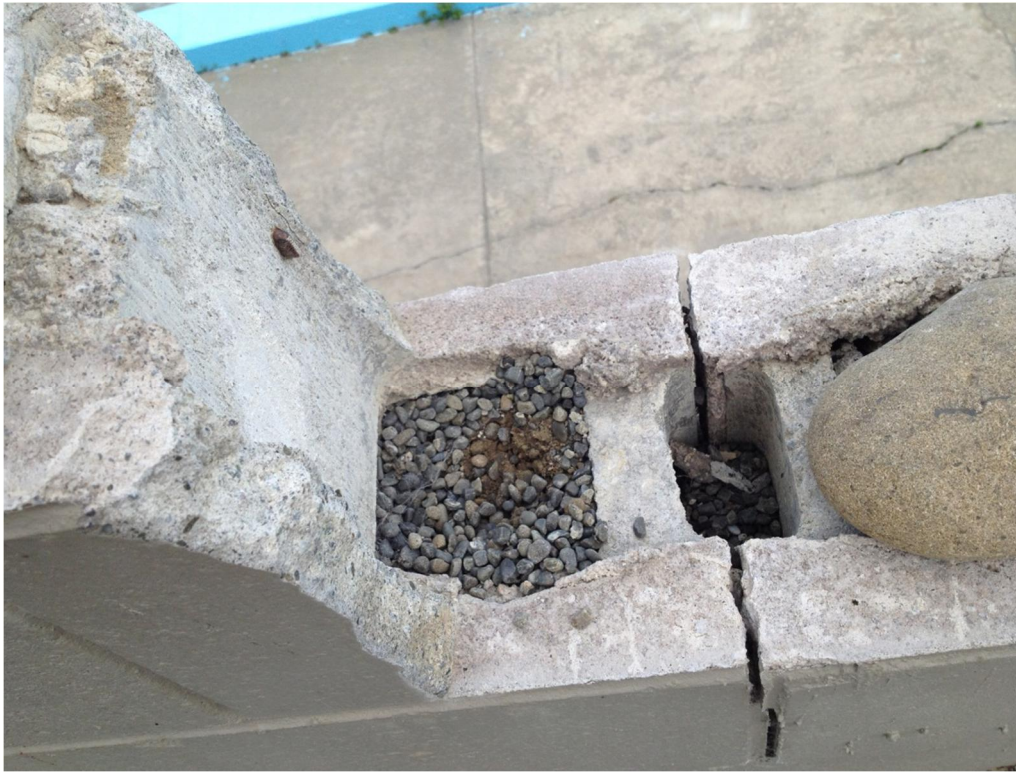
Photo 11: Concrete masonry fence to the north of the pool.

Damage Description: Cracked and dislodged concrete masonry units.
