CHRISTCHURCH CITY COUNCIL
PRK_2231_BLDG_001 EQ2
Packe Reserve Shed
129 Packe Street, Edgeware

QUALITATIVE ASSESSMENT REPORT
FINAL

- Rev B
- 23 May 2013

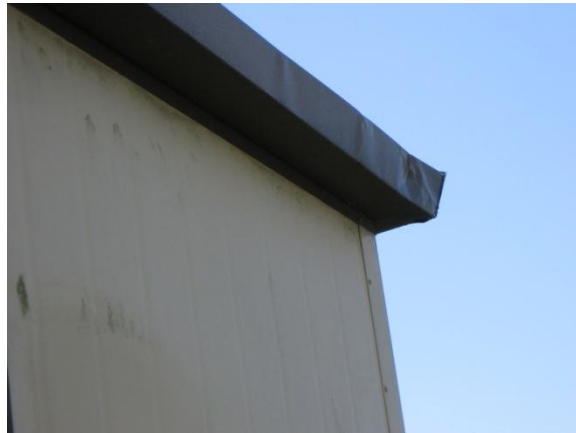
- 1) No earthquake-related damage was observed during our site inspection.
- 2) Gaps opening up between wall cladding elements. This is not believed to be earthquake-related damage.
- 3) Impact damage on gutter on the south side of the building. This is not believed to be earthquake-related damage.
- 4) Rusting of steel elements throughout the building. This is not earthquake-related damage.

Photo 5: Impact damage on south gutter

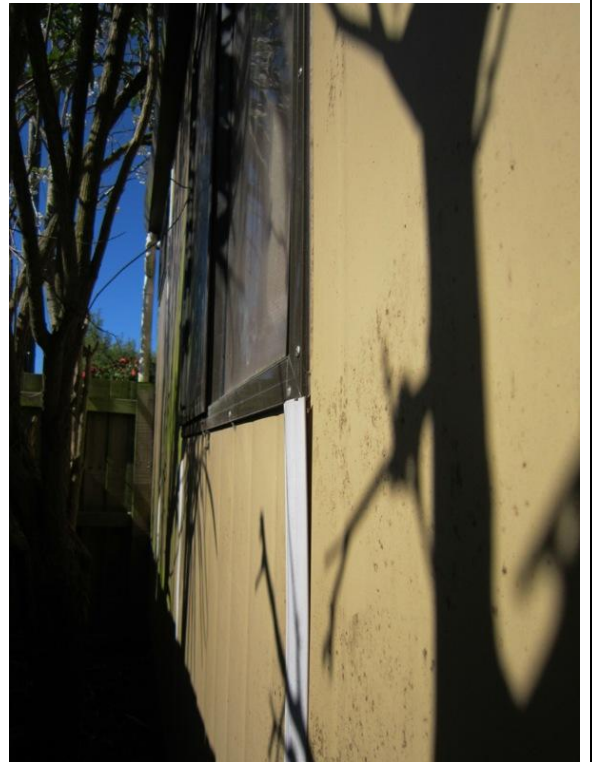
Photo 6: Gaps opening up between wall cladding elements

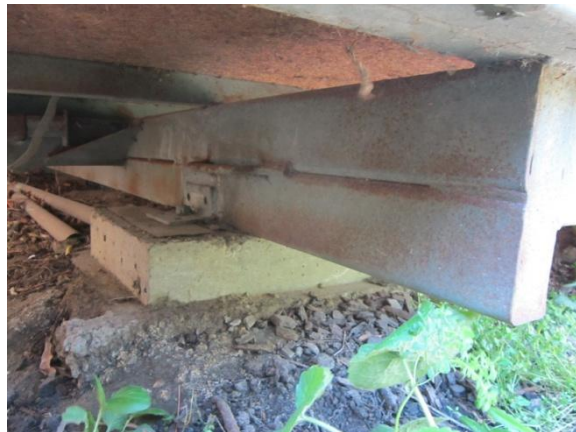
Photo 7: Foundation system showing rust on steel beam (typical)
