# CityCare Pages Road – Super Shed Detailed Engineering Evaluation BU 0879-017 EQ2 Quantitative Report

**Prepared for Christchurch City Council (Client)**

**By Beca Carter Hollings & Ferner Ltd (Beca)**

31 January 2014

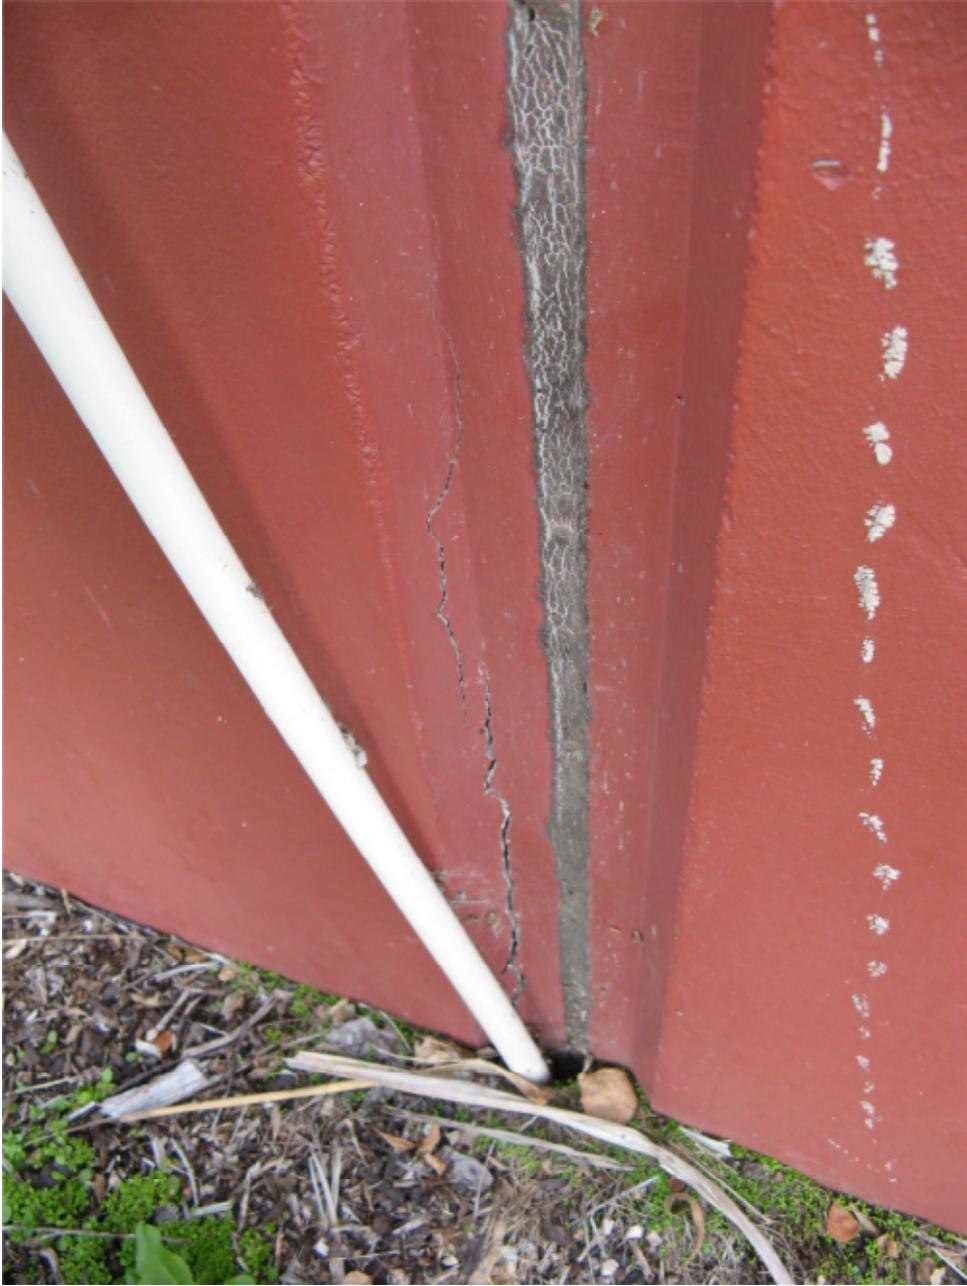
**Photo 8:** Typical cracking to concrete wall panel.

**Damage Description:** Cracking to concrete wall panel adjacent to joint.

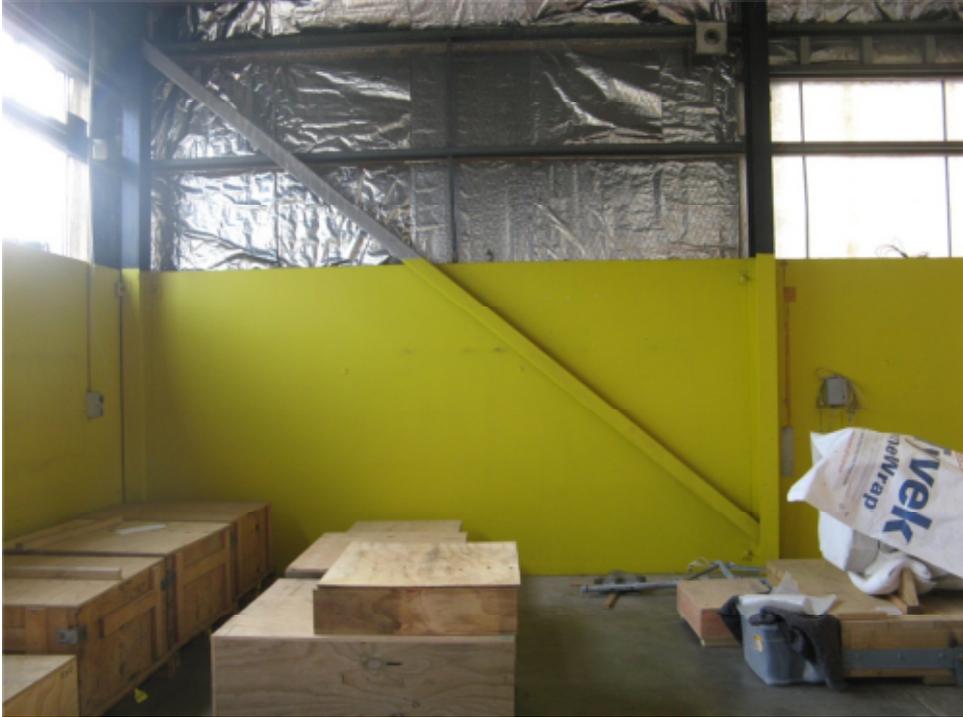
**Photo 9:** Tension/Compression brace with large connection eccentricities at each end.

- Intrusive investigations should be conducted to determine if there is vertical (wall) bracing below the mezzanine floor structure.
- A repair methodology should be developed for the braced columns where damage has occurred.

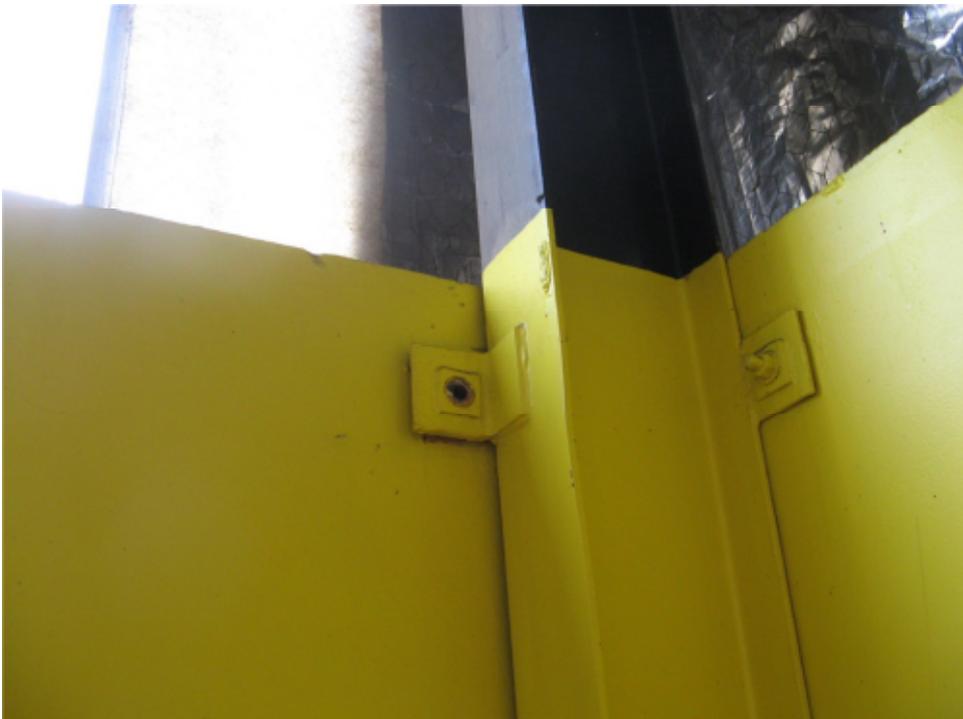
**Photo 10:** Panel connection with missing bolt at north corner of building.

**Damage Description:** Possible shear failure of bolt.

- Immediate and temporary repairs completed to the connections between the precast concrete cladding panels and steel portal frames, that have been installed to address the immediate falling hazard, should be reviewed and replaced, as required, with an appropriate long term solution.

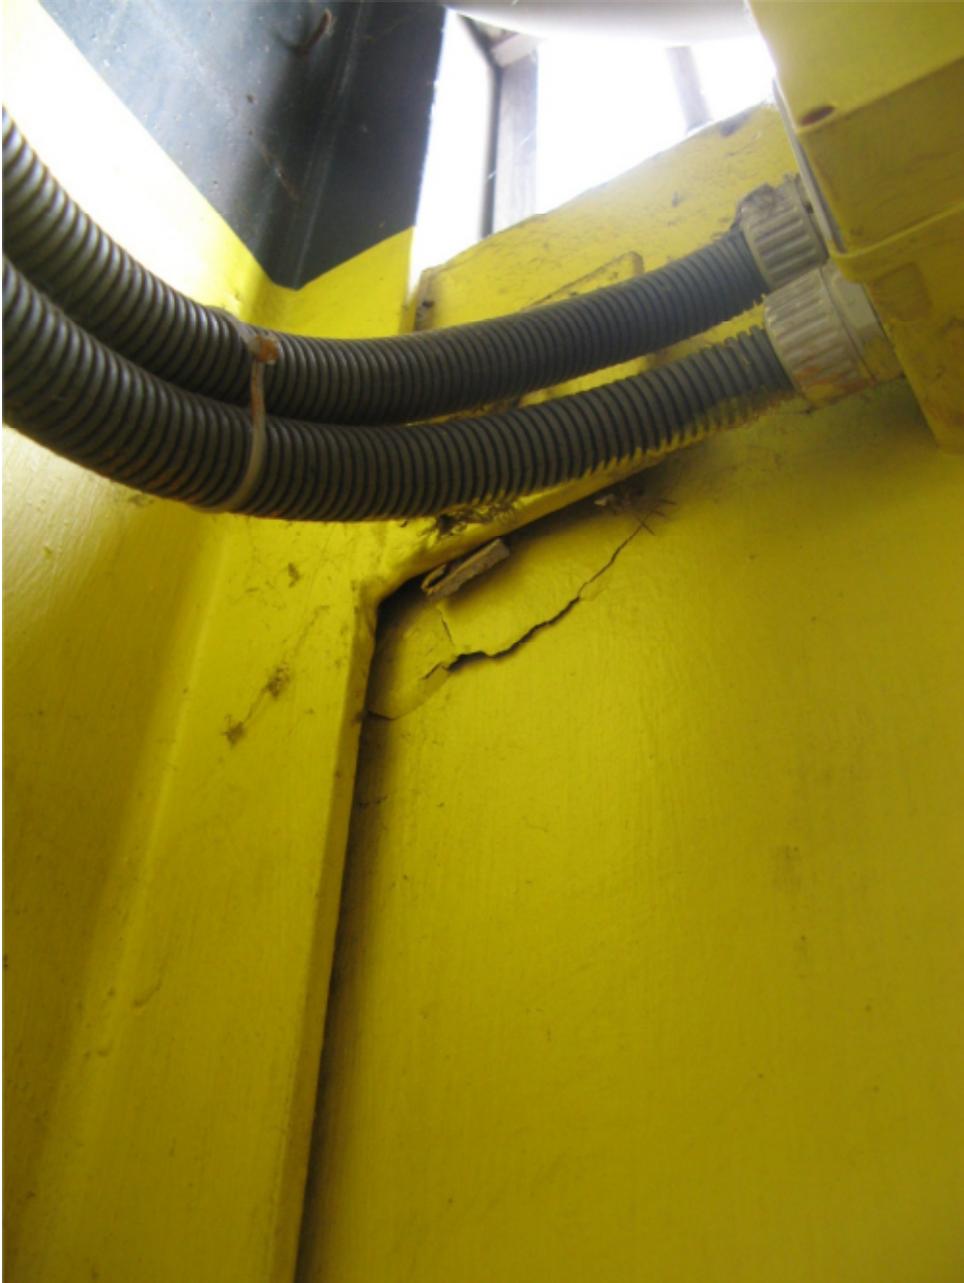
**Photo 11:** Panel connection with concrete spalling.

**Damage Description:** Possible shear/pull out failure of bolt/concrete panel.

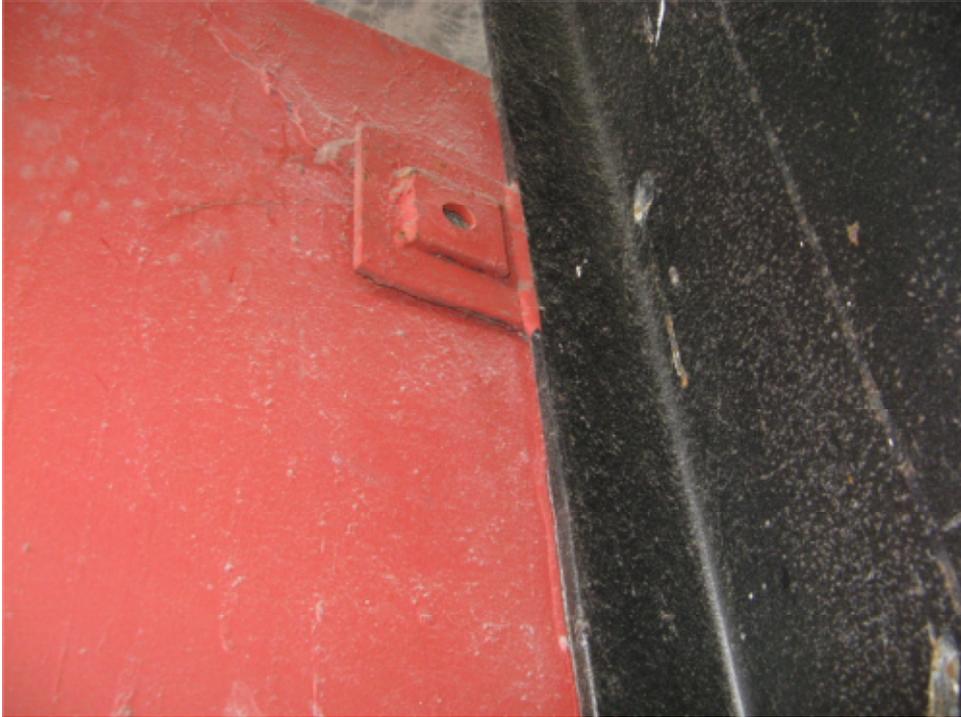
**Photo 12:** Panel connection with missing bolt at southern corner of building.

**Damage Description:** Possible shear failure of bolt.

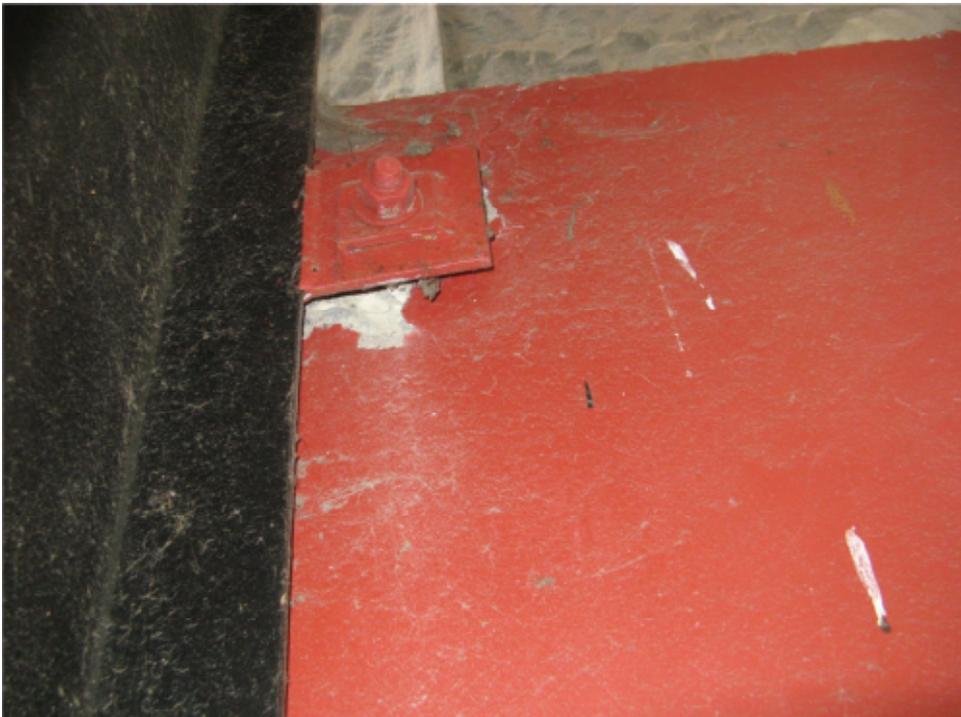
**Photo 13:** Panel connection with concrete spalling at southern corner of building.

**Damage Description:** Possible shear failure of bolt/panel.

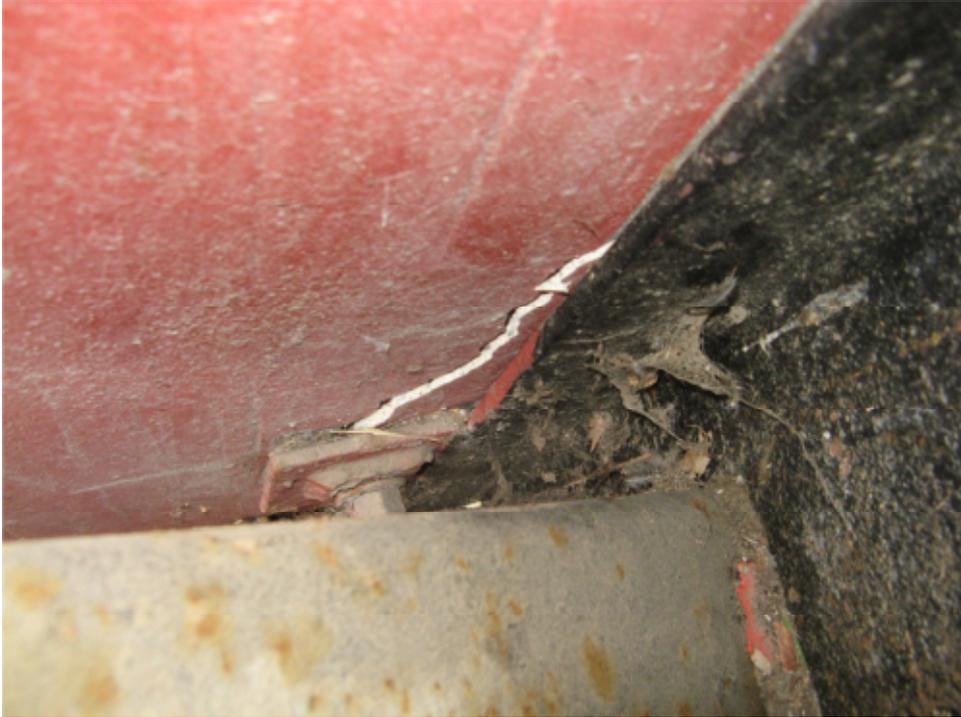
**Photo 14:** Panel connection with concrete cracking at southern corner of building.

**Damage Description:** Possible shear failure of bolt/concrete panel.

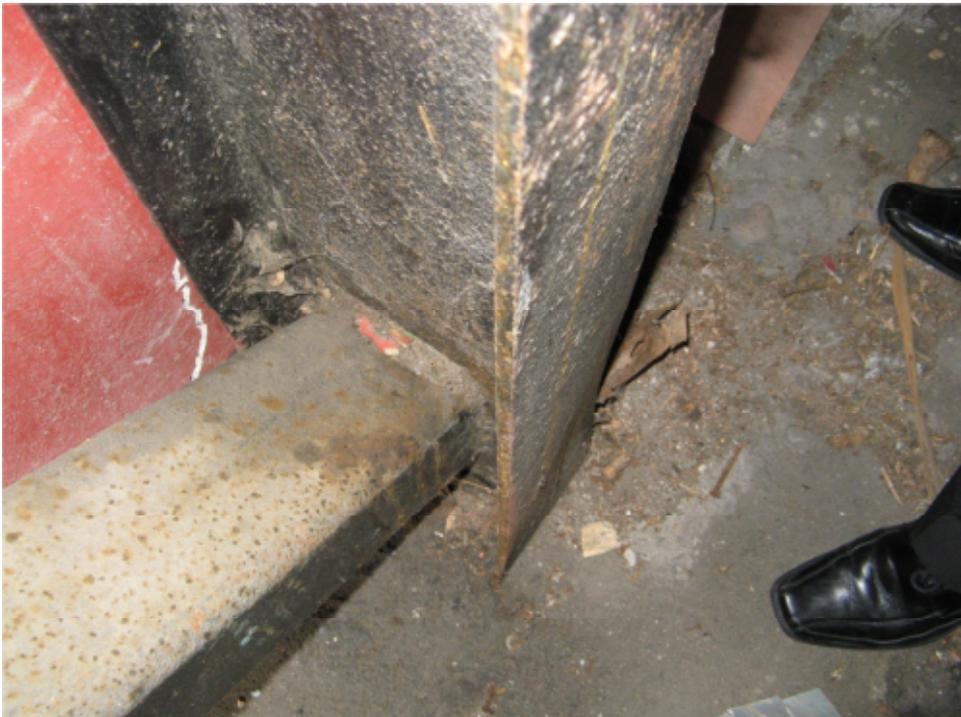
**Photo 15:** Tension/compression brace connection at southern corner of building.

**Damage Description:** Local bending of web and flange.

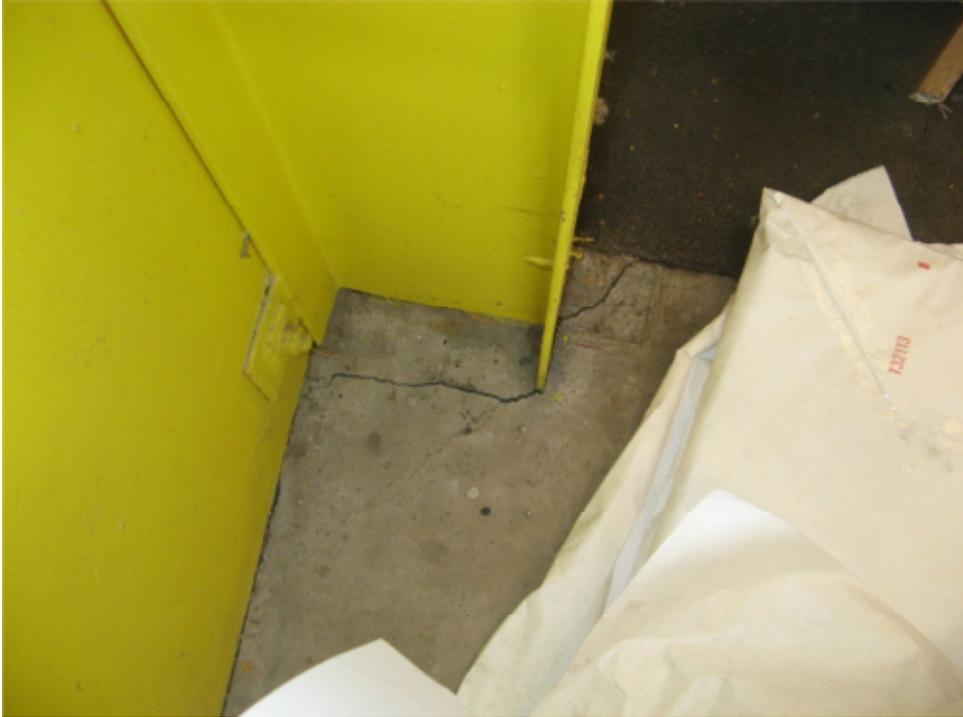
**Photo 16:** Typical cracking to concrete slab.

**Damage Description:** Cracking to concrete slab at column locations.

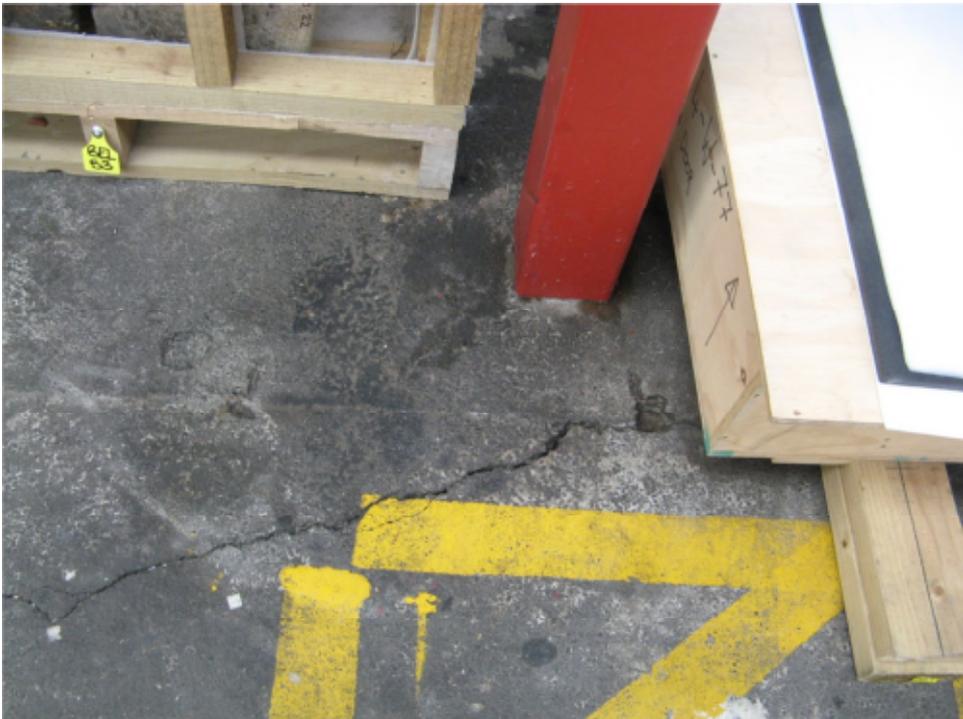
**Photo 17:** Cracking to asphalt pavement.

**Damage Description:** Cracking to asphalt pavement at column location.

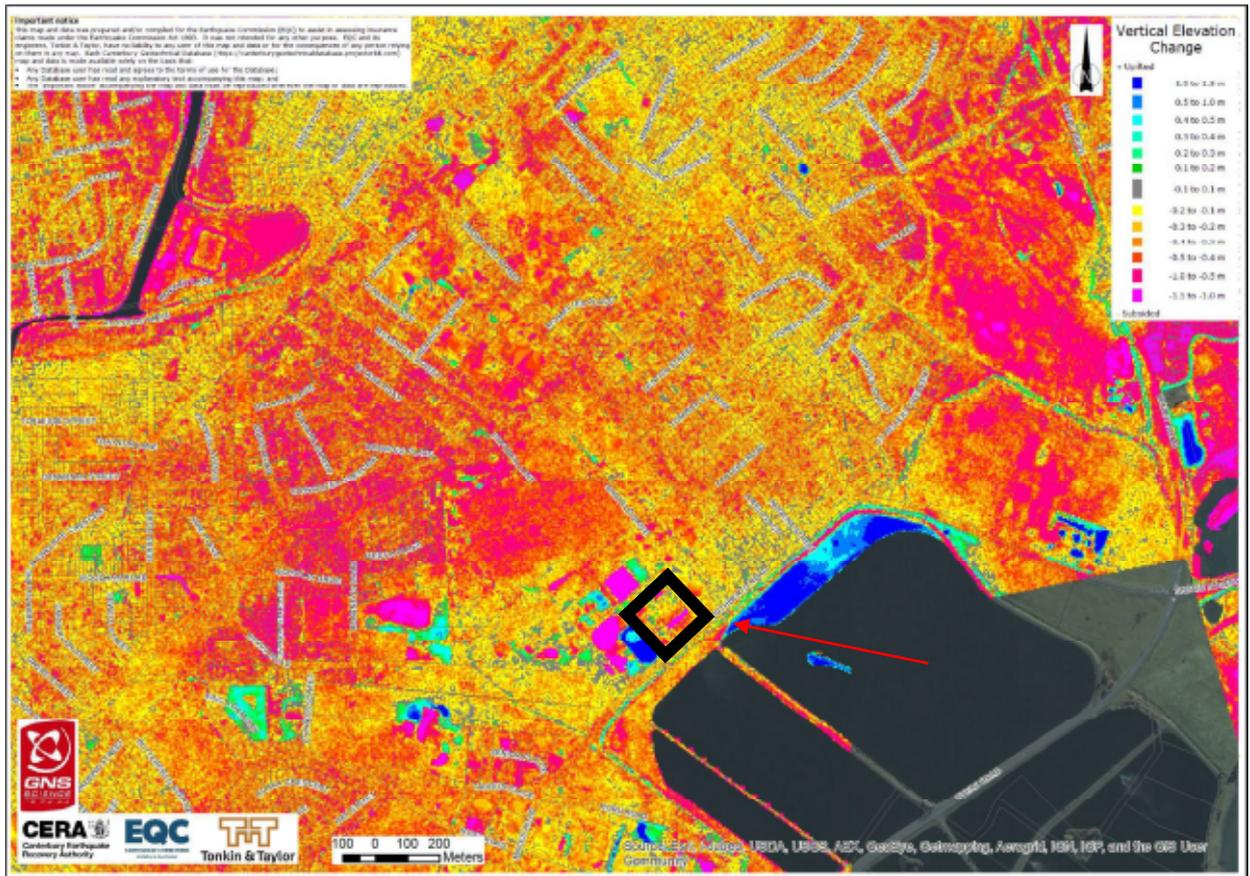
**Photo 18:** CERA published change in ground elevation between LiDAR in July 2003 and February 2012, with regional tectonic component of ground displacement removed. Approximate location of Supershed shown.

- A full damage assessment is carried out for insurance purposes.
- Based on CERA published ground elevation changes (refer Photo 16 in Appendix A) it is estimated that the ground level of the Supershed changed in the order of 200 – 300 mm. Aerial reconnaissance of the site on 24 February 2011 indicates widespread liquefaction occurred in the surrounding area, but our visual inspection found no signs of major differential settlement. A verticality and level survey could be carried out to determine the extent of settlement of the building for insurance purposes.

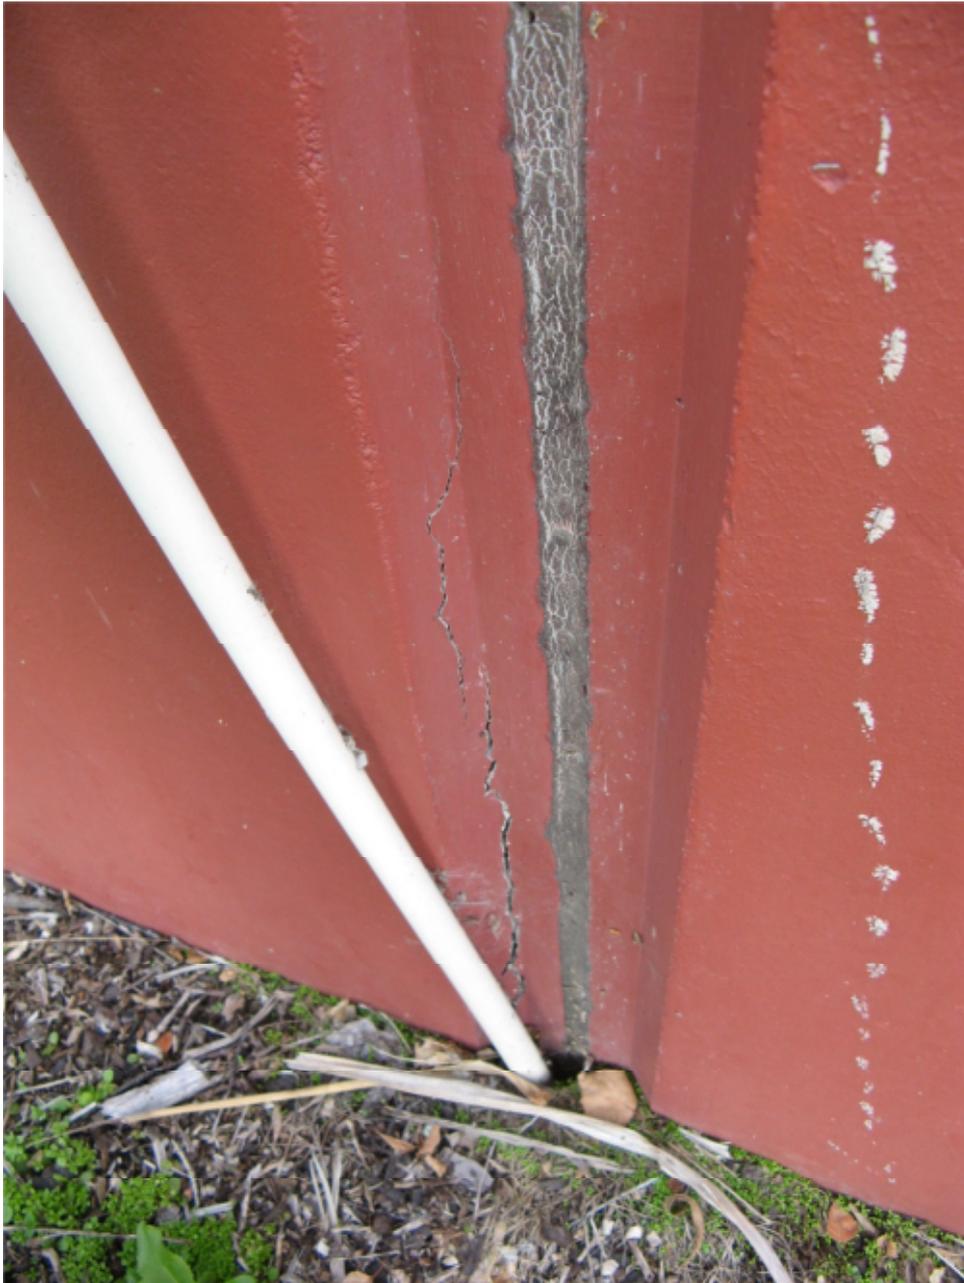
**Photo 8:** Typical cracking to concrete wall panel

**Damage Description:** Cracking to concrete wall panel adjacent to joint

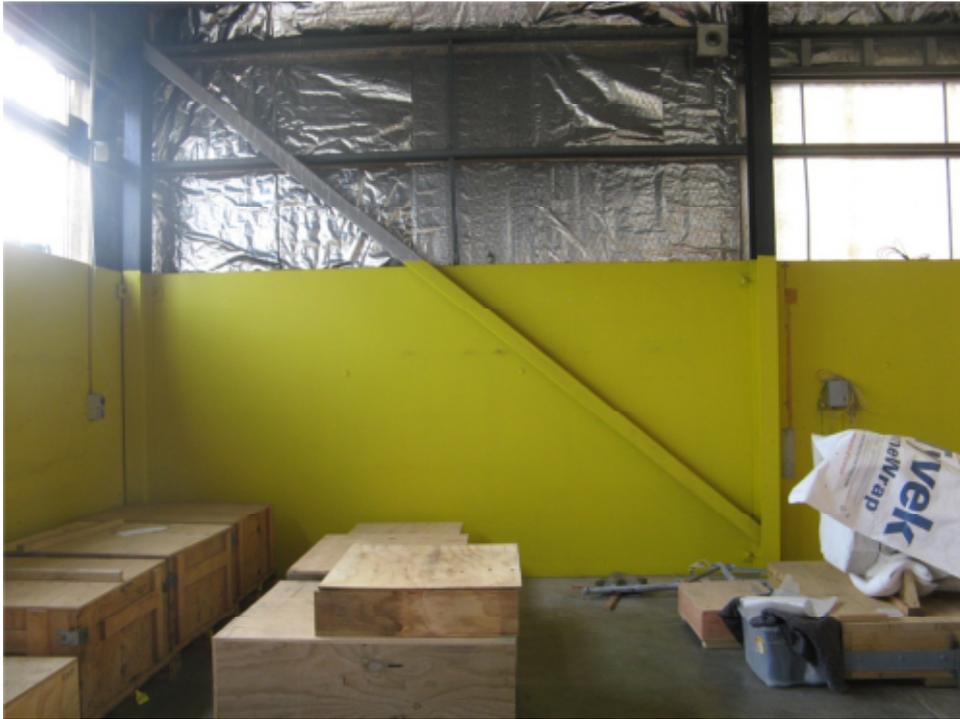
**Photo 9:** Tension/Compression brace with large connection eccentricities at each end

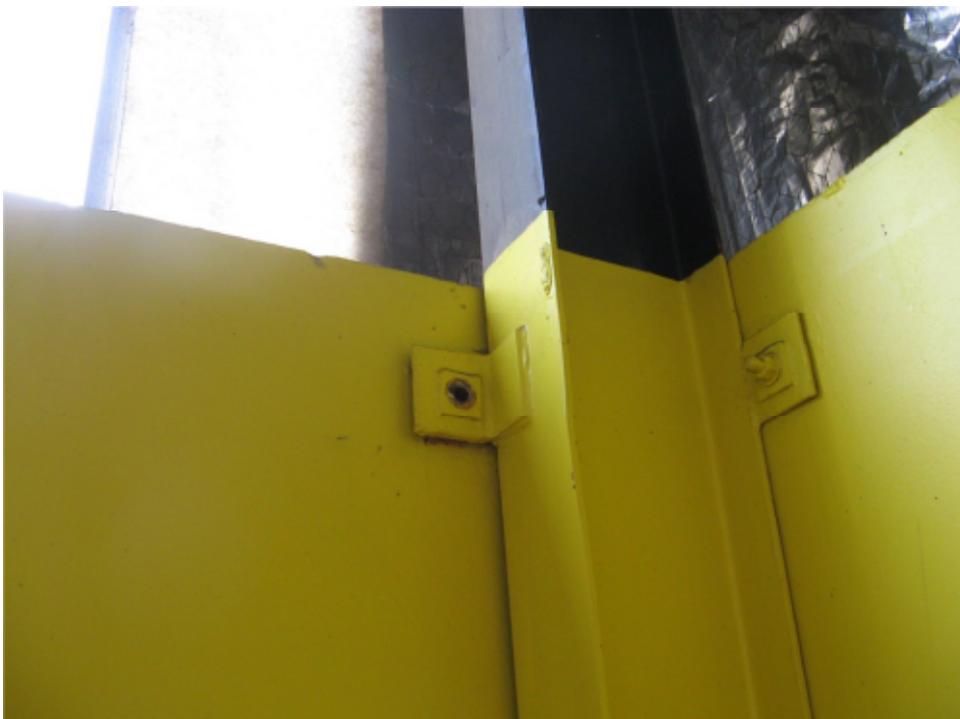
**Photo 9:** Panel connection with missing bolt at north corner of building

**Damage Description:** Possible shear failure of bolt.

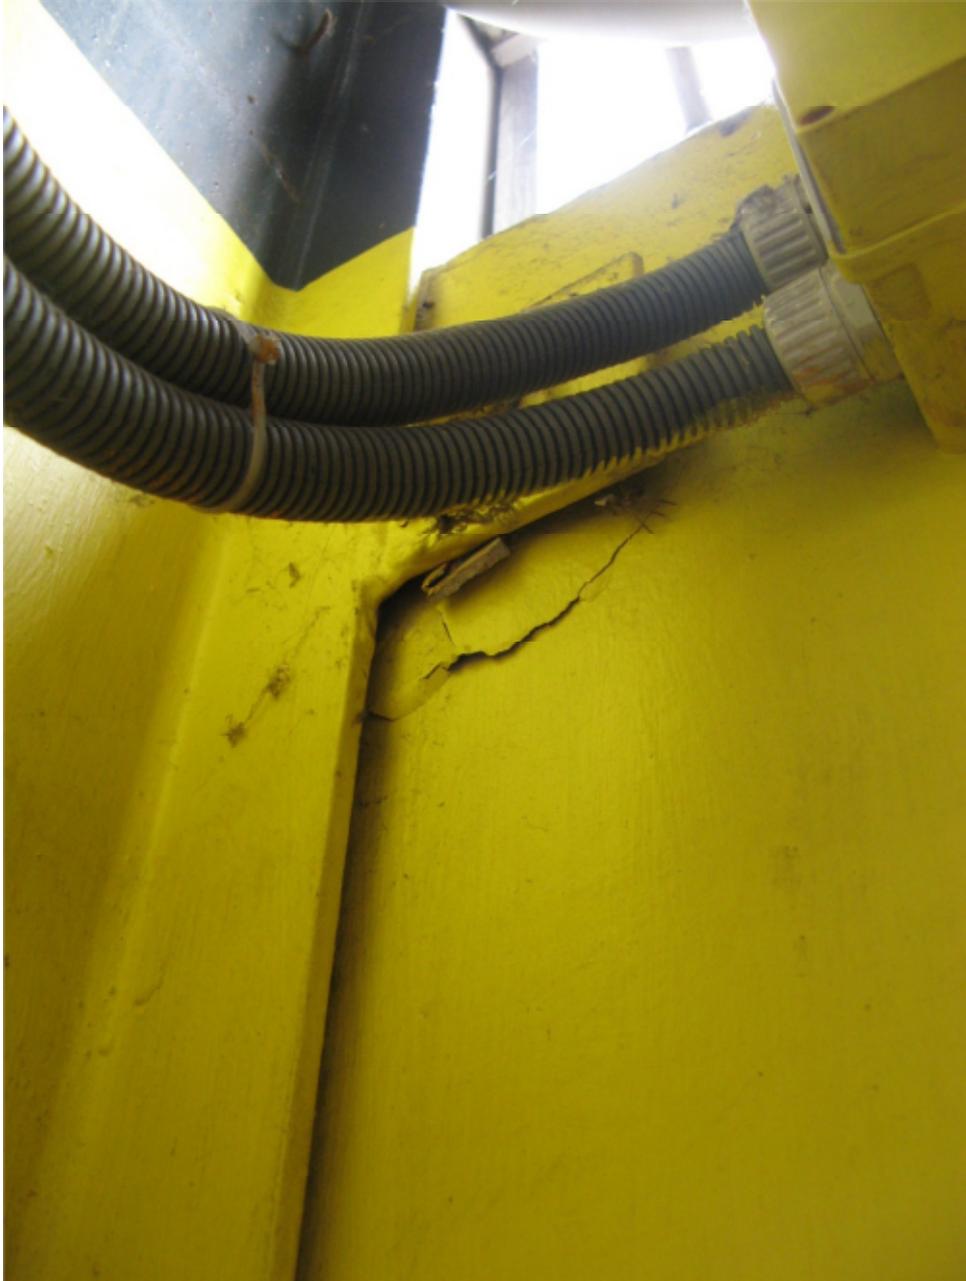
**Photo 10:** Panel connection with concrete spalling

**Damage Description:** Possible shear/pull out failure of bolt/concrete panel

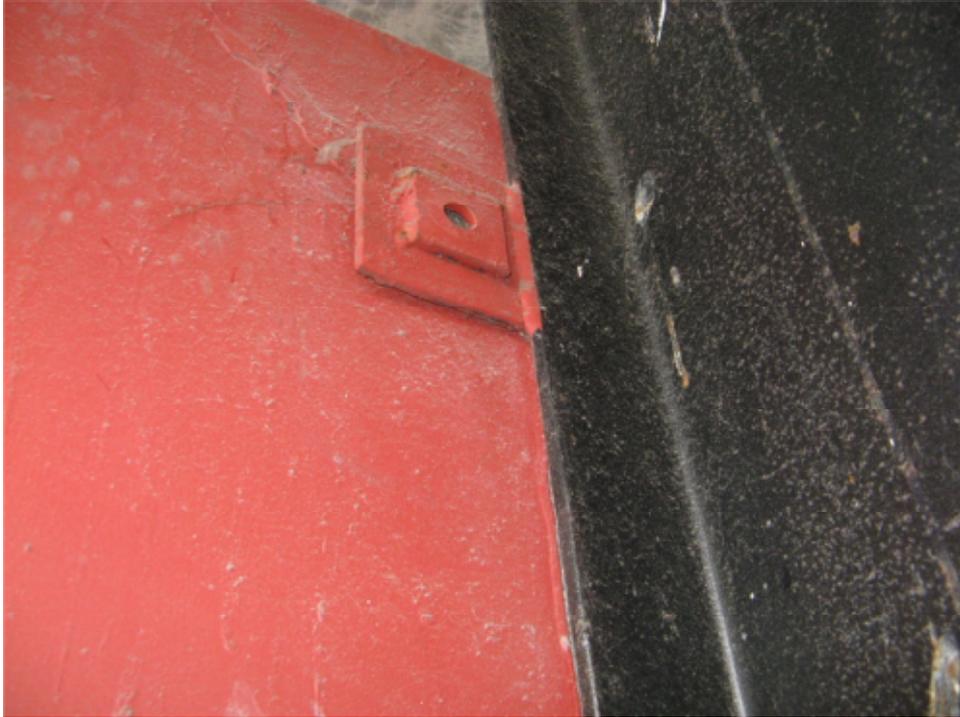
**Photo 11:** Panel connection with missing bolt at southern corner of building

**Damage Description:** Possible shear failure of bolt

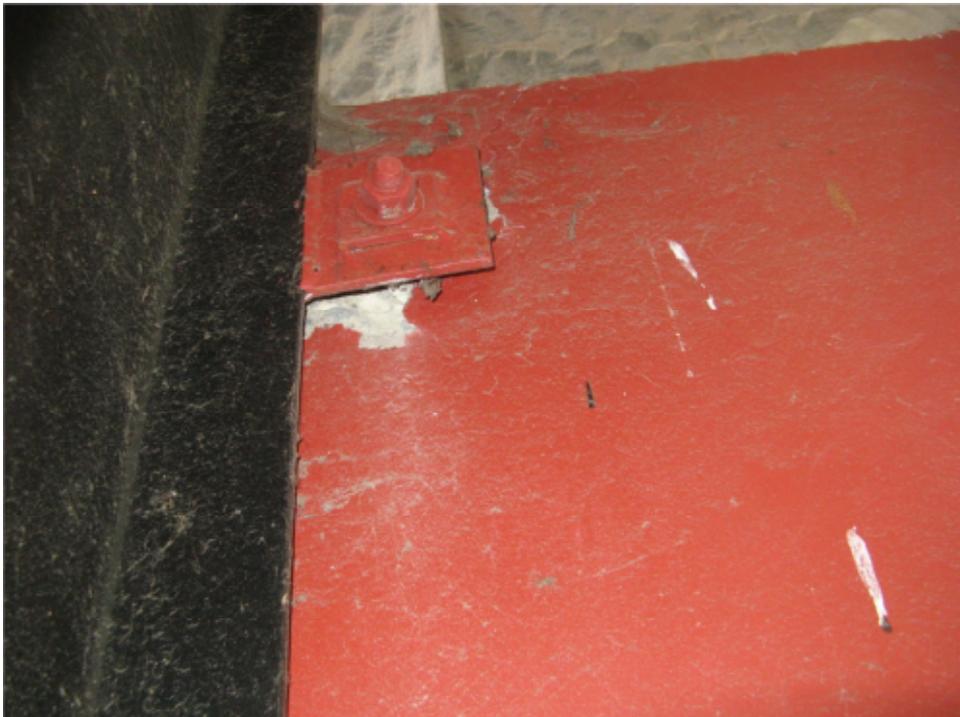
**Photo 12:** Panel connection with concrete spalling at southern corner of building

**Damage Description:** Possible shear failure of bolt/panel

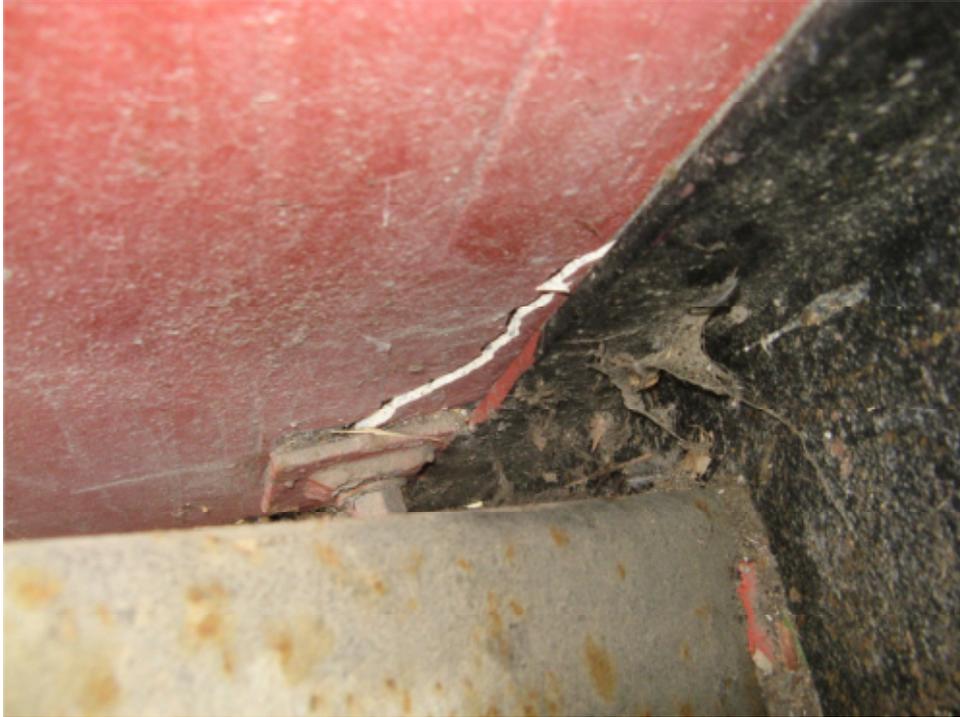
**Photo 13:** Panel connection with concrete cracking at southern corner of building

**Damage Description:** Possible shear failure of bolt/concrete panel

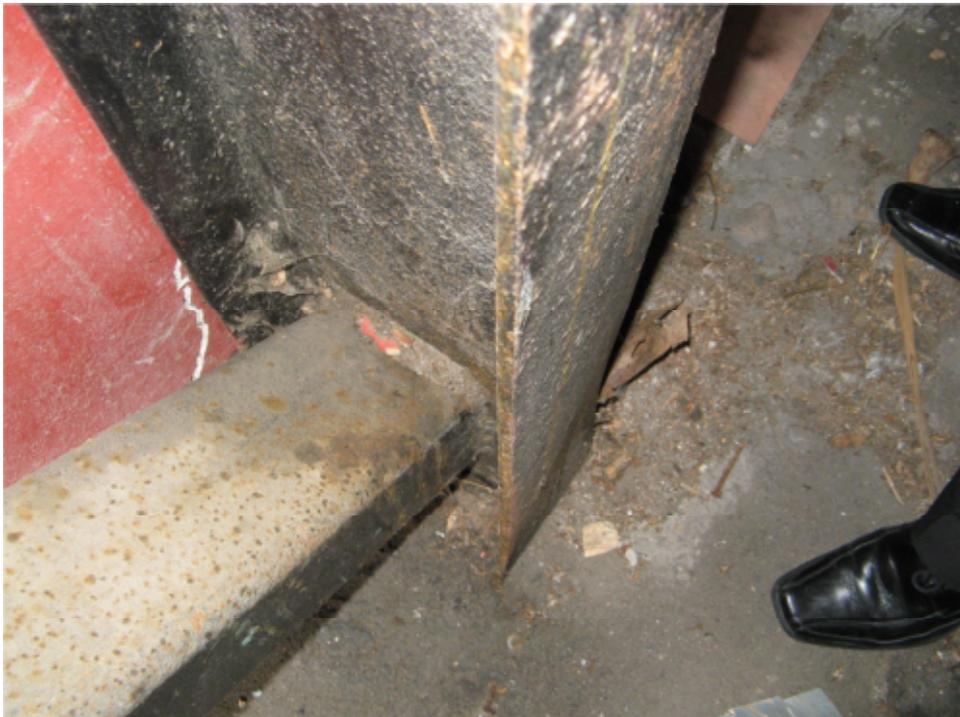
**Photo 14:** Tension/compression brace connection at southern corner of building

**Damage Description:** Local buckling of web and flange

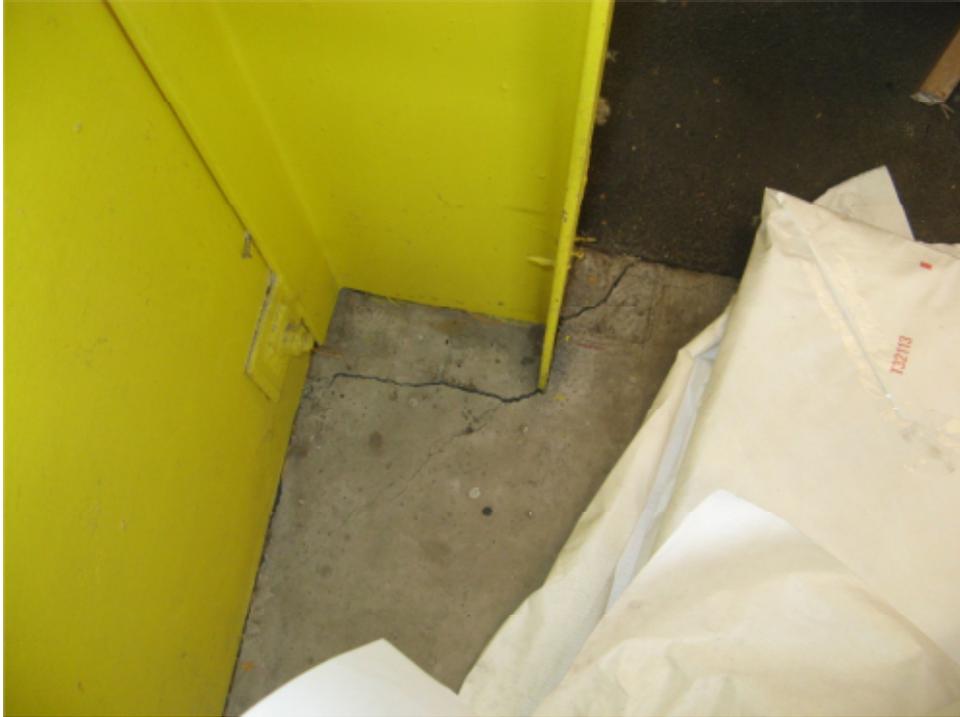
**Photo 15:** Typical cracking to concrete slab

**Damage Description:** Cracking to concrete slab at column locations

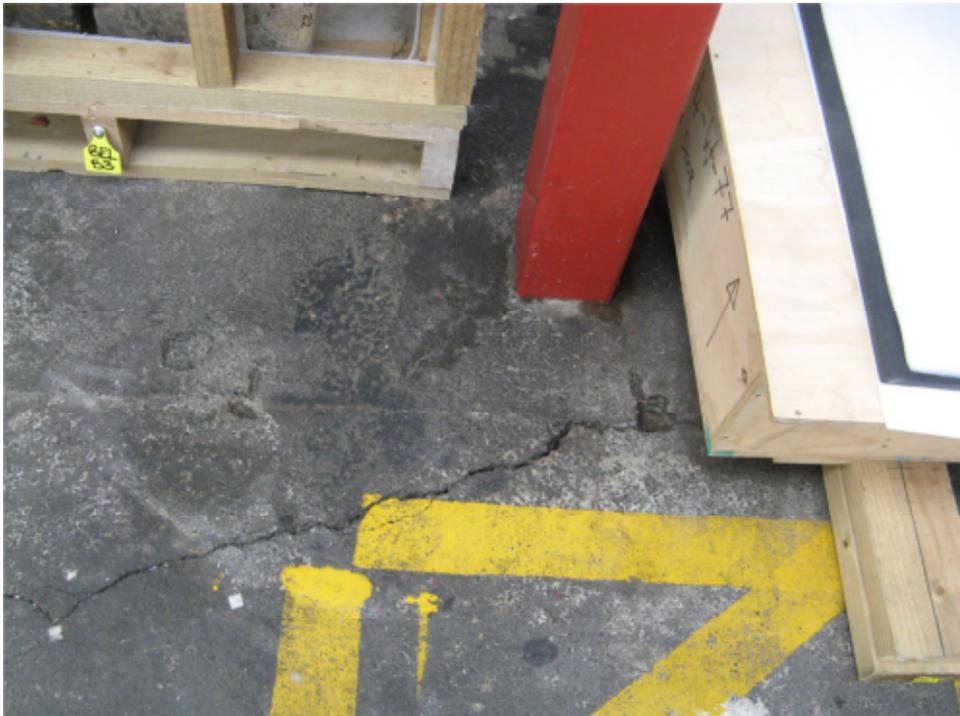
**Photo 15:** Cracking to asphalt pavement

**Damage Description:** Cracking to asphalt pavement at column location.
