Palliser Place Housing Complex PRO 0327

**Detailed Engineering Evaluation
Quantitative Assessment Report**

Palliser Place Housing Complex Quantitative Assessment Report

Date: January 2014
Reference: 6-QC387.00
Status: Final

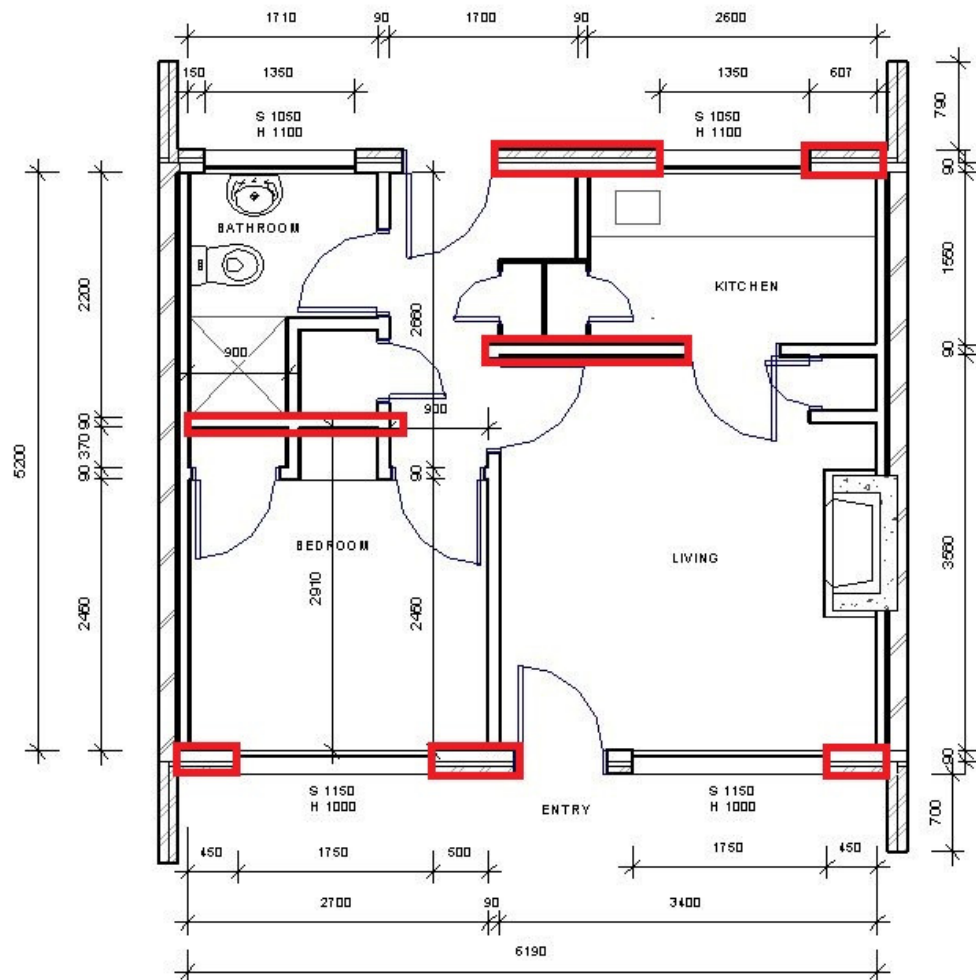
Figure 6: Walls used for bracing in the longitudinal direction.

The residential units have a capacities of 72% NBS as limited by the in-plane shear capacity of the timber-framed shear walls in the longitudinal direction.

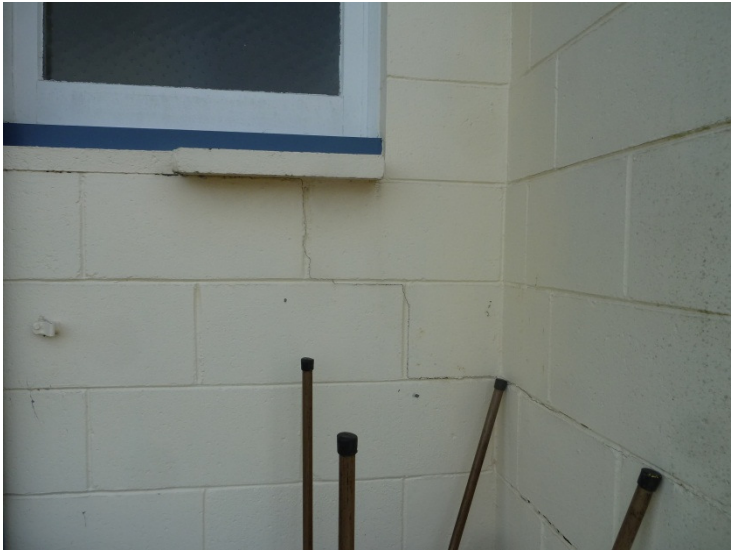
Stepped cracking in the concrete block veneer exterior cladding mortar joints was observed on the exterior of only a couple of units (Photo 9).

9.	Stepped cracking of blockwork. Occurs in only a few locations

- Veneer at height (gable ends) have the veneer ties checked
- Concrete perimeter footings be repaired on blocks where severe cracking occurs.
- Cosmetic repairs be undertaken as required.

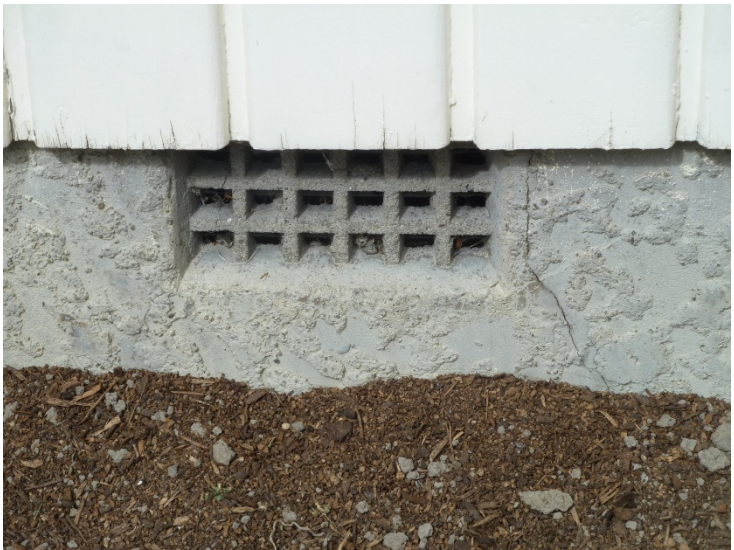
Minor hairline cracking of the concrete perimeter foundation footing was observed in some of the buildings (Photo 10).

10.	Hairline crack to concrete perimeter footing

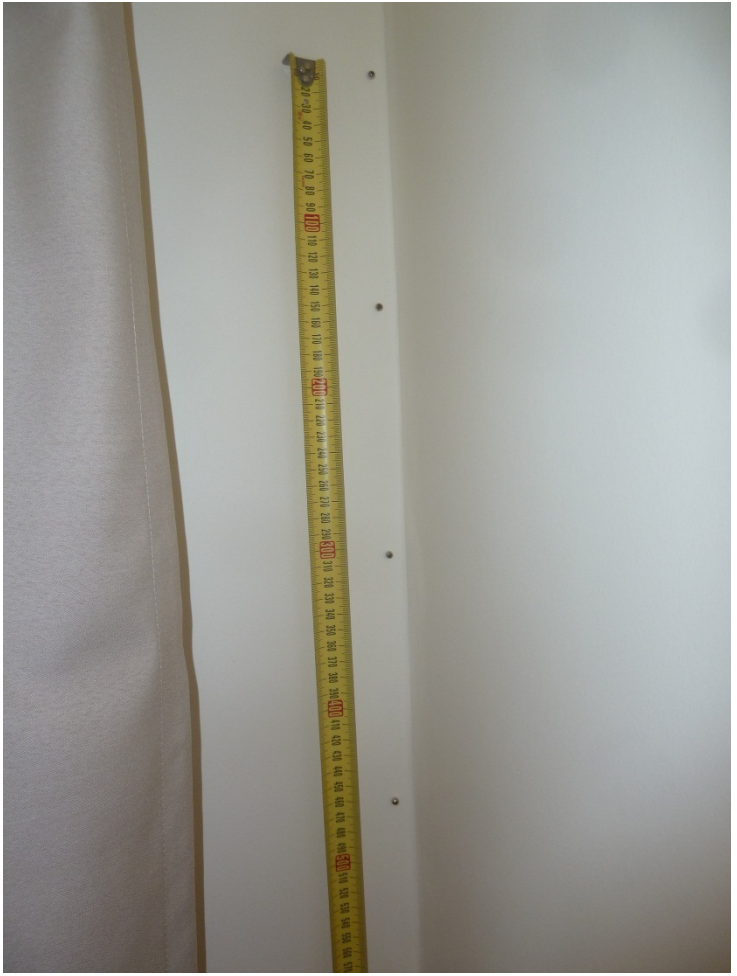
Increasing the number of nails in the plasterboard will not significantly improve the strength of the buildings.

11.	Typical spacing of interior lining fixings
