Toilets by Tennis Courts, Rawhiti Domain  
PRK 2004 BLDG 002 EQ2  
Detailed Engineering Evaluation  
Qualitative Report  
Version FINAL

Christchurch City Council

**Date**  
07<sup>th</sup> March 2013

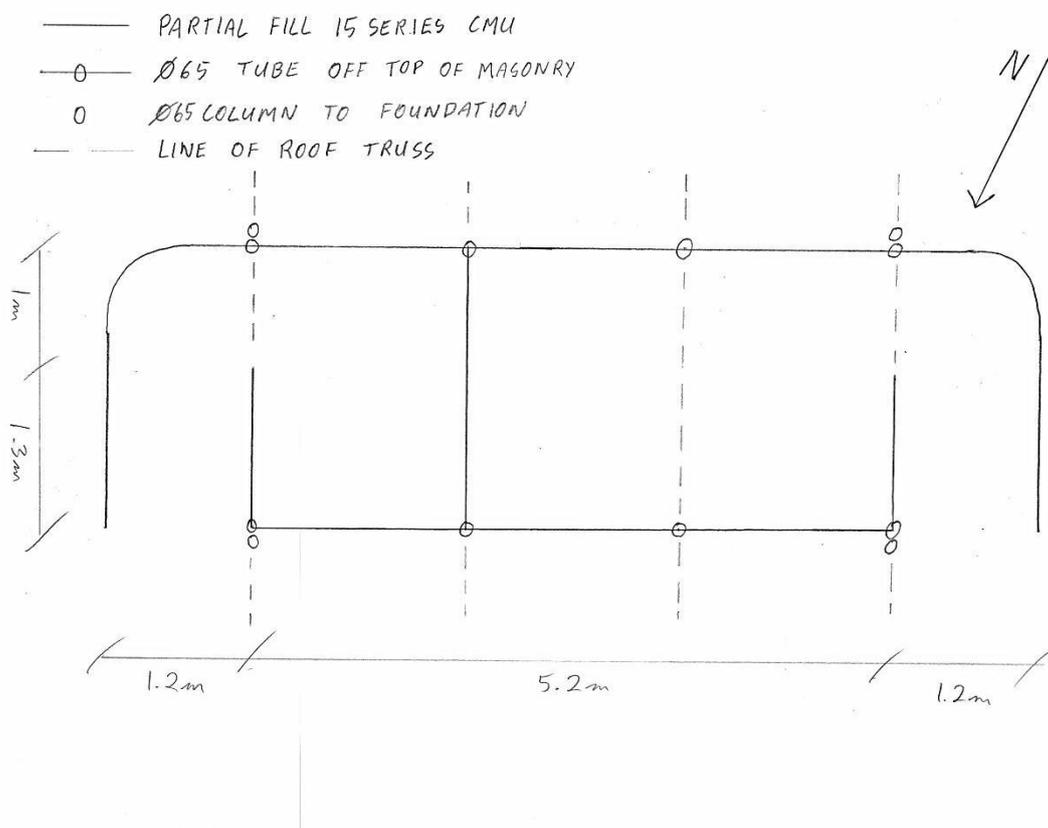
**Figure 2 Plan Sketch Showing Key Structural Elements**

The building roof is formed from curved steel corrugate sheets on a rigid steel tube purlin and truss frame. The roof frame has steel tube columns extending to foundations at each corner, however each truss is individually supported by steel tubes extending into the 15 series partial fill external masonry walls. Wall construction is consistent throughout. The floor is most likely formed by a slab on grade.

Excluding entrance wing walls, the roofed structure is approximately 5.2m in length and 2.3m in width with a height of 3.4m. The building occupies an approximate footprint of 12m<sup>2</sup> and is located over 20m from the nearest structure. The flat site is situated 500m west of the coast and 800m north of Avon River, and consists of many public amenities including golf course, oval, athletic track, tennis courts, club house and playground.

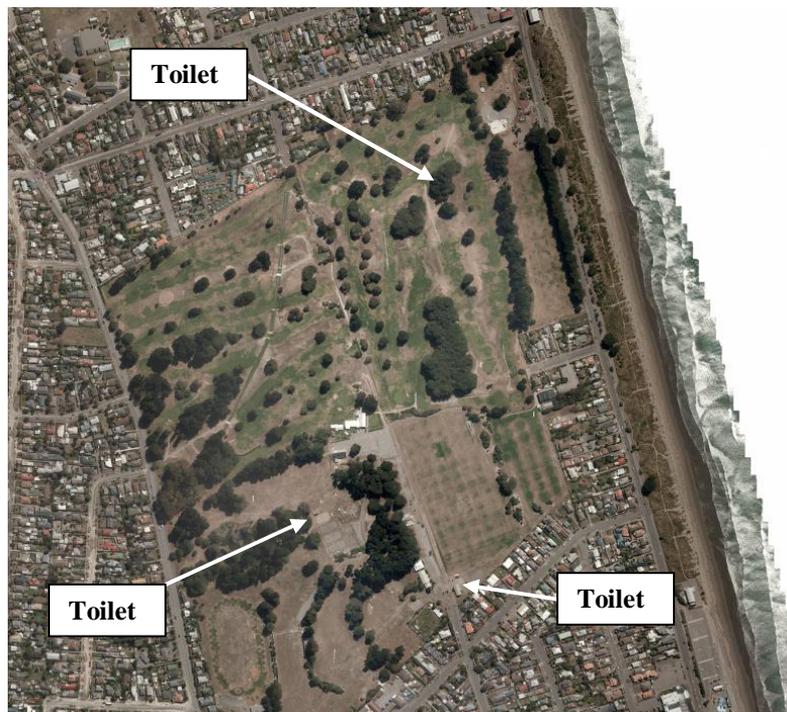
**Figure 3 Post February 2011 Earthquake Aerial Photography <sup>2</sup>**

Aerial photography taken following the 22 February 2011 earthquake shows no signs of liquefaction outside the building footprint or adjacent to the site, as shown in Figure 3.

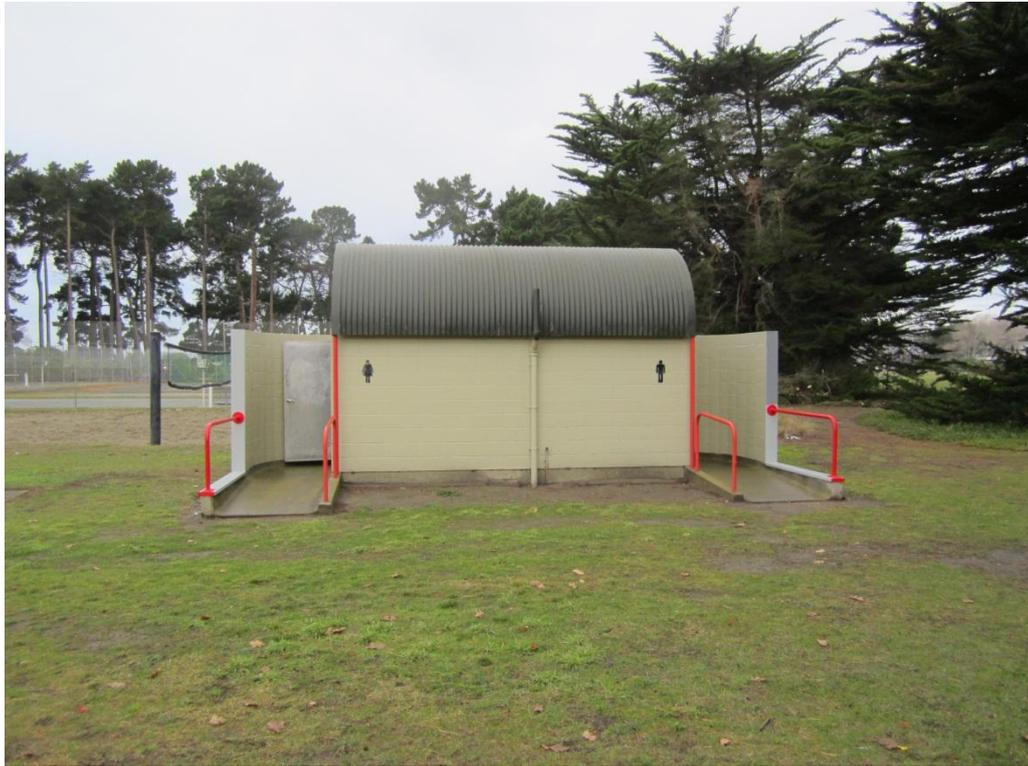
**Photograph 1 North elevation.**

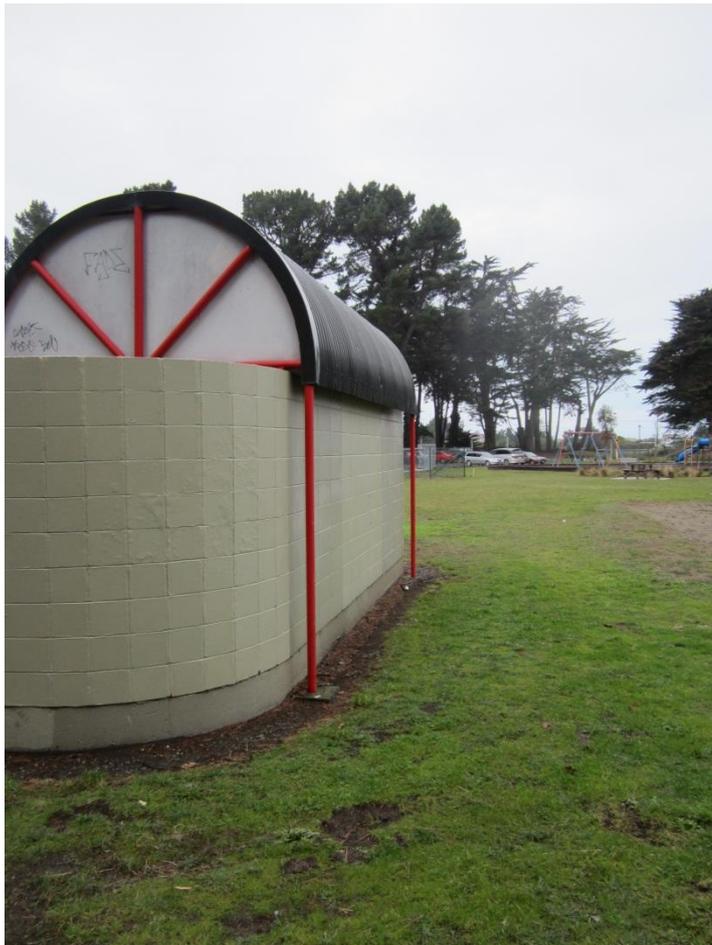
**Photograph 2 View of the toilet from the west.**

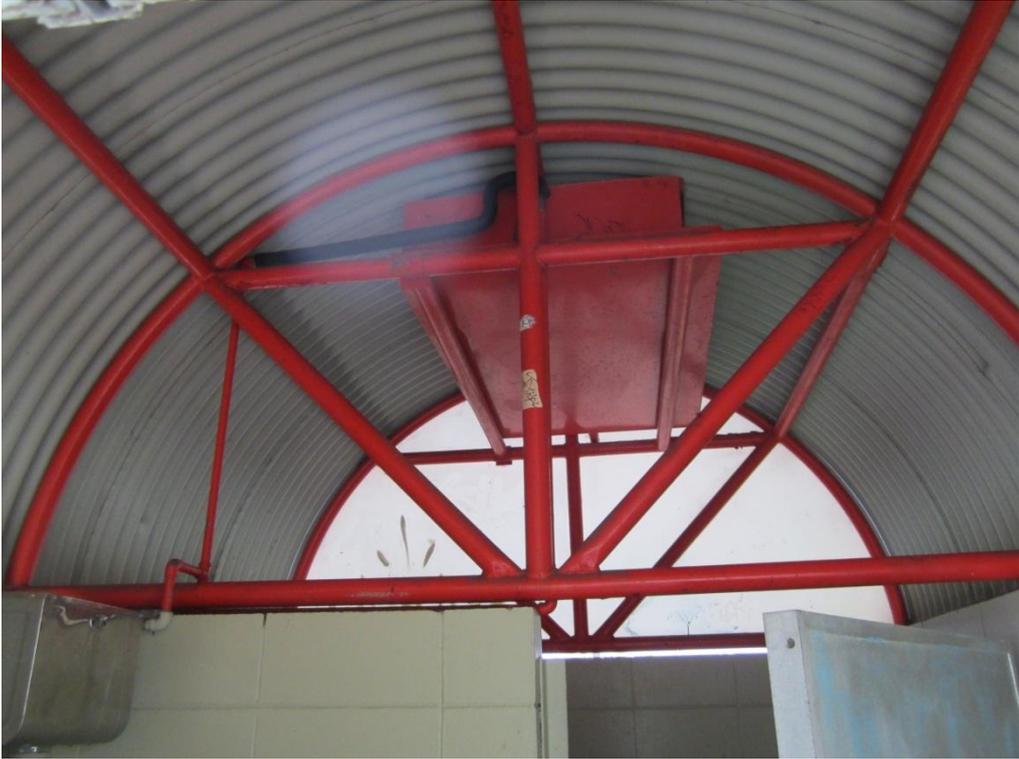
The roof structure was formed by rigidly connected steel tube purlins and trusses, forming a stable braced structure.

**Photograph 3 Roof truss and purlins.**

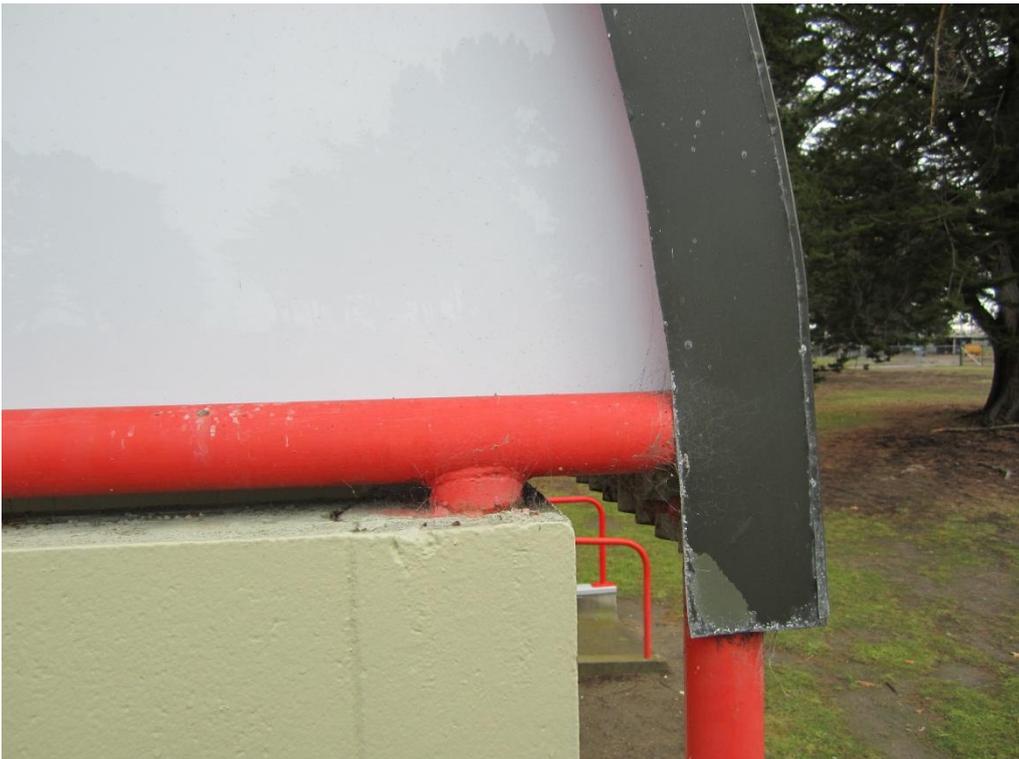
**Photograph 4 Roof truss anchored into top of wall, column adjacent.**

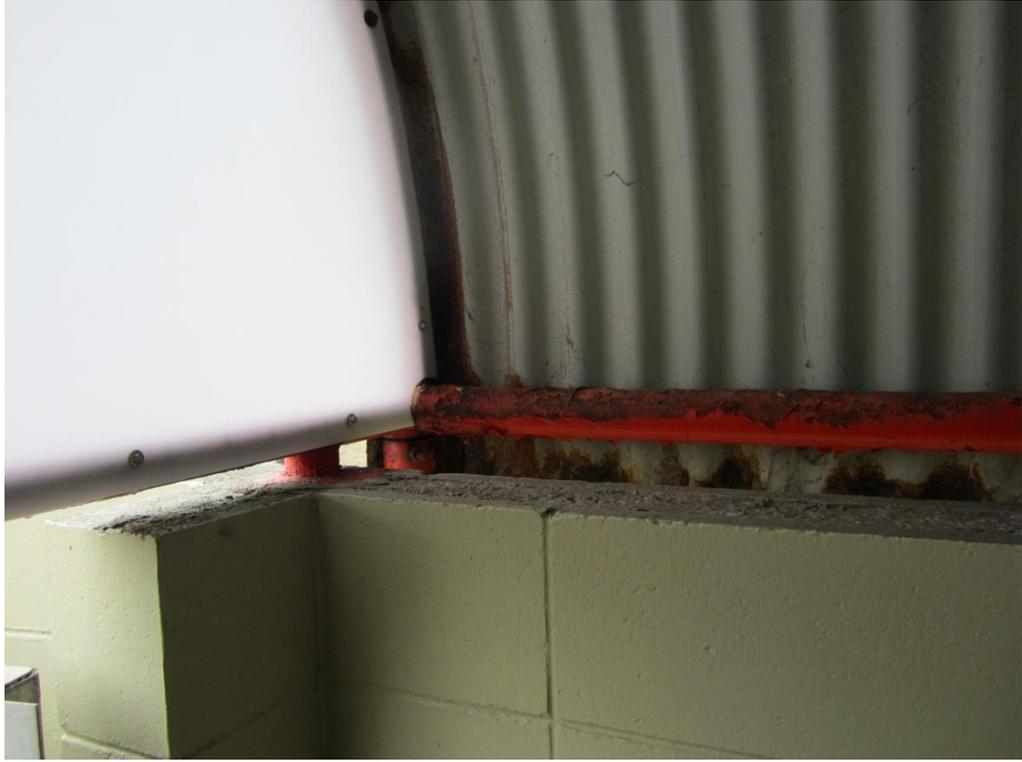
**Photograph 5 Purlin with rust.**

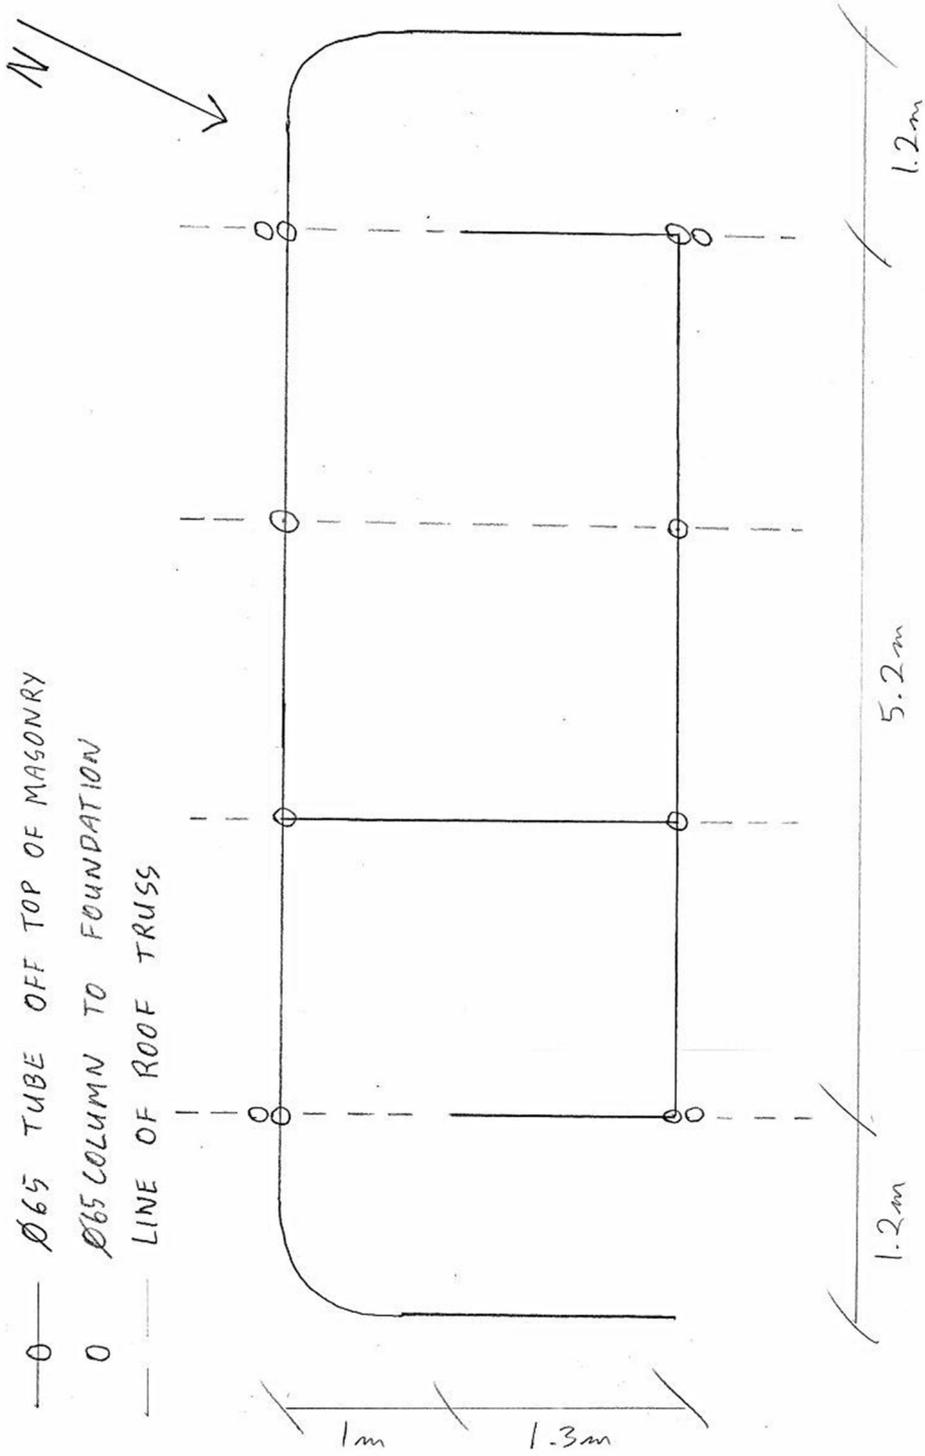
## Existing Drawings / Sketches

- PARTIAL FILL 15 SERIES CMU
- Ø65 TUBE OFF TOP OF MASONRY
- Ø65 COLUMN TO FOUNDATION
- — — LINE OF ROOF TRUSS
