CHRISTCHURCH CITY COUNCIL

Rawhiti Golfcourse West Pumphouse

104 Shaw Ave, New Brighton

QUALITATIVE ASSESSMENT REPORT

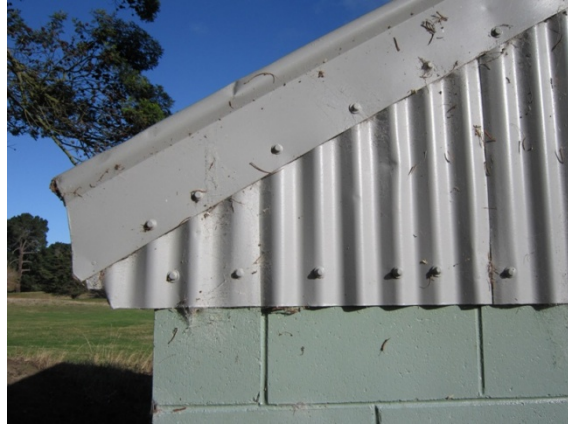
Photo 5: Corrugated steel roof cladding.

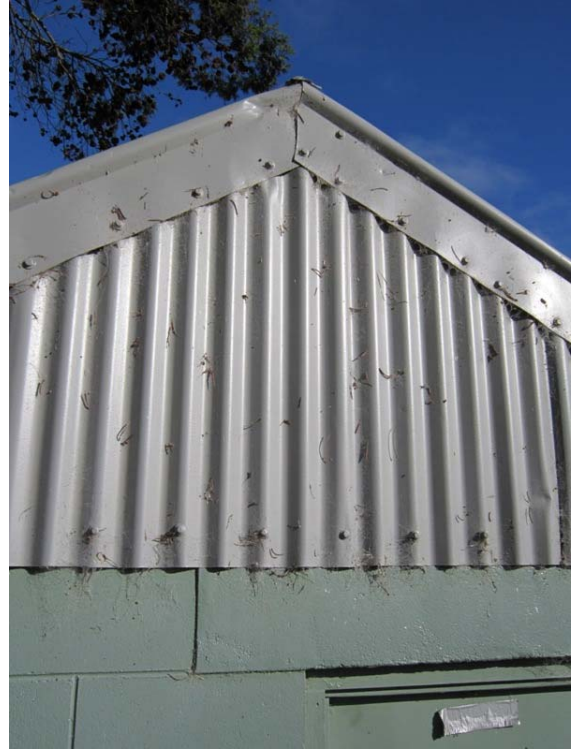
Photo 6: Corrugated steel roof cladding.

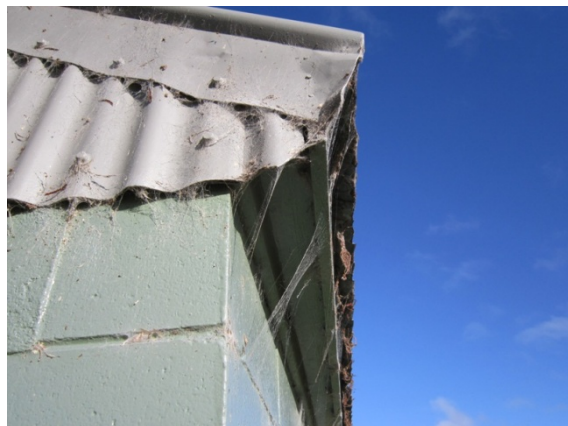
Photo 7: Corrugated steel roof cladding.

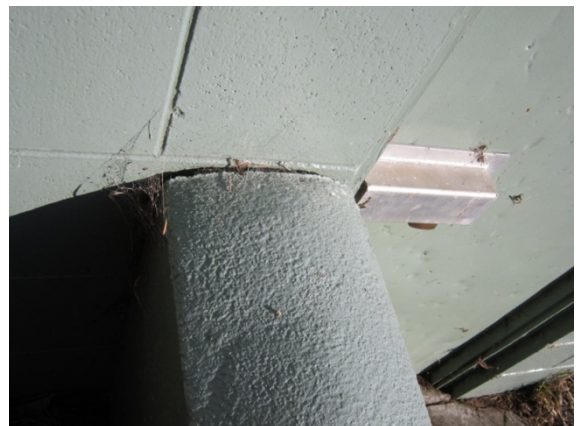
Photo 8: Low masonry wall extending off north wall of building.

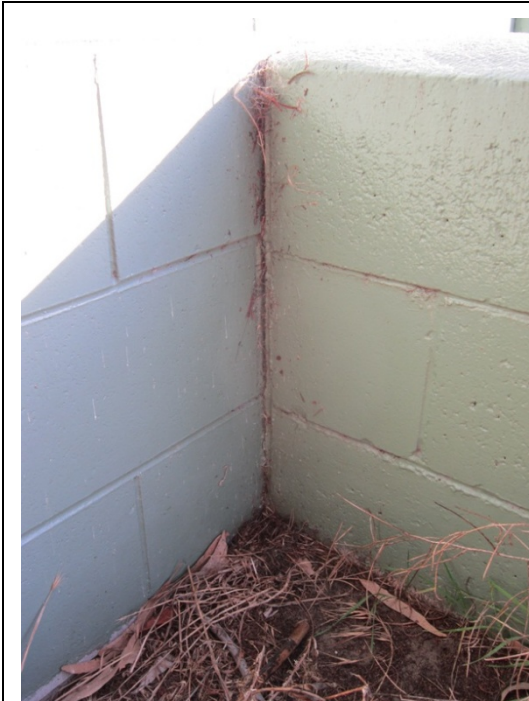
Photo 9: Low masonry wall extending off north wall of building.

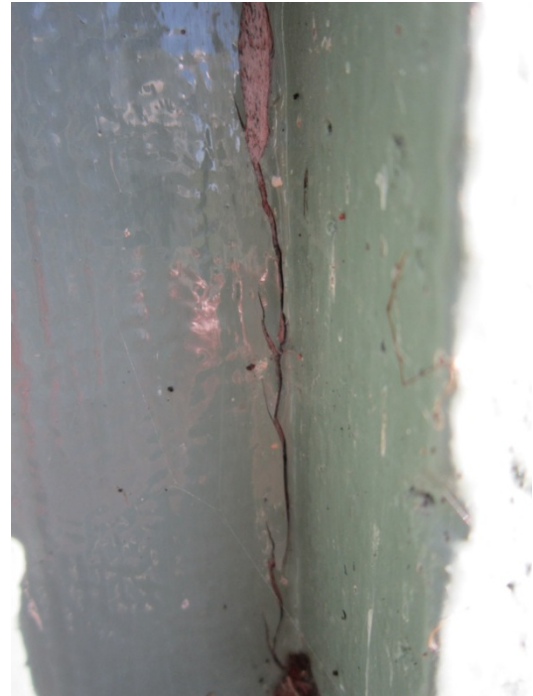
- 1) Step cracking along mortar joints on the west and south walls.
- 2) Gap opening up between the low non-structural masonry wall on the north side and the main building north wall.
- 3) Gap opening up between the timber doorframe and the masonry wall on the north side.
- 4) Low quality pointing was noted throughout the building, but this is not earthquake-related damage.

Photo 10: Gap opening up between low masonry wall and main north building wall.

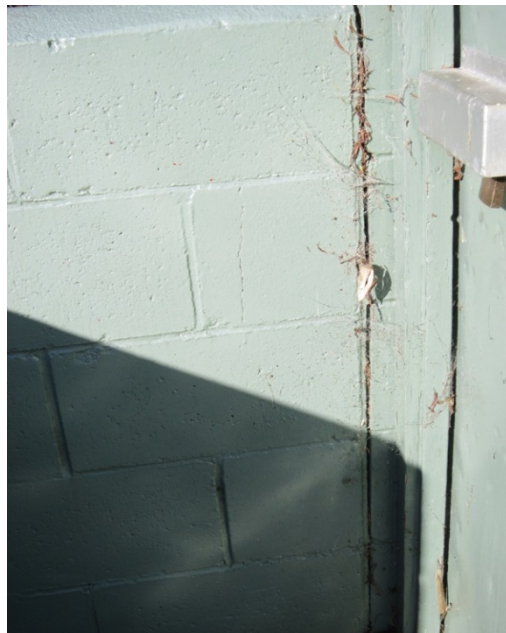
Photo 11: Gap opening up between low masonry wall and main north building wall.

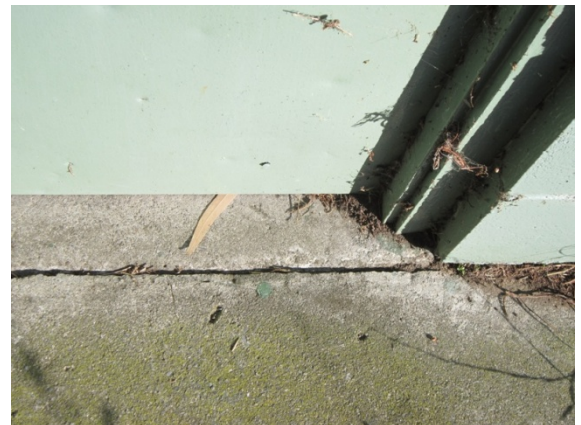
Photo 12: Concrete ground slab.

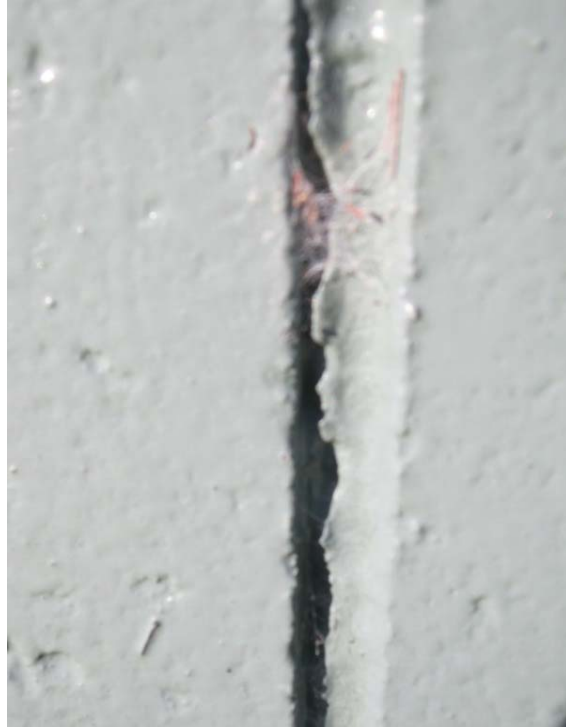
Photo 13: Cracking along mortar joints on west wall.

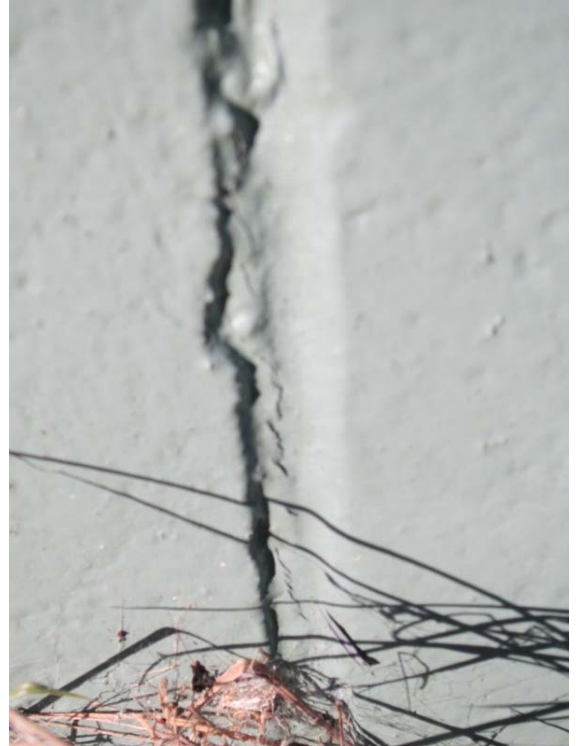
Photo 14: Cracking along mortar joints on west wall.

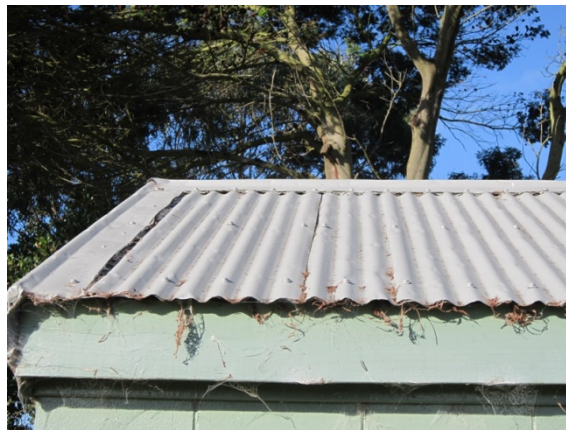
Photo 15: Corrugated steel roof cladding.

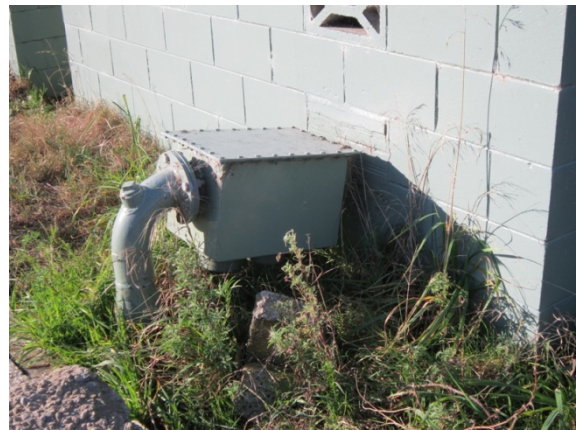
Photo 16: Pipe connection to pump room on west side.

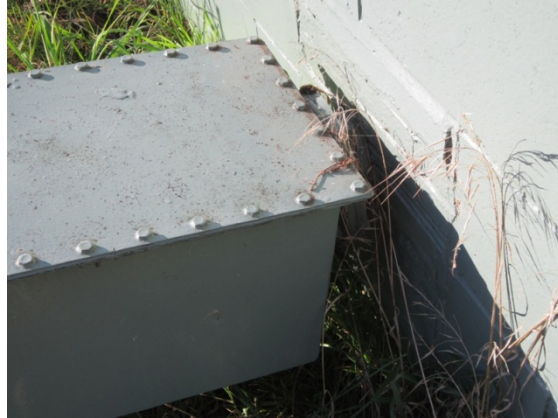
Photo 17: Pipe connection to pump room on west side.

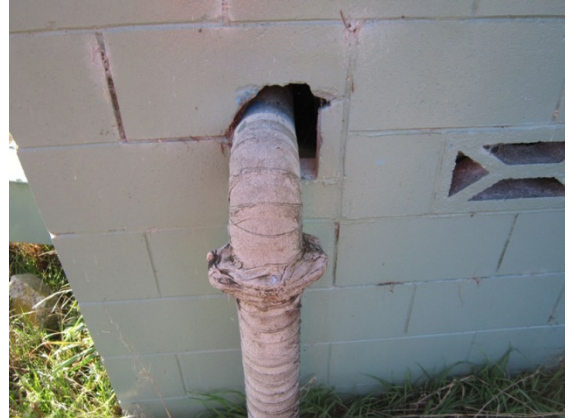
Photo 18: Pipe connection to pump room on south side.

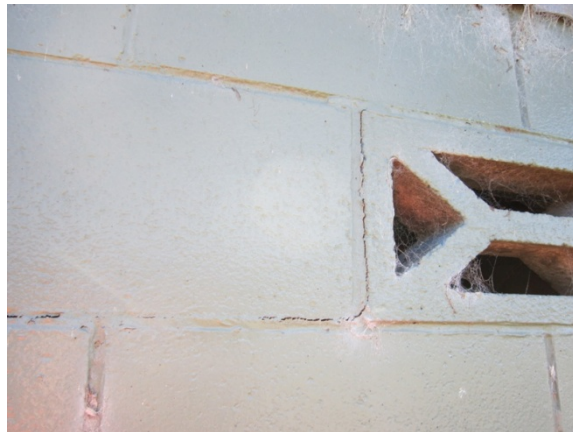
Photo 19: Step cracking along mortar joints on south wall.

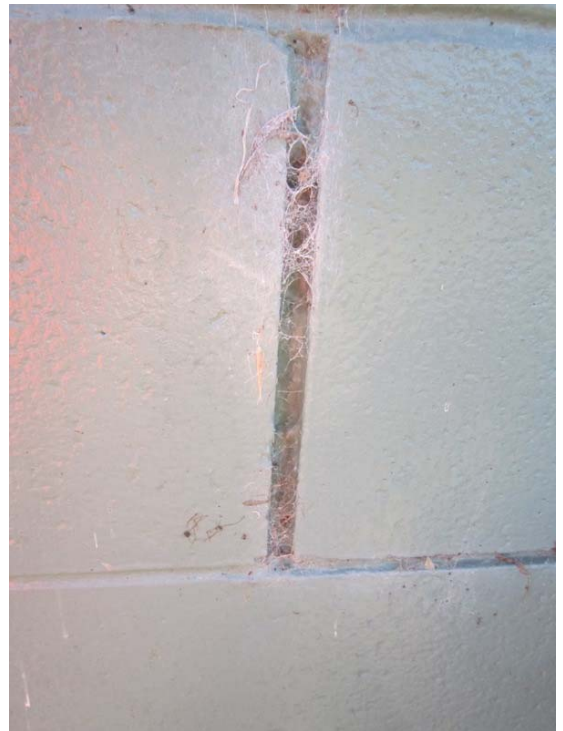
Photo 20: Existing low quality pointing of mortar on south wall.

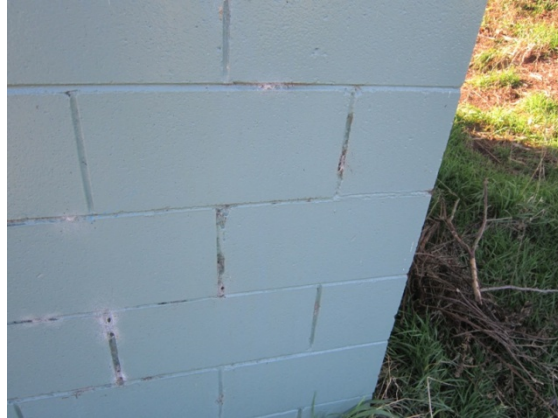
Photo 21: Existing low quality pointing of mortar on south wall.

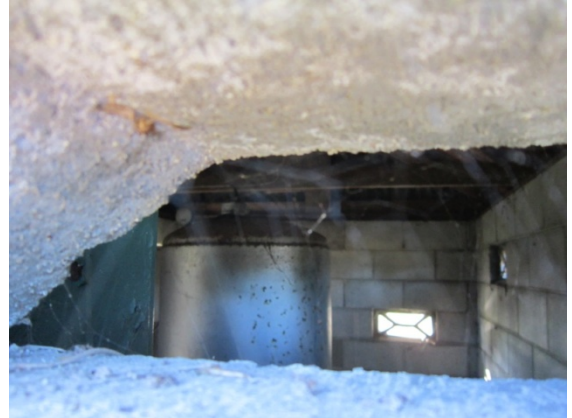
Photo 22: Interior of west pumphouse.

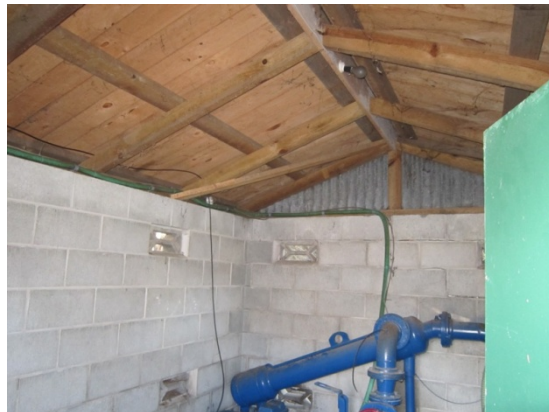
Photo 23: Interior of east pumphouse, indicative of timber-framed roof in west pumphouse.

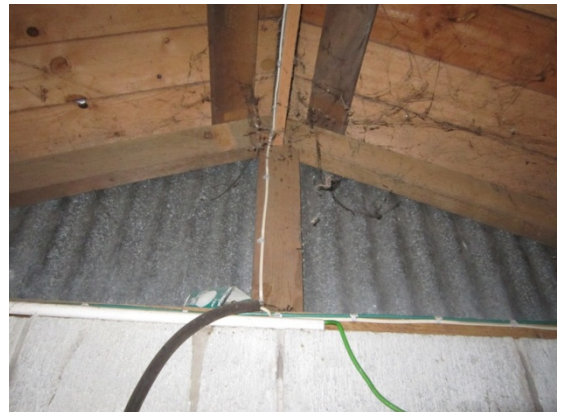
Photo 24: Interior of east pumphouse, indicative of timber-framed roof in west pumphouse.

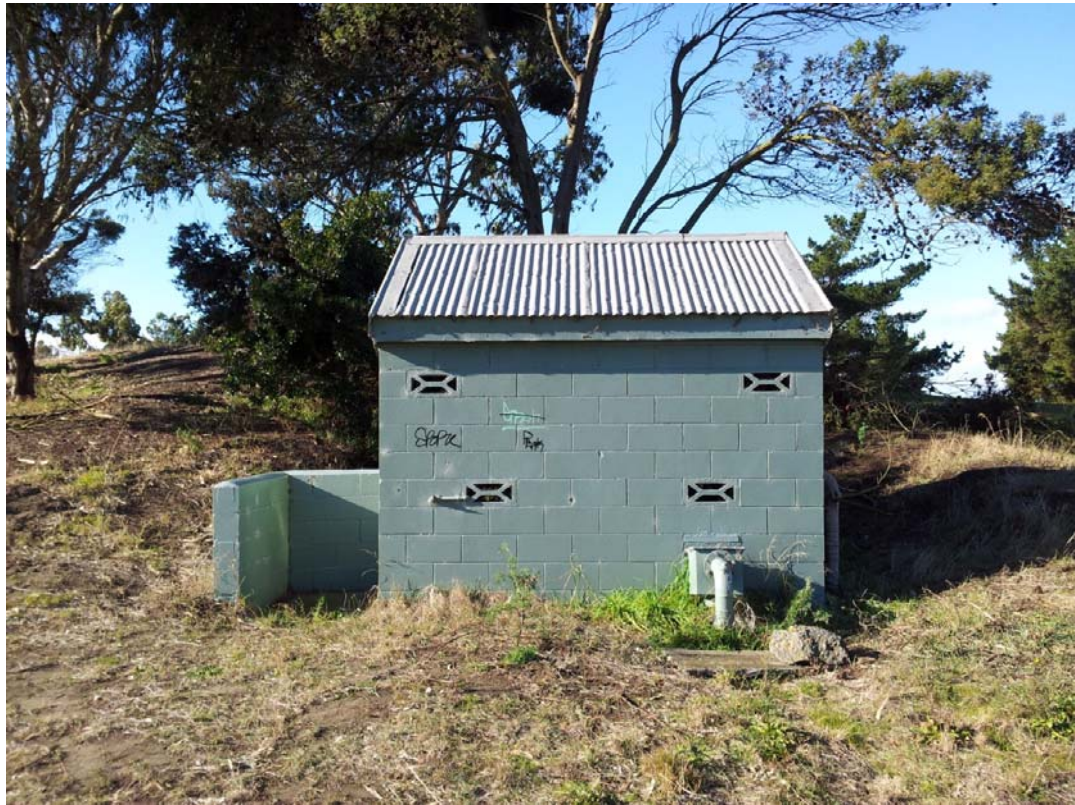
The building was noted to be a masonry block construction with sheet metal roof and slab on grade foundations. There was an upward slope of approximately 20-30 degrees from the eastern side of the building. Minor step cracking was noted in masonry blocks from the external inspection. No apparent evidence of liquefaction or land damage was noted in the surrounding vicinity. Any sand present on the surface was likely to be windblown sand from the nearby beach.

■ Figure 7 - Overview of the building (western elevation)

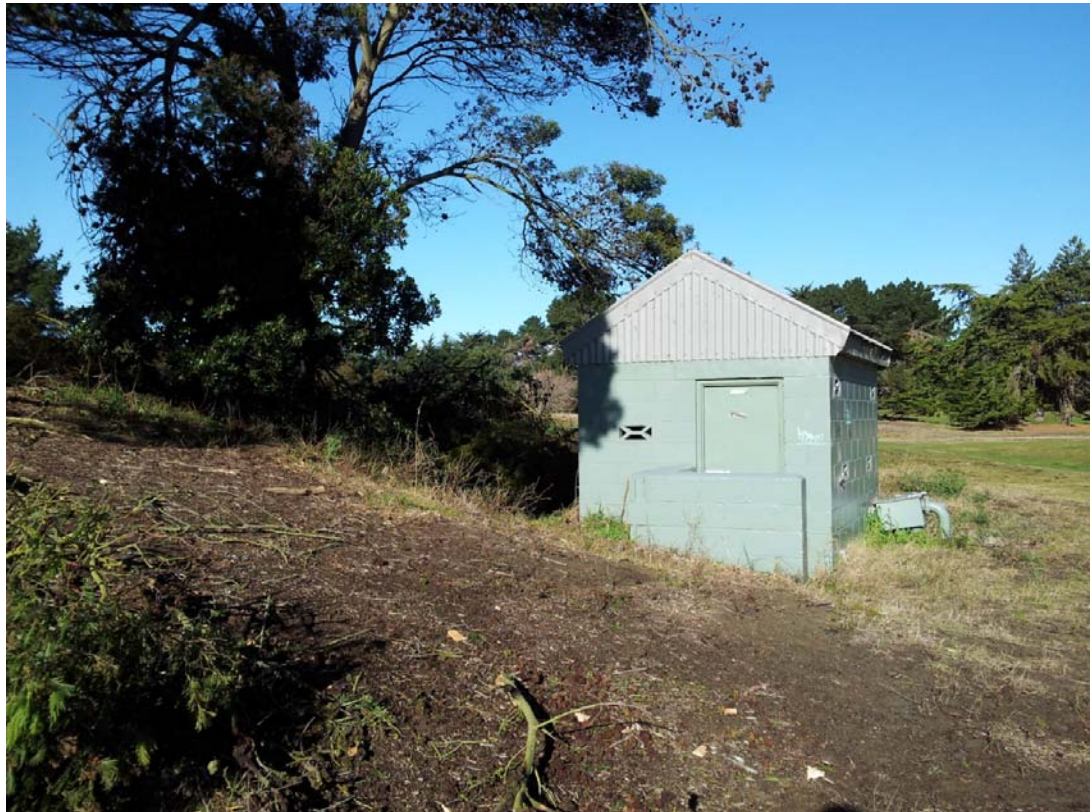
■ **Figure 8 - Overview of the building (northern elevation)**

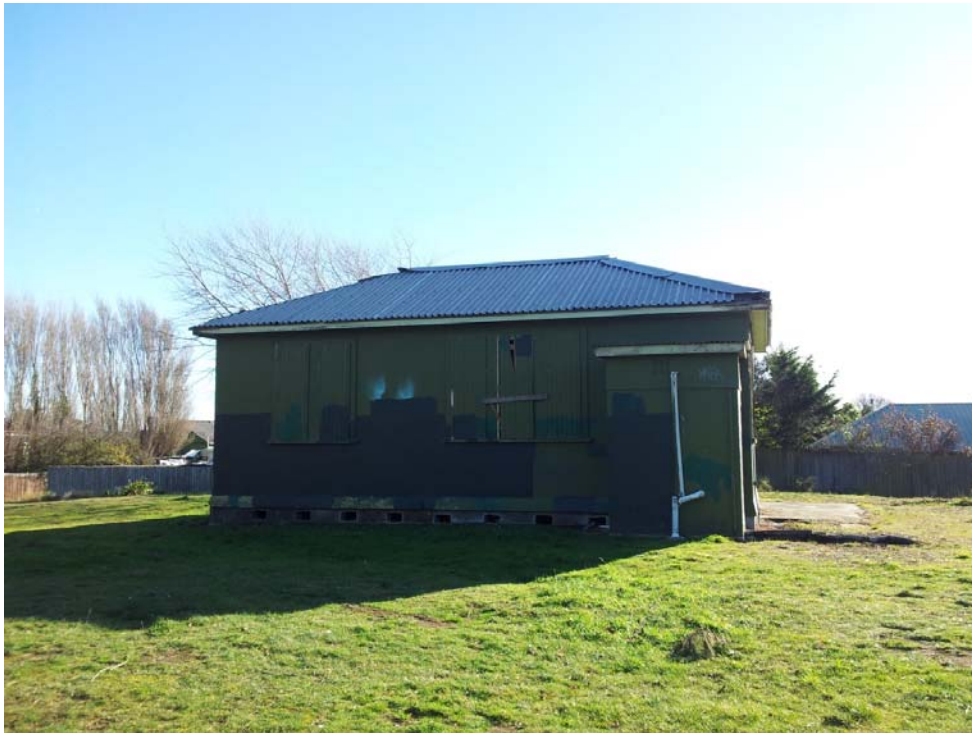
■ **Figure 9 - Overview of the building (south elevation)**

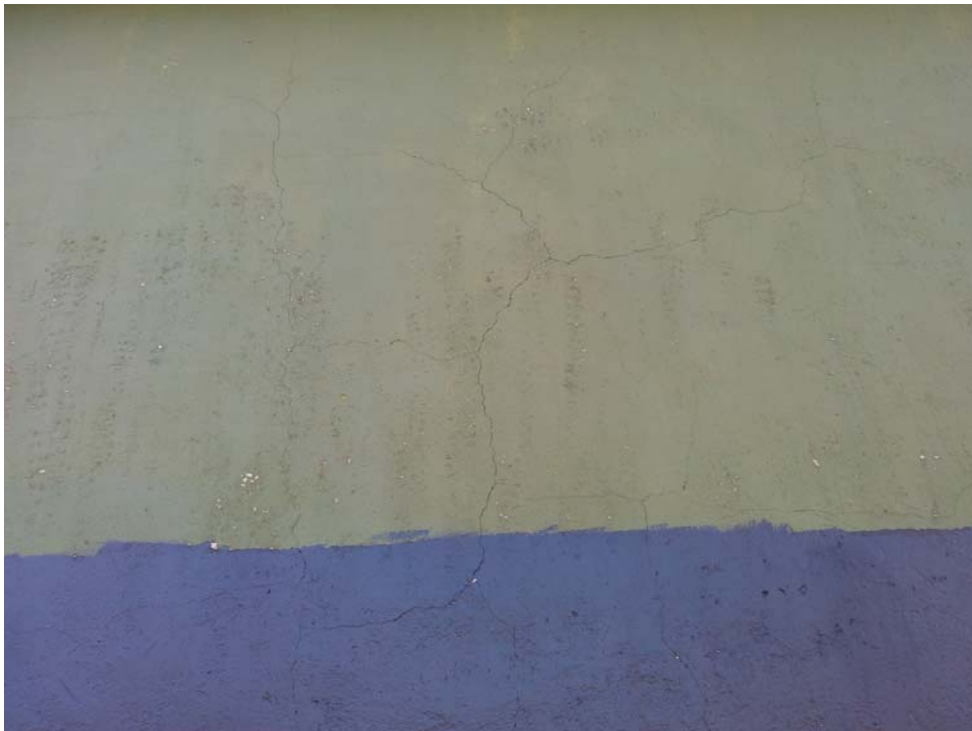
■ **Figure 10 - Observed cracks in the wall**

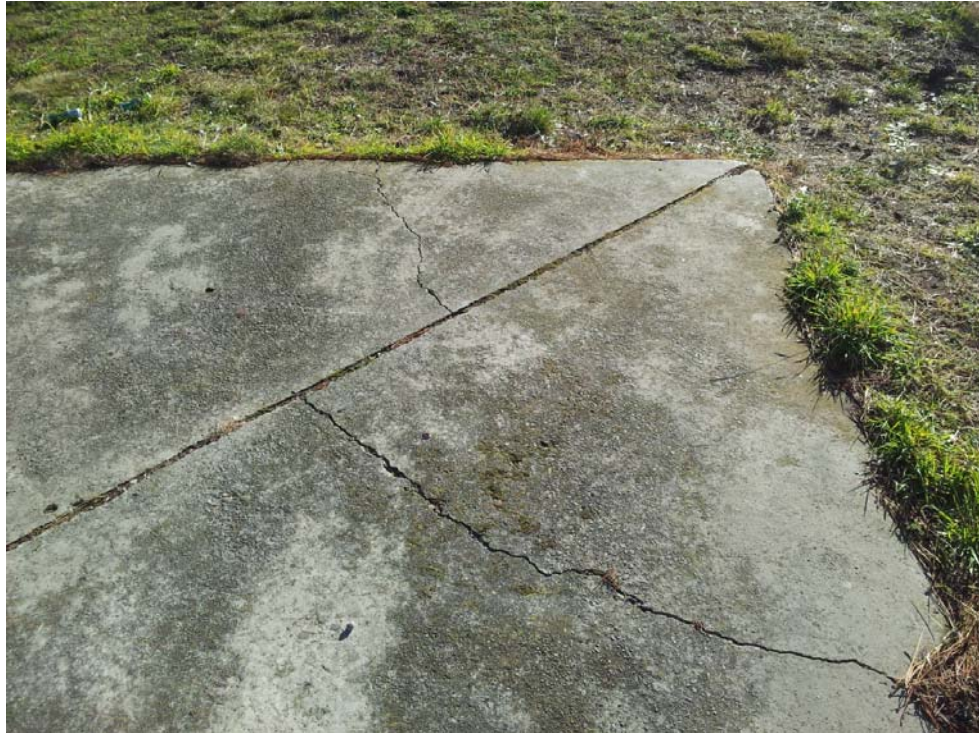
■ **Figure 11 - Cracking in external concrete ground slab**

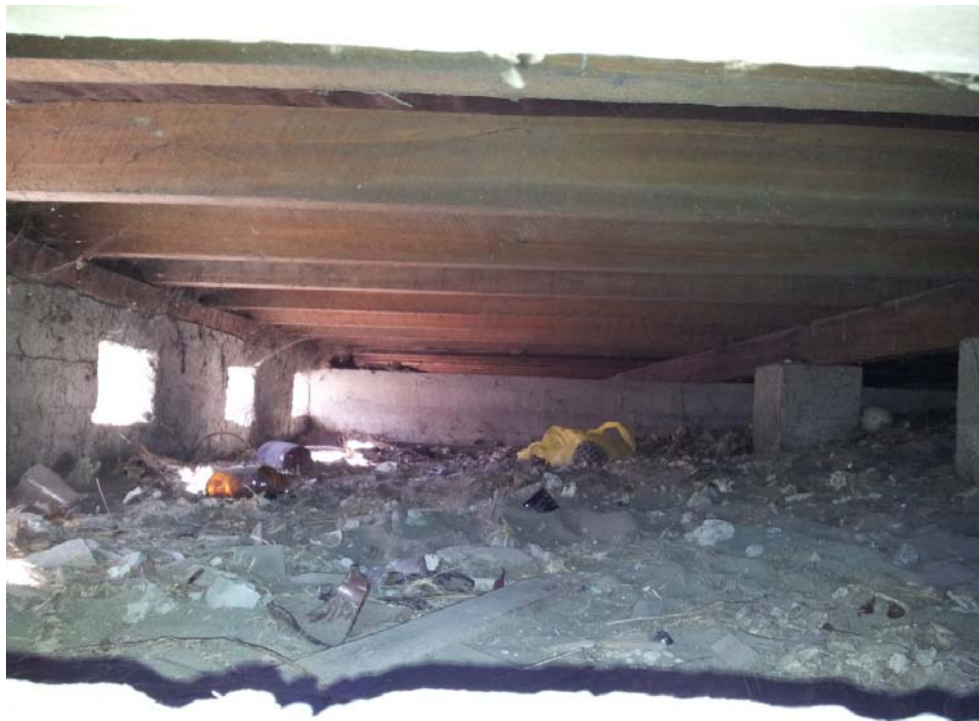
■ **Figure 12 - Foundation details**
