Project: Richmond Community Centre

Qualitative Engineering Evaluation

Prepared for: Christchurch City Council

Date: 28 June 2013

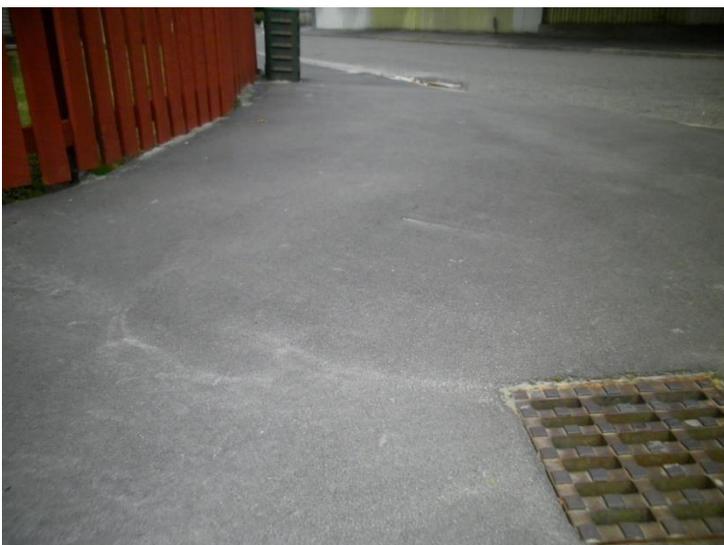
Sizable liquefaction boil below asphalt

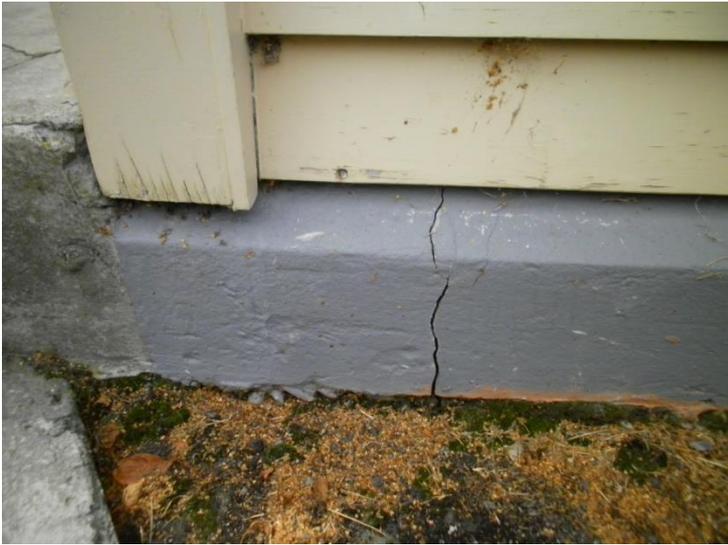
Perimeter foundation damage is likely due to a combination of differential settlement due to liquefaction and shear and flexural seismic loads transferred into it from walls and the floor. Although the Richmond Community Centre has suffered damage, at present it is considered that the damage has not reduced residual seismic capacity sufficiently to warrant building closure.

Crack in concrete perimeter foundation

It is recommended that the building be re-levelled with new piles and an enhanced perimeter footing installed, where required, in accordance with section 4.2 of DBH “Revised guidance on repairing and rebuilding houses affected by the Canterbury earthquake sequence” (November 2011). **It is recommended that a geotechnical investigation is carried out** to confirm the suitability of this repair approach.

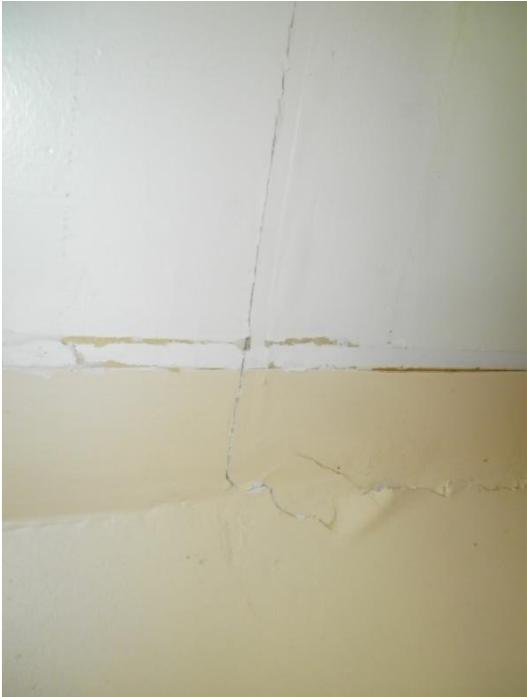
Lining damage at ceiling wall intersection

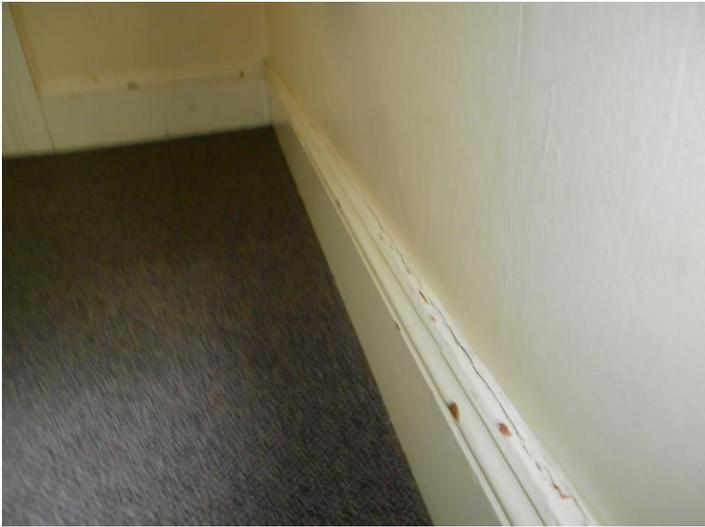
Lining damage at floor level

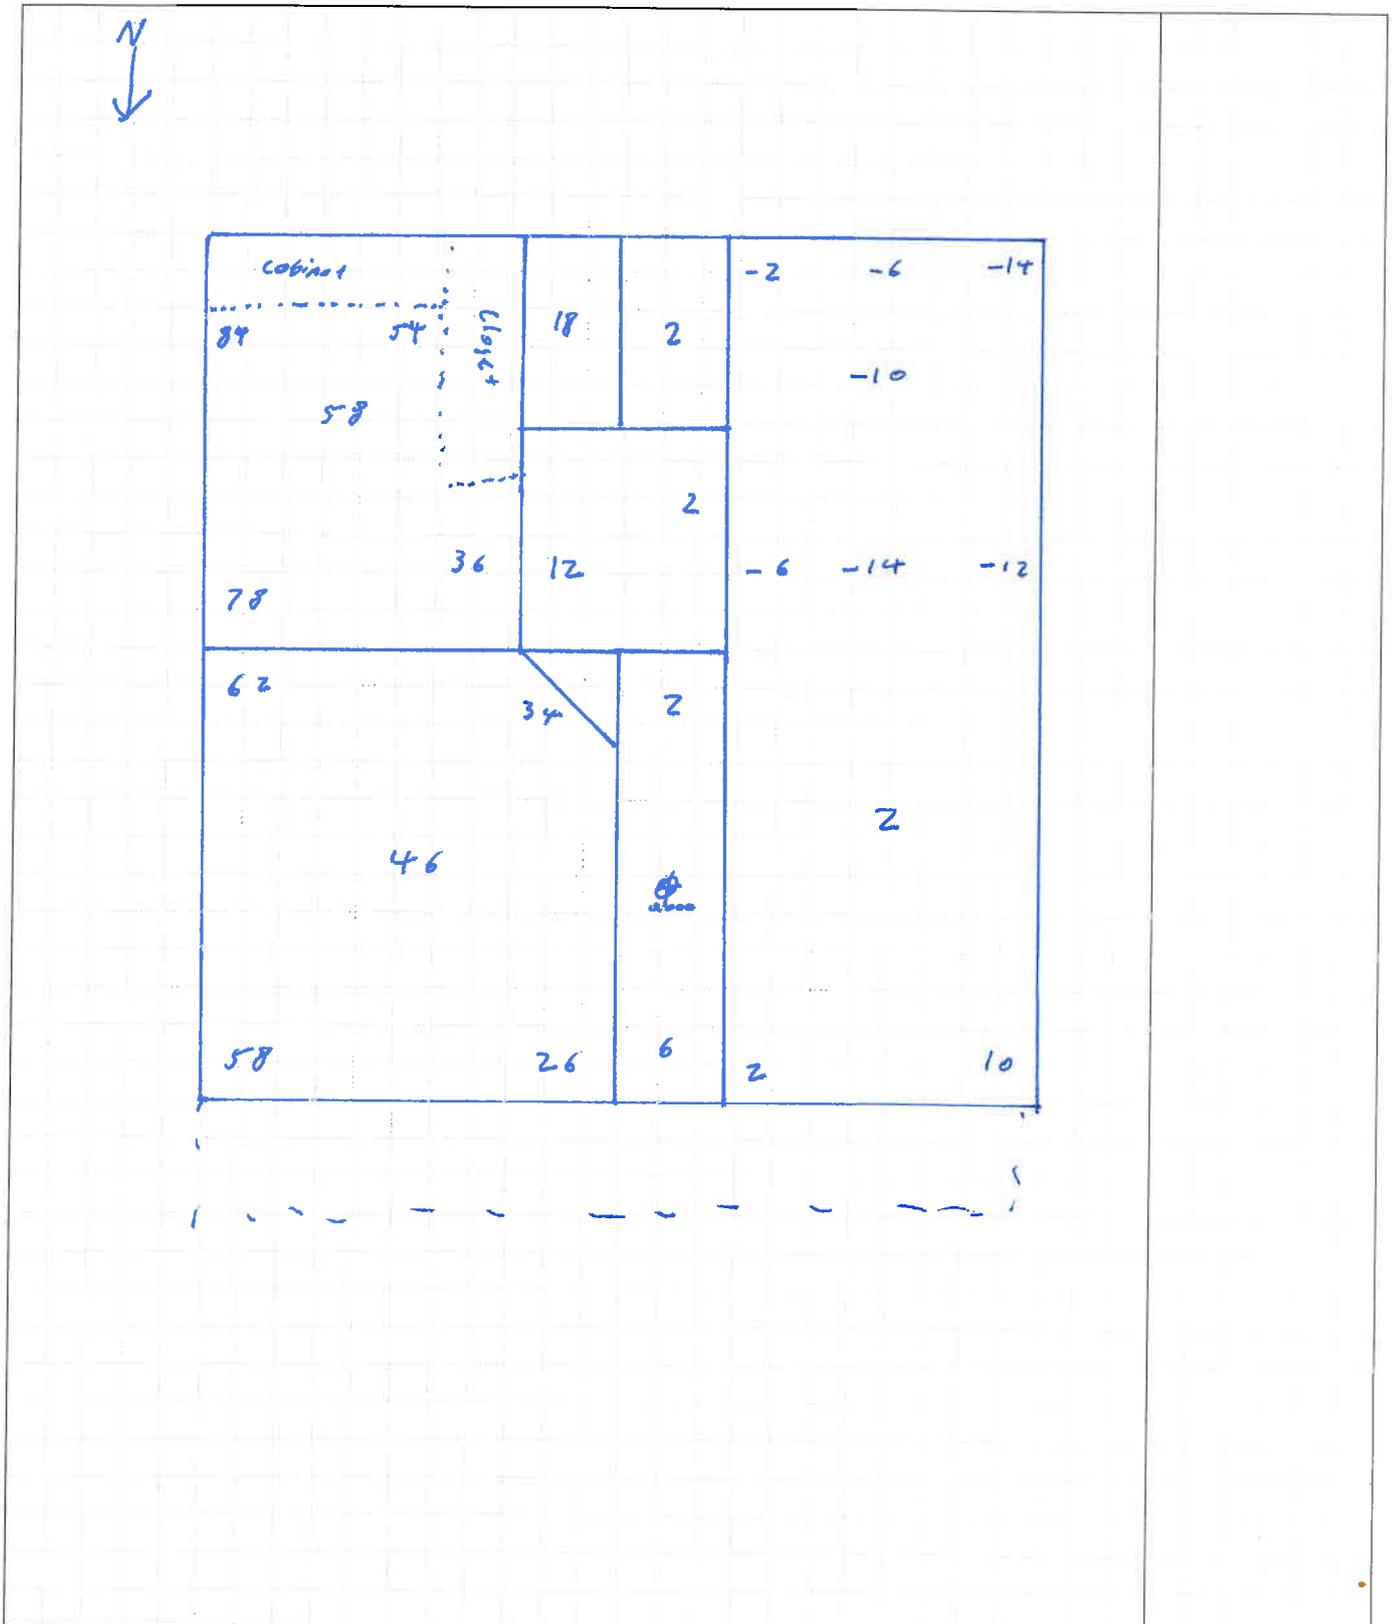
Client: CCC	Date: 17/05/12
Project/Job: Richmond Community Centre	Job No: 228360
Subject: Level Survey	Sheet No: 1 By: DL

The floor levels for the Richmond Community Centre were found to be outside acceptable limits. The entire building is leaning in the North-West direction with a change in level of 98mm recorded on the southern wall line.
