# **Richmond Park Pavilion PRK 0671 BLDG 003 EQ2**

**Detailed Engineering Evaluation**

**Quantitative Assessment Report**

**39 Medway Street, Christchurch**

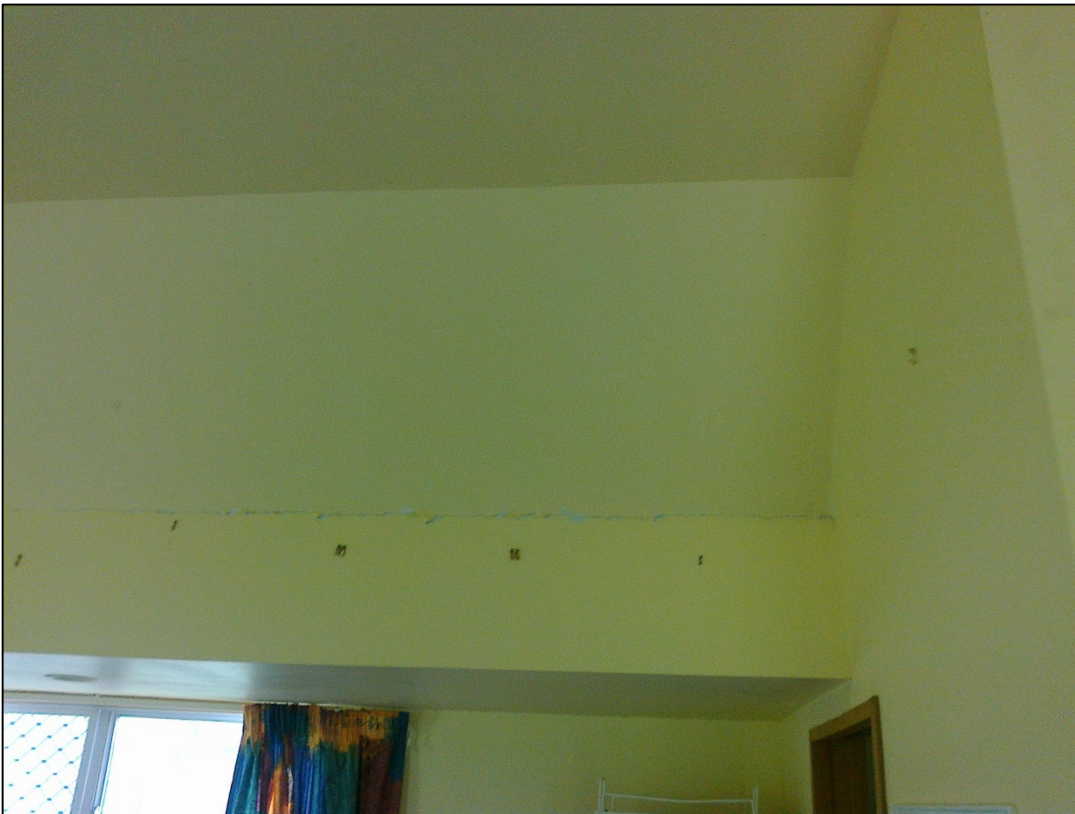
The northern part of the building has a ceiling lining, which is boxed down adjacent to the wall locations (refer to photos in Appendix A,) and tapers to create a high flat ceiling in the centre of the building. This ceiling lining is not expected to transfer horizontal loads due to the possibility of the joints failing at the tapered locations.

**Photo 8: Cracking of ceiling seam.**

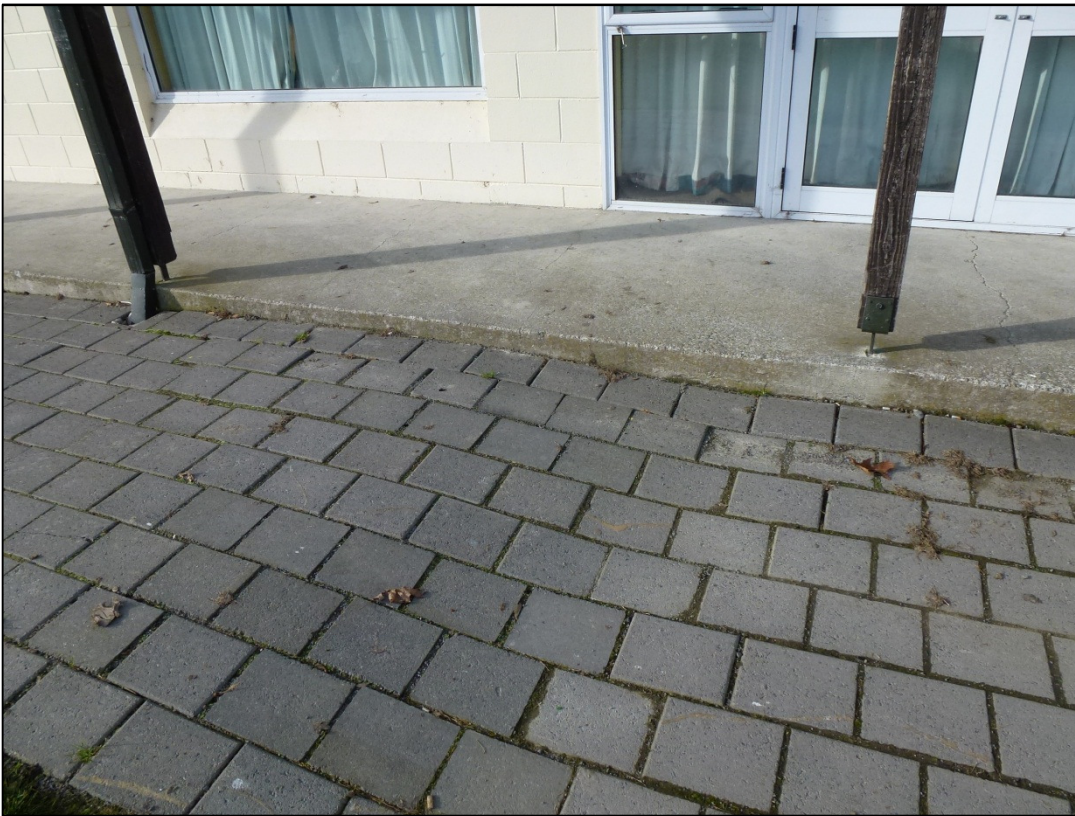
- multiple hairline cracks in the concrete slab forming the raised patio on the western side;
- hairline crack in the concrete slab in the changing rooms;
- a number of moderate vertical cracks (up to 1.5mm wide) on the eastern wall;
- cracks in the ceiling lining seam in the northern part of the building; and
- cracking of lintel beams and window sills.

There was evidence of liquefaction around the building, with approximately 70mm vertical settlement of pavers adjacent to the raised patio. We were advised by the President of the Cricket Club that liquefaction also occurred inside the northern part of the building (this was not observed by Opus). The floor was newly carpeted in the northern part of the building at the time of inspection and therefore the extent of cracks or repairs (if any) could not be inspected.

**Photo 9: Cracks on slab on western side. Note settlement of paving due to liquefaction.**

- A level survey is recommended to determine if the concrete floor slab has settled differentially, and to quantify the magnitude of settlement.
- Depending on the results of the level survey, further site specific investigations may be required.
- The existing foundations appear to have performed reasonably well. Provided the results of the level survey indicate the foundation has not settled beyond serviceability limits, further investigations are not deemed necessary and repair of the cracks in the slab can be carried out.

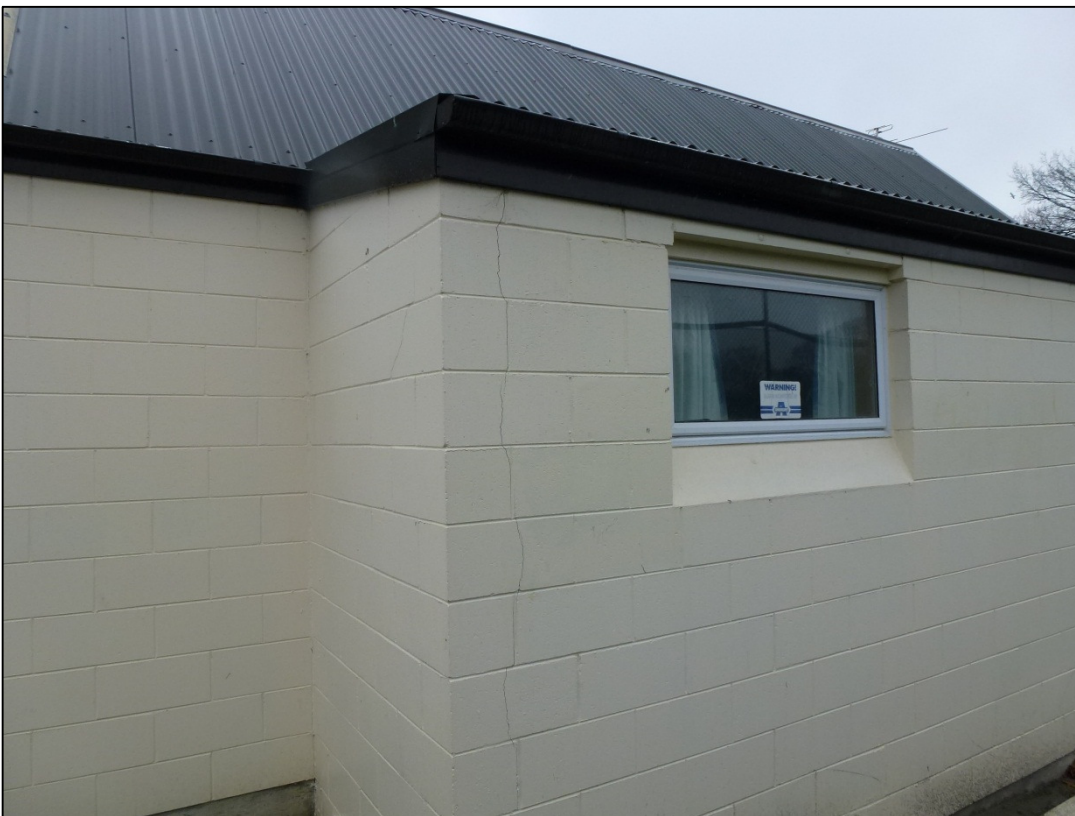
**Photo 10: Vertical cracks on eastern wall (approx. 1.5mm wide).**

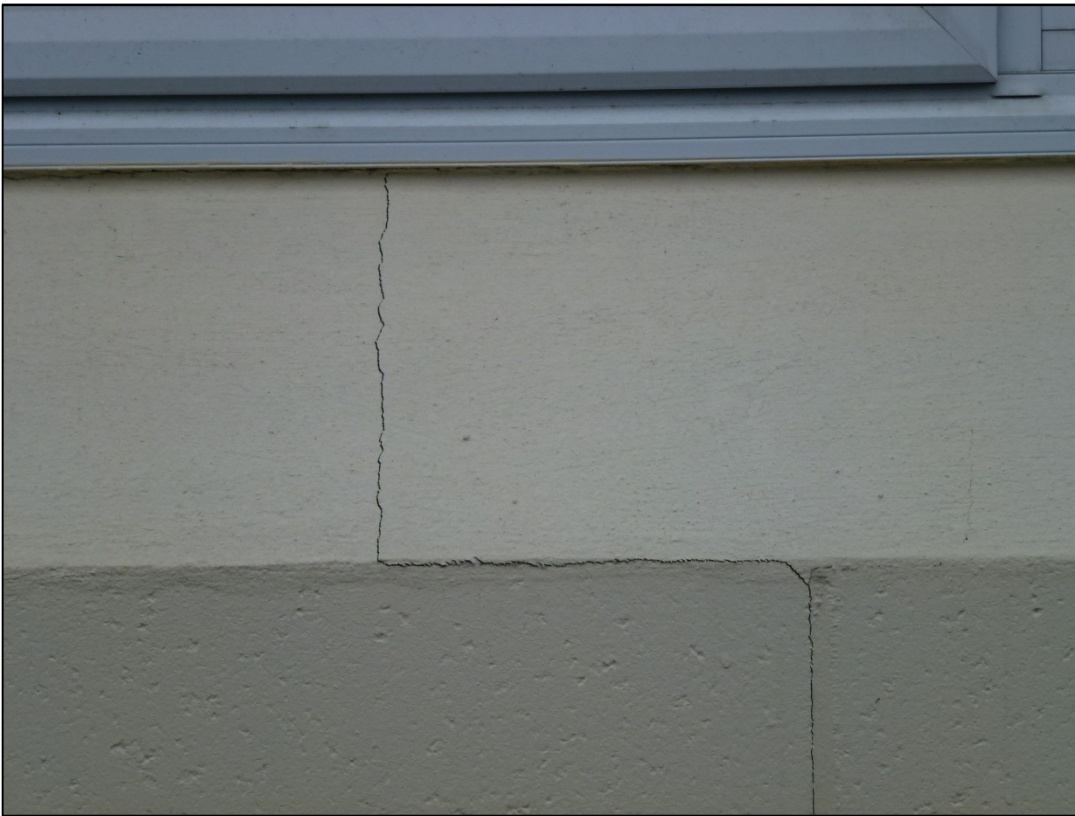
**Photo 11: Cracking of sill below window opening.**

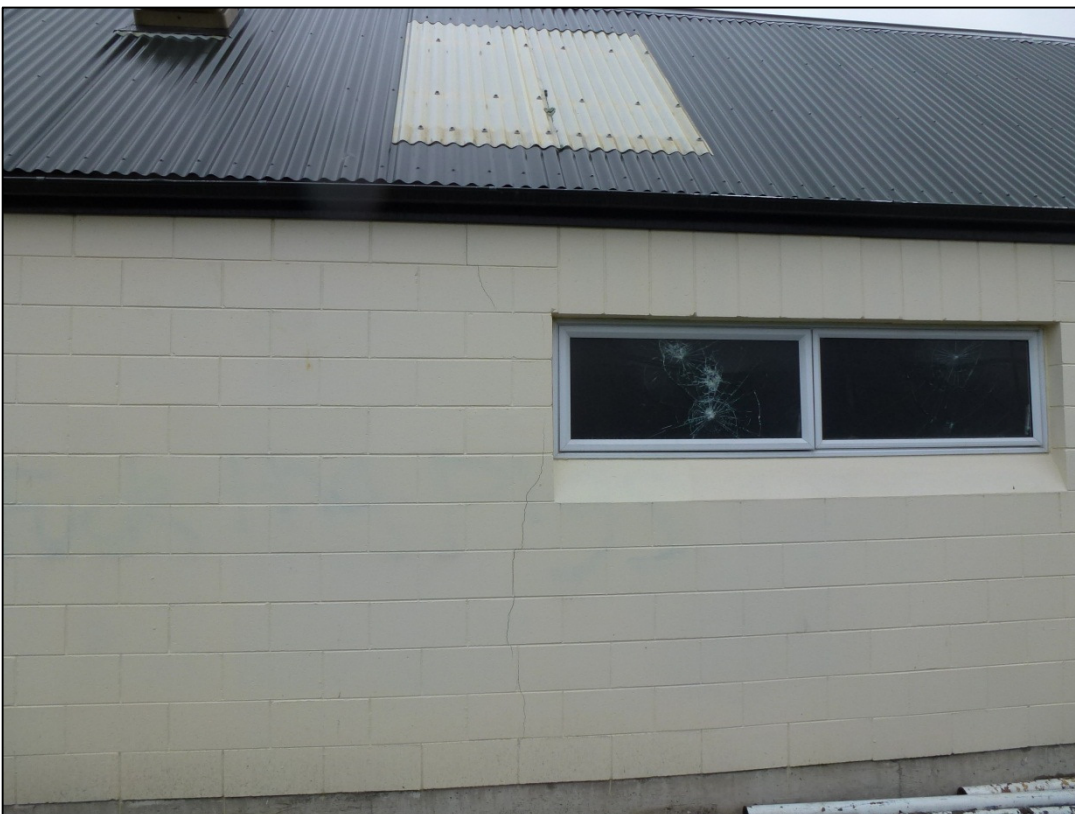
**Photo 12: Vertical crack on wall.**

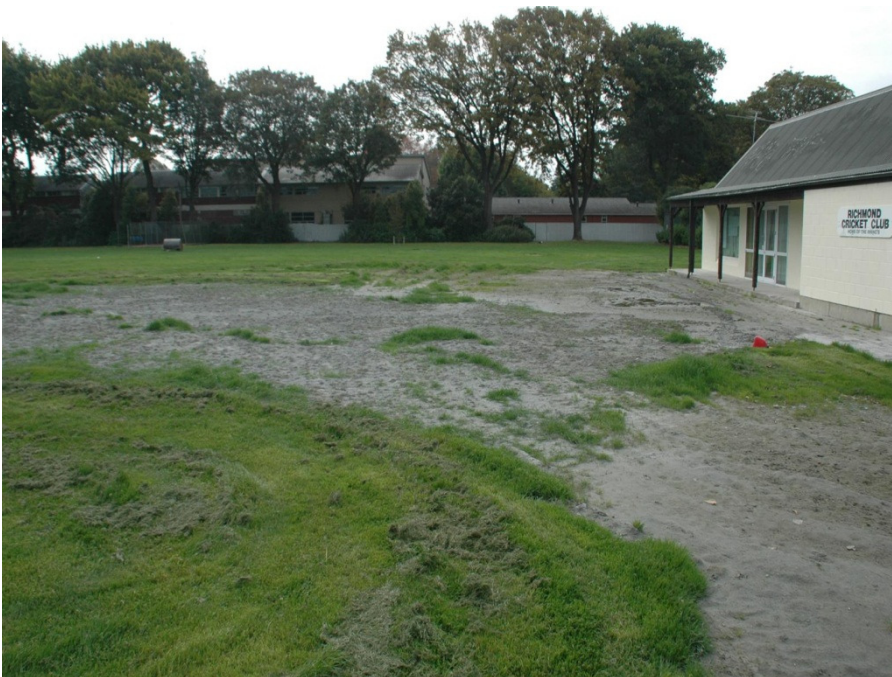
**Photograph 2. Ejected silts and sands, looking towards the north.**

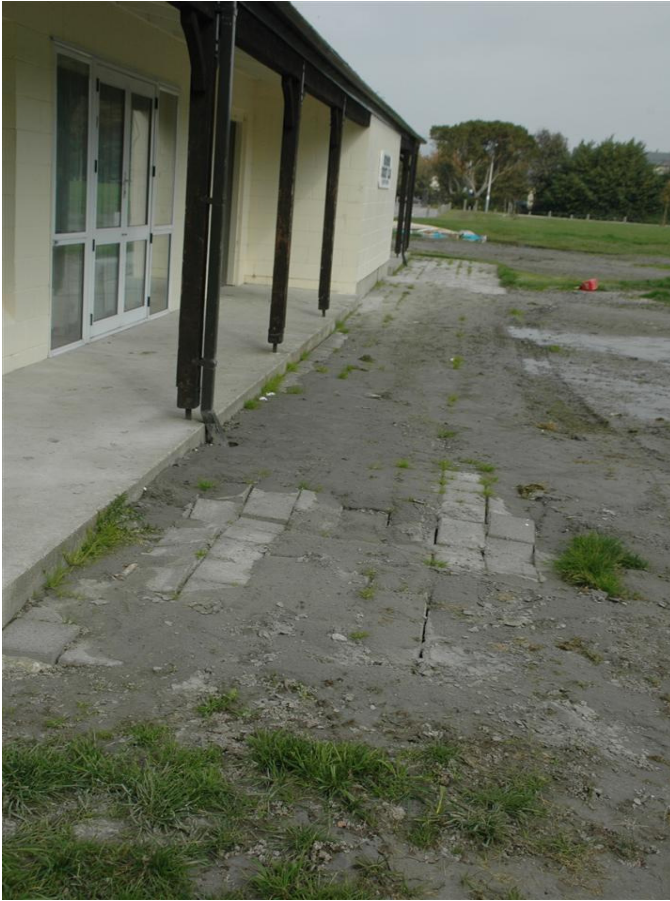
**Photograph 3. View along western wall, showing ejected silts and sands.**

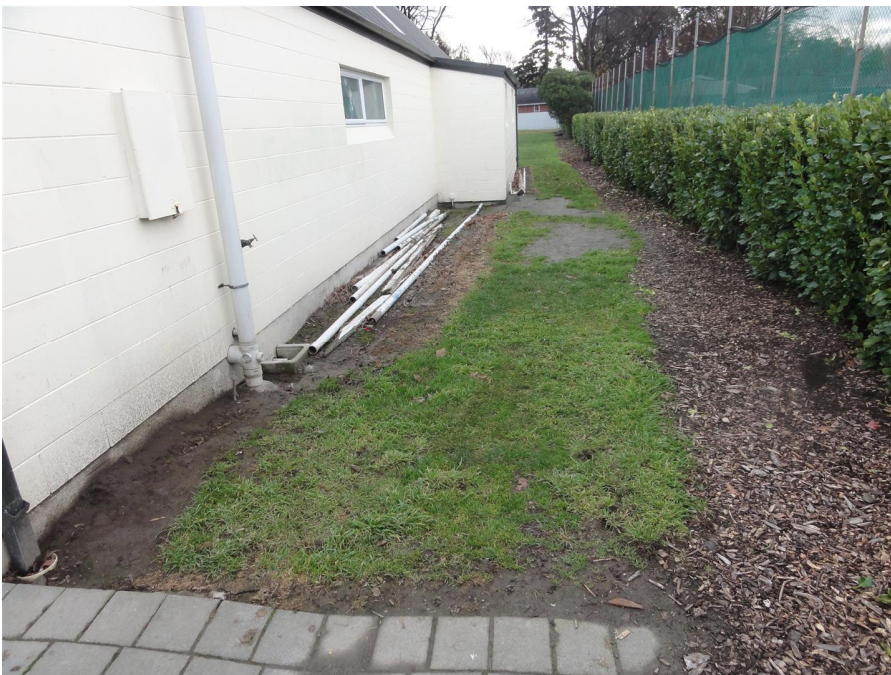
**Photograph 4. View along eastern wall, showing ejected silts and sands.**

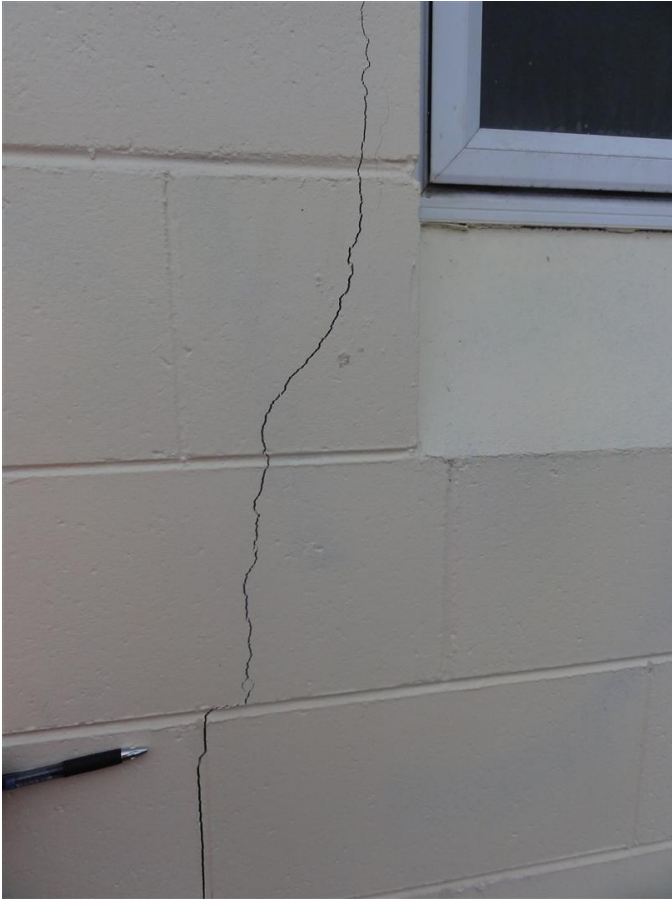
**Photograph 5. 1.5mm wide crack in eastern external concrete block work.**

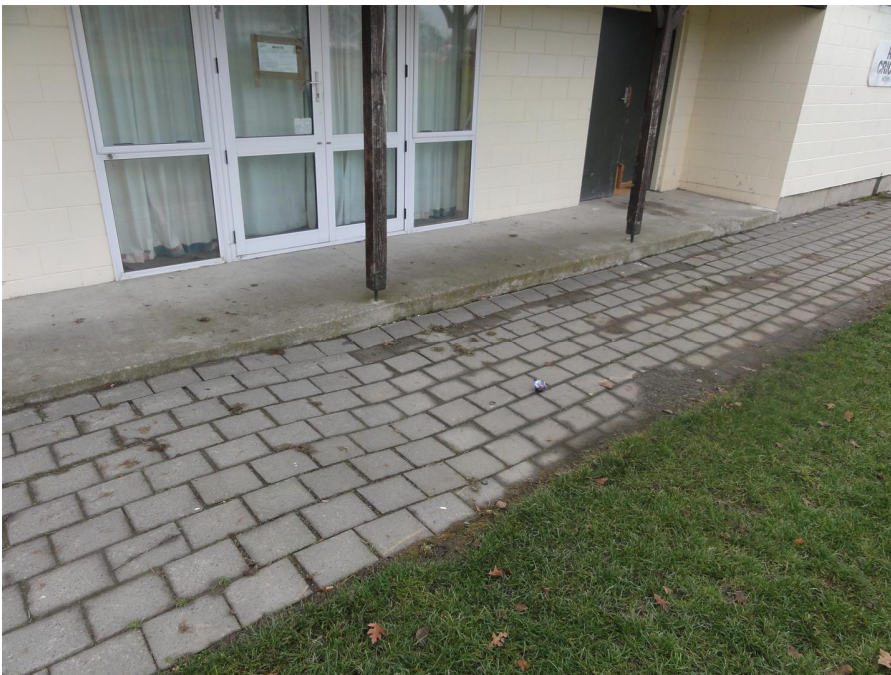
- Approximately 70mm of heave has occurred under the pavers adjacent to the raised patio on the western side of the building;
- Multiple hairline cracks in the concrete slab forming the raised patio on the western side of the building;
- Misaligned and tilting pavers;
- Hairline crack in the concrete slab of the changing rooms;
- A 1.5mm wide crack down the external concrete block wall on the eastern side of the building;
- Numerous areas of ejected liquefied silt/sand adjacent to the eastern, southern and western walls of the Pavilion;
- No evidence of lateral spreading was observed at the site.

**Photograph 6. Approximately 70mm heave of the pavers adjacent to the raised patio (western side of pavilion).**

- A level survey is recommended to determine if the concrete floor slab has settled differentially, and to quantify the magnitude of settlement.
- Depending on the results of the level survey, further site specific investigations may be required.
- The existing foundations appear to have performed reasonably well. Provided the results of the level survey indicate the foundation has not settled beyond serviceability limits, further investigations are not deemed necessary and repair of the cracks in the slab can be carried out.

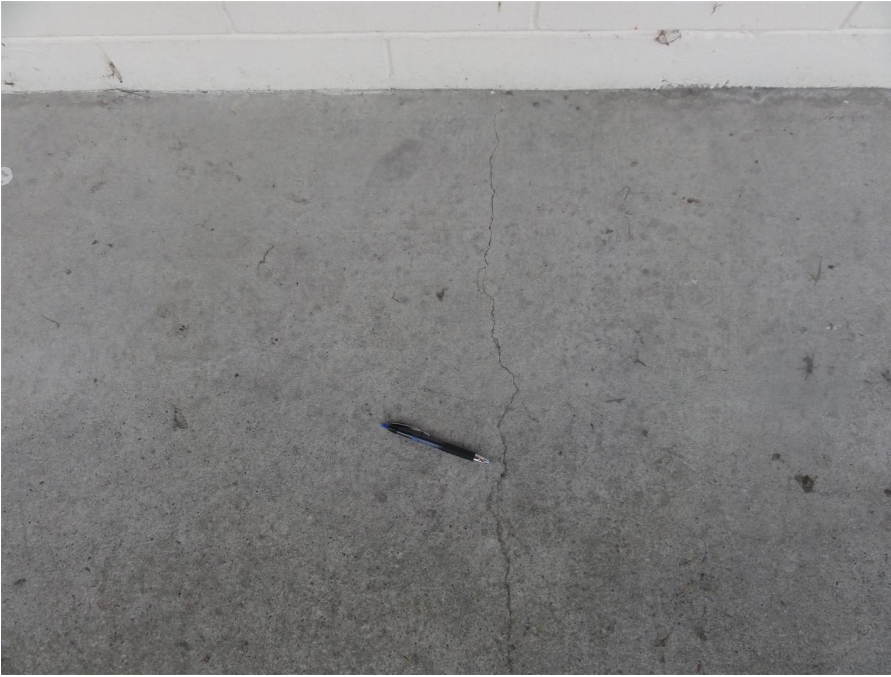
**Photograph 7. Typical hairline crack through concrete slab along raised patio.**

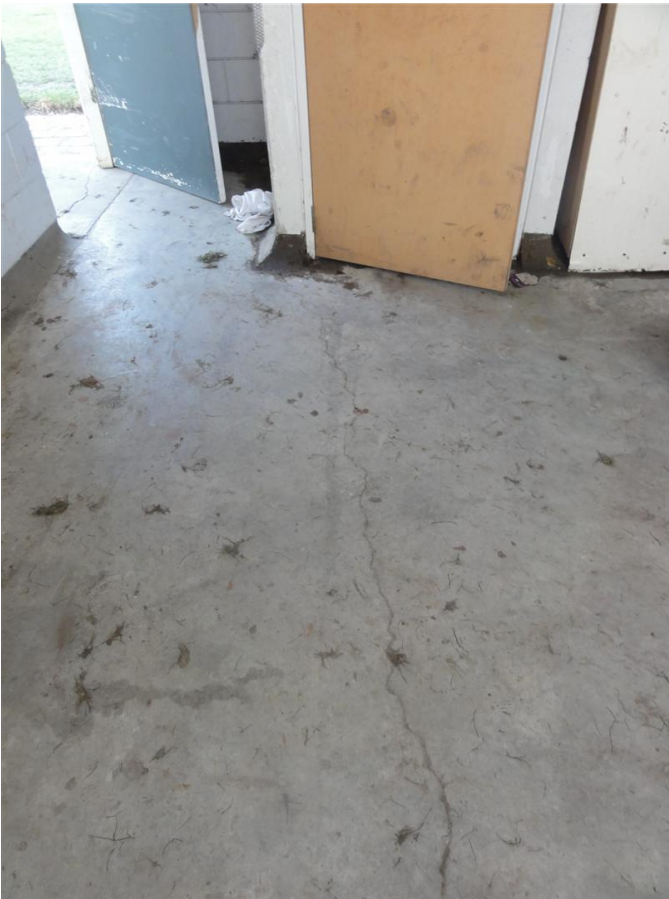
**Photograph 8. Hairline crack along concrete slab in changing rooms.**
