**Quantitative Assessment Report  
THE ROSE CHAPEL – 866 COLOMBO  
STREET**

# The Rose Chapel - Detailed Engineering Evaluation

## Quantitative Assessment Report

Date: 14<sup>th</sup> July 2012  
Reference: 6.DP138.00  
Status: Final

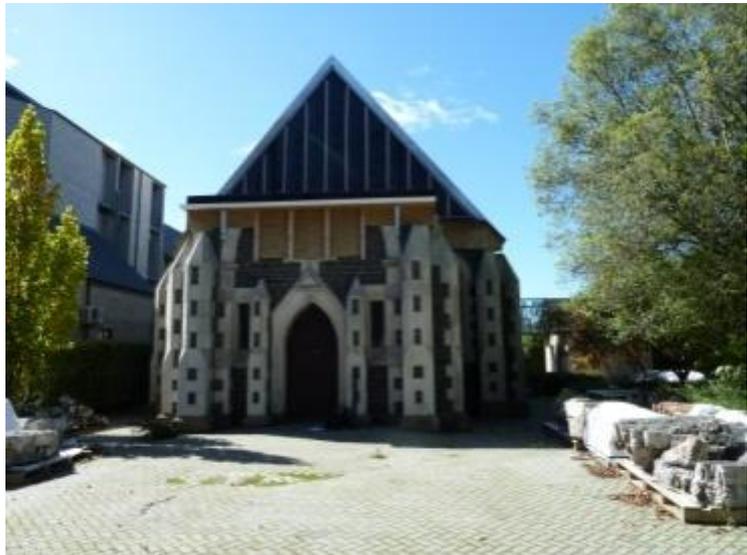
Photograph 2 - After February 2011 earthquake

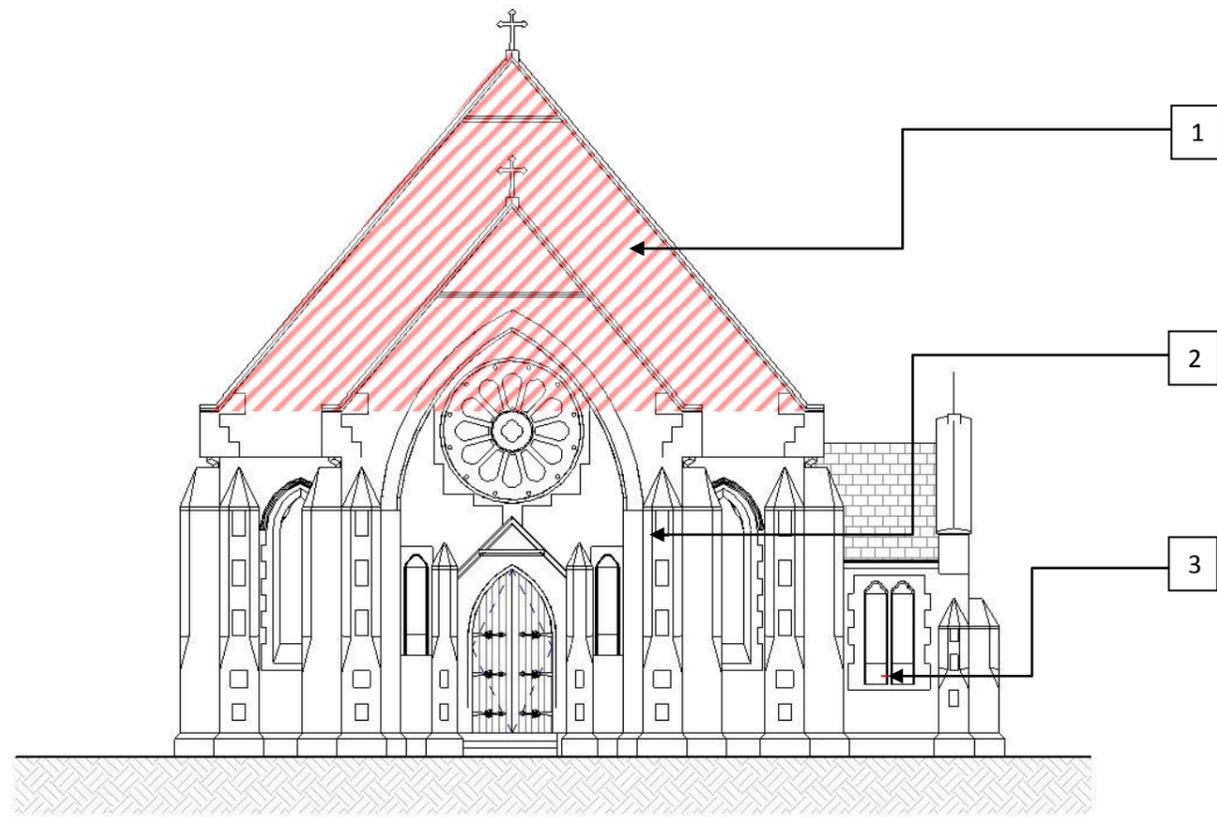
W Existing West Elevation  
101 1:50

Schedule No.	Description
1	Indicates areas of the building that have collapsed due to the earthquake
2	Cement rendering beginning to peel off areas of recent repair
3	Damage to base of stone column
4	Vertical cracking has appeared between the corncing
5	Damp ingress from guttering above, damp noted on the inside walls

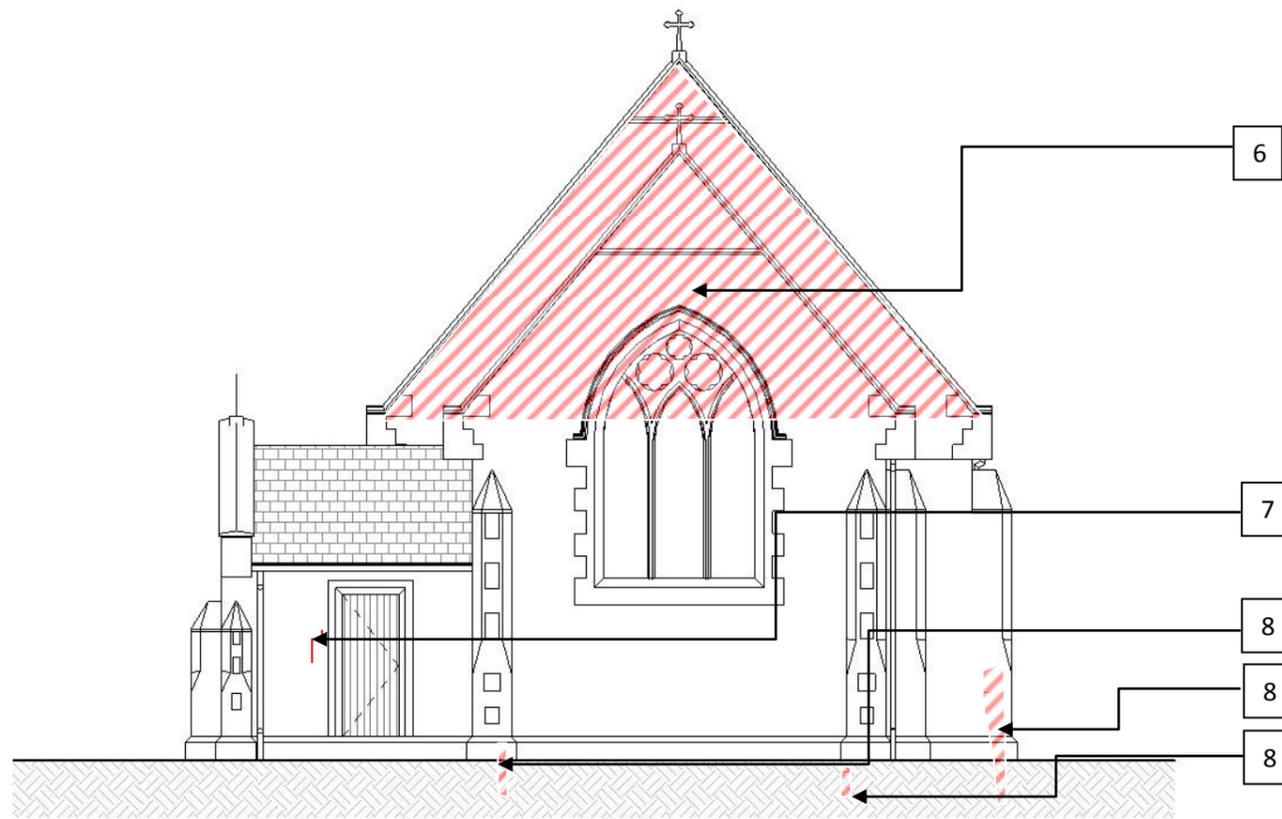
1 Existing East Elevation  
101 1:50

Schedule No.	Description
6	Indicates areas of the building that have collapsed due to the earthquake
7	Vertical shear crack 1-3mm located around door lintel
8	Loss of facing stone
9	Pocket in wall, facing stone removed exposing brick
10	Loss of stone to top of buttress

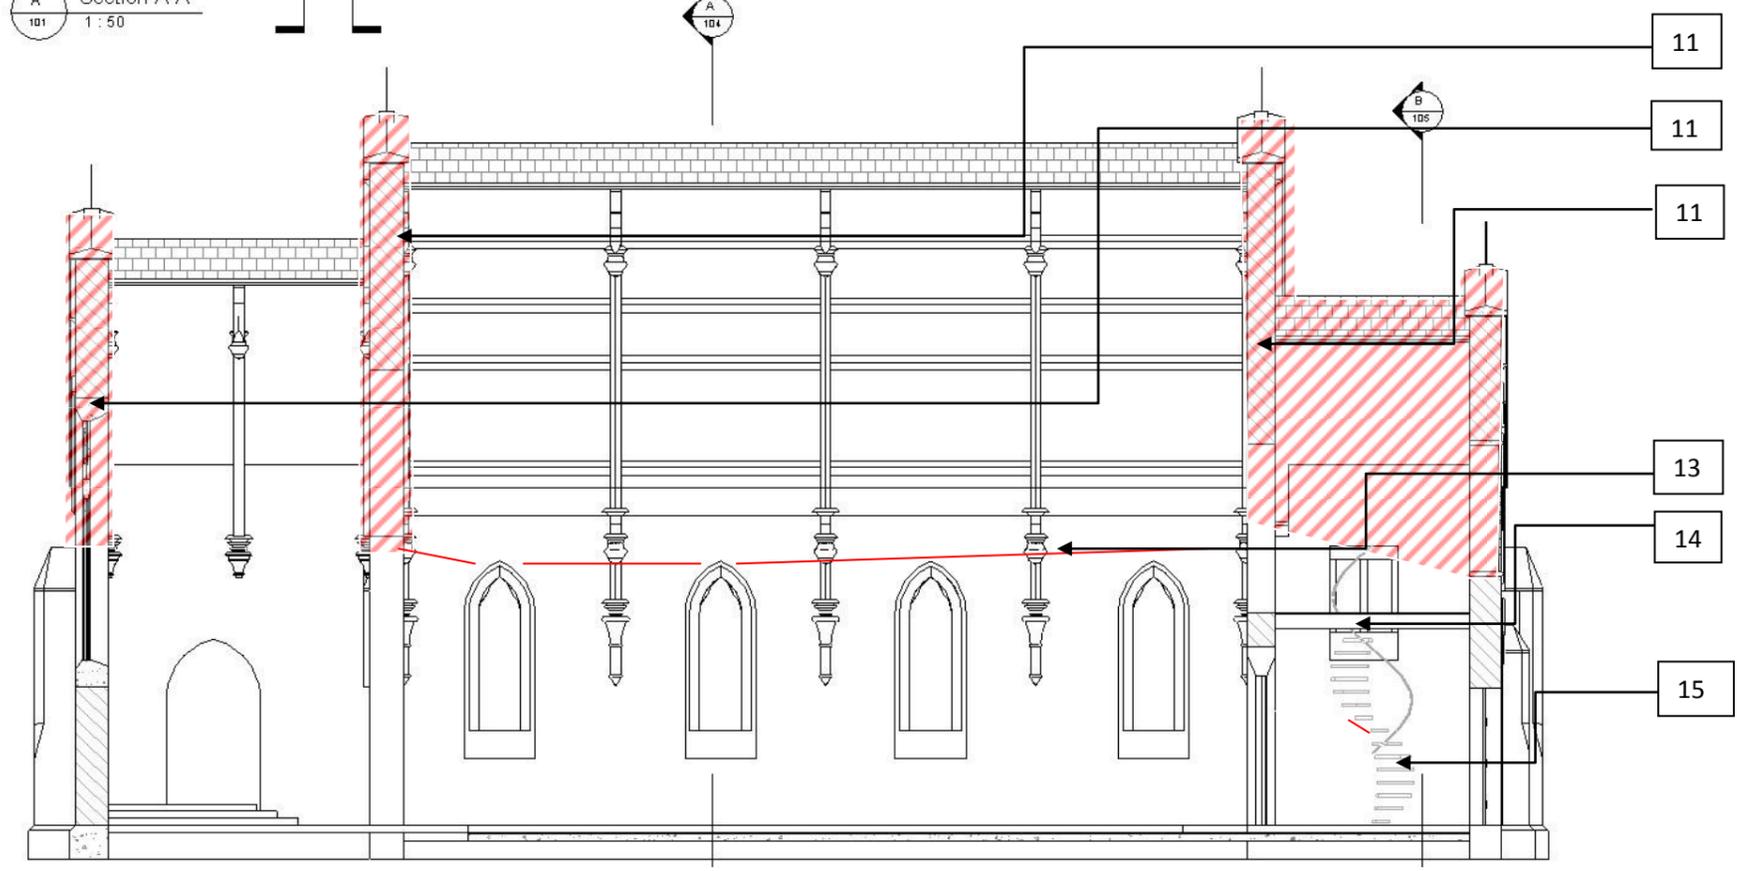
Schedule No.	Description	Photo Ref.
11	Indicates areas of the building that have collapsed due to the earthquake	
12	Gable wall showing signs of a 2° lean out of plane towards the toilet block. Damage to some of the internal rafters	Fig 16
13	Horizontal crack approx 1mm spanning the length of the church located above the existing window heads	Fig 17
14	Shear cracks in most of the timber floor joists due to the roof collapsing onto the joists	Fig 18
15	Spiral stair case removed previously	Fig 19

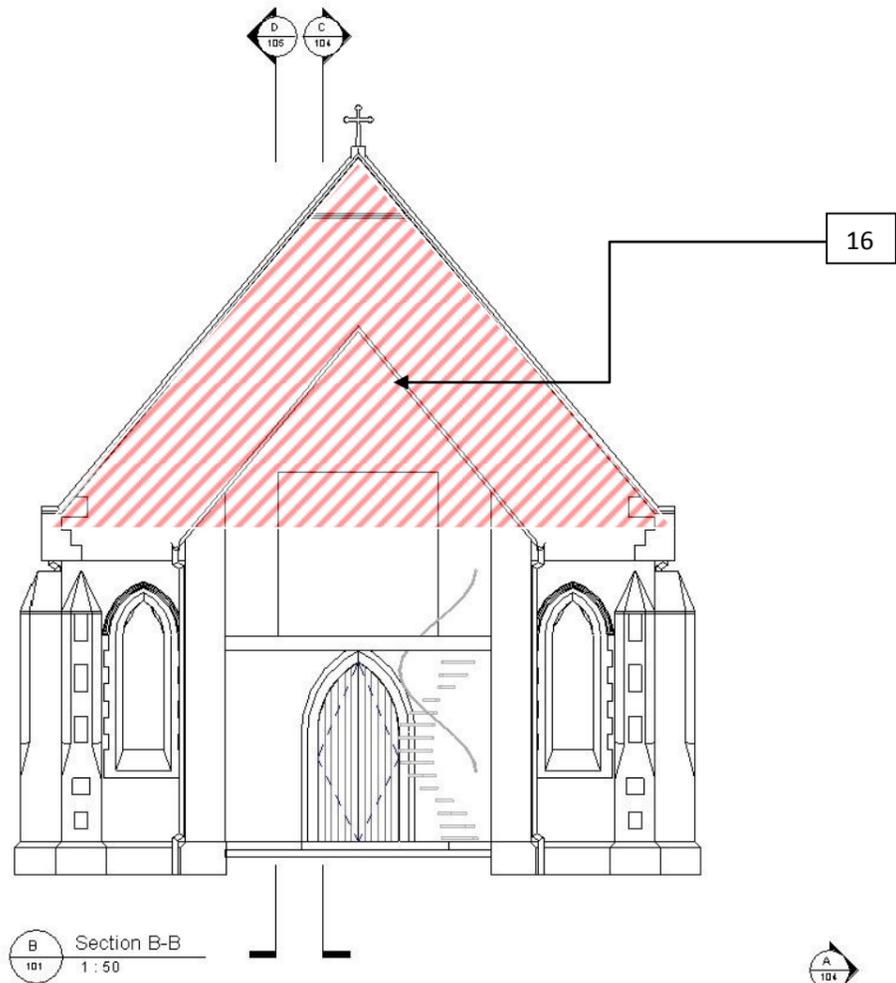
- 16 Indicates areas of the building that have collapsed due to the earthquake
- 17 Horizontal crack approx 1-2mm spanning the length of the building
- 18 Horizontal crack approx 1mm spanning the length of the church located at the base of the windows

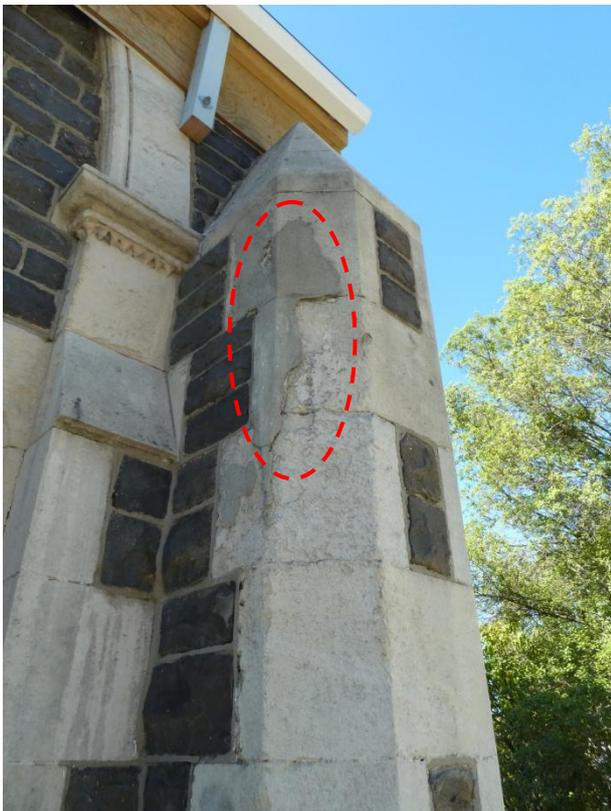
Figure 9 – New concrete render peeling away from existing stone

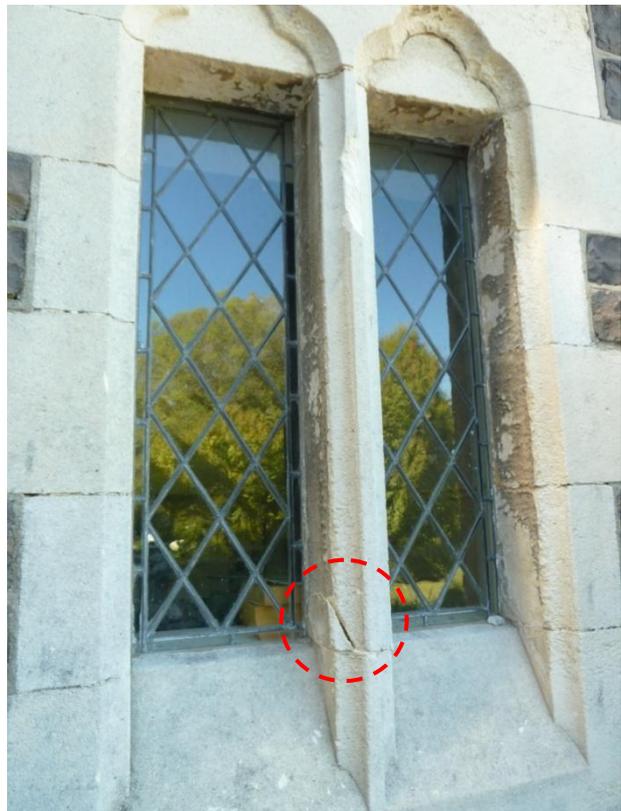
Figure 10 – Horizontal crack and stone pulling away from central column

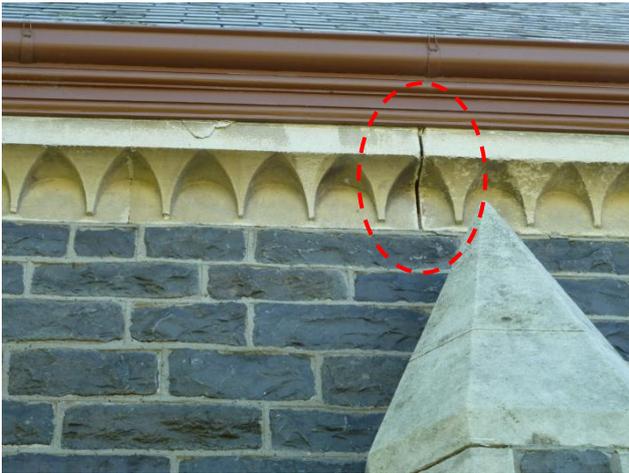
Figure 11 – Vertical joint opened up in between corncing likely to be historic

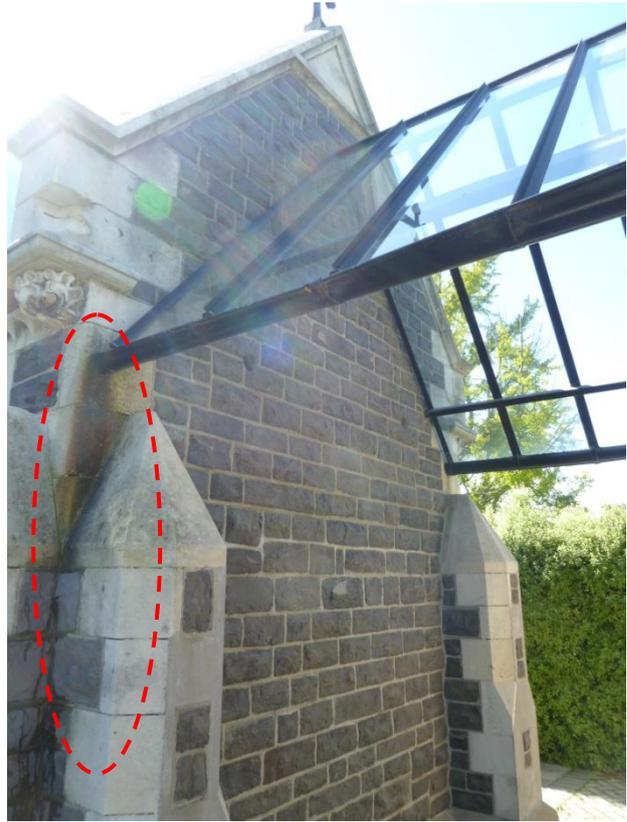
Figure 12 – water ingress from failing guttering

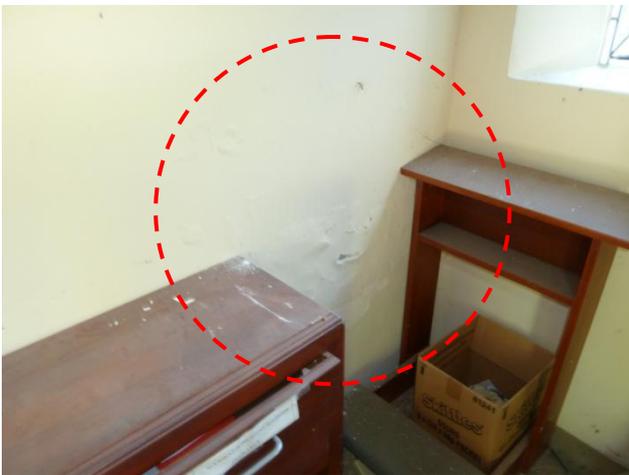
Figure 13 – Internal water ingress from failing guttering

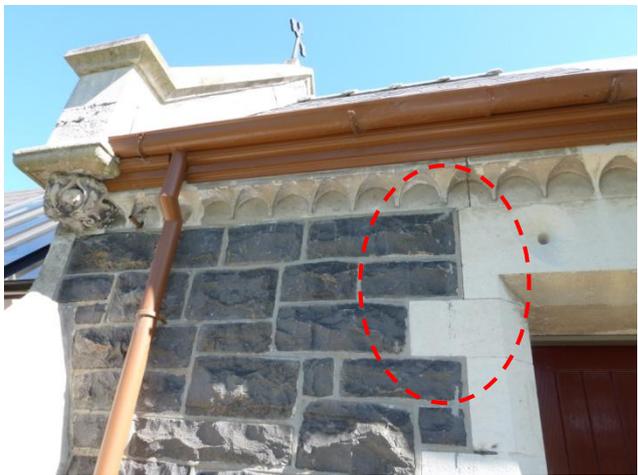
Figure 14 - Shear cracks forming between the door lintel and masonry wall

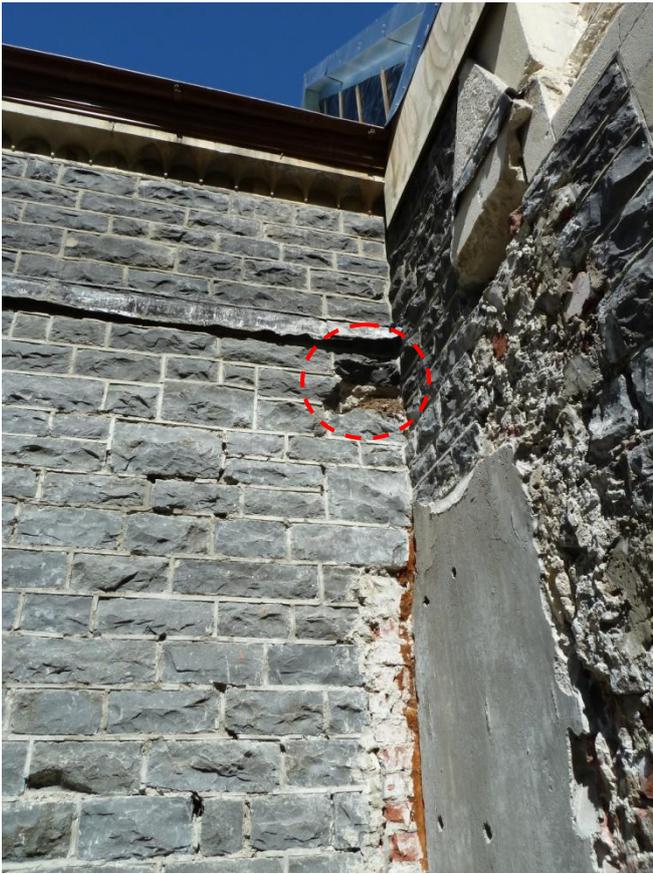
Figure 15 - Pocket in wall appears to be historic

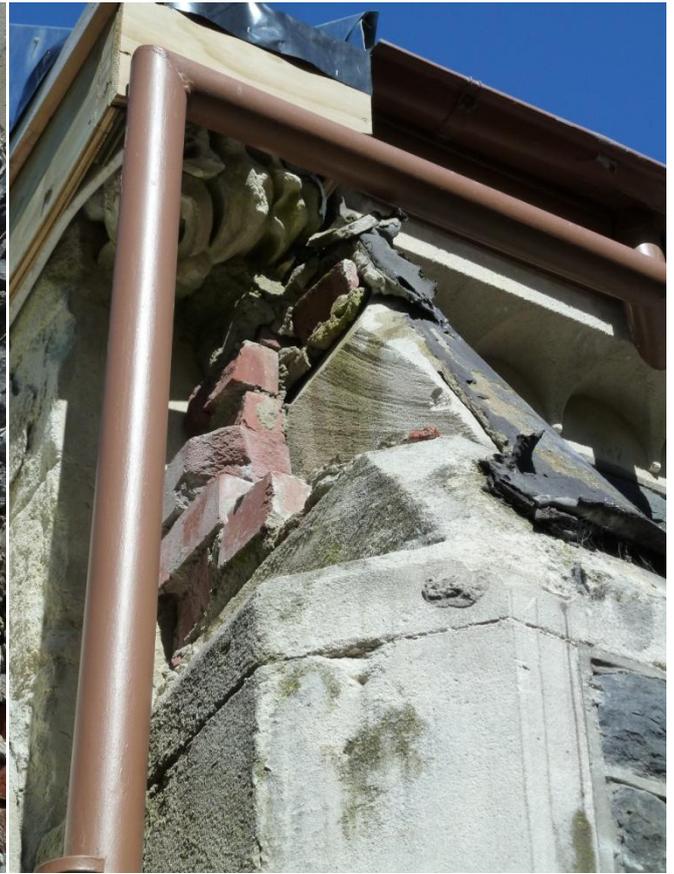
Figure 16 – Top of buttress suffered from damage and removal of facade stone

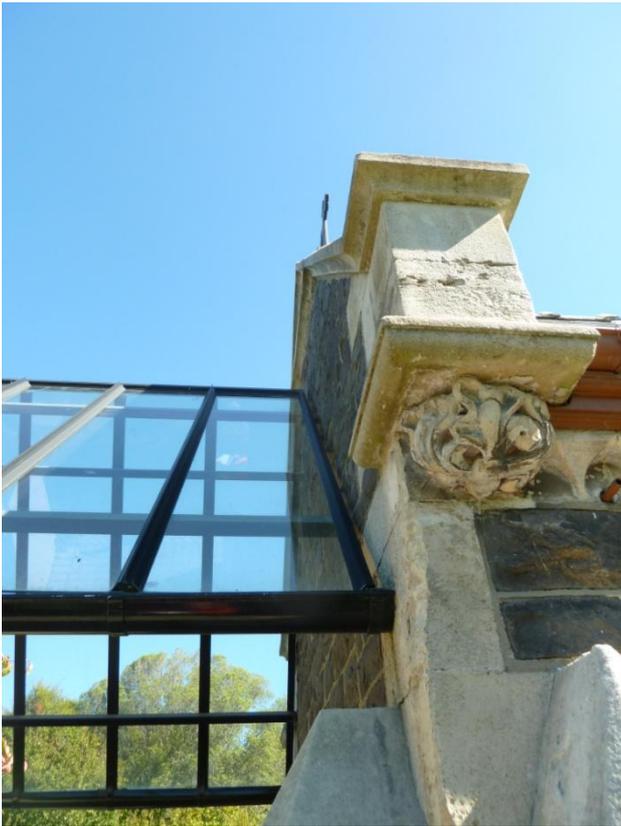
Figure 17 – Gable wall showing signs moving out of plane

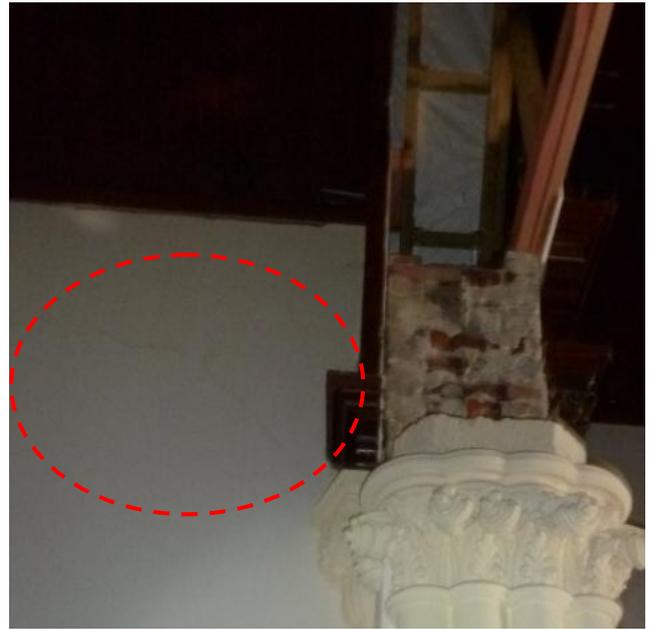
Figure 18 – High level horizontal cracking

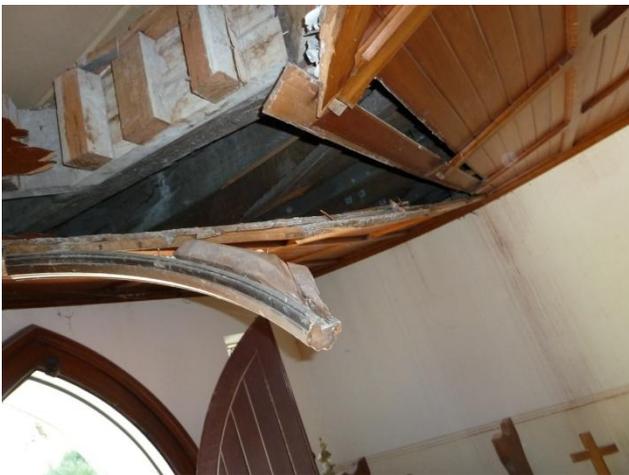
Figure 19 – Internal timber floors failure in Nave

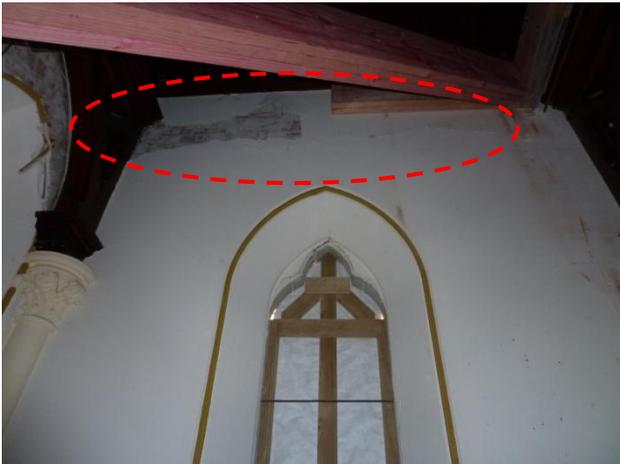
Figure 21 – High level horizontal cracking North Elevation

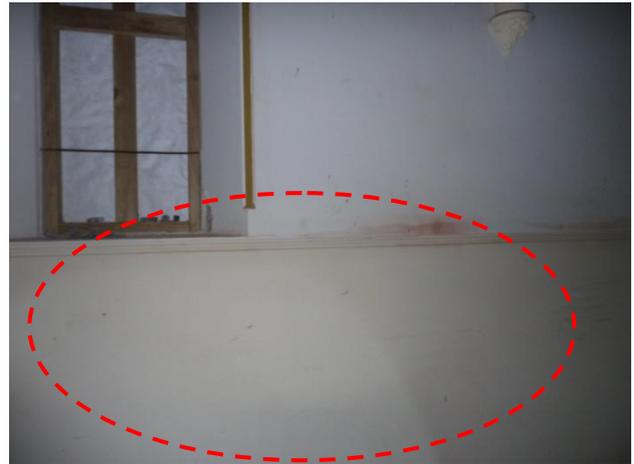
Figure 22 – Low level horizontal cracking North elevation

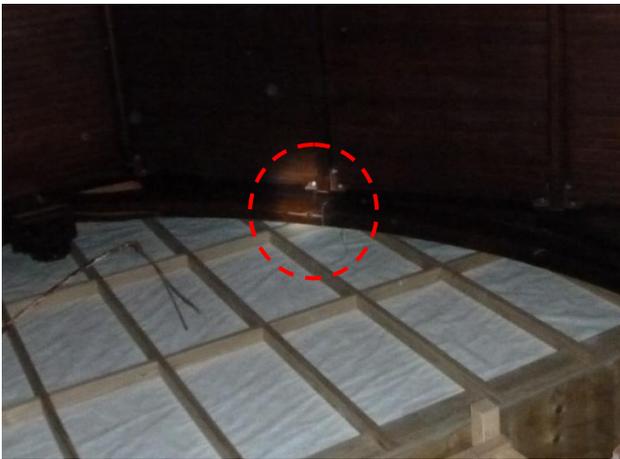
Figure 23 – Shear crack in roof truss connection

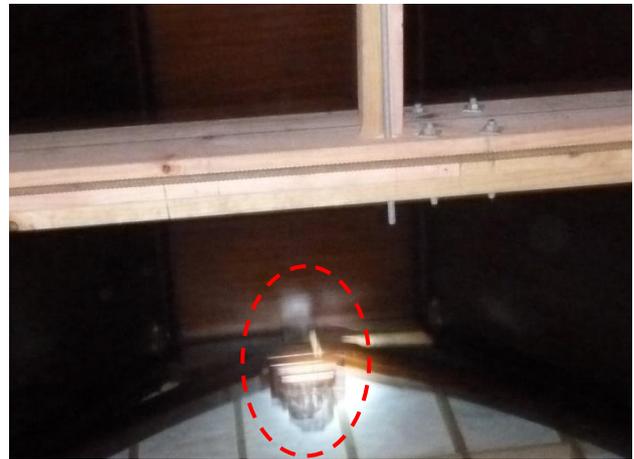
Figure 24 – shear failure at the apex of timber truss roof

It is likely from the observed damage that strengthening in the roof could not resist the applied seismic loads. This is evident from the visual damage to the timber trusses. In general, the connections between the purlin and trusses are showing signs of distress and the connections can be observed to be pulling away from one another.

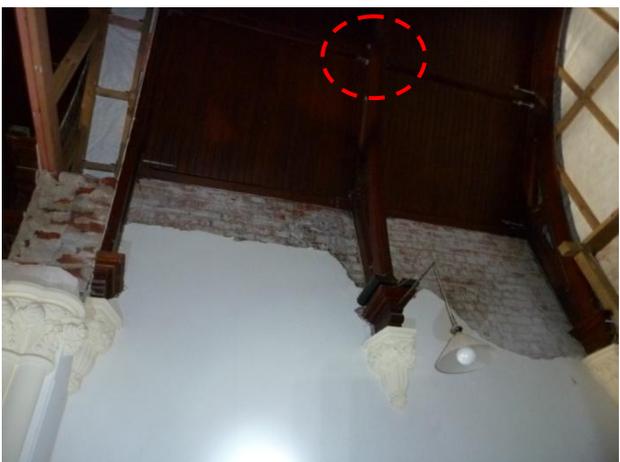
Figure 25 – Purlin connections pulling away from main truss

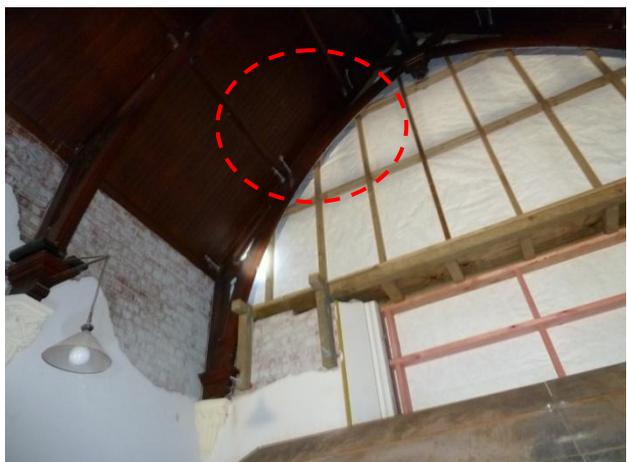
The building performed similar to other buildings of this construction and age. In particular, the failure mechanism of the gable end walls was common for this type of seismic retrofit. The roof was resin anchored into the end gable wall and it is likely to have failed due to the connections pulling out of the gable end wall. The overall structure of the south and north walls has fared well, with minimal structural damage to the walls, and a reasonable amount of residual seismic capacity.

Figure 26 – Gable end ties failed in pull out
