DETAILED ENGINEERING EVALUATION – QUALITATIVE AND QUANTITATIVE REPORT

SCARBOROUGH CLOCK TOWER

SCARBOROUGH CLOCK TOWER (Scarborough Park, 147 Esplanade Rd, Sumner)

Capital Programme Group
Christchurch City Council

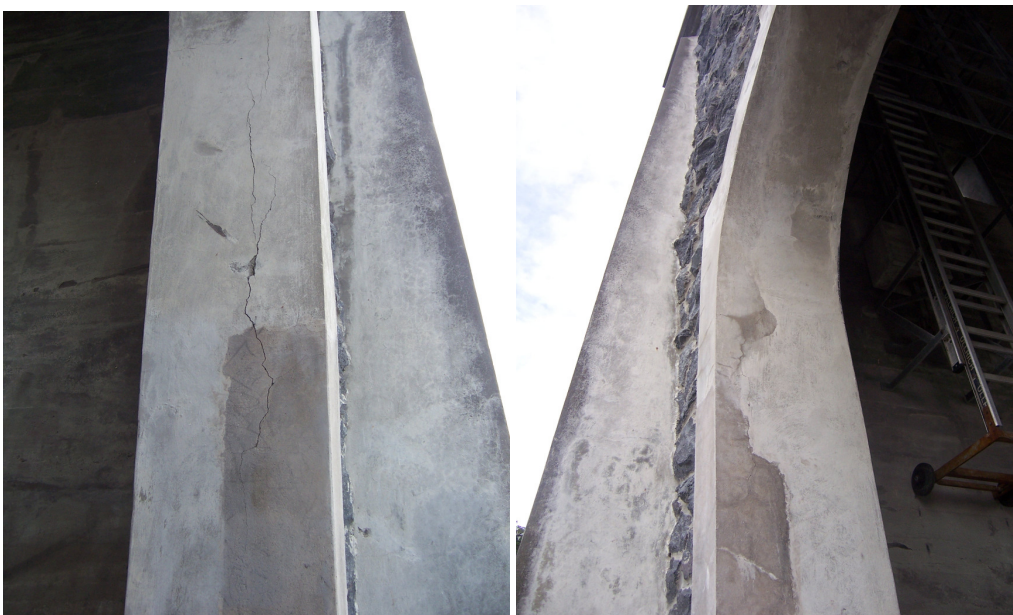
- The clock tower is not in close proximity to any buildings.
- Its general condition is not considered to pose an immediate risk to the public.
- Some cracking of the superstructure appears to be related to corrosion of the underlying reinforcement due to water ingress. This is also evident at some of the more "recent" patch repairs where the recent seismic activity has caused damage. Overall the cracking has likely worsened and there is some new cracking which can be attributed to the earthquakes (Figure 7a).

Figure 7a – Vertical crack on the inside of the north face arch

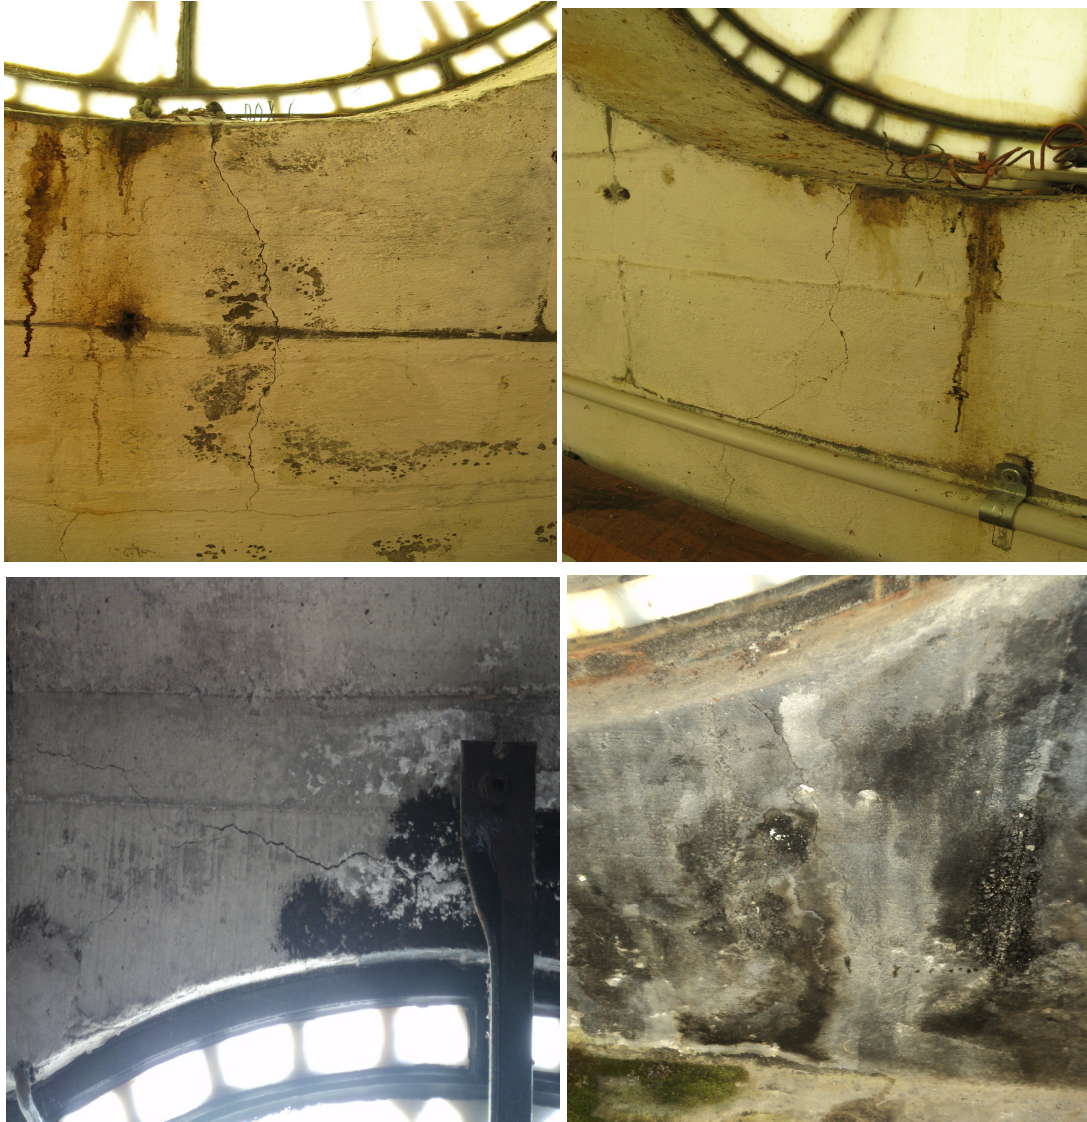
- All four interior clock face rebates and surrounding walls have vertical and horizontal cracks (max size approximately 0.4mm). Some ingress of water was observed indicating that water might be corroding the underlying reinforcing bars and potentially damaging the internal clock equipment (Figure 7b).

Figure 7b – Interior of the north and East faces showing the vertical cracks and moisture inside the clock tower

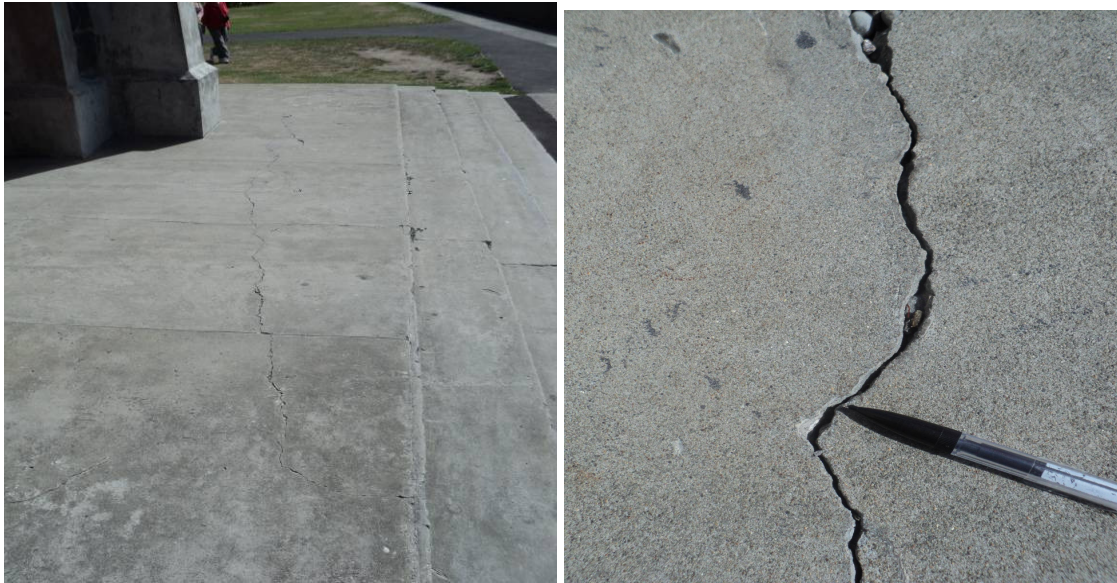
- The tower appears to be vertical, but there is evidence of some lateral movement due to slab repairs adjacent to the sea wall. The cracks in the slab around the perimeter of the tower are most likely due to the tower foundations moving behaving differently from the shallower slab and step footing (Figure 7c).

Figure 7c – Cracks around the slab around the perimeter of the tower

No level or verticality surveys were conducted for this building. However, the tower appears to be vertical. There is evidence of some lateral movement of the tower due to recent slab repairs adjacent to the sea wall.

- The structure requires maintenance to reduce the corrosion of the bars and spalling of the concrete in some parts of the structure.
- If the client want to upgrade the structure to a higher level of the new building standard in order to reduce drift levels it will requires to strengthening foundation by using screw piles in combination of strengthening walls by using FRP or similar products. This will require geotechnical investigations and model complex computer analysis of the structure.
- Repair slab and steps

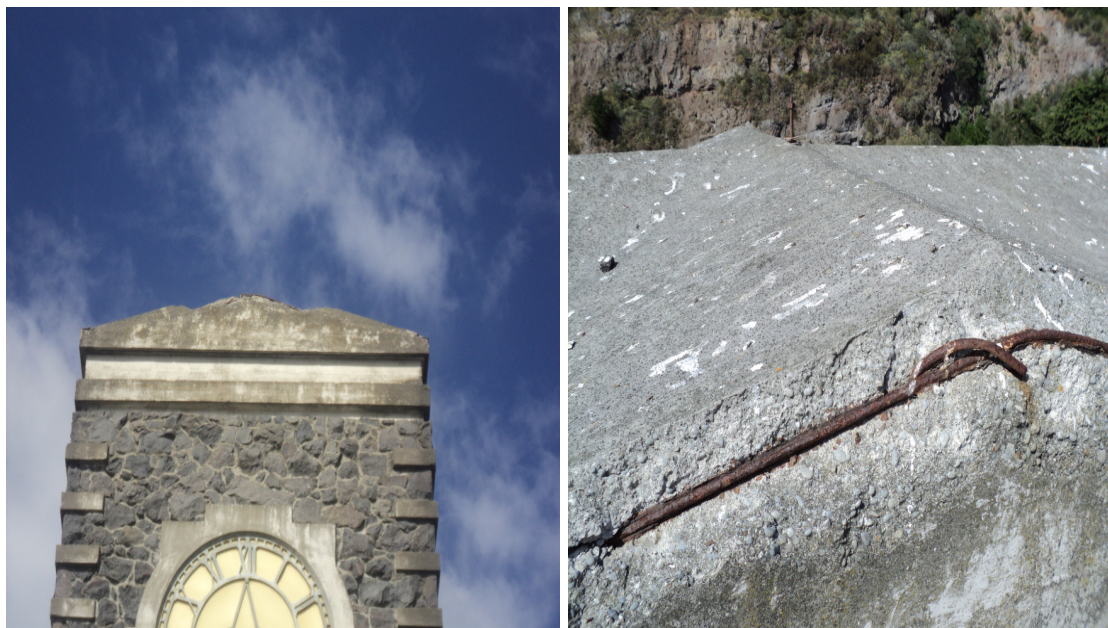
- An inspection of the top of the tower revealed damage to the concrete roof. A closer inspection of this area indicated that there was no immediate danger from loose concrete. The concrete spalling is due to deterioration of the concrete and corrosion of the reinforcement. Further investigations to determine the extent of the issue and specify suitable repairs is required (Figure 7d).

Figure 7d – Concrete spalling at the roof

Minor repairs are required to prevent corrosion on the reinforcing steel and concrete spalling.

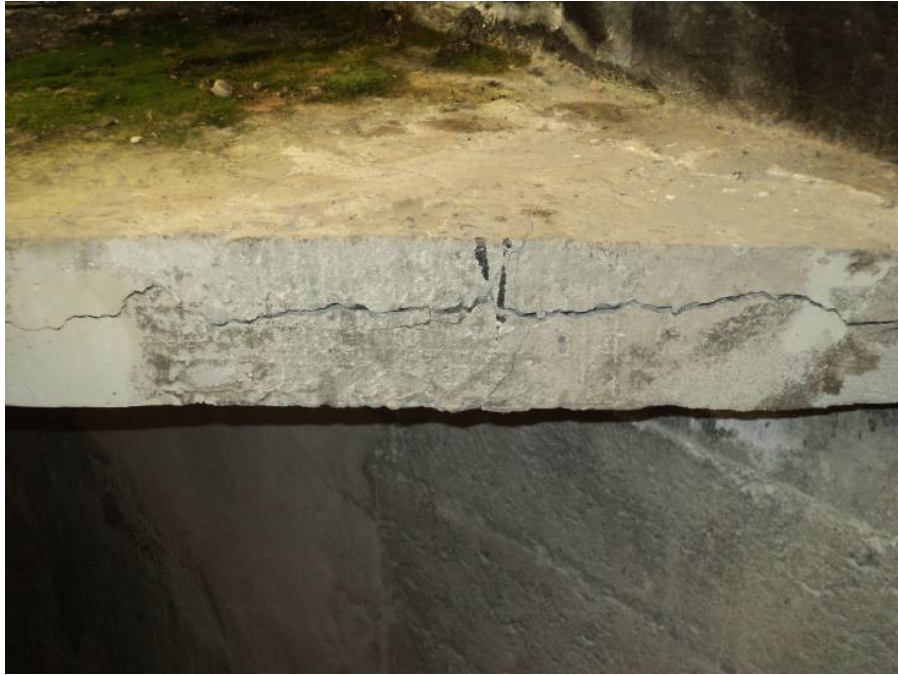
- A horizontal crack was observed in the side of the penetration through the 1st floor slab

Figure 7e – Crack in concrete slab at 1st floor
