Shirley Library
Quantitative Engineering
Evaluation

Functional Location ID: PRO 2215 B001

Address: 36 Marshland Road, Shirley

Date: 27 May 2013

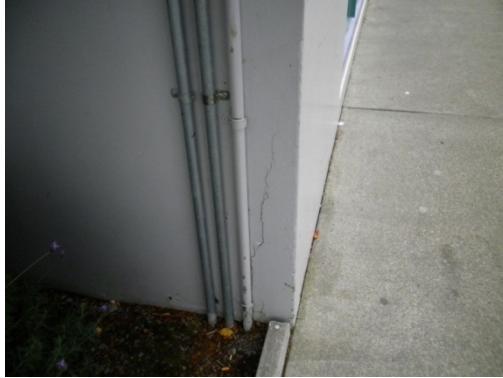
The most significant observed damage was splitting and spalling at the ends of precast concrete panels near the connection to the pad and floor slab and widening of the control joints to the concrete floor slab. This damage is likely due to compression failure as the panel rocked under the seismic loads. Panel rocking can generate high localized compression forces at the ends of the panels above the foundation pads. For this type of structure, the highest load generated by rocking occurs at the extremity of the last panel, which is exactly the location of the damage. Although the edges of the corner panels have burst, further rocking is unlikely to cause the damage to progress significantly because compressive forces required to burst further concrete off the panel will be higher than those that have caused the initial damage. Carpet tiles above the interior floor slab adjacent to the areas of damage to the panels were lifted but no damage to the interior concrete slab was observed.

<p>Concrete spalling at connection between adjacent panels above foundation pad (on west facade).</p>

Additional strengthening is not required in any of the structural systems. Visible cracks and spalling can be repaired using epoxy-based coating and patching mortar. As the structural strength of the concrete elements has not been reduced in the earthquakes, the repairing objective will be to prevent concrete degradation and the rebar corrosion as a result of the minor damage.

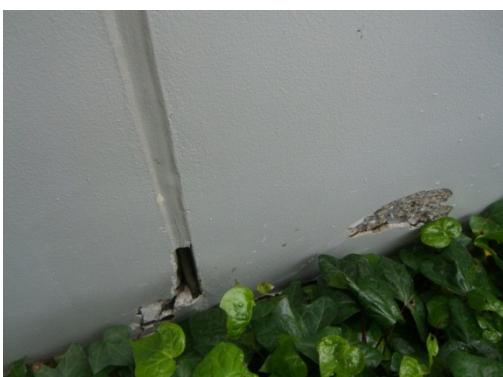
The evidence of pull-out actions was noticed exclusively to the detail connecting the concrete precast panels to the web of the portal frame's column (see drawing's typical portal details 5, S1-6). The assembly is an angle connected to the precast panels with a plate and dynabolts. The detail is used to stabilize the portal frame in case of an out-of-plane drift or torsion of the portal's column, which may have occurred during the earthquakes. However, the level of damage is very low, and it doesn't influence on the general stability of the building, so as for the not properly installed washer.

<p>Evidence of pull-out actions in some connections.</p>

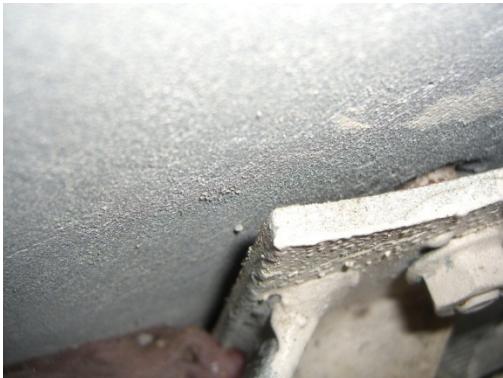
<p>Connection's washer not properly installed.</p>

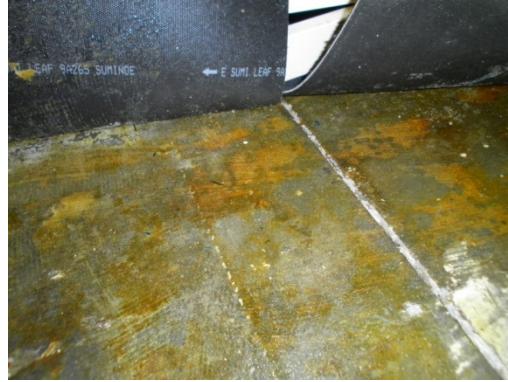
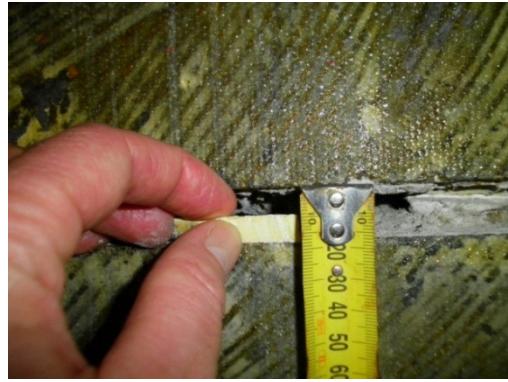
Widening of the floor slab and control joints is of some concern because it may have resulted in a permanent increase in overall slab width. Where it was observed the control joint width was measured at approximately 4 to 10mm. The proportion of the crack width due to earthquake effects can only be estimated as some of the crack width is due to the original saw cut and some due to slab shrinkage. However some is clearly due to earthquake effects and this can be seen in the carpet tiles bridging the cracks. Where the cracks have widened the carpet tiles no longer fit snuggly. Not all control joints were observed and it may be that more than one parallel joint has expanded. This movement may have resulted in the lateral displacement of the foundation pads supporting the portal frame legs and the base of the precast cladding panels although no evidence of this was observed on the building exterior. To make sure no displacement occurred, a level survey was carried out in the previous assessment and a verticality survey was carried out in the present one (see Appendix A).

<p>Important widening of slab control joint by up to 10.0mm.</p>

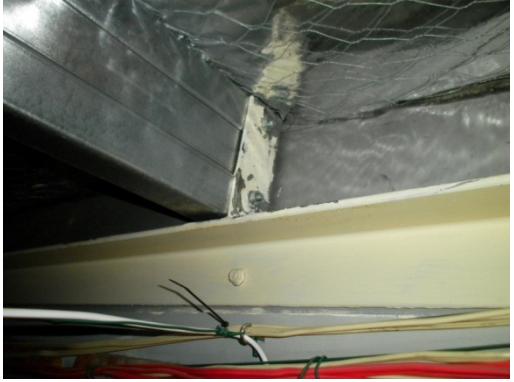
- A purlin has been added between the first and second purlin, in the second portal frame span, on the north-east side of the building.
- The north beam of the third portal frame from the east side has been replaced and is connected (weld) to the knee. Welding seems to be full capacity and no damage was observed.

Differences between the existing construction and the drawing. Rafter welded to the knee.

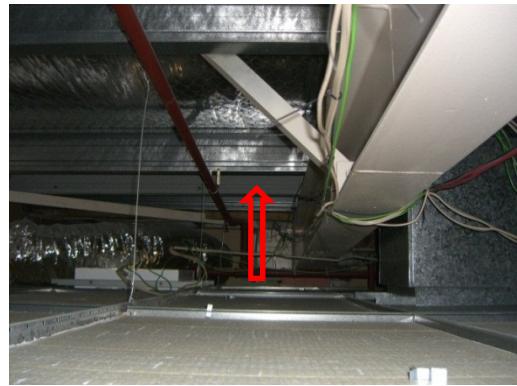
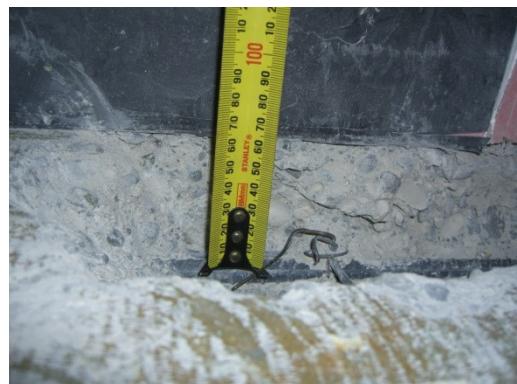
No sign of movement or yielding were observed in the connections during the intrusive investigations. All the elements inspected were as shown on drawings, according to their dimensions and quantity. The presence of bar thread for the bottom connections and the 668 mesh in the slab on grade were also confirmed.

Intrusive inspection of the bars connecting the precast panels and the slab.
