**Sockburn Civil Defence Training Centre**

**BU 1531-003 EQ2**

***Detailed Engineering Evaluation***

**Quantitative Assessment Report**

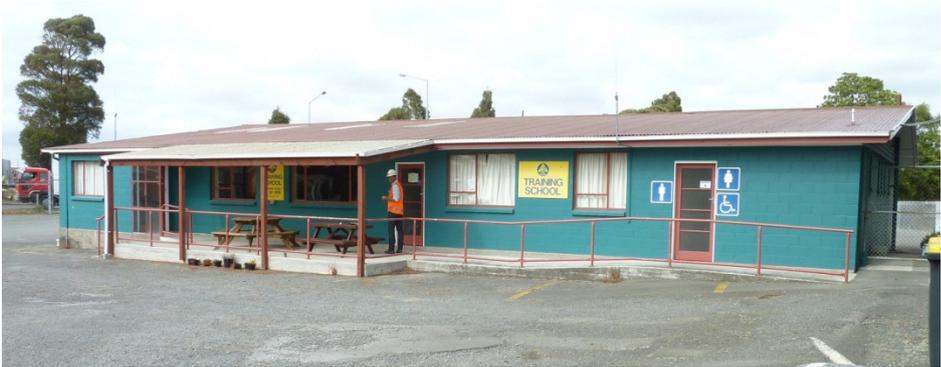
| Sockburn Civil Defence Training Centre | | |
|--|--|---|
| 1. | Looking at north-east face of the building | |

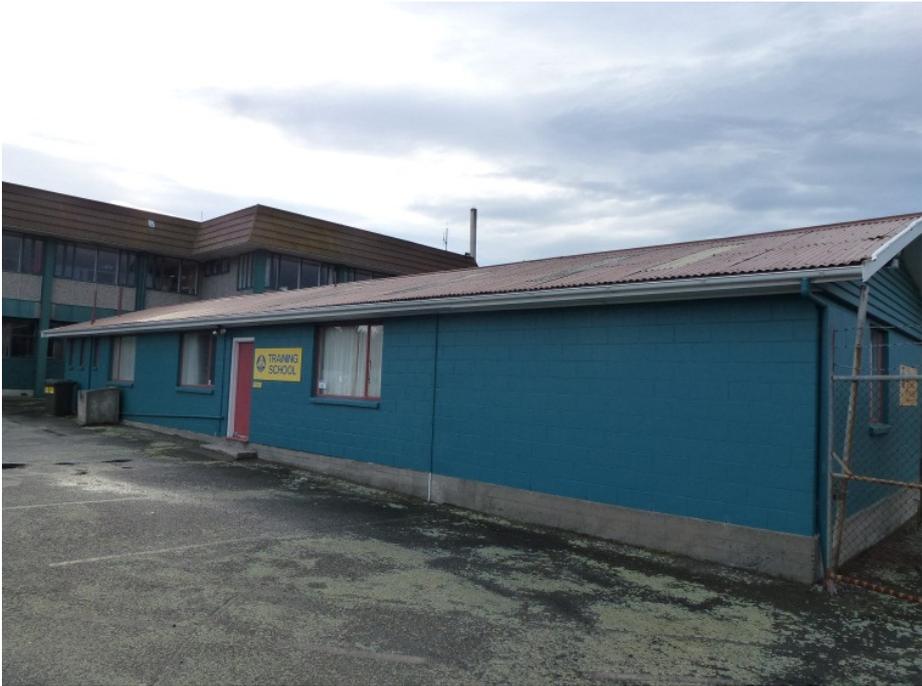
| Sockburn Civil Defence Training Centre | | |
|--|--|---|
| 2. | Looking at south west face of the building | |

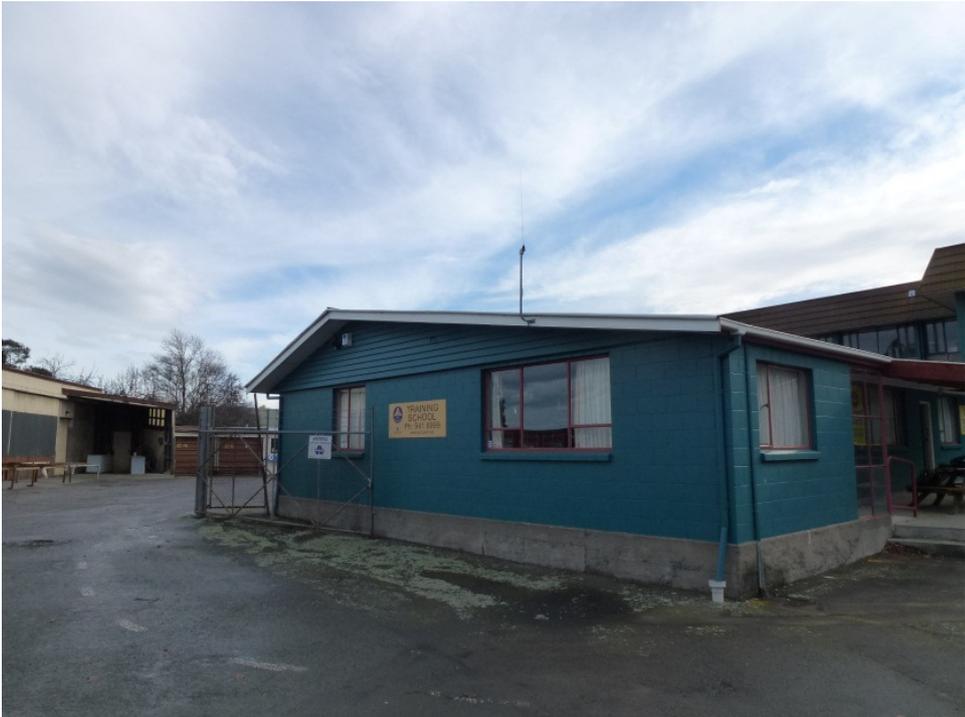
| <p>3.</p> | <p>Looking at the south-east end</p> | A photograph showing the south-east end of a teal-colored building. The building has a gabled roof and several windows. A sign on the wall reads "SHAWNEE SCHOOL". The ground is paved and there is a fence in the foreground. The sky is overcast. |

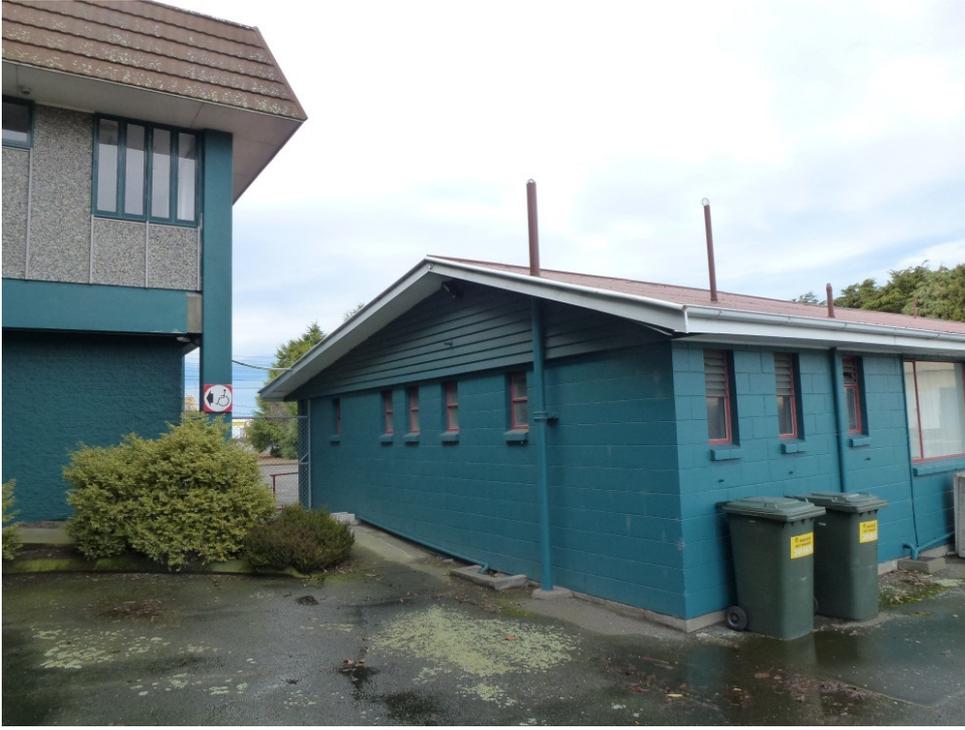
| <p>4.</p> | <p>Western corner of building</p> | A photograph showing the western corner of the teal-colored building. The building has a gabled roof and several windows. Two green trash bins are visible in the foreground. The ground is paved and there is a bush in the foreground. The sky is overcast. |

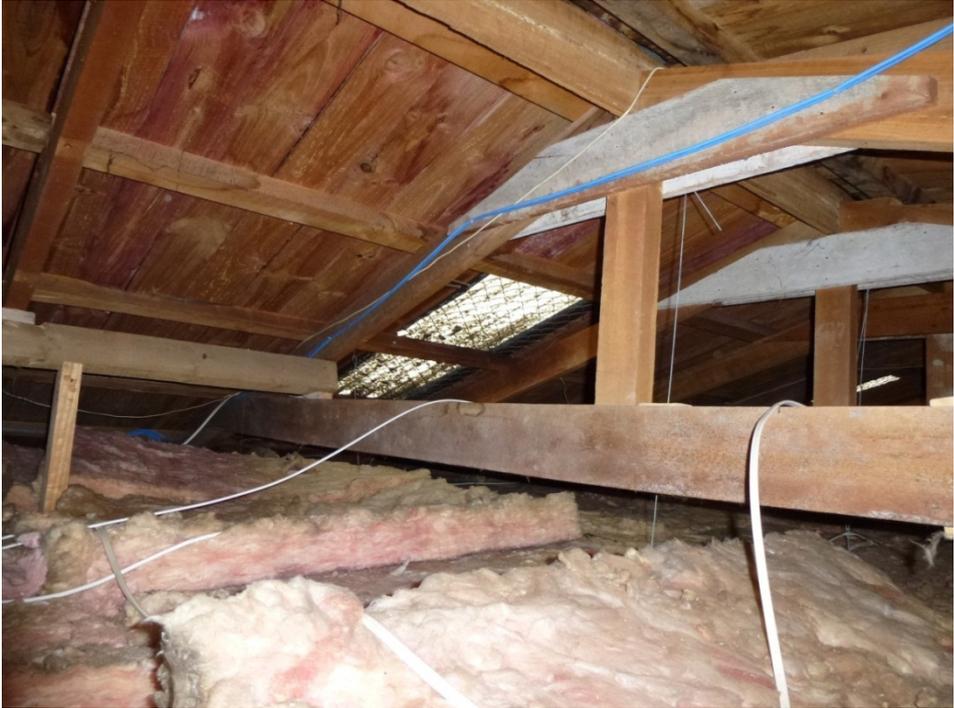
The suspended ceiling in the lecture room does not provide diaphragm action to transfer lateral loads to the wall elements. Diaphragm action is obtained in the café room plasterboard ceiling and also in the remainder of the building, which has an original Pinex ceiling lining. This ceiling type is expected to have a diagonal cut-between brace although this was not observed due to limited access to the roof space.

| <p>5.</p> | <p>Roof space above lecture room tiled ceiling</p> | |

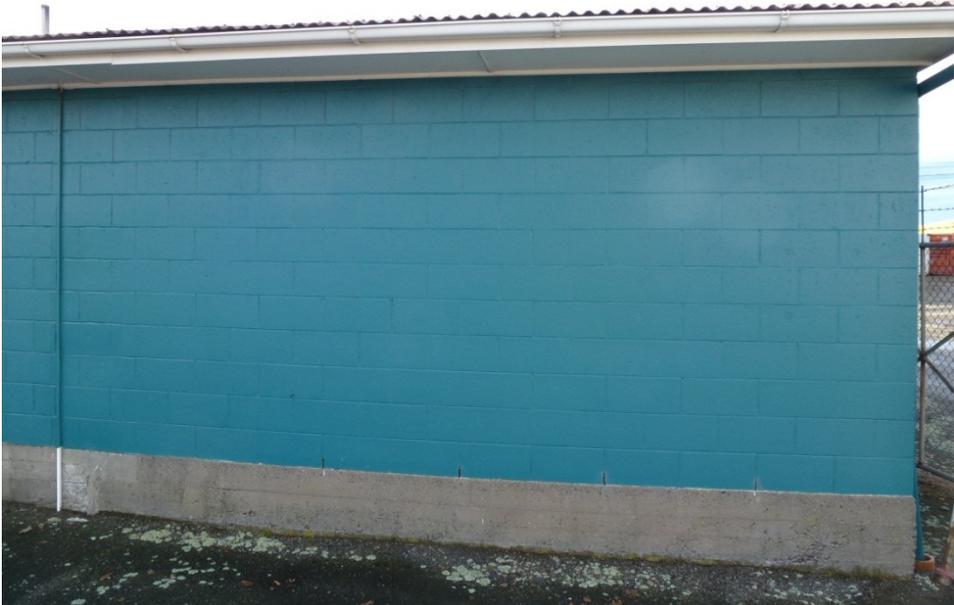
| <p>6.</p> | <p>Western face of southern corner showing different construction type of walls (notice vents at wall-foundation interface)</p> | |

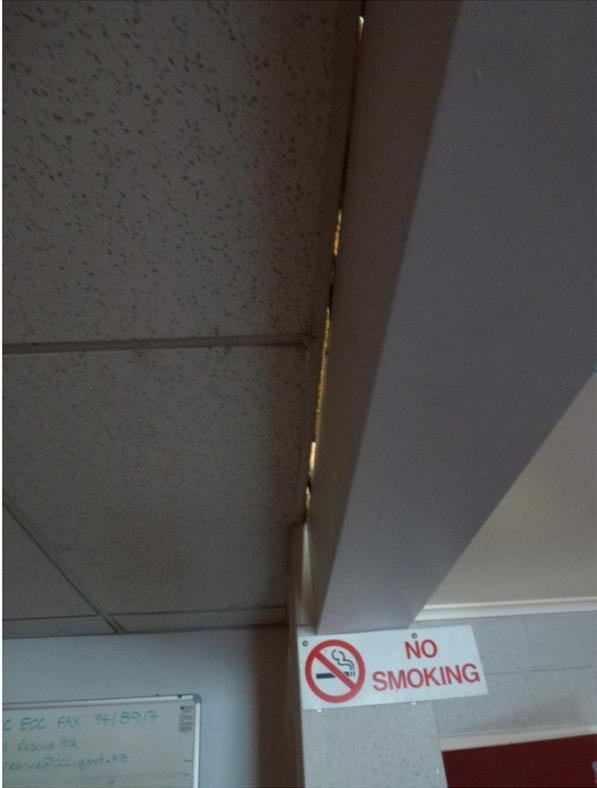
| <p>7.</p> | <p>Gap opening up between ceiling tiles and portal frame in lecture room</p> | |

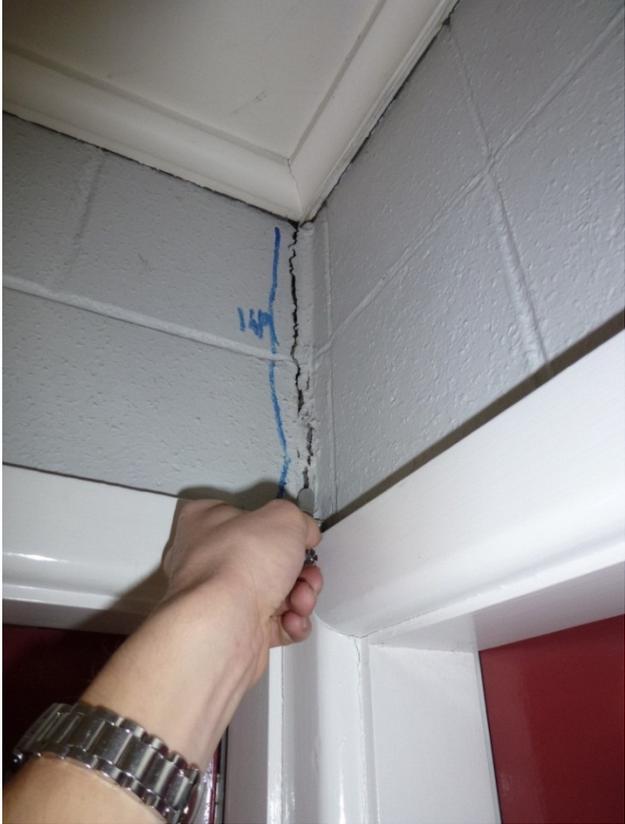
- a) Cracking up to 4mm wide at intersecting walls throughout the building in the top courses of the concrete block.
- b) Minor internal step cracks in the block walls in along the north-east side of the building, and in the west corner in the toilet block.
- c) Minor cracking of the Pinex ceiling lining in the shower area.
- d) A new gap between the suspended tiled ceiling system and the walls in the lecture room indicating rotation of the ceiling system.

| <p>8.</p> | <p>Cracking above door way in hallway at entrance to lecture room and café</p> | |

Remedial repair works to the cracked walls are required.

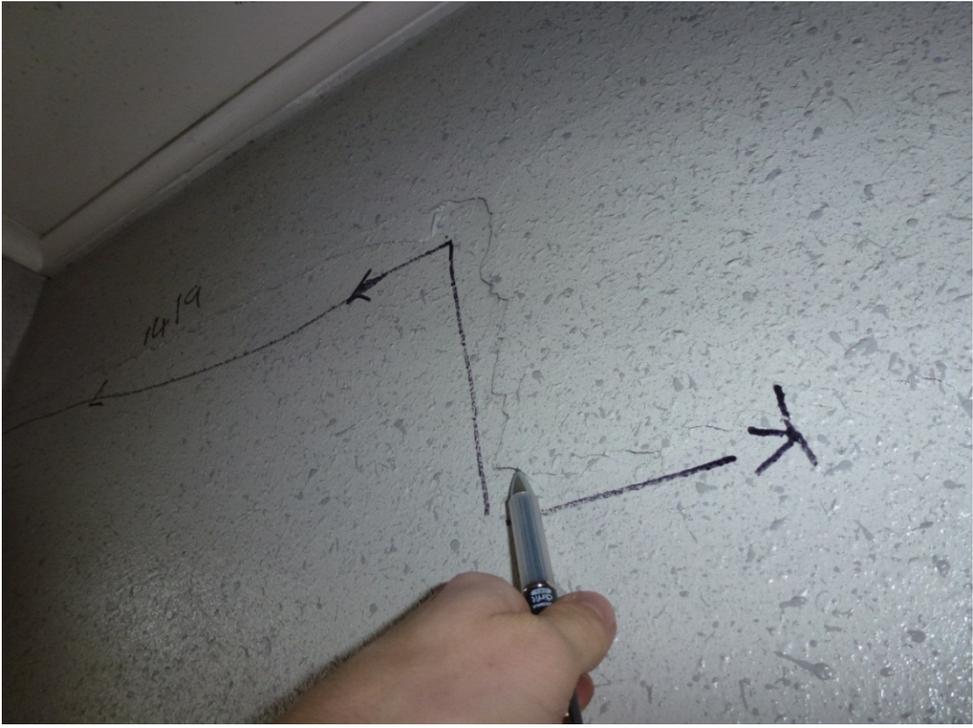
| <p>9.</p> | <p>Step crack<br/>in toilet wall<br/>lining</p> | |
