Spencer Park Camping Ground  
Holiday Cabins  
Qualitative Engineering Evaluation

**Reference:** 228605  
**Prepared for:**  
Christchurch City Council

**Address:** 100 Heyders Road, Spencerville

**Date:** 10 July 2013

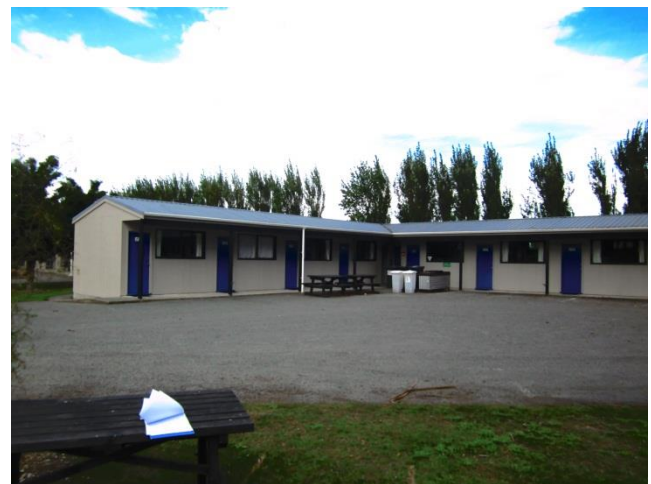
Building North Eastern elevation.

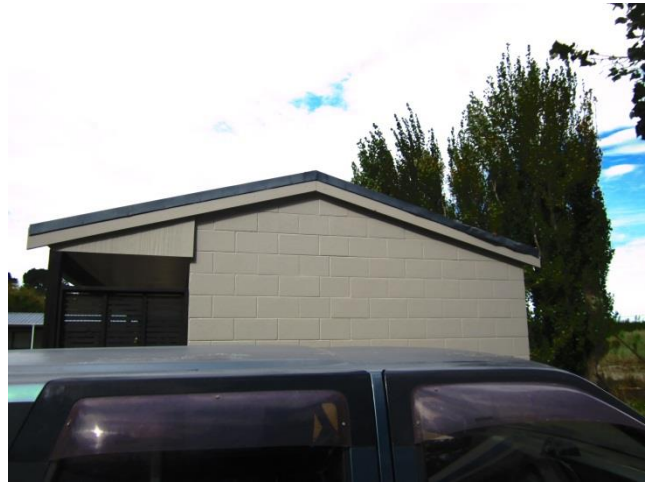
Building Northern end elevation.

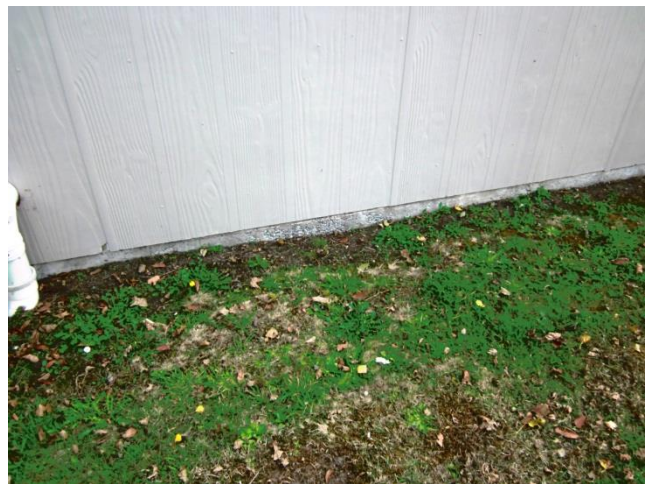
Vertical cement sheet boards and concrete slab below.

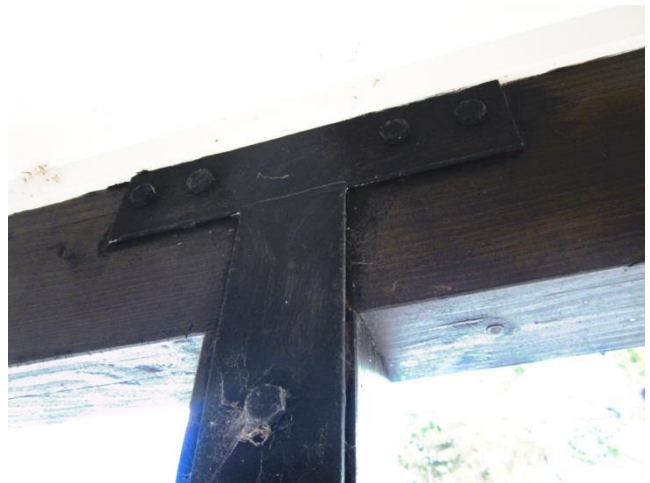
Timber veranda beams and post.

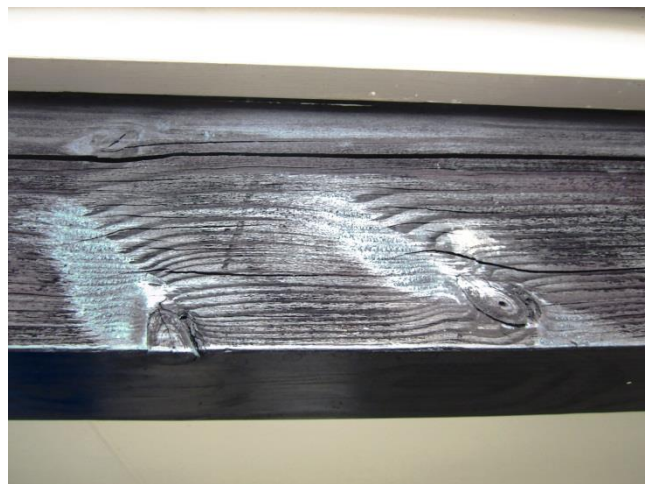
The damage observed in the Spencer Park Camping Ground Holiday Cabins was relatively minor. They were primarily splitting in the timber, cracking in the foundations/pavements and plasterboard linings. Of the various types of damage observed, only the plasterboard wall and ceiling lining cracks are likely to be exclusively earthquake related. Other damage, including the splitting in the timber beam and the cracking in the foundations/pavements may be due to historic in service conditions.

Splitting in the veranda timber beam.

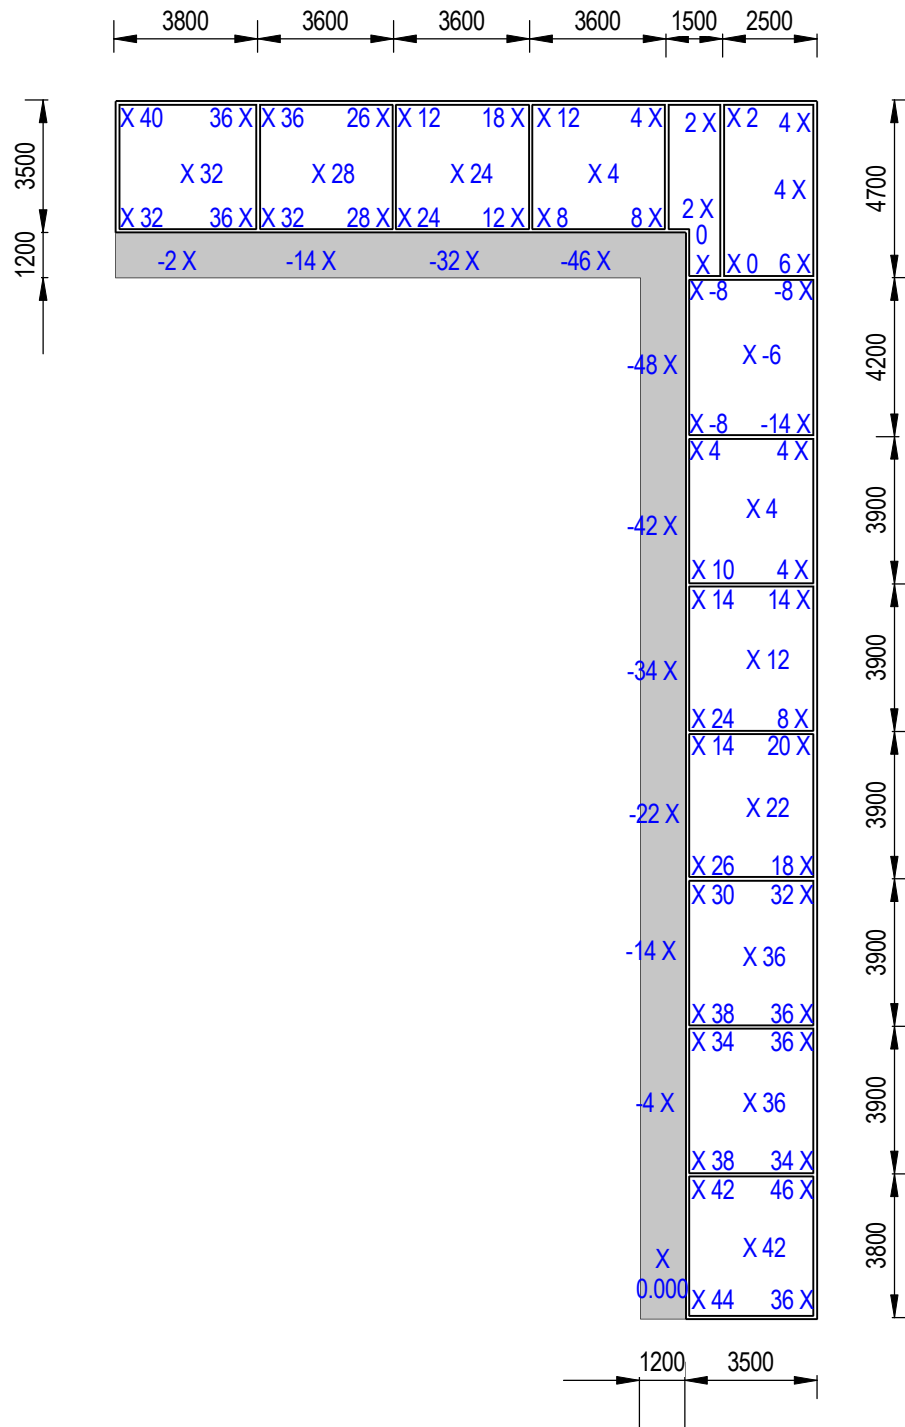
PROJECT
SPENCER PARK CAMPING GROUND HOLIDAY CABINS
TITLE
LEVEL SURVEY C BLOCK

A levels survey was undertaken on the floor coverings of the building to quantify the level of unevenness. The levels survey results were within the 1 in 200 or 0.5% slope threshold set by the Department of Building and Housing’s November 2011 Guidelines. Therefore no further action in the form of re-leveling is considered necessary.
