Spencer Park Camping Ground
Lodge
Qualitative Engineering Evaluation

Reference: 228607
Prepared for:
Christchurch City Council

Address: 100 Heyders Road, Spencerville

Date: 28 June 2013

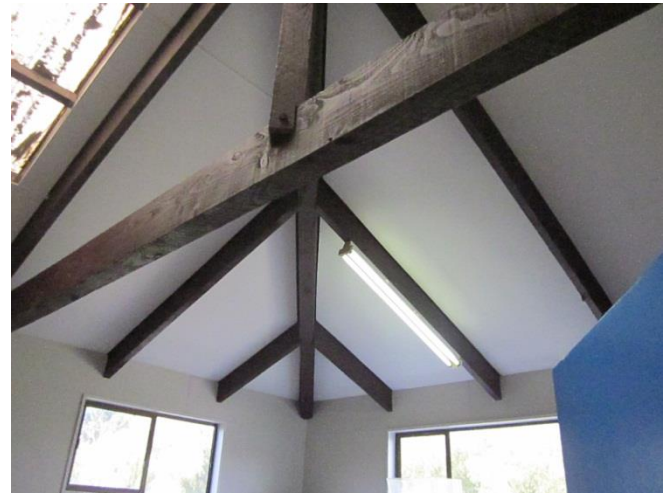
Timber purlins and pre-nailed trusses in the toilet block addition.

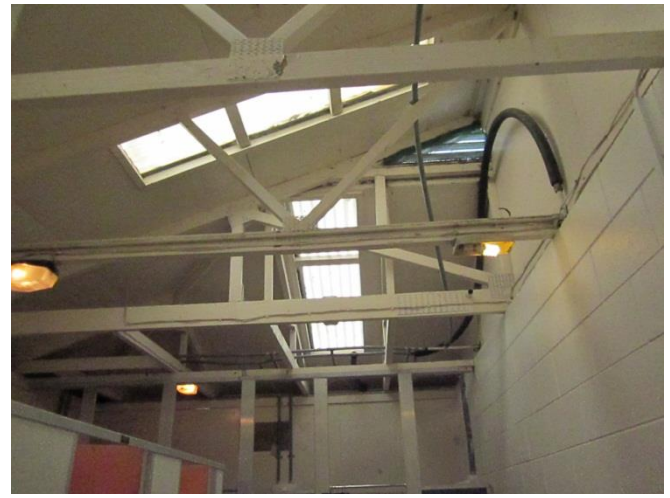
The Spencer Park Camping Ground Lodge was in use at the time of the damage assessment. The only damage noted from the damage assessment was cracking in the joints between the precast concrete tilt up double tee units.

Damage was limited primarily to cracking in the joints between the precast concrete tilt up double tee units. Additionally the levels survey has shown that there has been no differential settlement of the foundations of the Lodge.

Joint between two precast concrete tilt up precast double tee units.

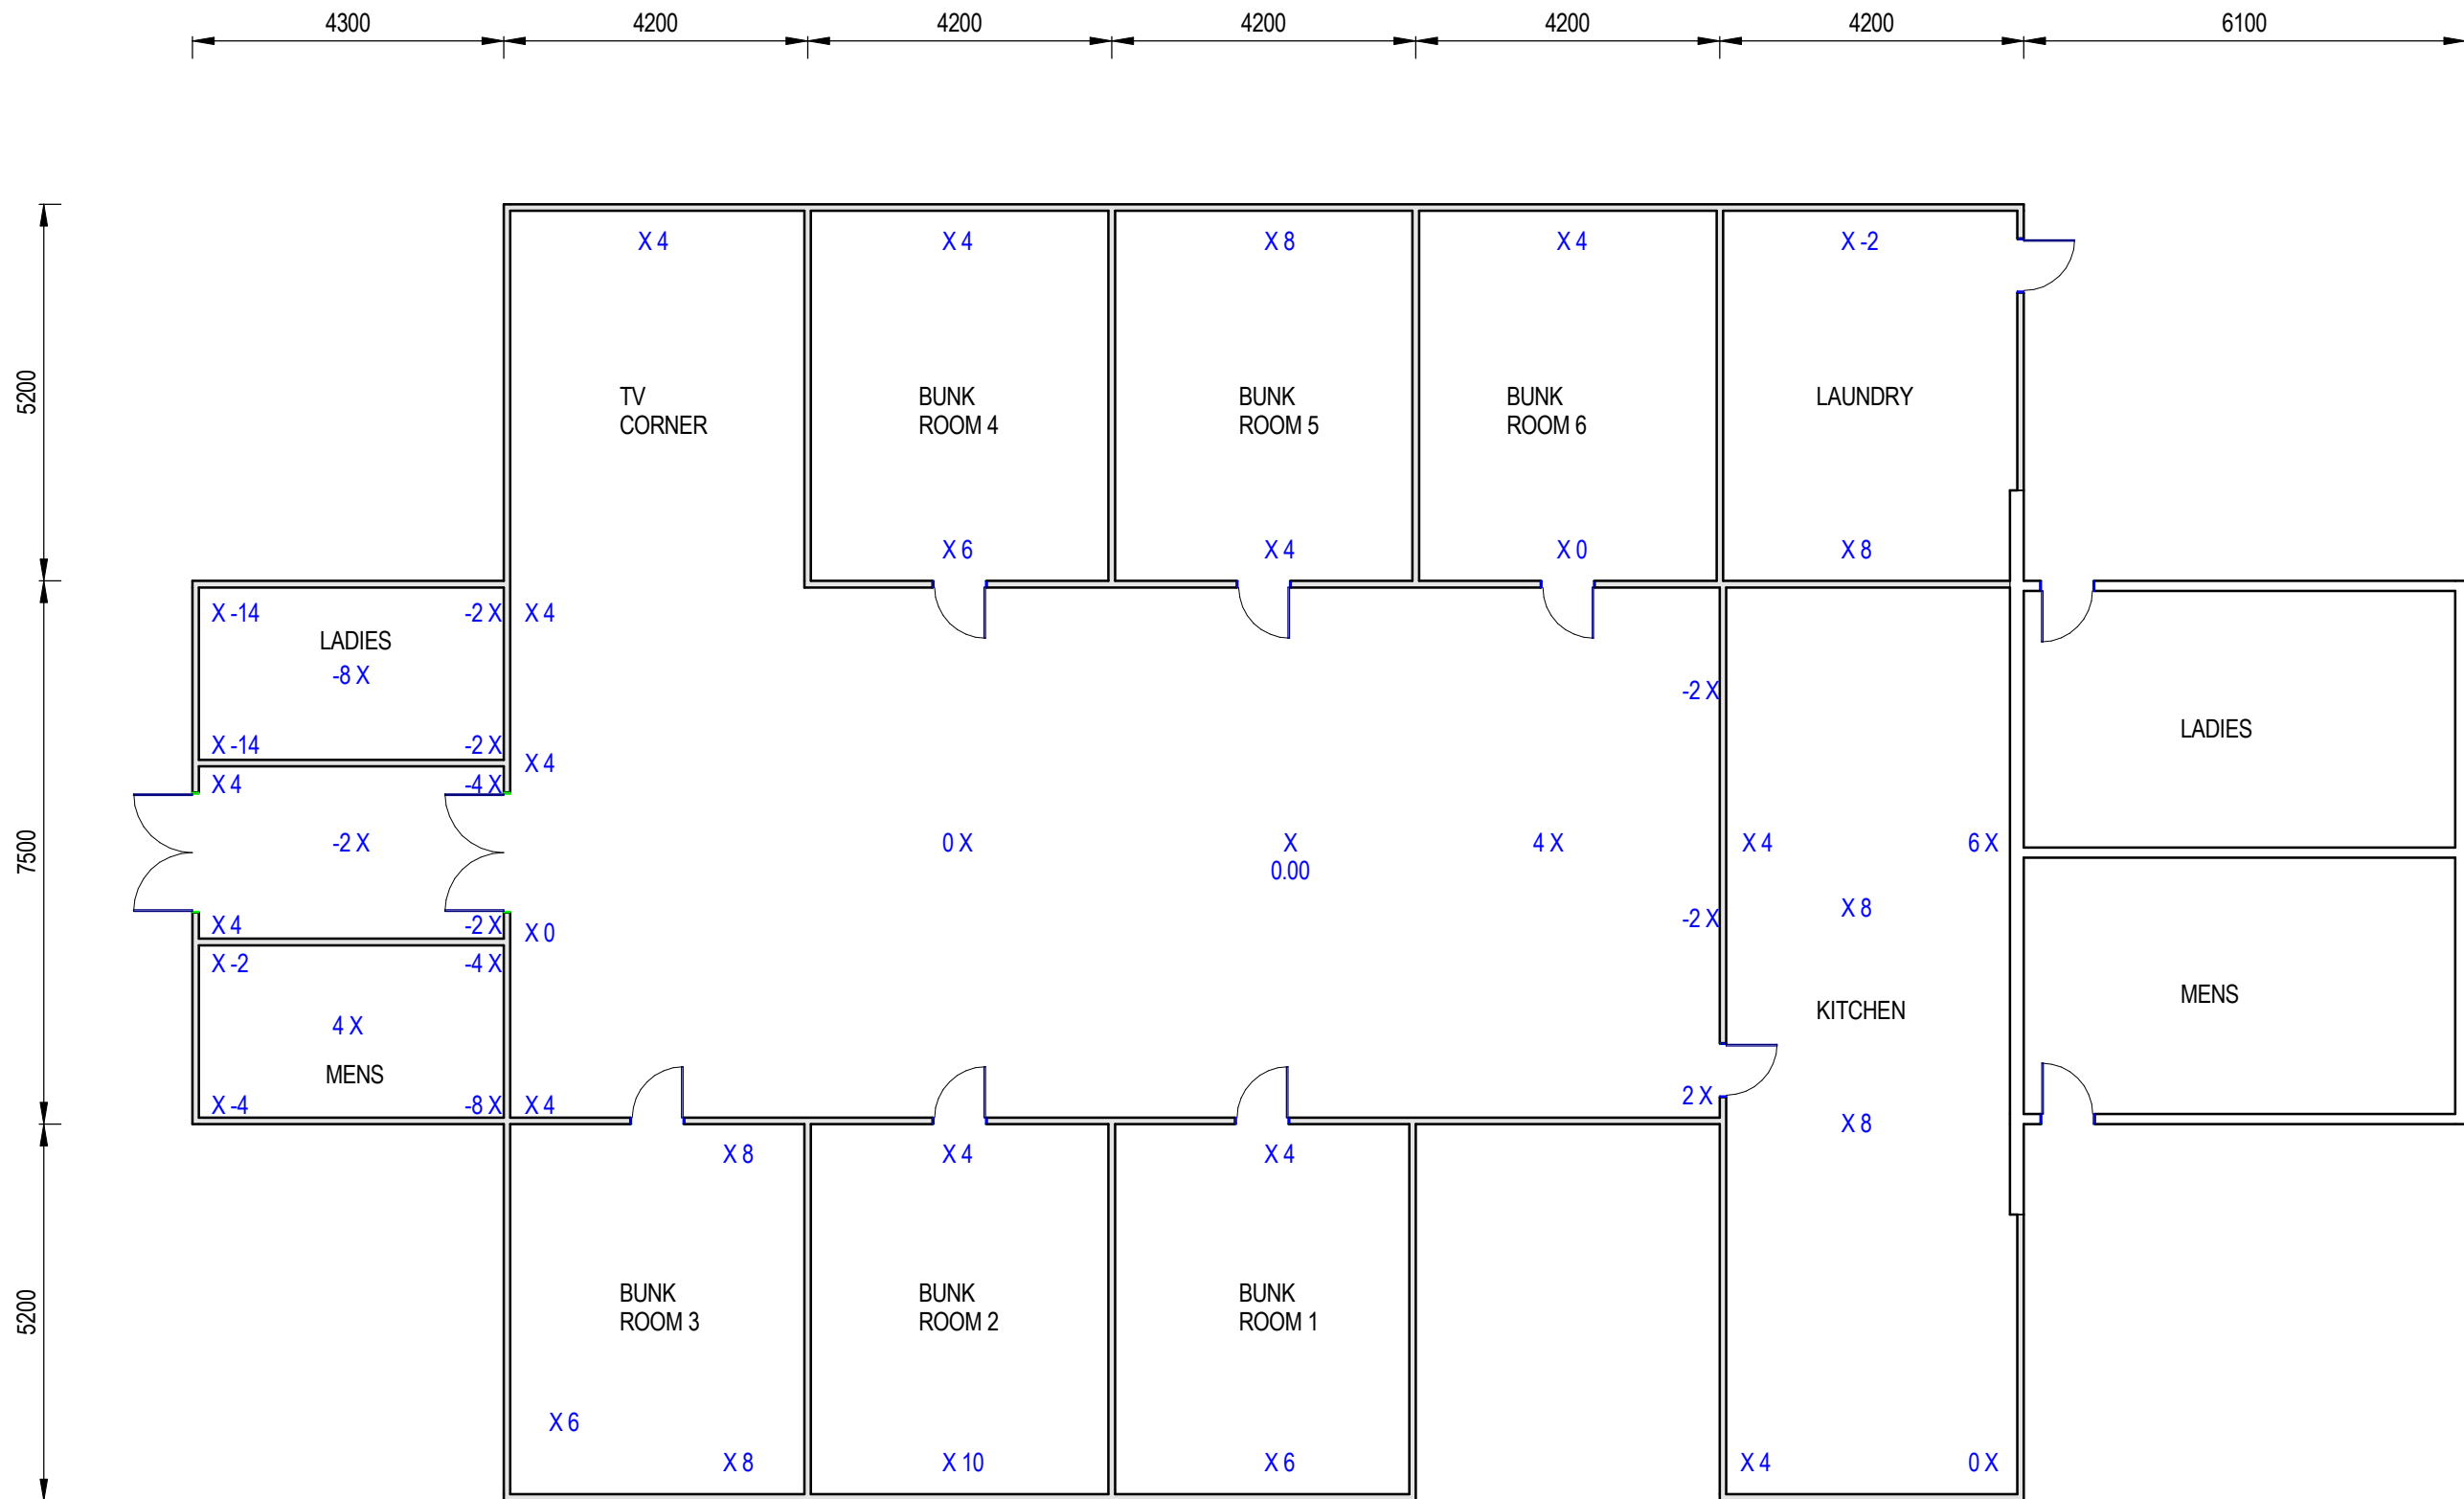
PROJECT
SPENCER PARK CAMPING GROUND LODGE
TITLE
LEVEL SURVEY

The floor levels for the Spencer Park Camping Ground Lodge were found to be within the recommended tolerances with slopes of up to 0.49% and a variation of 49mm over the floor plan.
