Stoddart Cottage
BU 3555-006 EQ2

Detailed Engineering Evaluation
Quantitative Assessment Report

Purau Avenue, Diamond Harbour

Date: 22 April 2013
Reference: 6-QUCCC.82
Status: FINAL

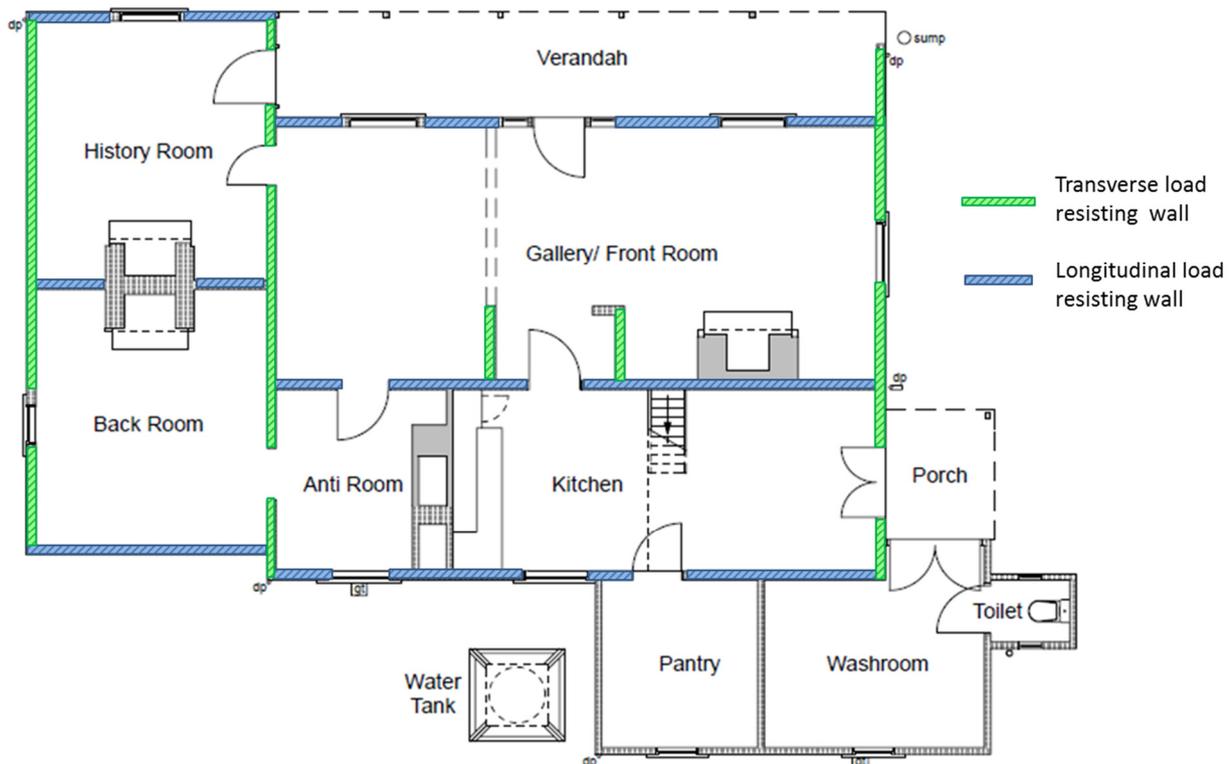
Figure 3: Building Layout and Location of Timber Bracing Wall

The lateral load resisting systems in both principal directions are the perimeter timber bracing walls. An overview of the key lateral resisting elements is as shown in Figure 3 below.

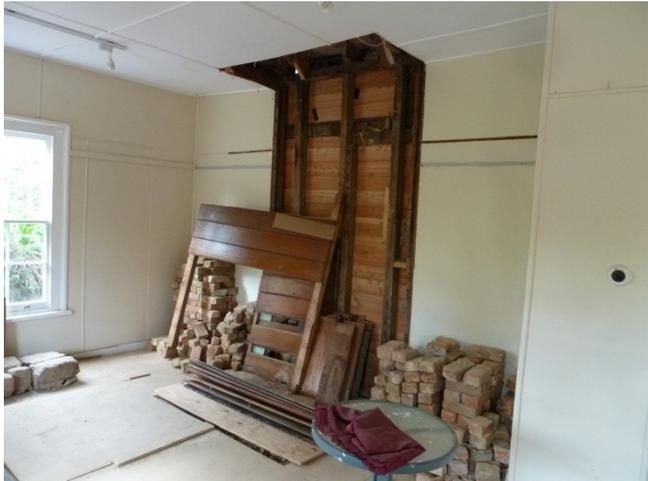
<p>2.</p>	<p>East chimney showing removed fireplace</p>

All three brick chimneys were severely damaged during the Canterbury earthquakes and have been reduced down to ceiling level except for the east chimney where the entire chimney including fireplace has been deconstructed. See Photo 2 in Appendix 1. Any future reinstatement of these chimneys would need to consider structural strengthening down to the ground level.

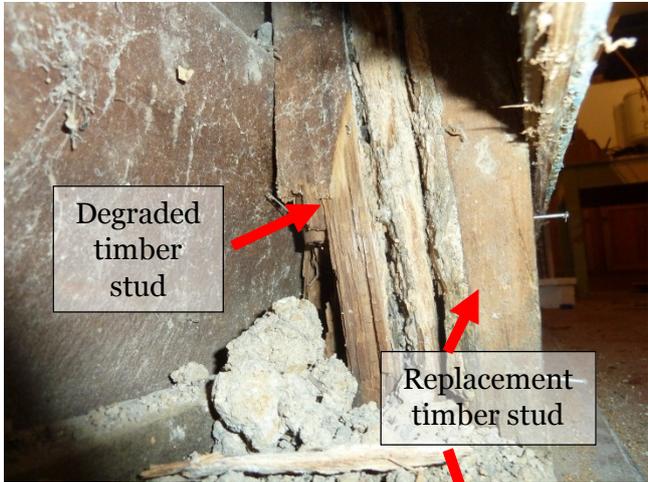
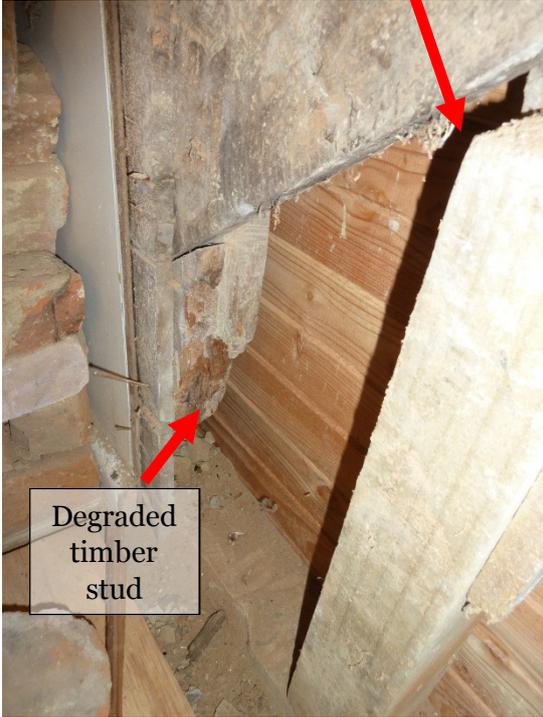
<p>3.</p>	<p>Previous restoration works</p> <p>Back area rear wall</p> <p>Wall between Front room and Back area</p>

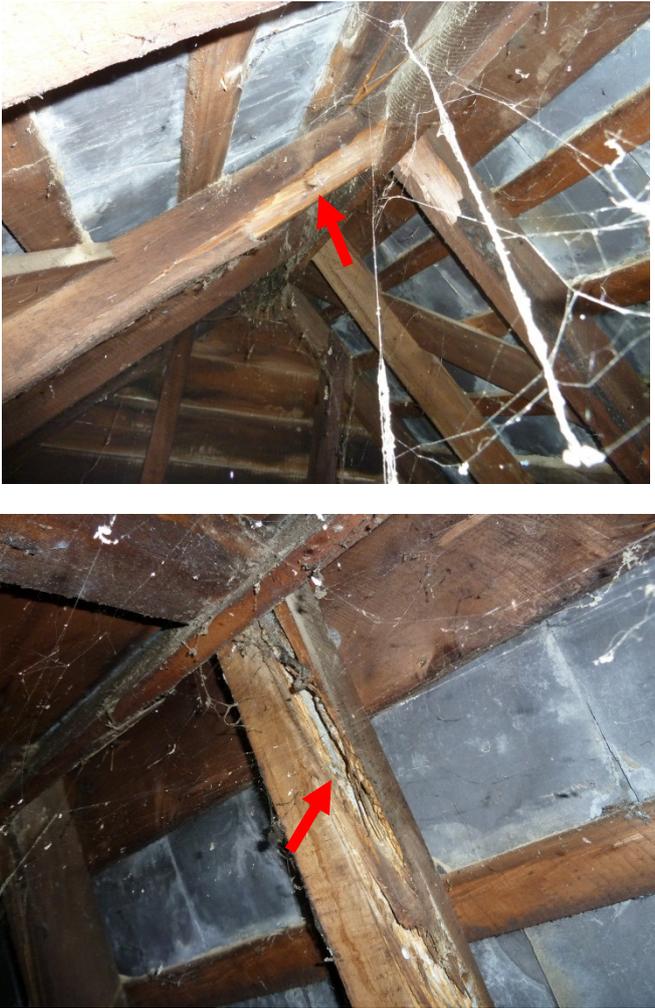
As expected for a 150 year old building, the timber members that are subjected to moisture are likely to degrade over time. There had been a couple of major restoration works undertaken in 1977 and 1986 as noted in the Conservation Plan Report [7]. Some of these works were noted during the intrusive site investigation. See Photo 3 in Appendix 1. Numerous remedial actions were also recommended in the Building Condition Report [8]. Additional areas of rotted timber at the front gable were also observed during the recent site investigations. See Photo 4 in Appendix 1.

<p>4.</p>	<p>Degraded timber rafters at front gable</p>

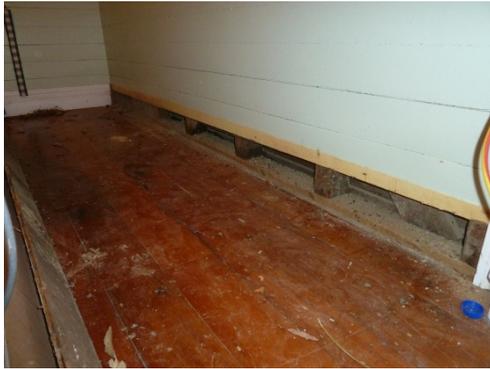
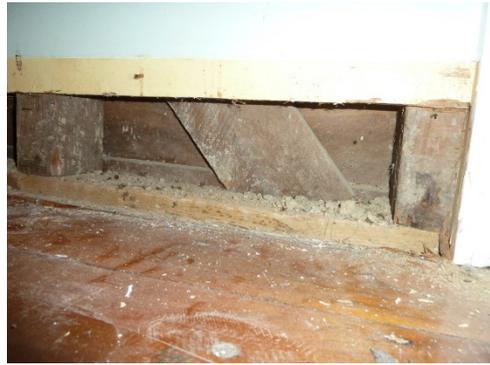
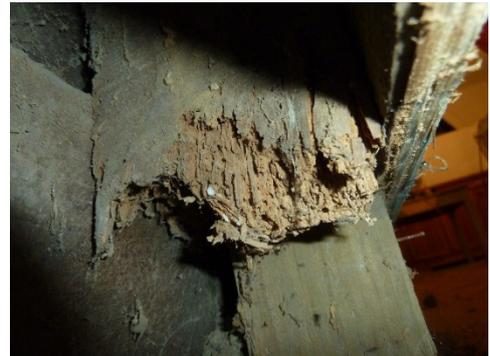
3

- Earth infill has been partially hollowed out during restoration so that new timber stud could be installed.
- Evidence of diagonal timber bracing member.
- Original timber stud had degraded and replaced with new stud.

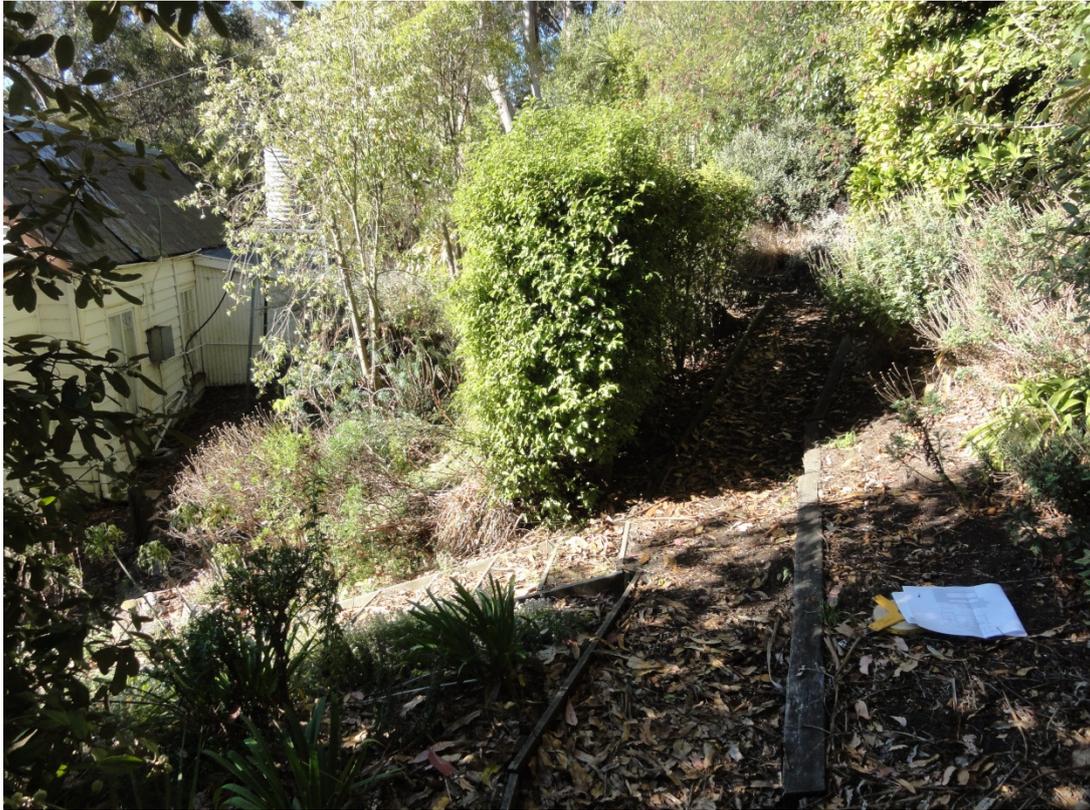
Photograph 5. Terraced slope to south of cottage, supported by a dry stone wall at the toe of the slope.

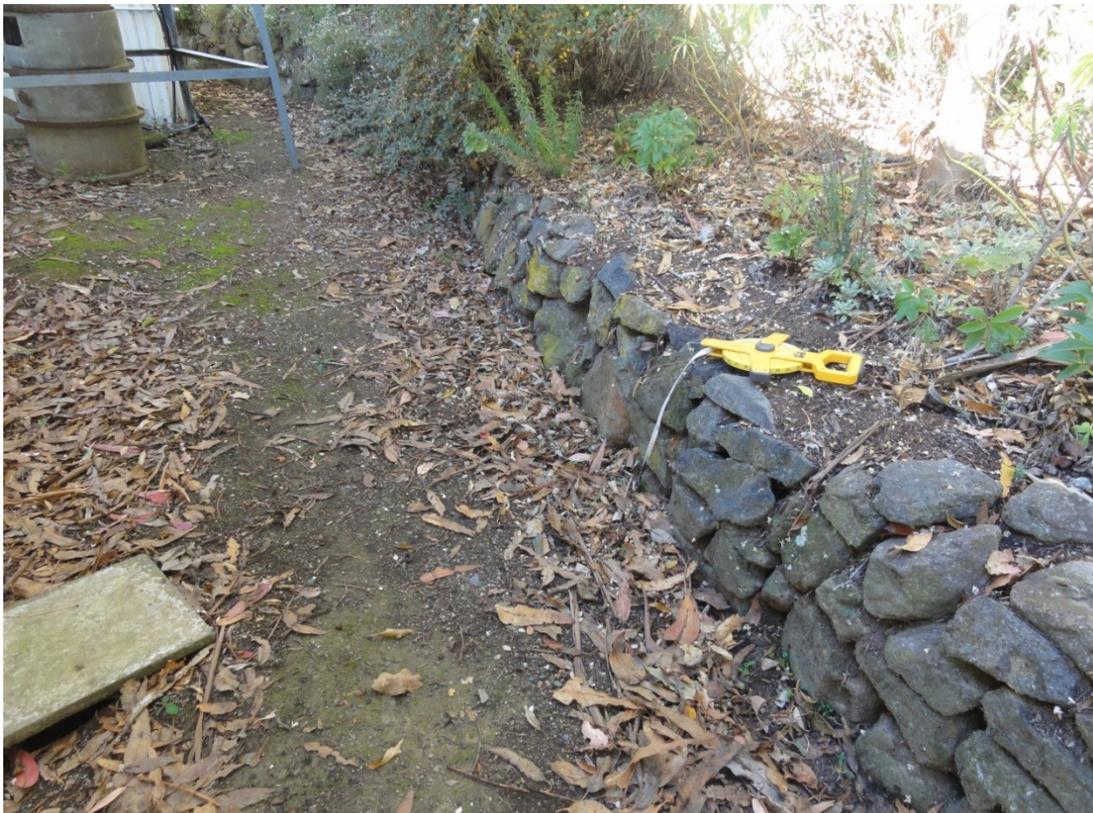
Photograph 6. Low drystone wall to south of cottage. Wall up to 1.2 m high behind SE corner of cottage.

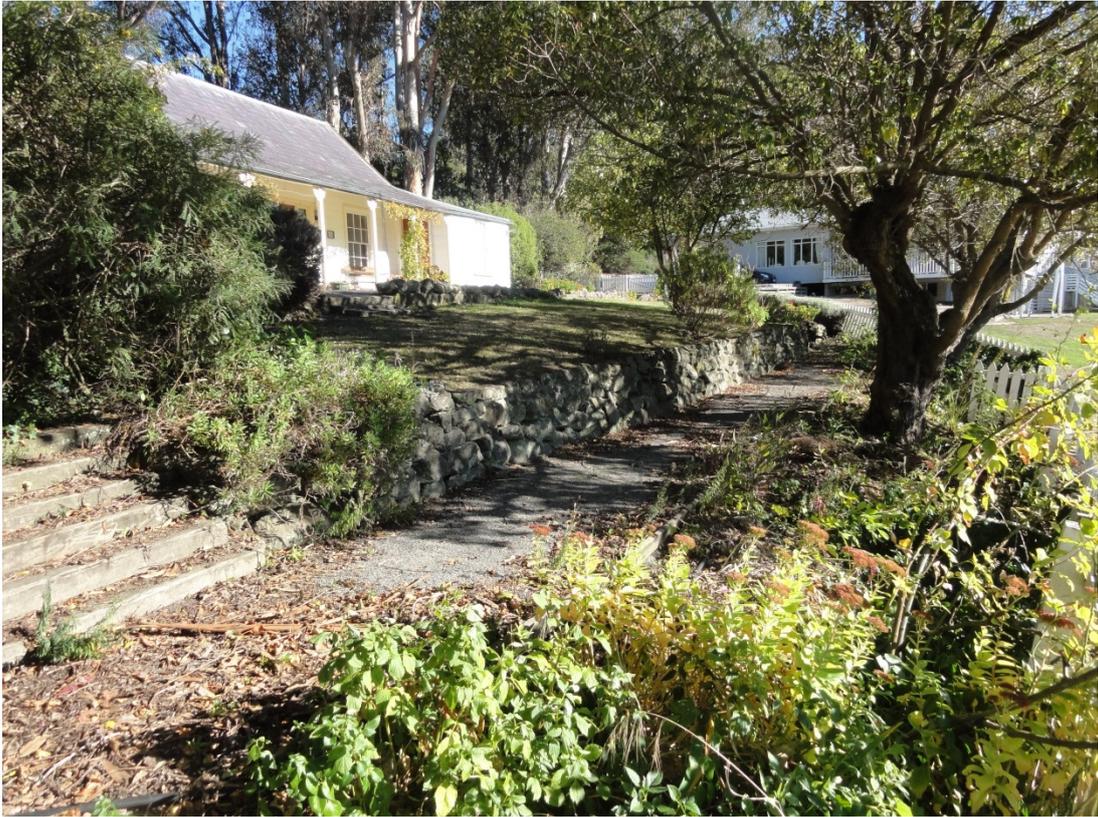
Photograph 7. Terrace below cottage, supported by drystone wall.
