Thompson Park - Toilets
Qualitative Engineering Evaluation

Functional Location ID: PRK 1316 BLDG 012

Reference: 228662

Date: 5 July 2013

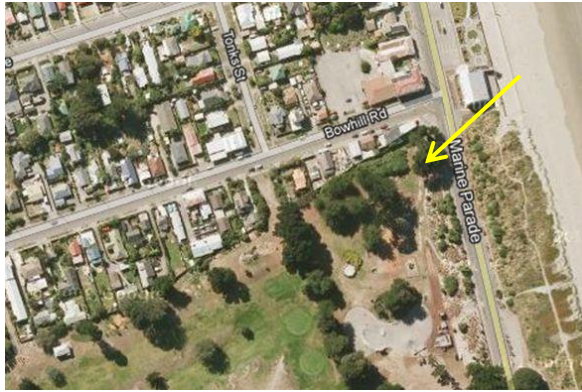
Aerial photograph of Thompson Park – Toilets.

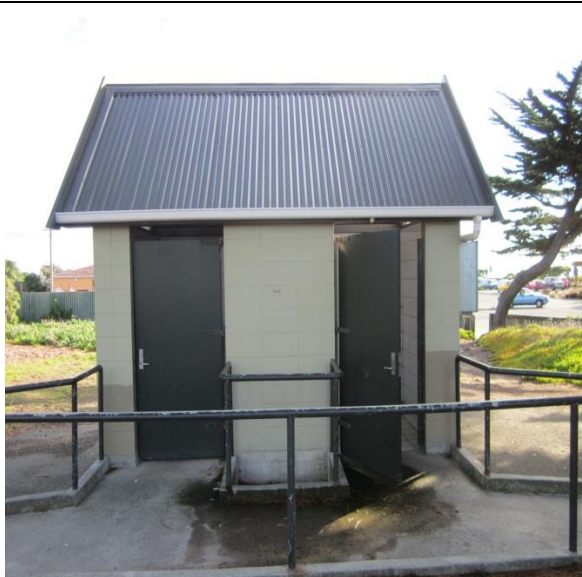
South view of the Thompson Park Toilets.

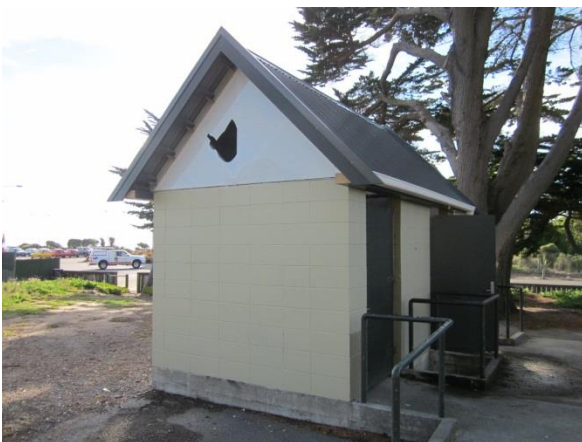
Western view of the Thompson Park Toilets.

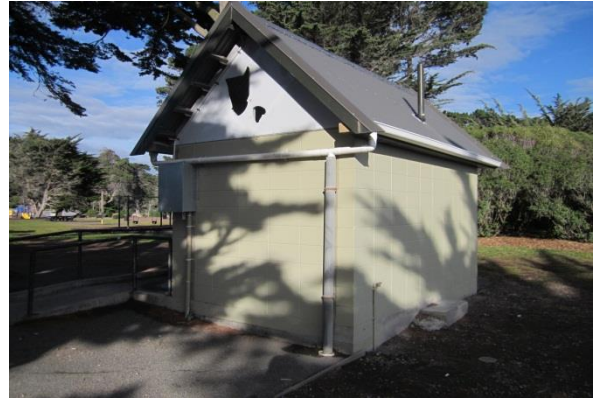
Eastern view of the Thompson Park Toilets.

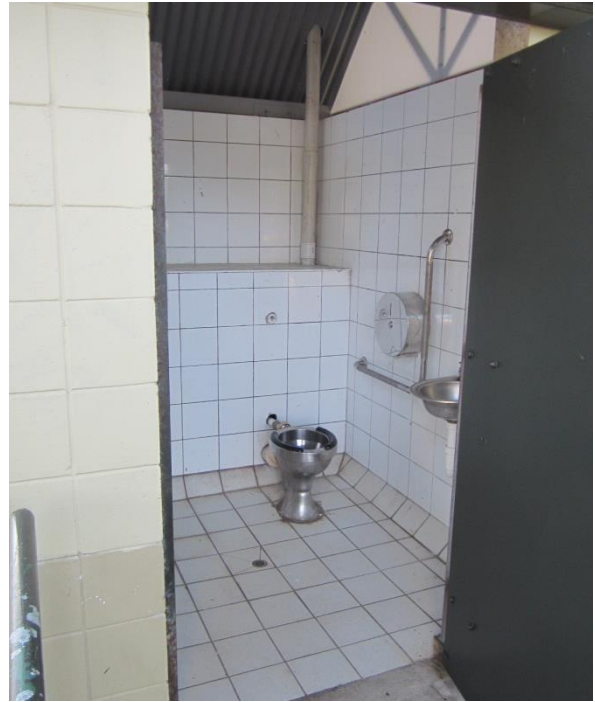
There was no observed damage to the Thompson Park - Toilets as a result of seismic actions. Buildings of this nature have a high bracing capacity. No damage was found on the tiled wall linings.

Internal view of the Thompson Park Toilets.

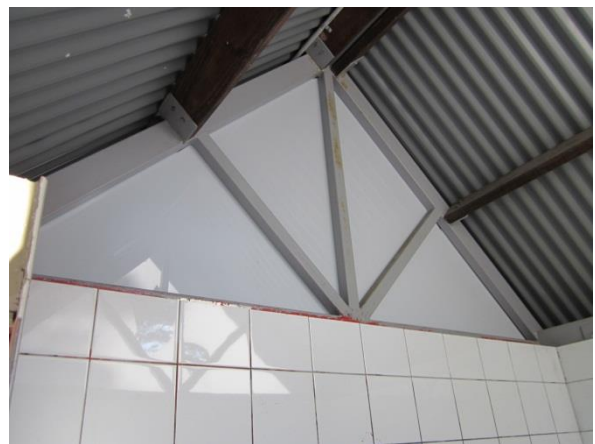
Truss detail.

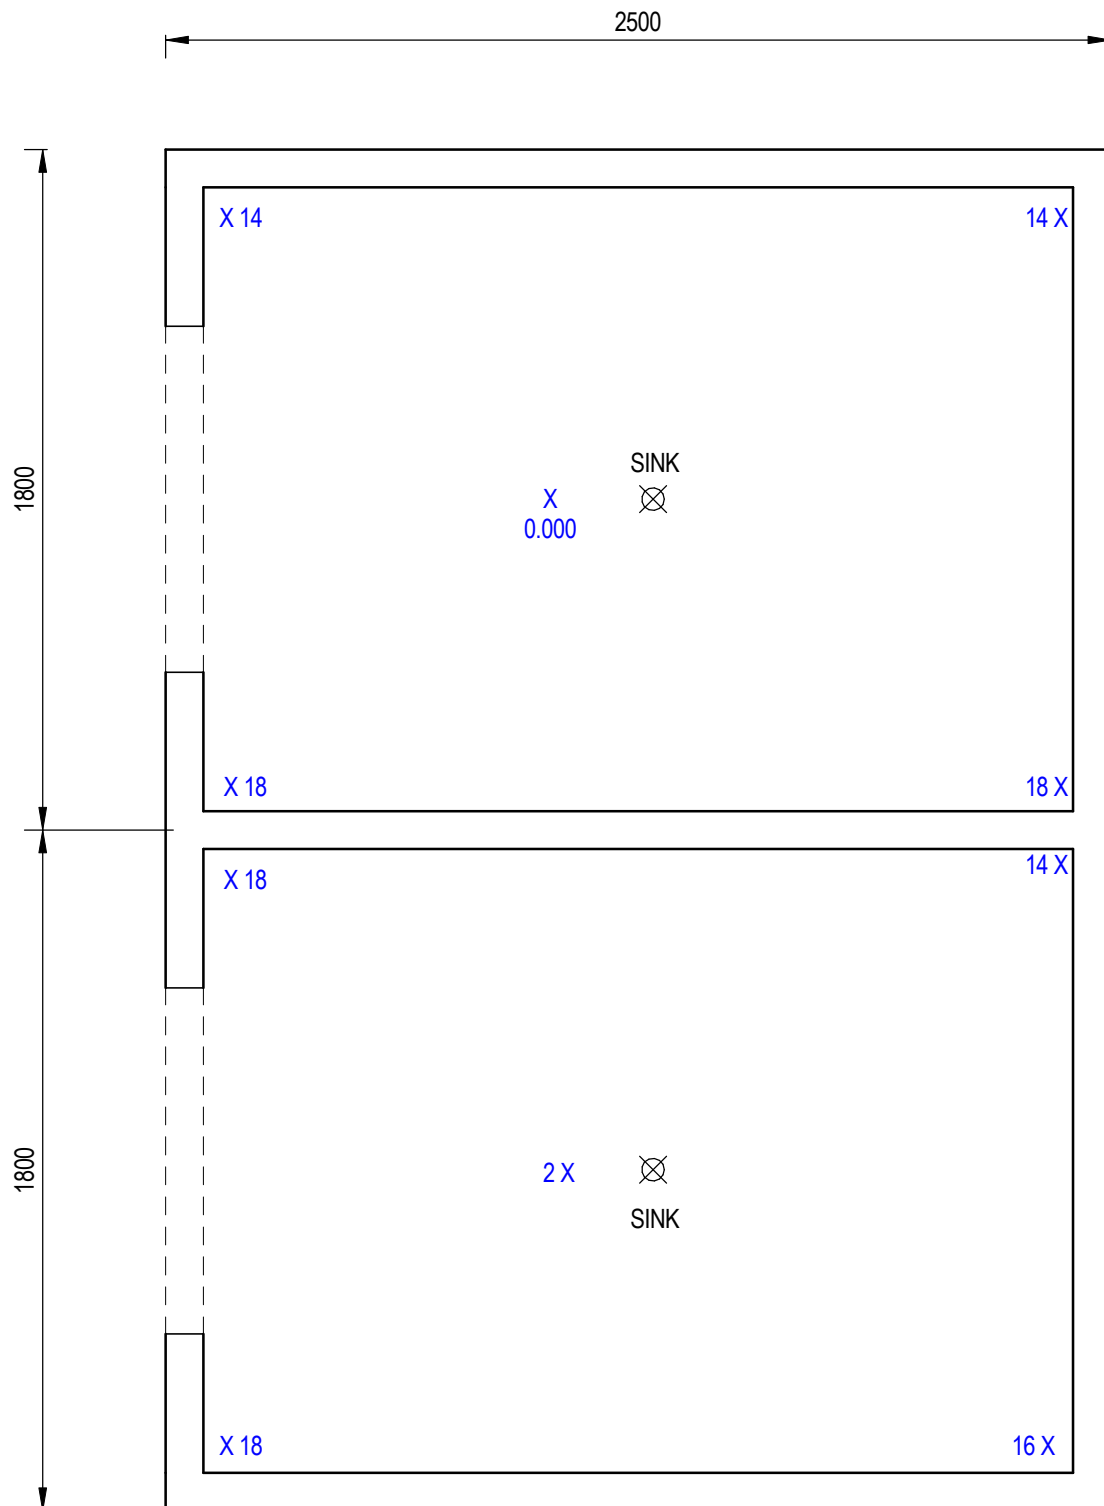
PROJECT
THOMPSON PARK TOILET BOWHILL ROAD
TITLE
LEVEL SURVEY

A floor level survey was undertaken to establish the level of unevenness across the floors. The results of the survey are presented on the attached sketch in Appendix A. All of the levels were taken on top of the existing floor coverings which may have introduced some margin of error.

The floor levels for the Thompson Park - Toilets were found to be within the recommended tolerances.
