# **Thurso Place Complex PRO 1321**

**Detailed Engineering Evaluation  
Quantitative Assessment Report**

**2 Thurso Place, Christchurch**

Date: June 2013  
Reference: 6-QUCC1.91  
Status: Final

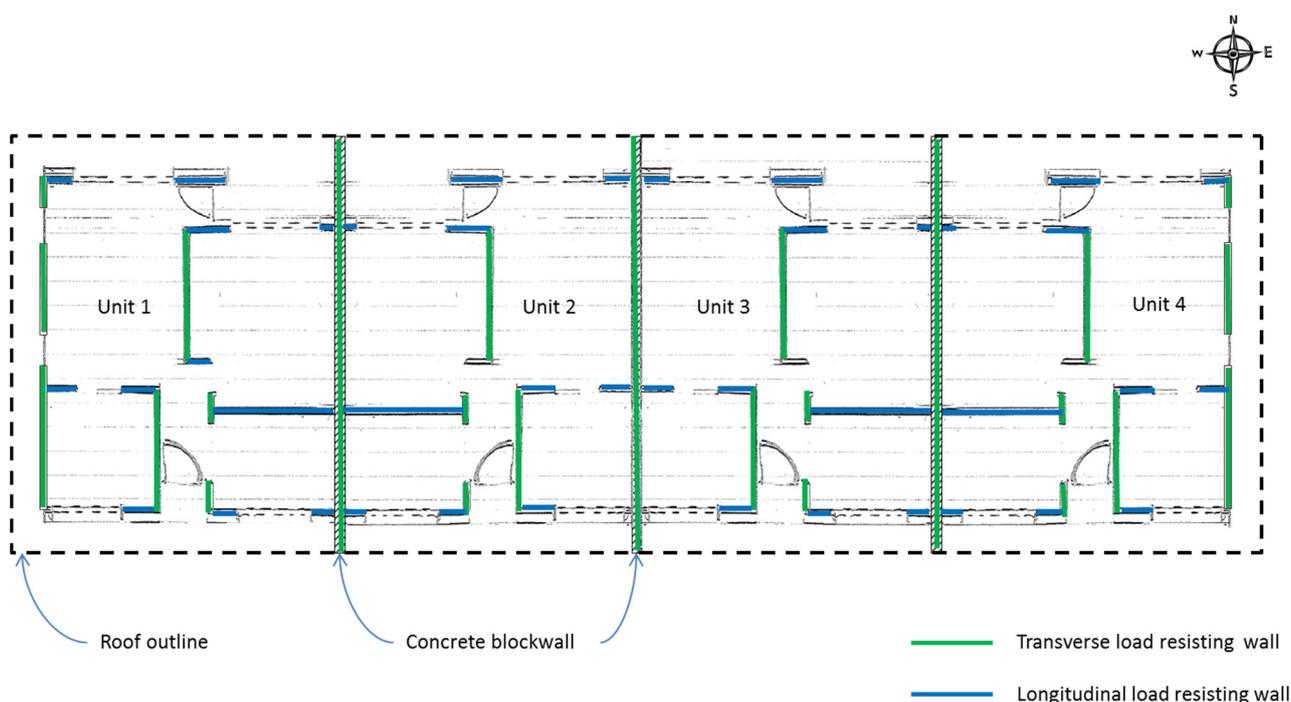
Figure 3: Building Layout and Location of Bracing Walls

In the transverse direction, the lateral load at the roof level is transferred to the internal timber bracing walls and the concrete blockwalls via the ceiling diaphragm and the transverse timber trusses. The longitudinal lateral loads are transferred to the external and internal walls via the ceiling diaphragm as well. An overview of the key lateral resisting elements is as shown in Figure 3 below.

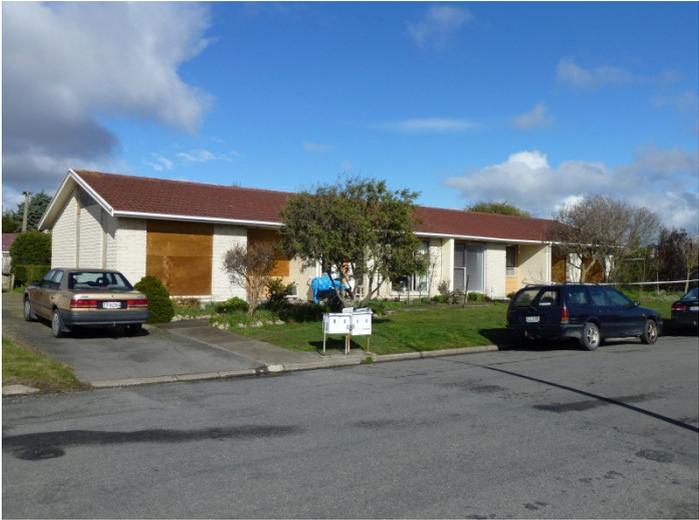
No.	Item description	Photo
1.	North elevation showing partial east elevation

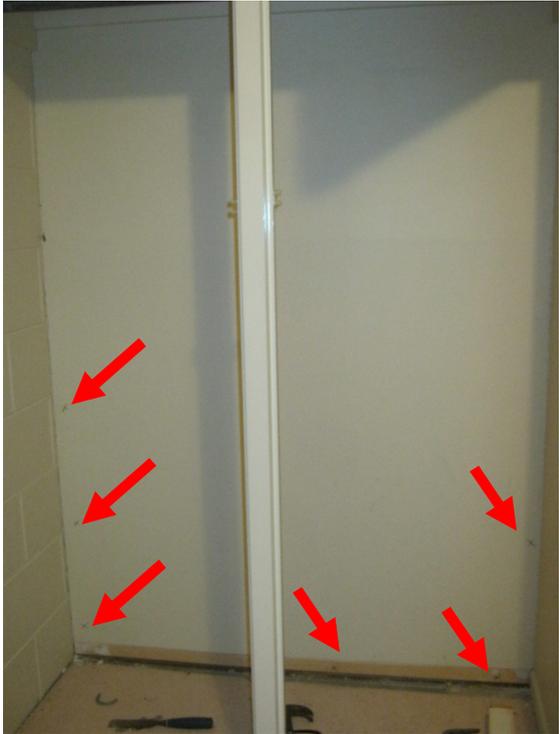
No observed earthquake related damage. However, a sample intrusive investigation to the bracing wall behind the Unit 1 wardrobe revealed only nominal fixing between the plasterboard and the timber framing. The nail pattern was even less than the minimum required during the period of construction. See Photo 2 in Appendix 1.

2.	Nominal nail fixings observed between plasterboard and timber framing behind Unit 1 wardrobe

Following the identification of the inadequate wall fixings as highlighted in Section 5.2 above, remedial works have been undertaken to all the units. Primarily, the key bracing walls have been remediated by installing additional screw fixings in accordance to GIB Ezybrace fastener requirements. Refer to Appendix 3 for the details of the remedial works.

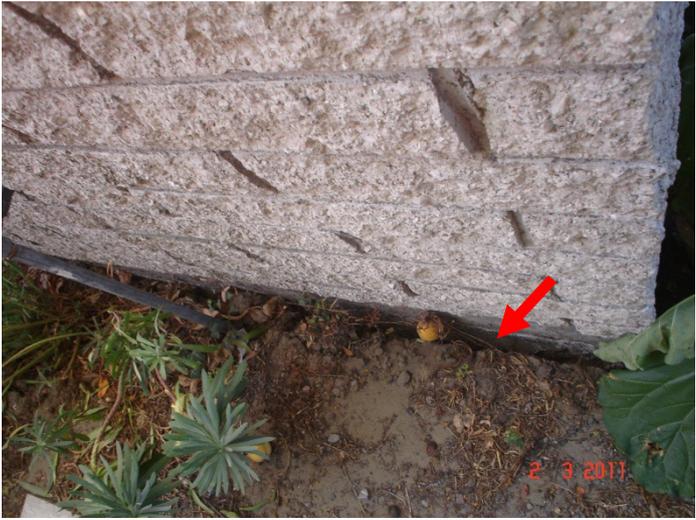
The foundation appears to have performed satisfactorily with no observed earthquake damage. Minor ground movement was observed during the initial rapid assessment on 2 March 2011. See Photo 3 in Appendix 1.

While there is some minor ground movement as noted in Section 5.4, the foundation has performed well overall.

<p>3.</p>	<p>Minor ground movement</p>

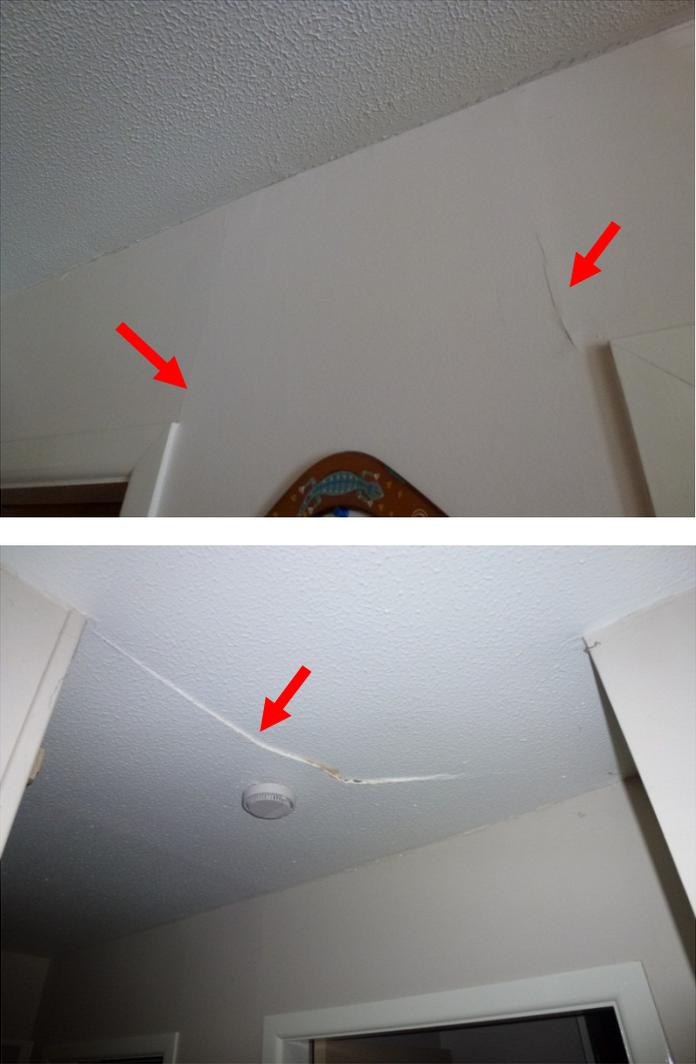
- Minor to moderate cracking to internal plasterboard lined walls and ceilings especially at corners of window and door frames. See Photo 4 in Appendix 1.
- Fallen block veneer to both ends of gable roof. See Photo 5 in Appendix 1. This damage has been repaired and replaced with lightweight wall cladding.
- Horizontal cracks to external block veneer typically at window sill level. See Photo 6 in Appendix 1.

<p>4.</p>	<p>Typical cracking to internal plasterboard lined walls and ceilings especially at corners of window and door frames</p>

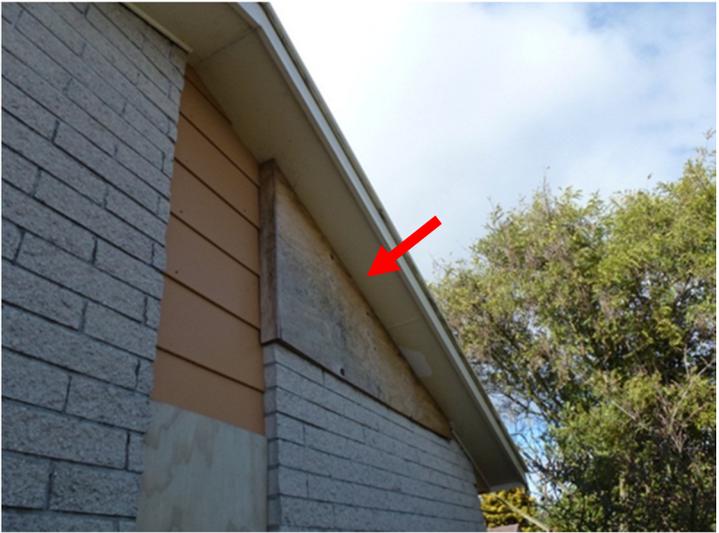
<p>5.</p>	<p>Temporary weatherproofing to gable end where block veneer had fallen/removed</p>

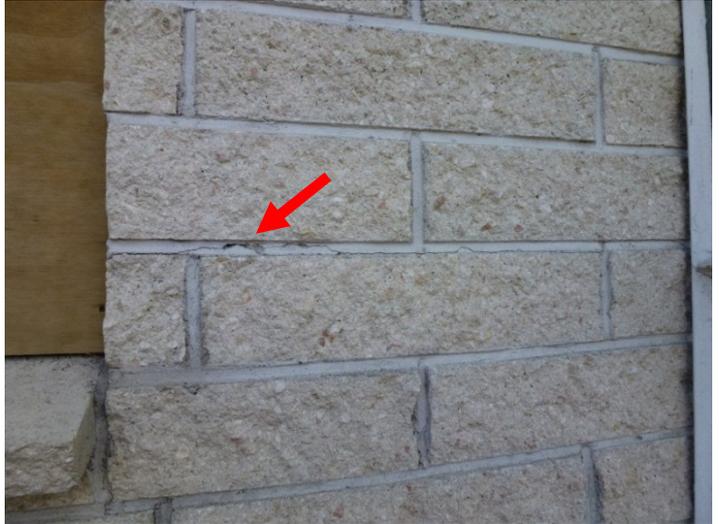
A photograph showing the exterior of a building's gable end. The wall features grey stone block veneer on the left and tan horizontal siding on the right. A section of the block veneer is missing, and the area is covered with a temporary weatherproofing material. A red arrow points to the edge of the weatherproofing.
<p>6.</p>	<p>Typical horizontal cracking to external block veneer</p>

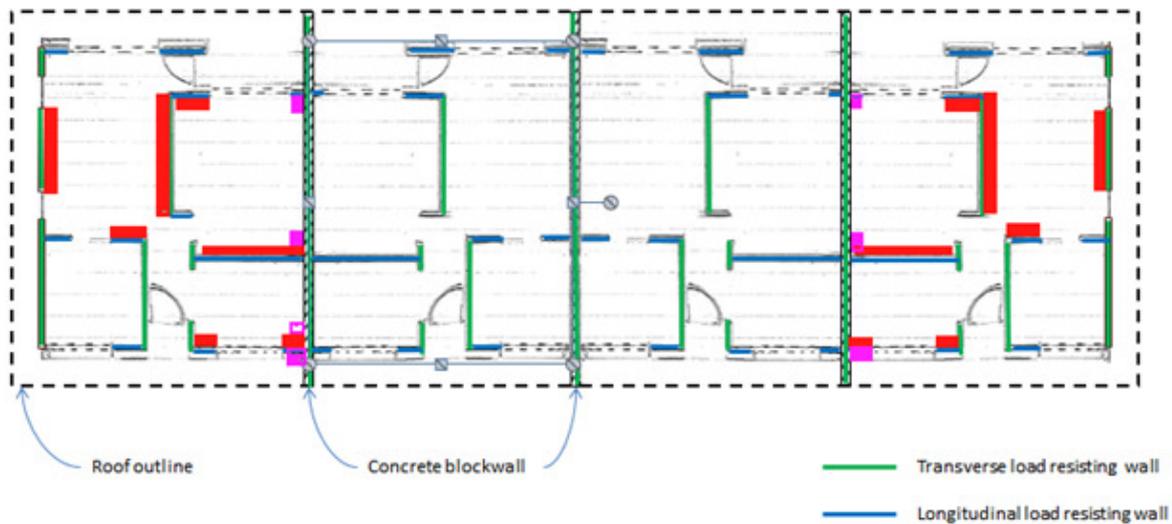
The roof lateral loads are distributed via the ceiling diaphragm to the respective direction's gib lined timber wall and concrete block partition wall.

- Walls screwed to Ezybrace Schedule.
- Timber frames re-attached to firewalls. Methodology attached. Please note that where gib is taking of infill cavity with Pink Batts wall R2.6. Where there is a bathroom replace with Aqualine gibboard.

Please note that if the Gib board in the area indicated is damaged it will need to be replaced with a full sheet so that joints do not occur at corners of openings. All new Gib board fixing is to follow current best practise.

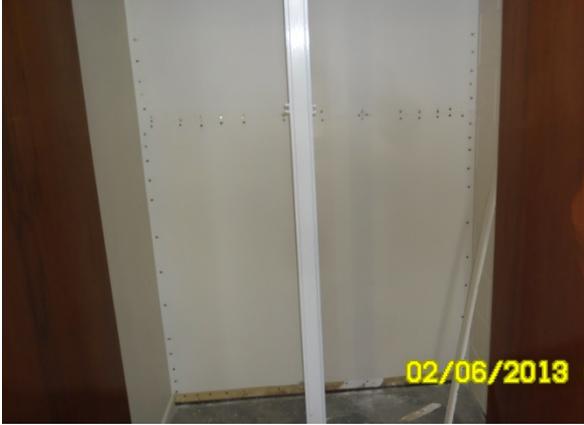
No.	Item description	Photo
7.	Typical additional screw fixings to bracing wall behind wardrobe

All the remedial works to all units have been completed. Refer photos 7 & 8 in Appendix 3. Further enhancement could be made by replacing the heavy concrete tiled roof with lightweight roof cladding.

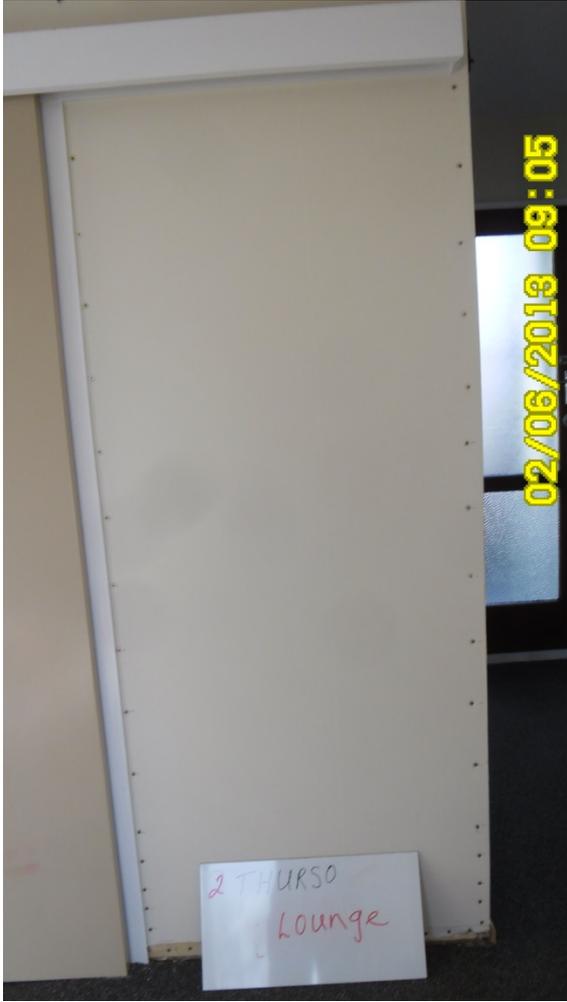
8.	Typical additional screw fixings to bracing wall in living room
