Treddinick Place Housing Complex PRO 3520

**Detailed Engineering Evaluation
Quantitative Assessment Report**

Treddinick Place Housing Complex Quantitative Assessment Report

58 London Street, Lyttelton

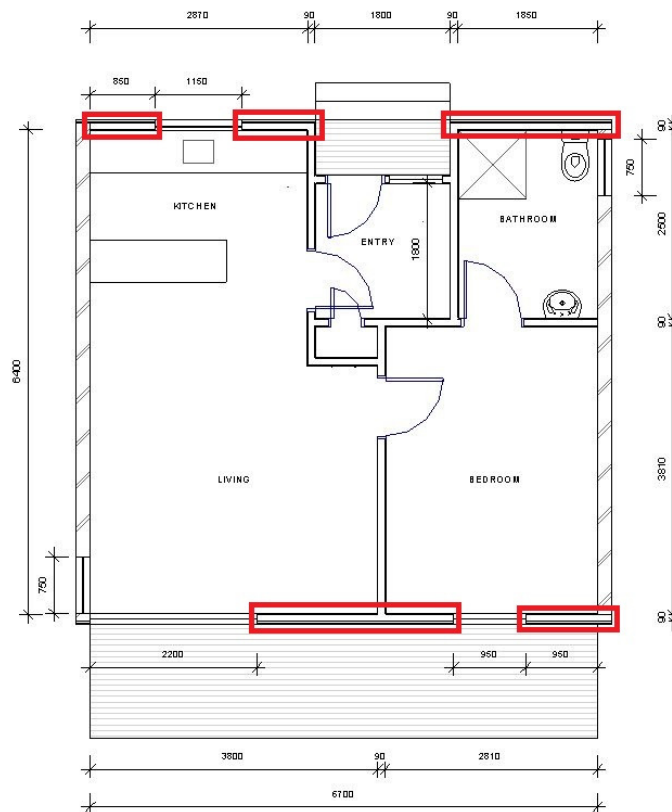
The residential units have capacities of 100% NBS as limited by the shear capacity of the timber-framed shear walls in the longitudinal direction. They are deemed to be 'low risk' in a design seismic event according to NZSEE guidelines.

Figure 5: Walls used for bracing in the longitudinal direction.

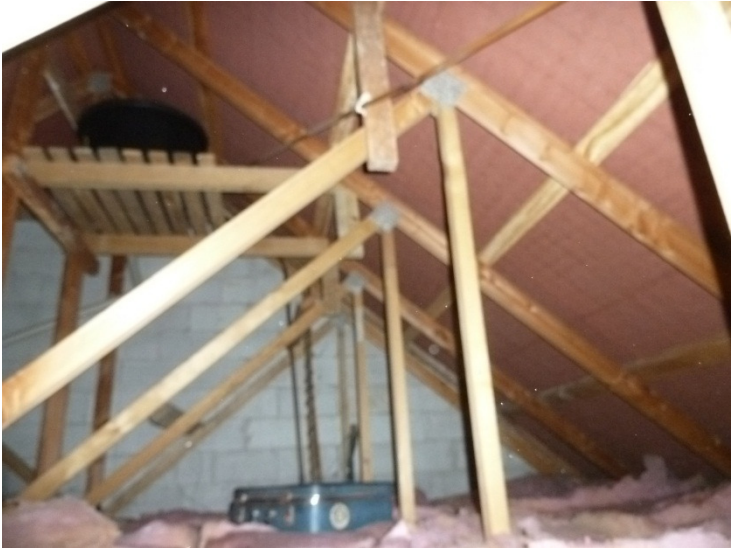
During the investigations, unsecured, plastic header tanks were observed in the roof spaces of the units.

7.	Typical roof void

- Cosmetic repairs be undertaken as required.
- Header tanks in the roofs be properly secured.

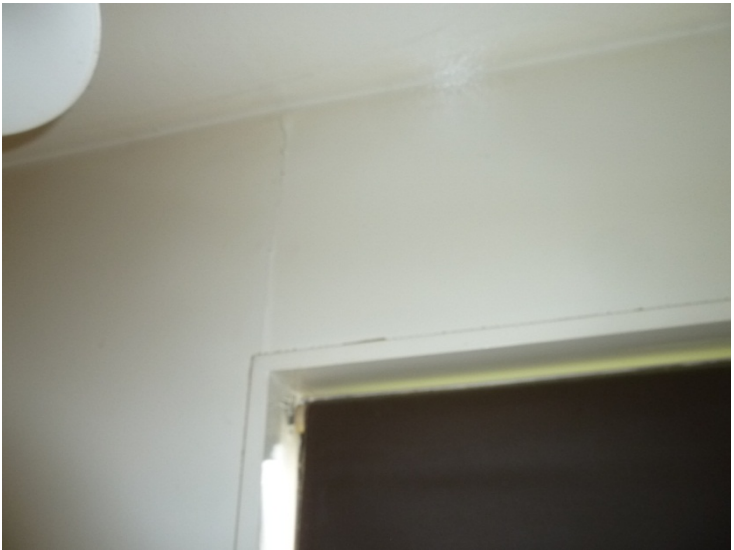
The residential units suffered minor damage to non-structural elements. This included cracking of the interior wall and ceiling linings. Structural damage to the residential units was generally minor. This damage is deemed not to affect the seismic capacity of the structure.

9.	Typical lounge area	 
10.	Typical cracking of internal wall lining

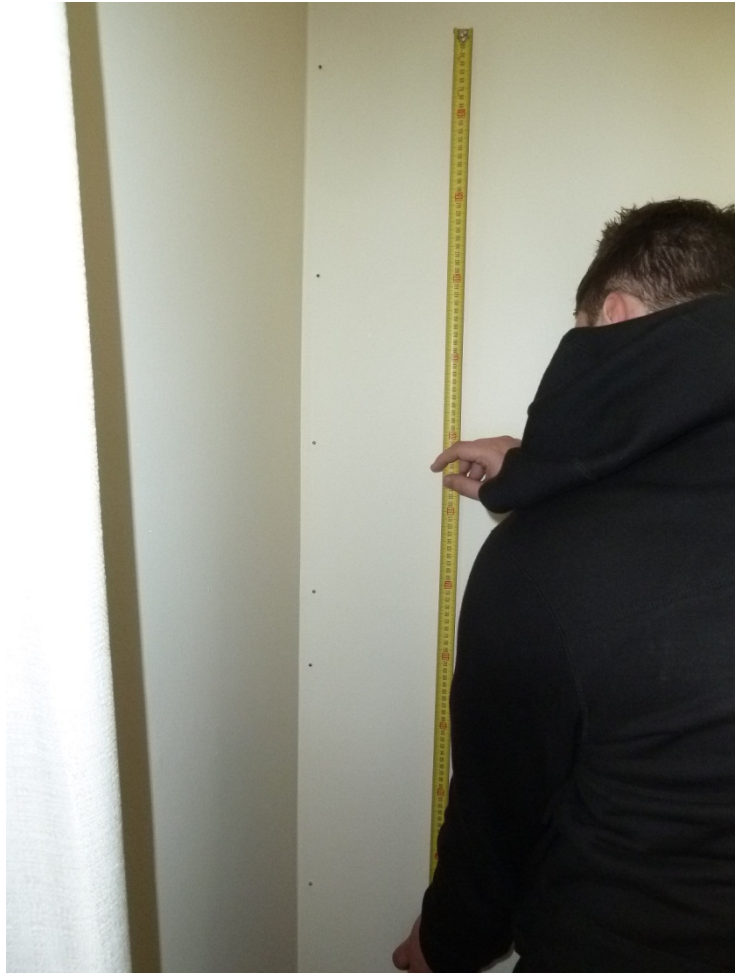
The internal lining nail spacings were measured on site to vary between 200-300mm.

11.	Typical internal lining nail spacings

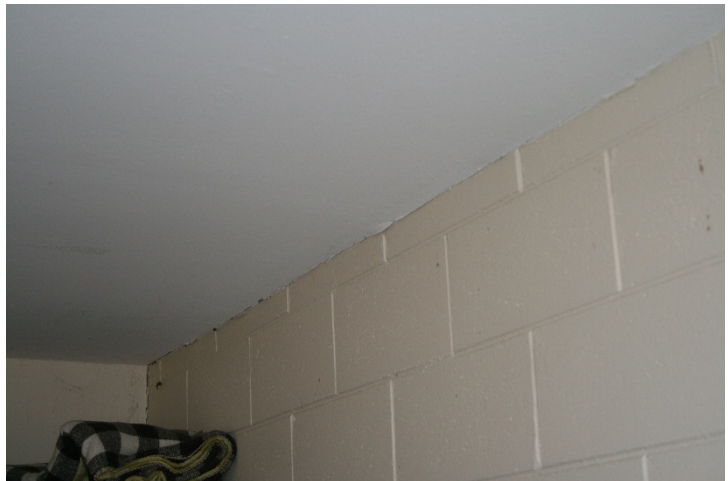
Minor to moderate cracking and separation of plasterboard ceiling diaphragms and firewall was observed in the units (photo 12). This form of damage is common throughout the units.

12.	Separation between ceiling and firewall (Unit 2)

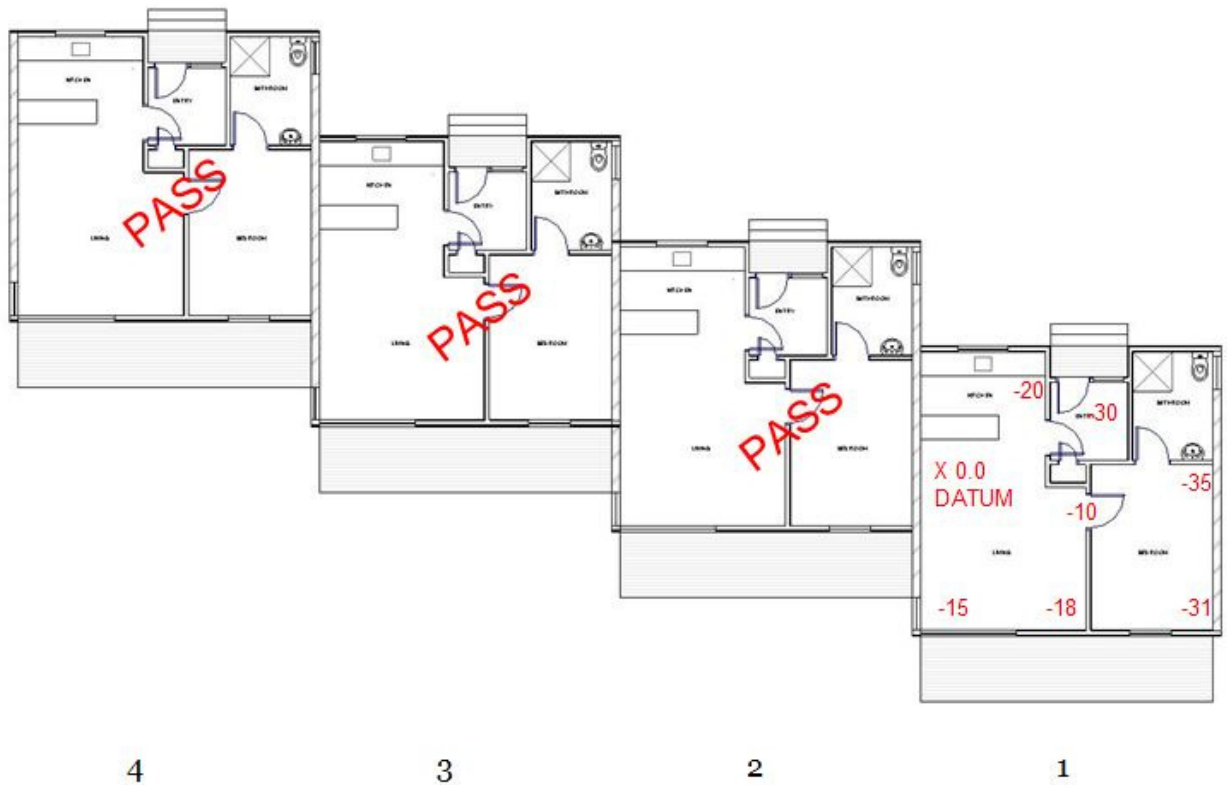
TREDDINICK PLACE: UNITS 1-4

A full level survey was not deemed to be necessary at Treddinick Place as it is located in a Port Hills zone. Properties in Port Hill zones suffered nil damage due to liquefaction and/or settlement but are potentially at risk of rock fall, cliff collapse and land slips. In lieu of a full level survey, a laser level was placed in each unit so that differentials in vertical levels could be measured at the extreme ends of the unit. These values could then be used to determine the floor slope of the entire unit. For this site, the maximum slope in a unit was 9mm/m (which exceeds the 5mm/m limitation imposed by MBIE guidelines).

The results of the level survey indicate the possibility of ground settlement due to the earthquakes in Unit 1. The floor slopes were measured to be beyond the 5mm/m limitation imposed by MBIE guidelines. However, it was noted by the resident that the particle board floors were initially not fixed down adequately and as a result have popped up.
