**Tyrone Street
Housing Complex
PRO 0376**

**Detailed Engineering Evaluation
Quantitative Assessment Report**

**3-5 Tyrone Street, Belfast Christchurch
8051**

Date: December 2013
Reference: 6-QC410.00
Status: Final

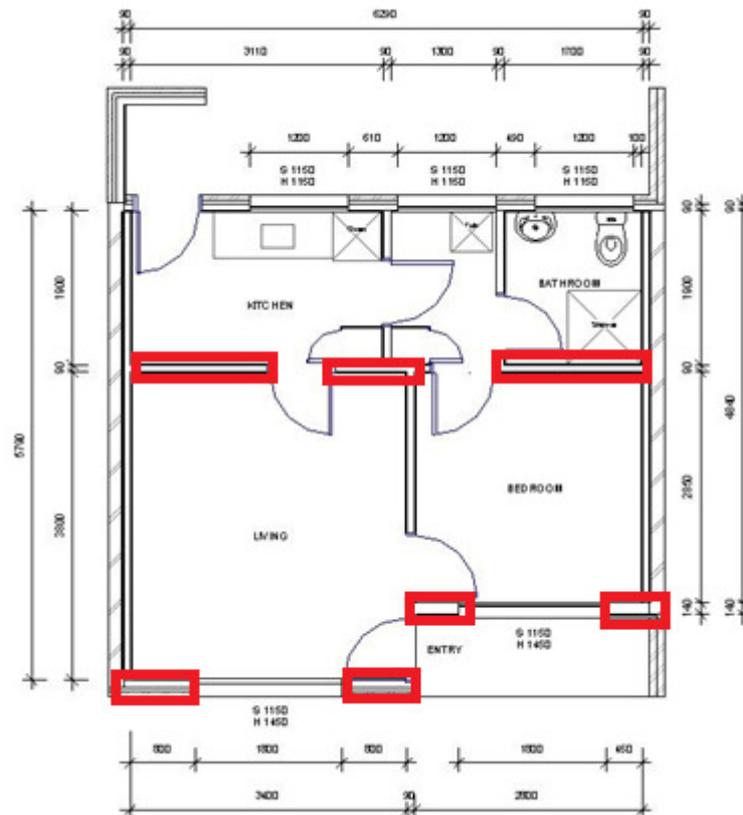
Figure 6: Walls used for bracing in the longitudinal direction.

The residential units have a capacity of 54% NBS as limited by the in-plane shear capacity of the timber-framed shear walls in the longitudinal direction. They are deemed to be a 'moderate risk' in a design seismic event according to NZSEE guidelines. Their level of risk 5-10 times that of a 100% NBS building.

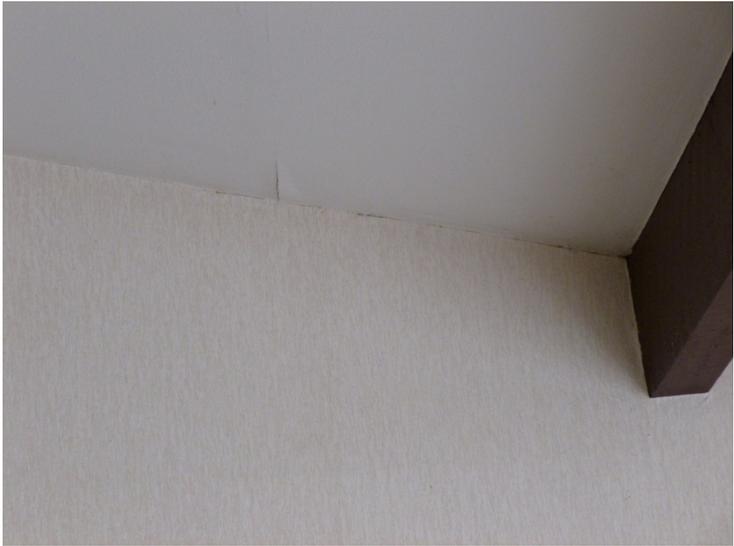
Some cracking of the plasterboard ceiling diaphragm was observed in most units (photo 3).

3.	Typical cracking in ceiling diaphragm

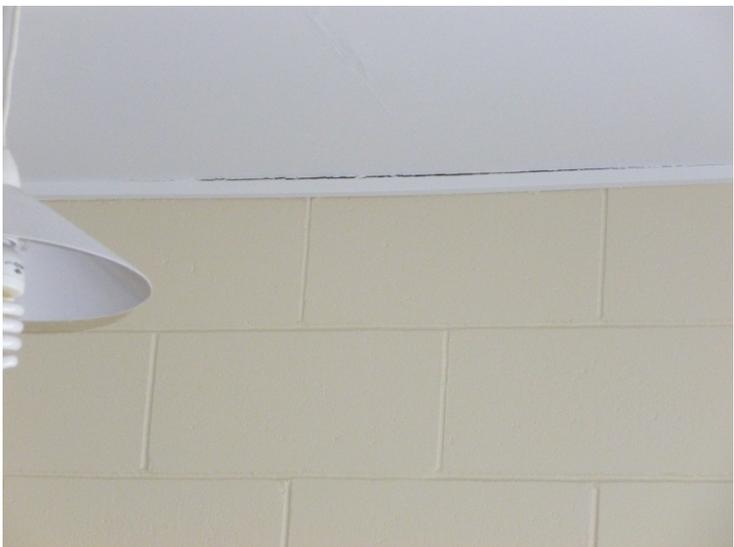
In all units it was noted that there was separation cracking between the firewalls and the ceiling (photo 4). There was also separation between many cupboards and the walls. Some units also showed separation between ceiling and wall, usually in the kitchen or bathroom (photo 5). Several units showed varying degrees of plasterboard cracking in line with windows and doors (photos 6 and 7). Most units displayed some cracking along the ceiling beam in the living room (photo 8). It was also noted that there was vertical cracking from the ceiling beam in Unit 3/3 (photo 9).

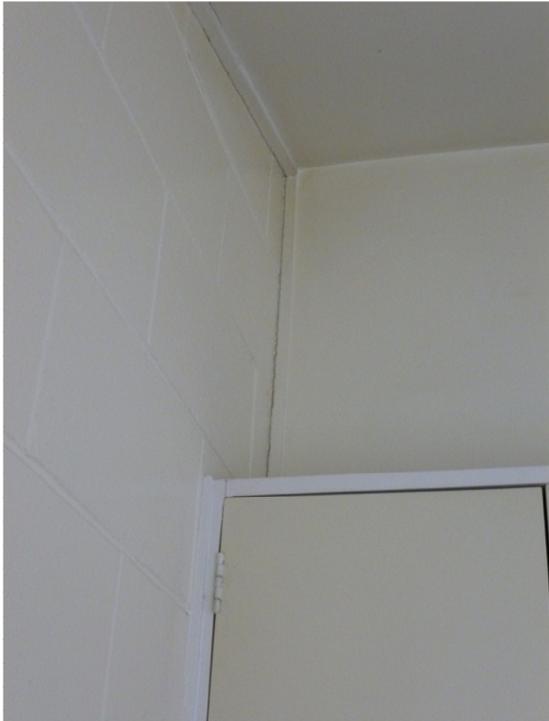
<p>5.</p>	<p>Typical separation around wall</p>

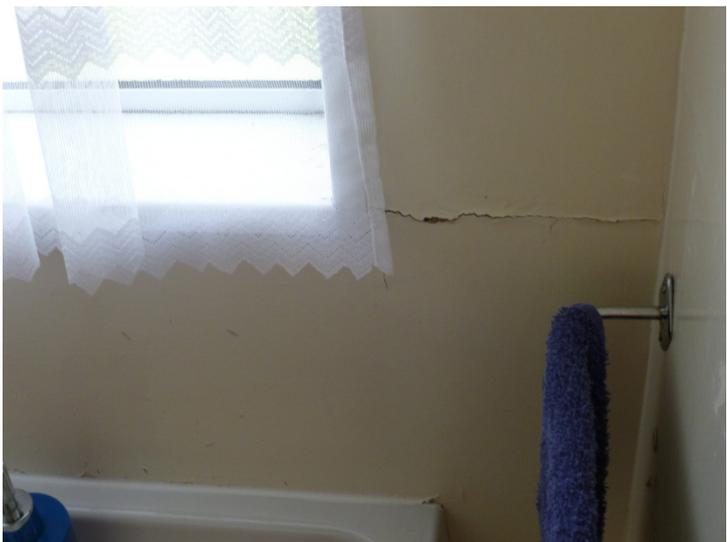
<p>6.</p>	<p>Cracking along line of window – Unit 3/2</p>

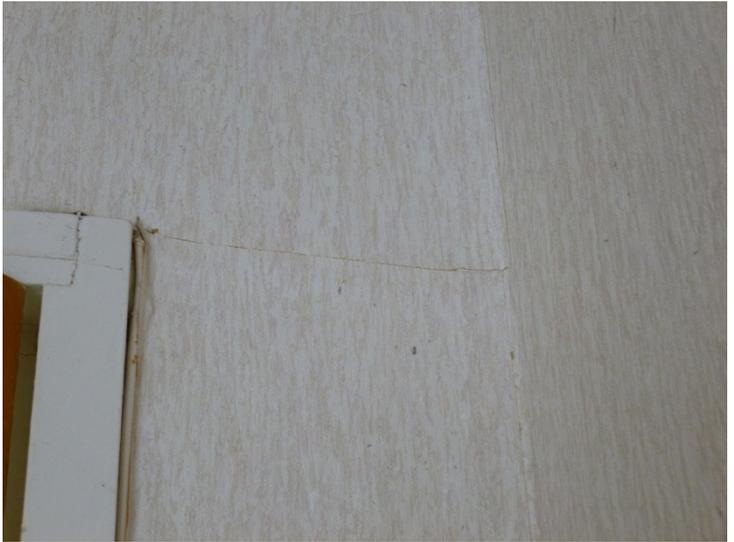
7.	Typical cracking in line with door frames

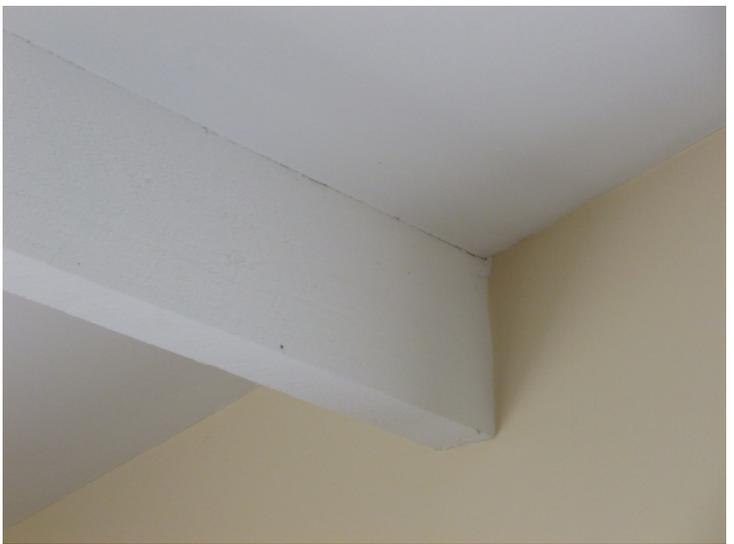
8.	Typical separation along ceiling beam

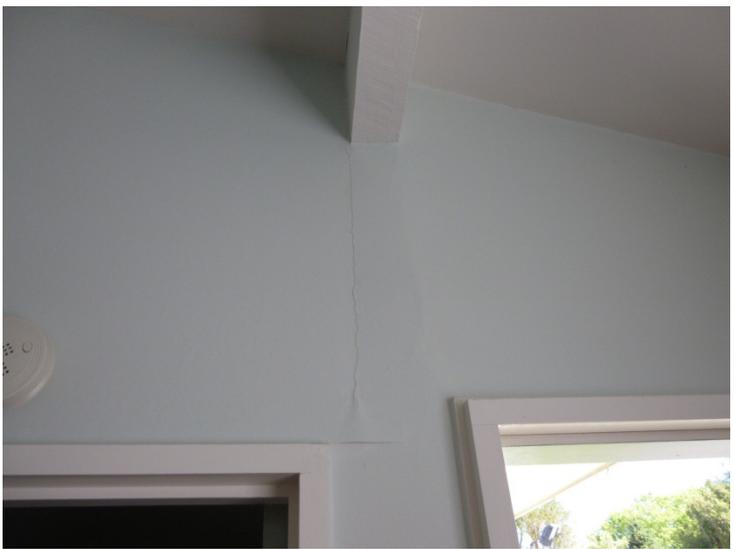
9.	Vertical cracking from ceiling beam – Unit 3/3

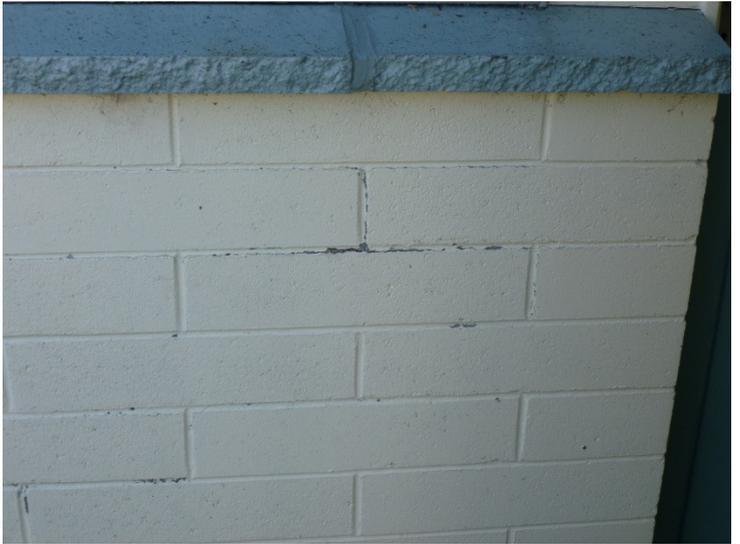
Stepped cracking in the block veneer was noted in two walls at the back of Block B (photo 10).

10.	Typical stepped cracking in veneer (Block B)

- Veneer at height (gable ends) have their veneer ties checked.
- A strengthening works scheme be developed to increase the seismic capacity of all buildings to at least 67% NBS. This will need to consider compliance with accessibility and fire requirements.
- Cosmetic repairs be undertaken.
