Victoria Park – Old Ranger Office
Qualitative Engineering Evaluation

Reference: 228666
Prepared for:
Christchurch City Council

Functional Location ID: PRK 1829 BLDG 015

Date: 5 July 2013

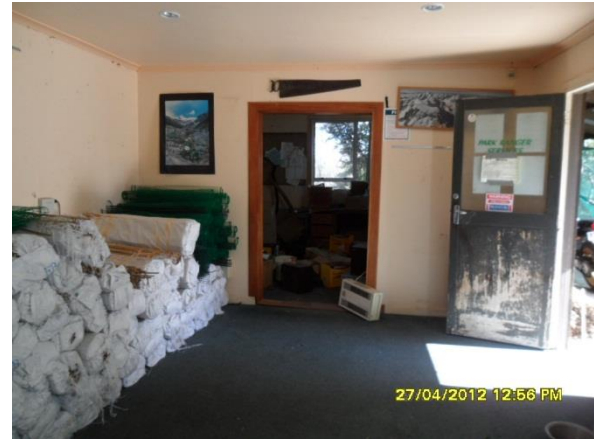
Internal southwest corner of the building.

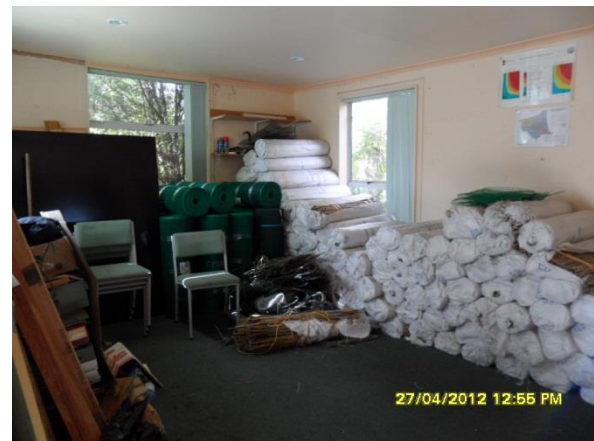
Internal north view of the building.

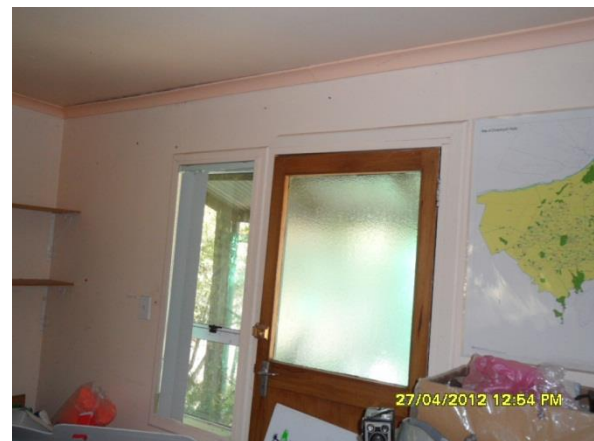
Internal view of northern room.

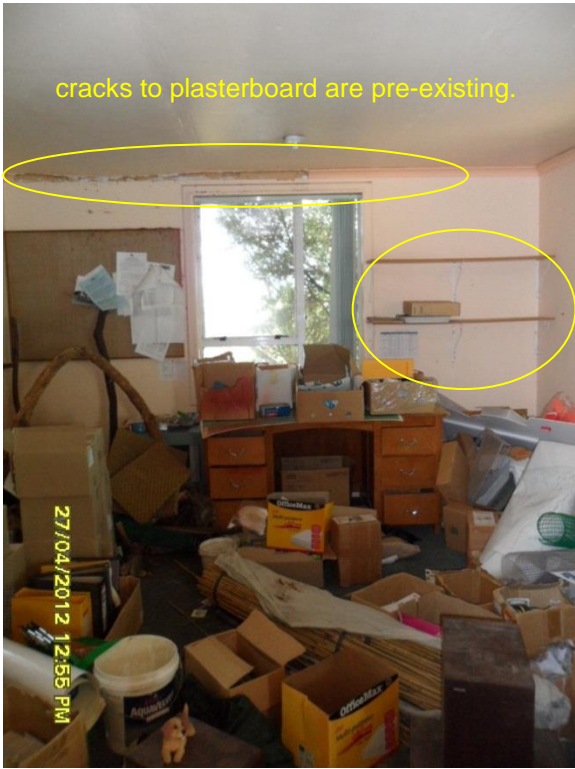
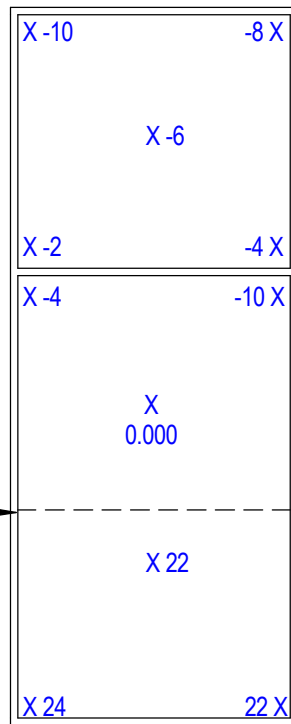
PROJECT
VICTORIA PARK OLD RANGERS OFFICE
TITLE
LEVEL SURVEY

The floor levels for the Victoria Park – Old Ranger Office were found to be within the recommended tolerances.

CARPET UNDERLAY
(THICKER ALONG THIS LINE)
