Victoria Park – Shed (10x9)
Qualitative Engineering Evaluation

Reference: 228907

Prepared for:
Christchurch City
Council

Date: 25 February 2013

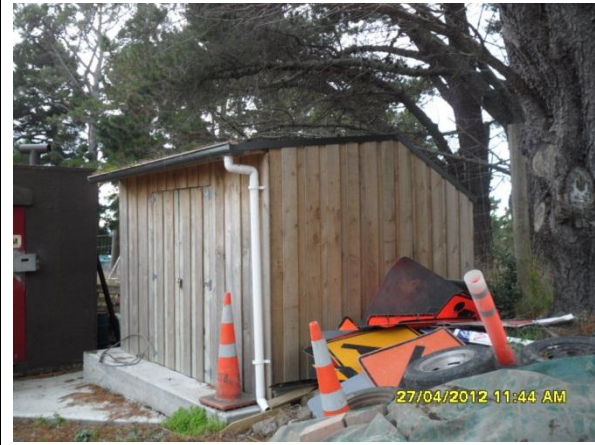
View of the building from driveway.

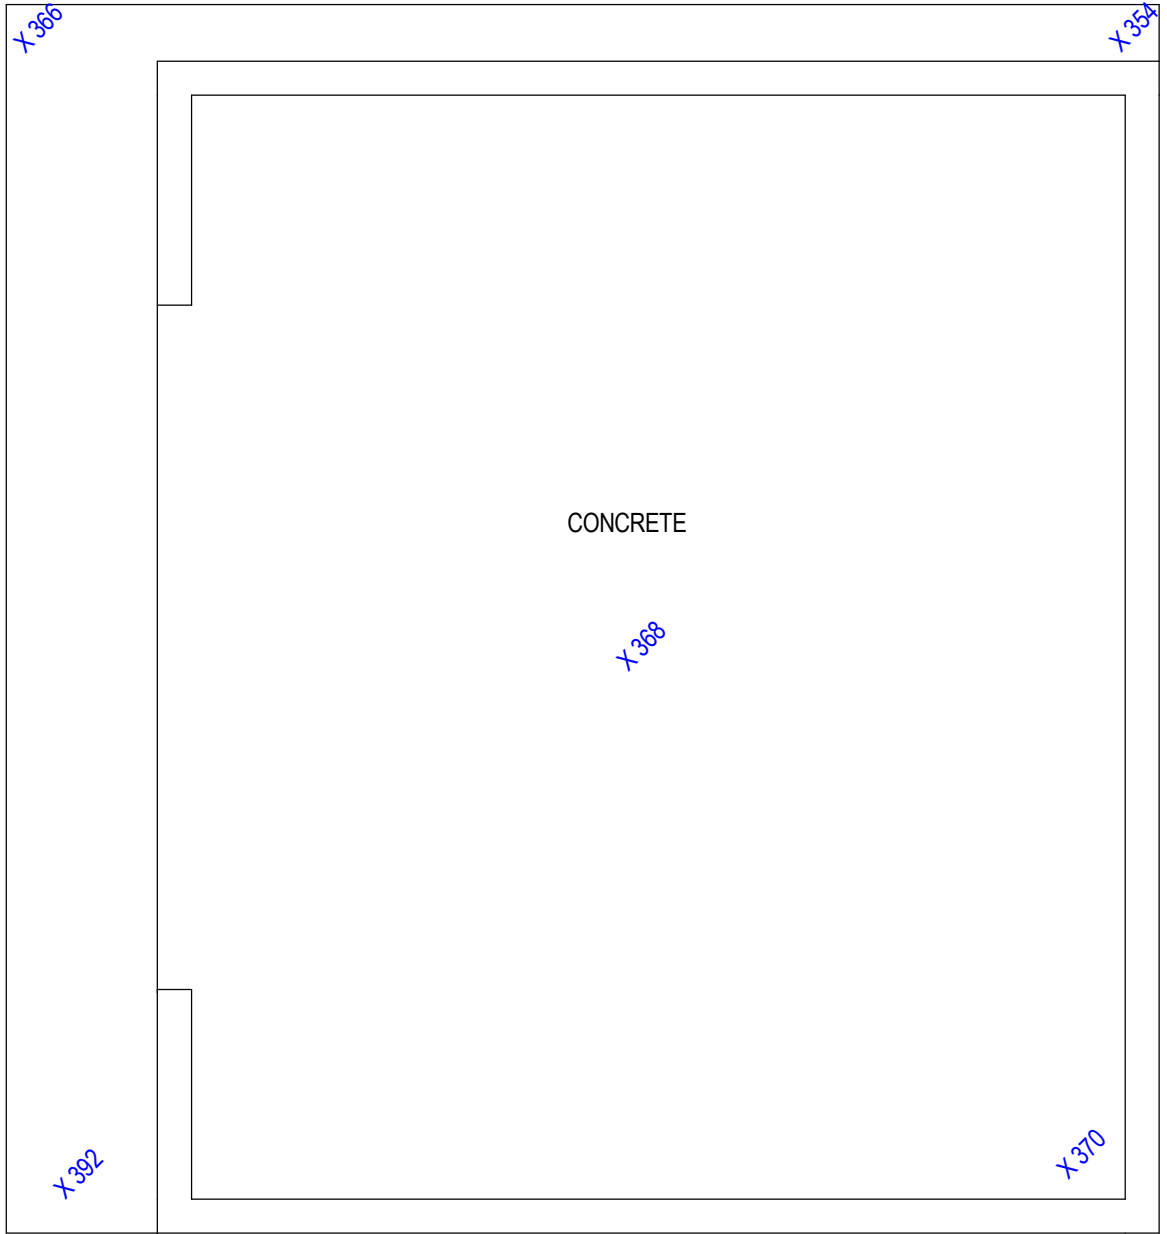
PROJECT
VICTORIA PARK SHED (10x9)
TITLE
LEVEL SURVEY

The floor levels for the Victoria Park – Shed (10x9) were found to be over the recommended tolerances. However, the floor level variations appear to be original construction variations and not due to recent seismic activity.
