**Waimakariri Road Soil Store**  
**PRO 0360-001**  
Detailed Engineering Evaluation  
Qualitative Report  
FINAL Version

22 Waimakariri Road, Harewood,  
Christchurch

Christchurch City Council

**Date**  
24/05/2013

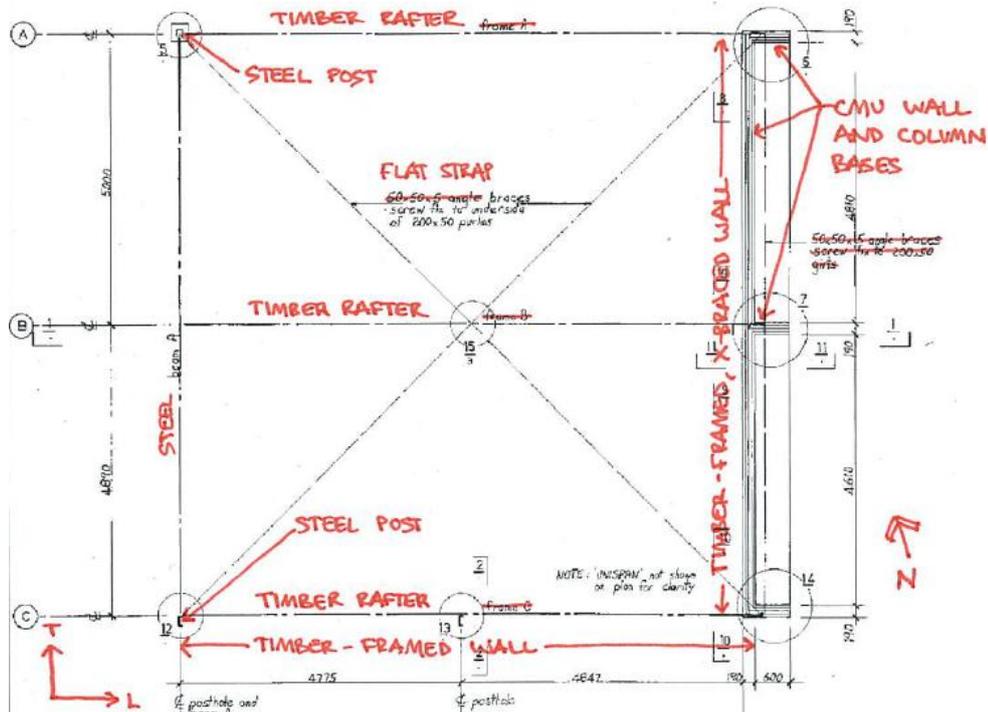
**Figure 2 Plan Sketch Showing Key Structural Elements**

Figure 2 below shows the plan view from the original construction drawings, with modifications in red.

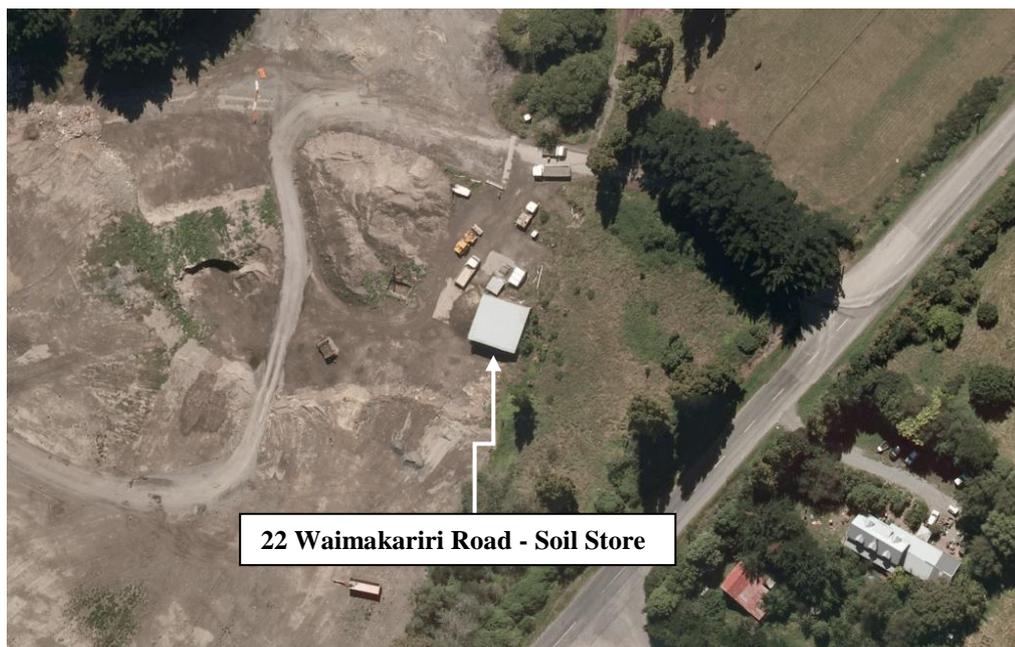
**Figure 3 Post February 2011 Earthquake Aerial Photography<sup>2</sup>**

Aerial photography taken following the 22 February 2011 earthquake shows no signs of liquefaction outside the building footprint or adjacent to the site, as shown in Figure 3.

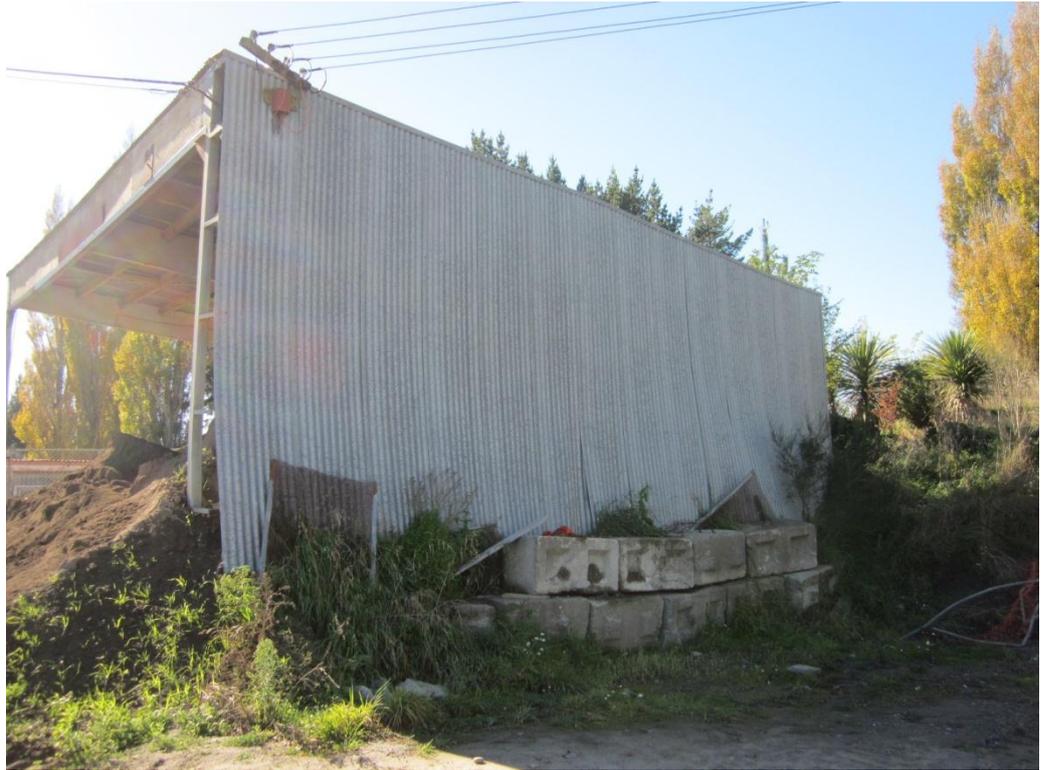
**Photograph 1: Southwest corner elevation.**

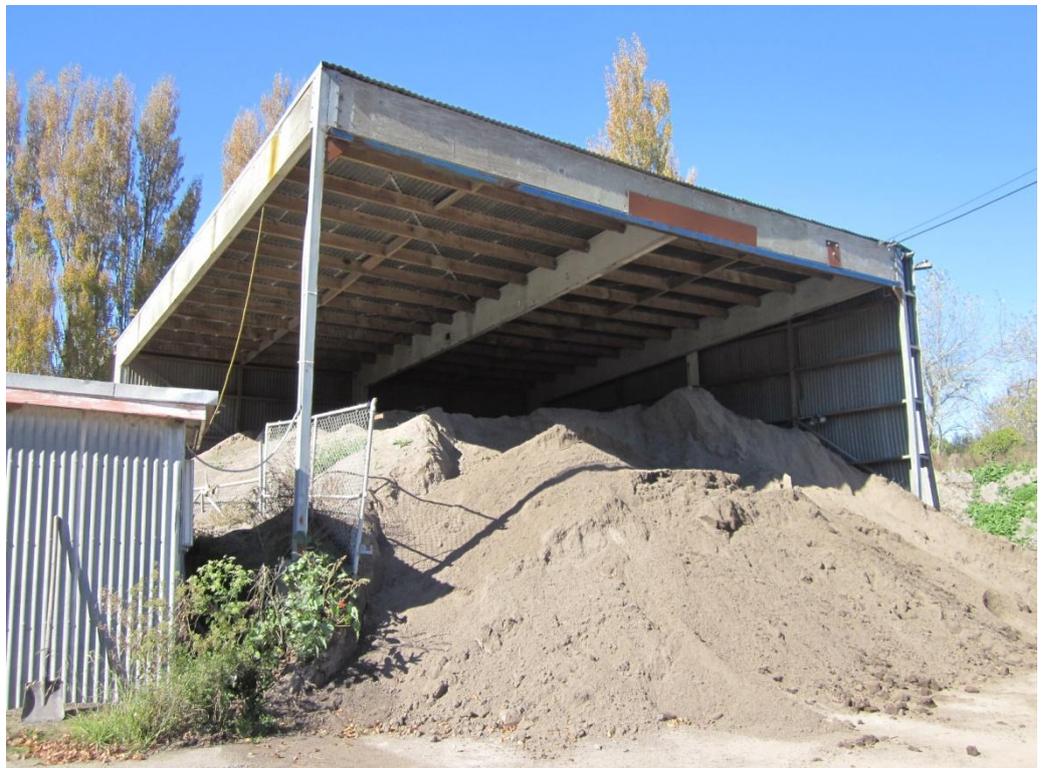
**Photograph 2: Northwest corner elevation.**

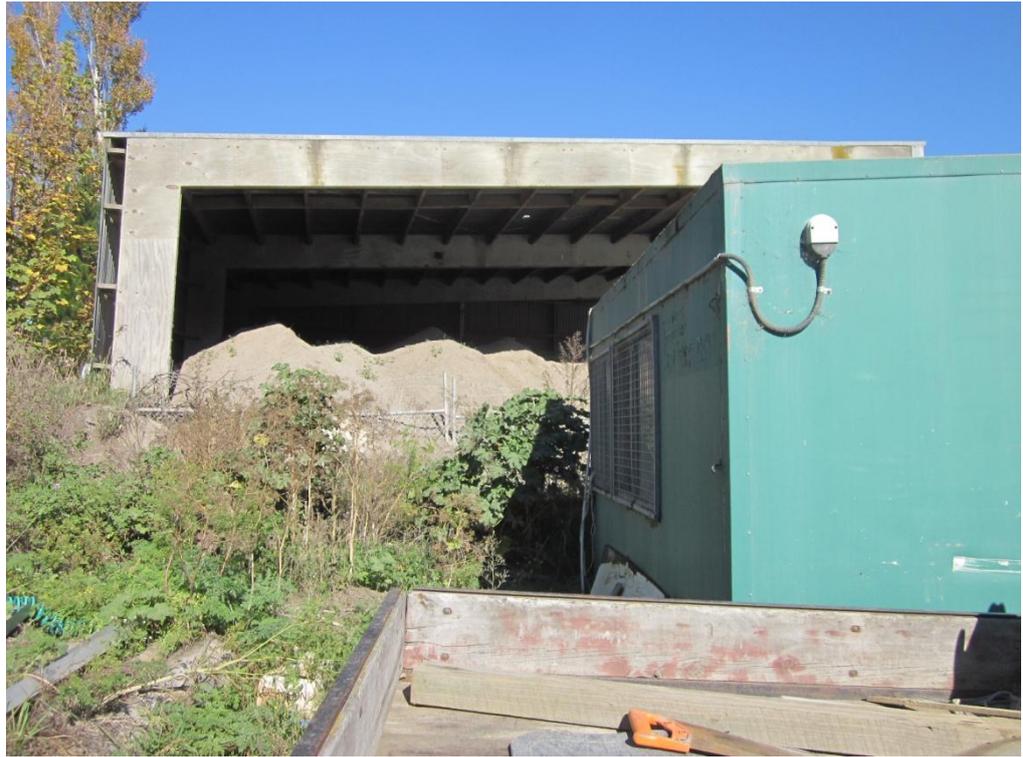
**Photograph 3: North elevation. Portable building on the right obscures view.**

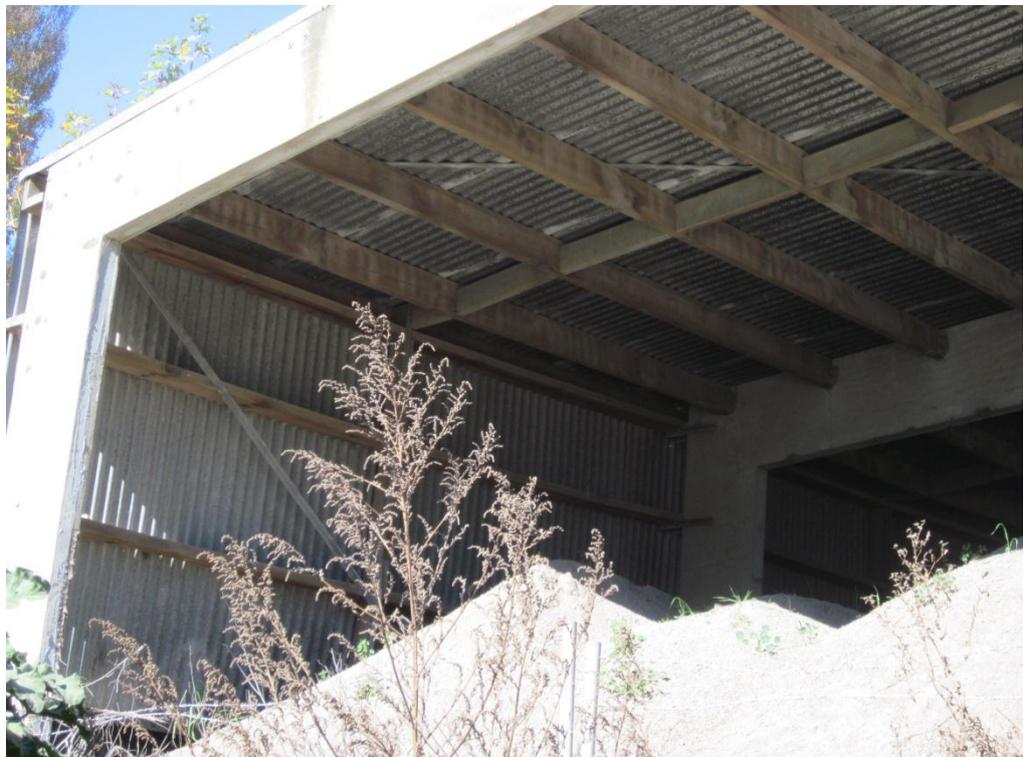
**Photograph 4: View looking at the eastern wall and roof structure.**

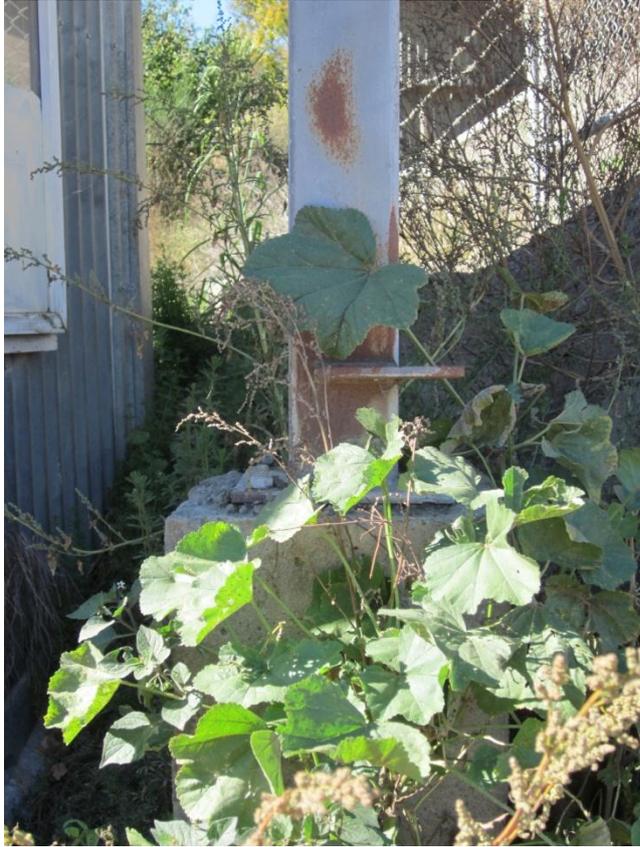
**Photograph 5: Base of steel frame post, bolted to concrete base.**

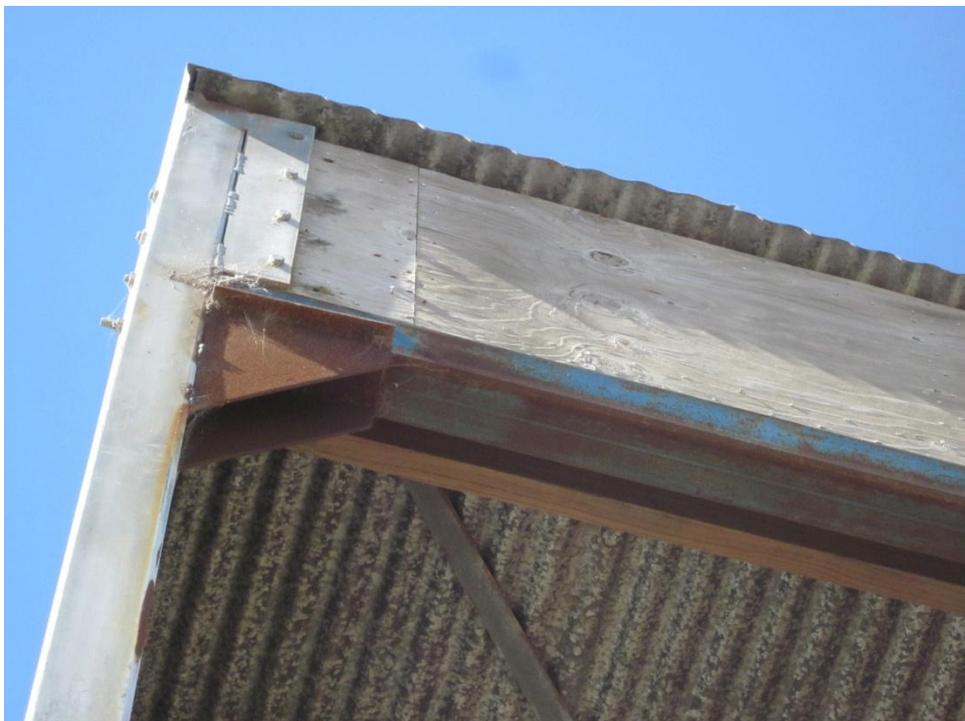
**Photograph 6: Top of northern steel frame post at beam connection. Note steel beam (painted blue) underneath deep timber beam.**

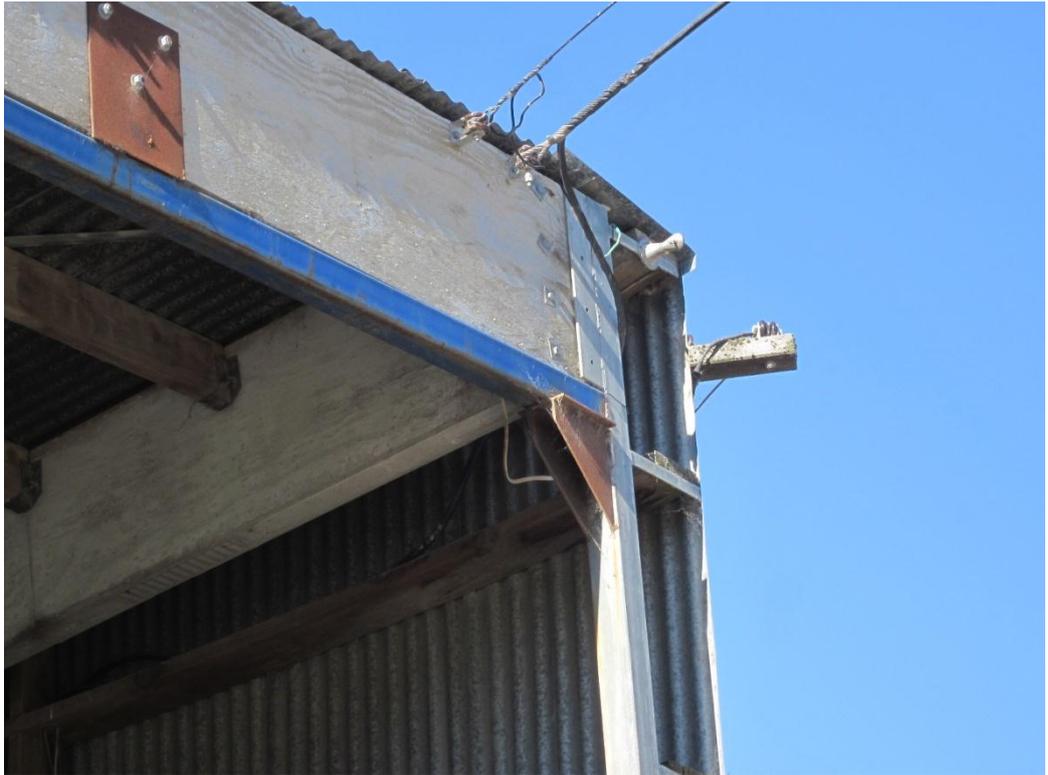
**Photograph 7: Top of southern steel frame post. Note steel beam (painted blue) underneath deep timber beam.**

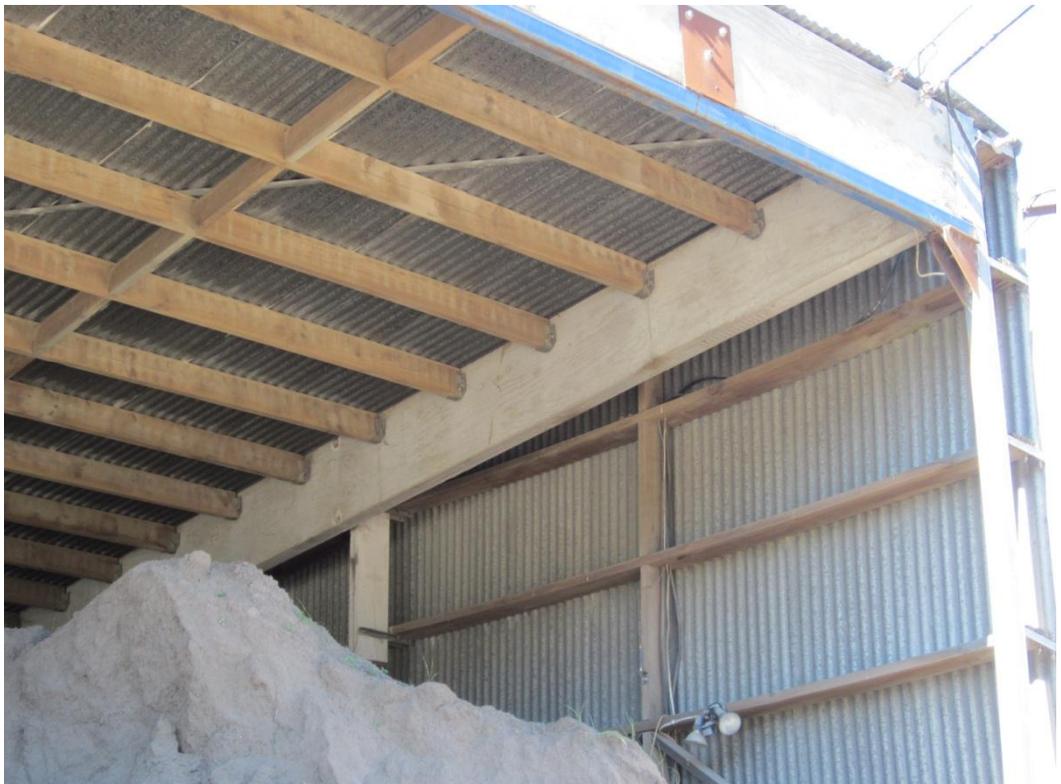
Residual displacement of the southern wall cladding was observed. This is due to soil pressure against the wall, which may or may not have been exacerbated during recent seismic activity. The chain link fence on the northern side of the structure showed similar residual displacement.

**Photograph 8: Southern wall and roof framing.**
