CHRISTCHURCH CITY COUNCIL
PRK_0657_BLDG_004 EQ2
Westminster Park – Community Building
272 Westminster Street, Mairehau

QUALITATIVE ASSESSMENT REPORT
FINAL

- Rev C
- 29 May 2013

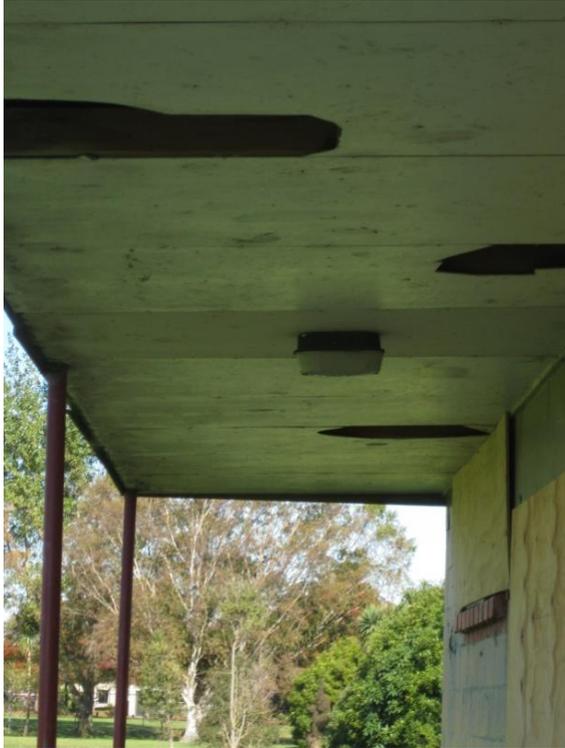
Photo 5: Existing damage to soffit lining

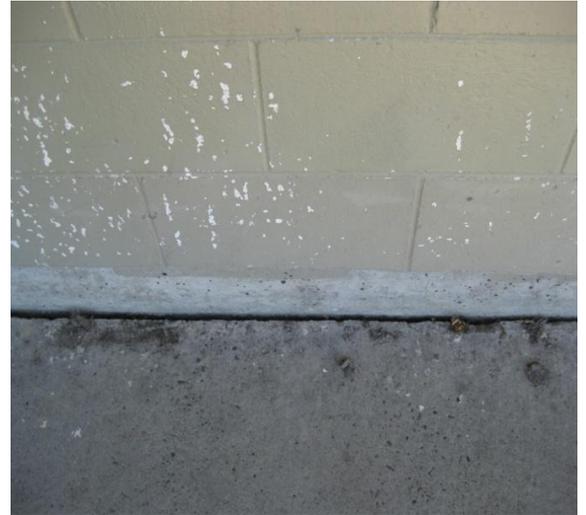
- 1) Step cracking along mortar joints throughout the walls of the building.
- 2) External concrete floor slab pulling away from the building on the southern side.
- 3) Cracking along the top lintel on the south wall.
- 4) Hairline cracks in the foundation.
- 5) Cracking around door frame and architrave on the east wall.
- 6) Damage to soffit lining on southern side of building was noted, but it does not appear to be a result of earthquake damage.

Photo 6: External ground slab pulling away from south wall

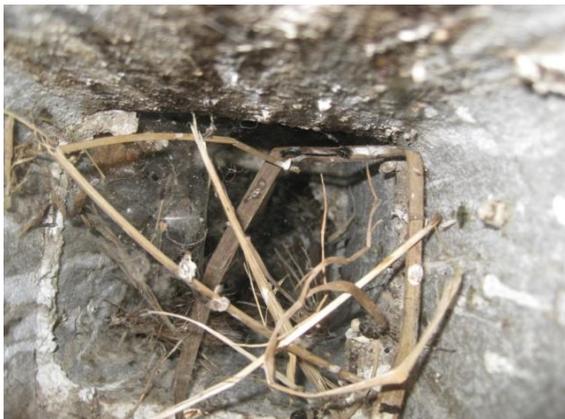
- Load-bearing unreinforced masonry walls on all sides of the building, due to their low out-of-plane bending capacity and long spans.

Photo 7: Looking inside the unreinforced block wall on the southern side of the building.

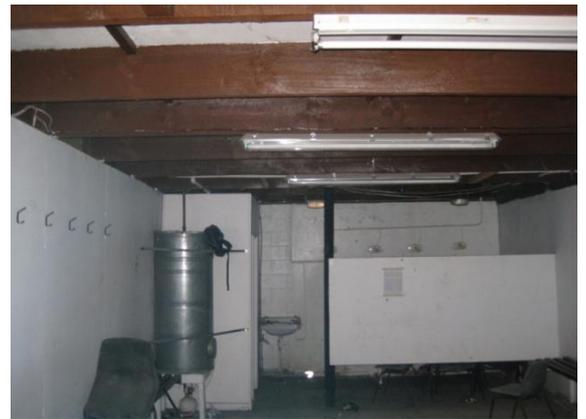
Photo 8: Internal view of building through hole in masonry showing timber-framed ceiling.

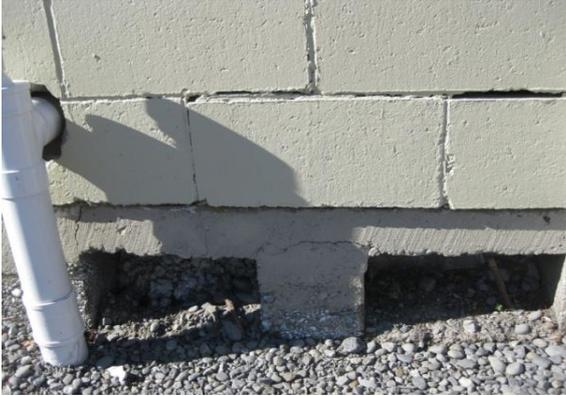
<p>Photo 9: Hairline cracking in foundation under north wall.</p>	<p>Photo 10: Low-quality pointing between blocks on north wall.</p>

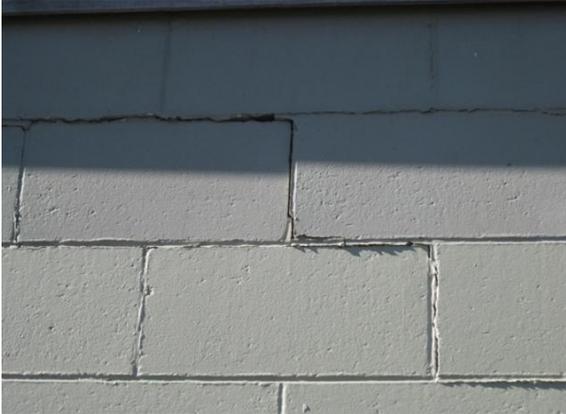
<p>Photo 11: Step cracking along mortar joints (typical on all walls).</p>	<p>Photo 12: Cracking in timber doorframe on north wall.</p>

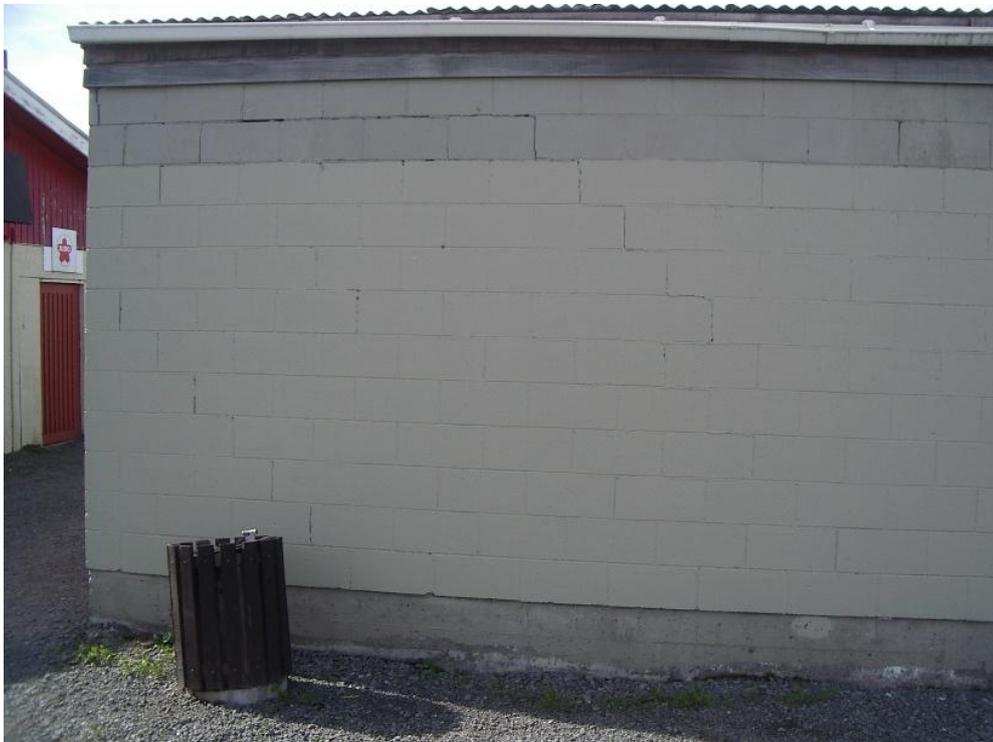
Both of the buildings on site were concrete and metal roof constructions. Some cracks in the walls of buildings were observed during the external inspection of the site. The windows on both of the building were boarded up but it is unknown if this is a result of earthquake damage. There were no signs that liquefaction occurred at the site. The site was asphalted to the NW, with large playing field to the SE of the building. There was no obvious land damage on site.

■ **Figure 7 Observed cracks in the Westminster Street community building**
