**CHRISTCHURCH CITY COUNCIL**  
BU 0697-009 EQ2  
Plant Shed - Woodham Park  
157 Woodham Road, Linwood

QUALITATIVE ASSESSMENT REPORT  
FINAL

- Rev B
- 24 September 2012

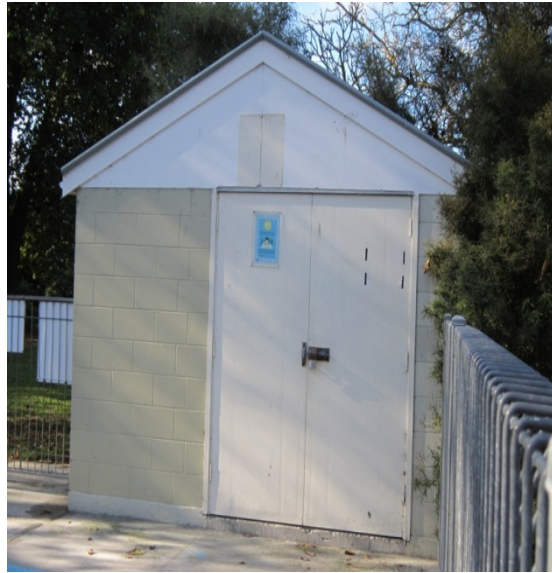
Photo 1: West elevation

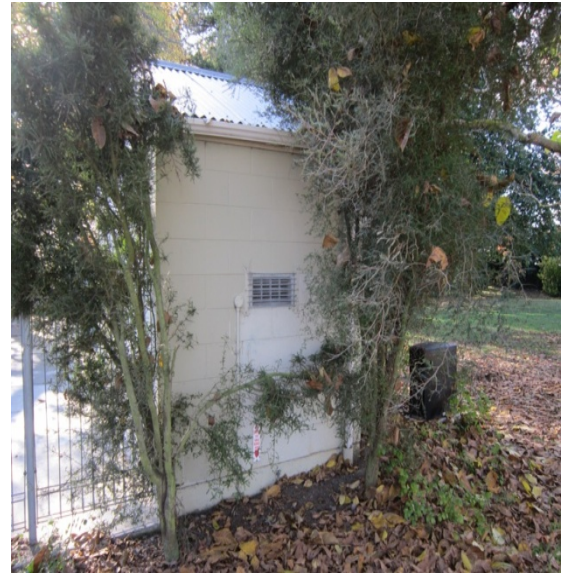
Photo 2: South elevation

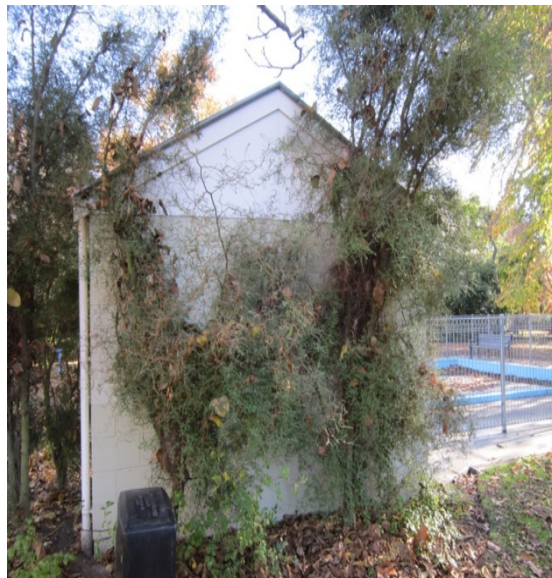
Photo 3: East elevation

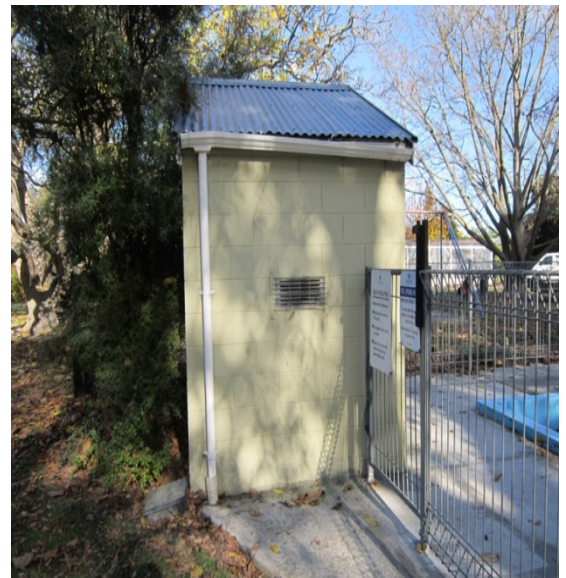
Photo 4: North elevation

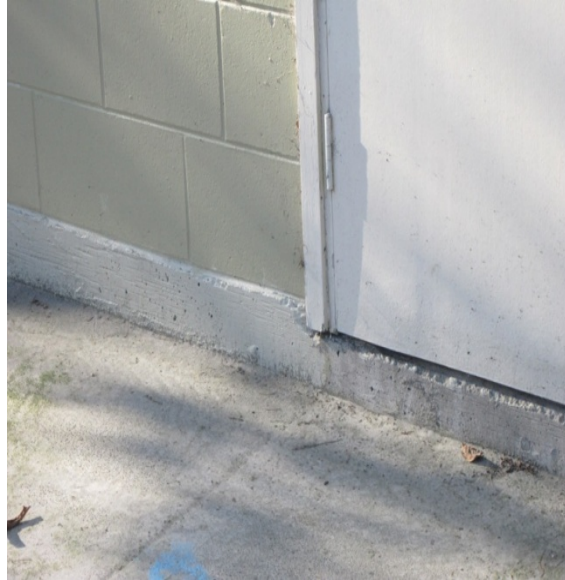
Photo 5: Concrete footing under masonry wall and entrance on west side.

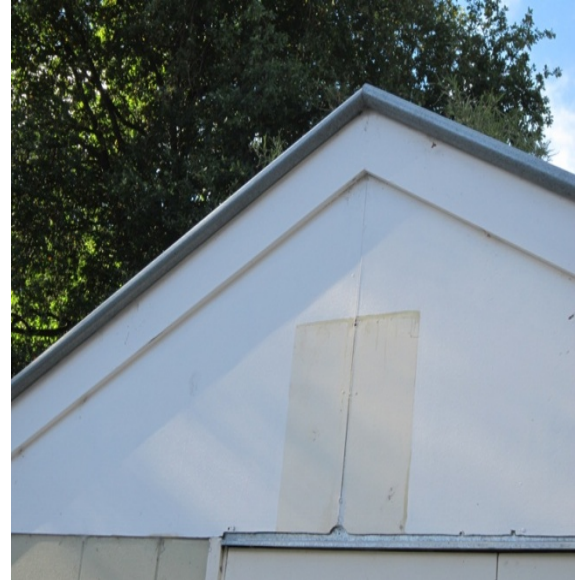
Photo 6: Roof cladding over west masonry wall and entrance.

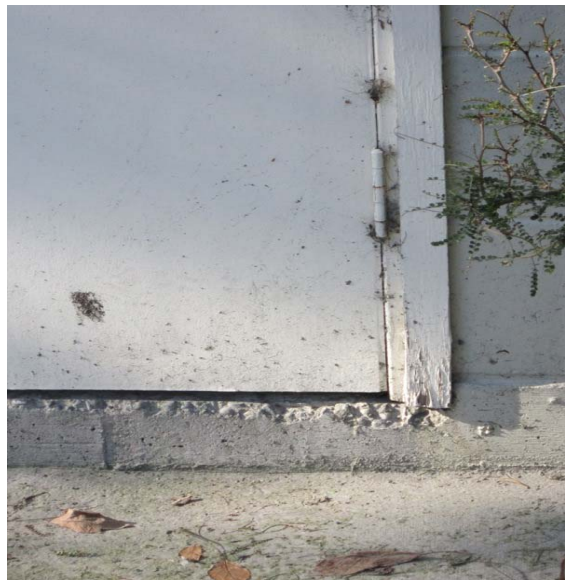
Photo 7: Spalling of low quality concrete footing under entrance on west side.

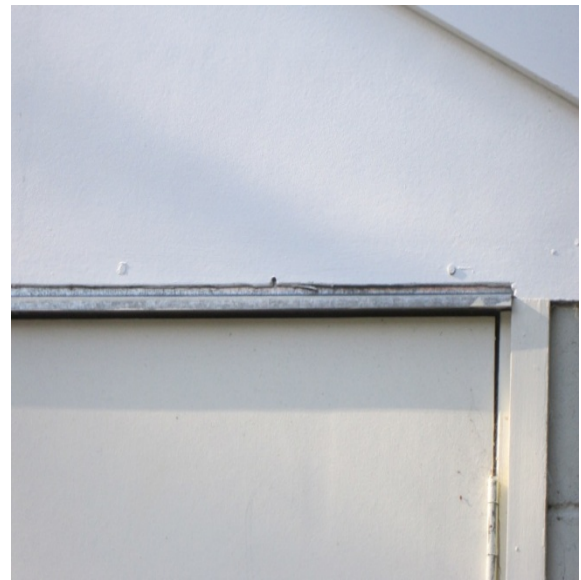
Photo 8: Doorframe for entrance on west side.

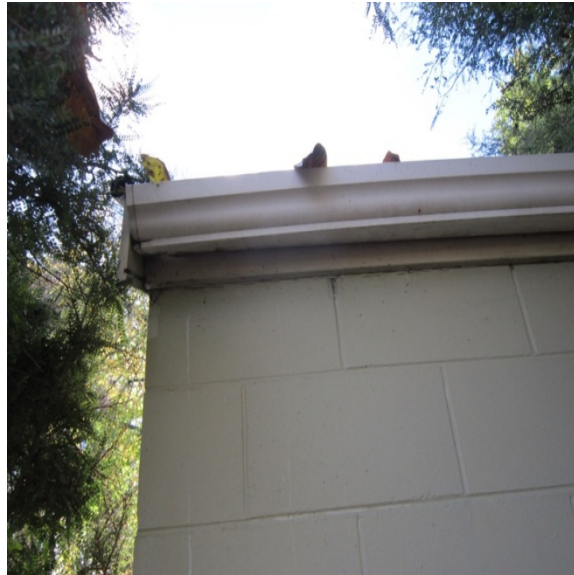
Photo 9: Gutter and south masonry wall.

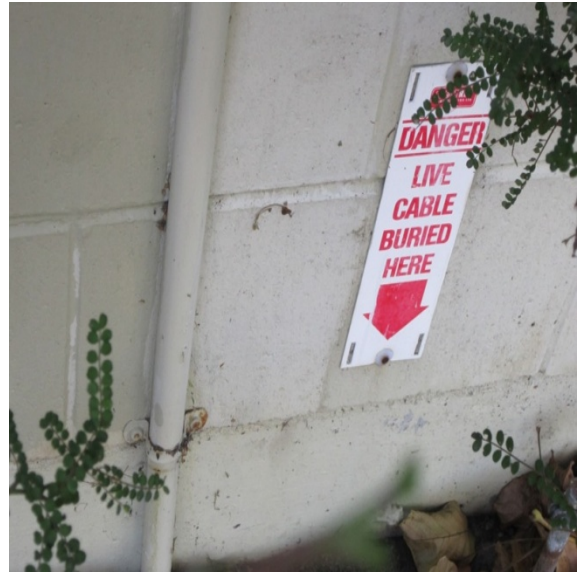
Photo 10: West masonry wall and footing underneath.

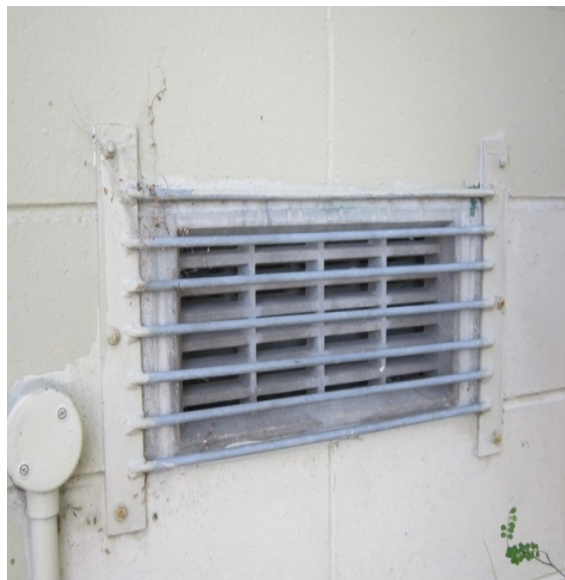
Photo 11: Ventilation grate on west wall.  
Anchors in masonry blocks.

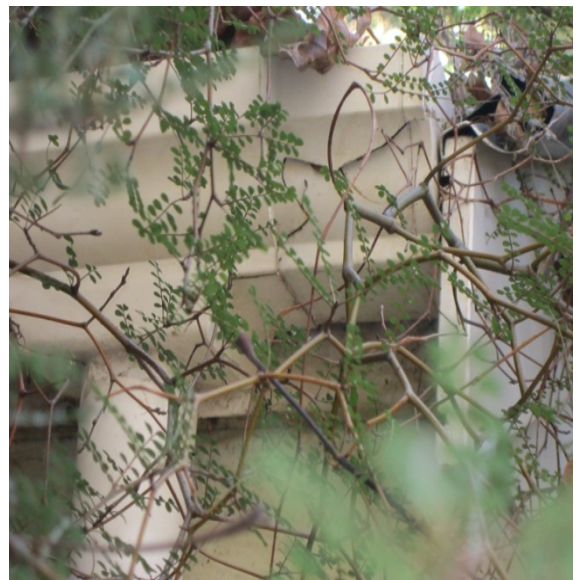
Photo 12: Gutter and downpipe on south side.

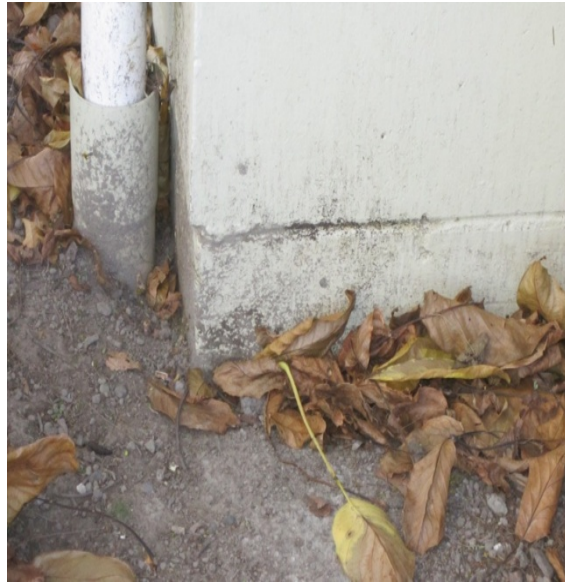
Photo 13: Downpipe from south gutter and footing on east side.

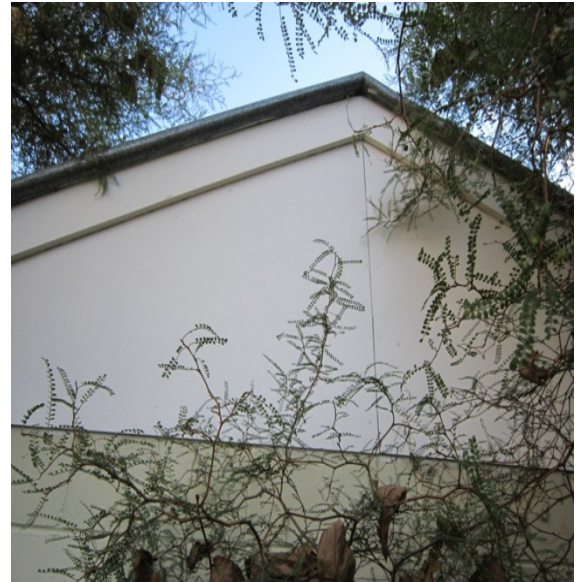
Photo 14: Roof cladding over south masonry wall.

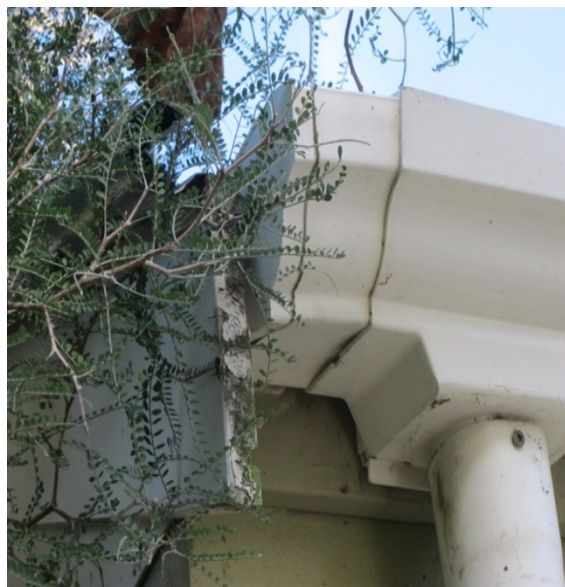
Photo 15: Gutter and downpipe on north side.

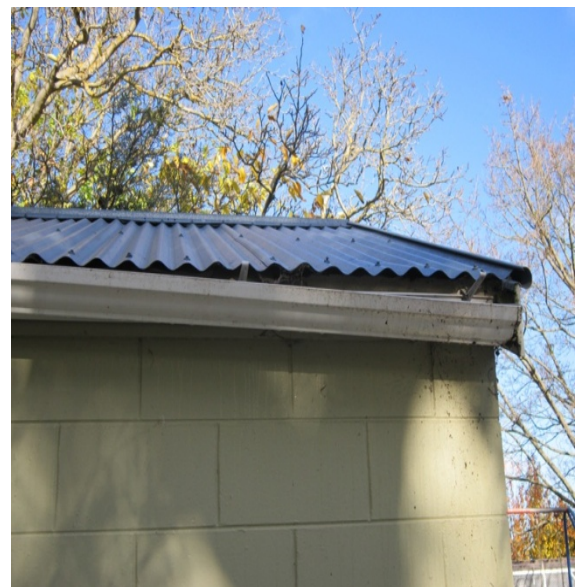
- 1) No earthquake-related damage was observed during our site inspection.
- 2) Dislodged gutter on the north side was noted due to lack of supporting elements, however this is localised and not believed to be earthquake-related damage.

Photo 16: Sloped gutter on north side due to loose support connection.

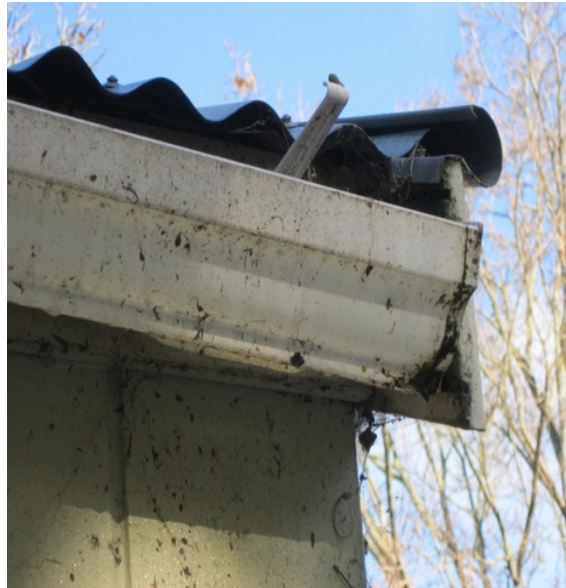
Photo 17: Sloped gutter on north side due to loose support connection.

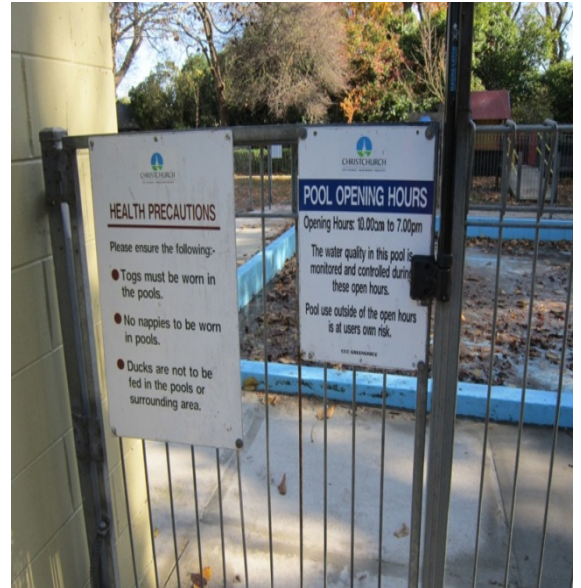
Photo 18: Paddling pool notices and gate.

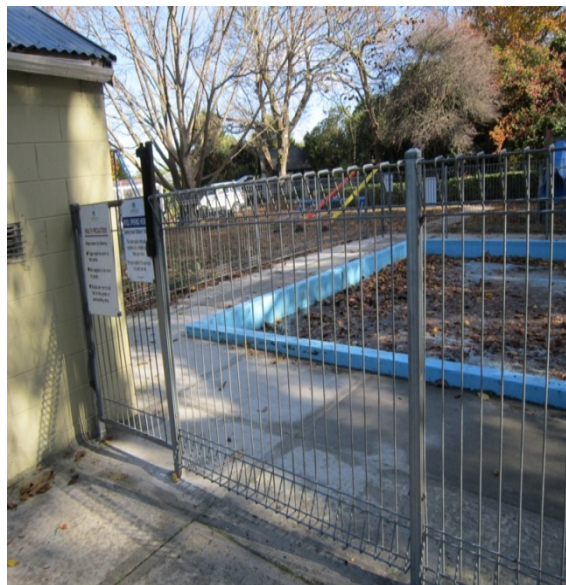
Photo 19: Paddling pool west of building.

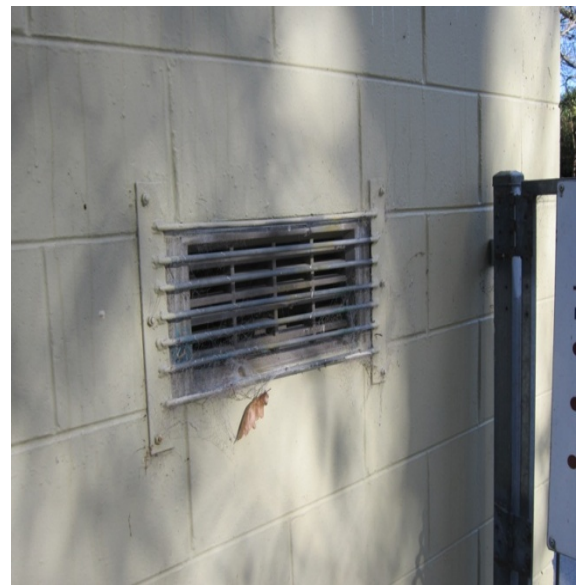
Photo 20: Ventilation grate on east wall. Anchors in masonry blocks.

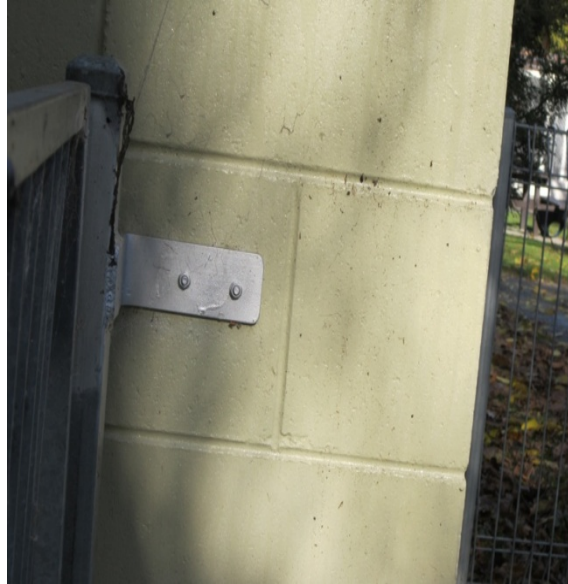
Photo 21: Anchors into masonry elements on north side for top gate connection.

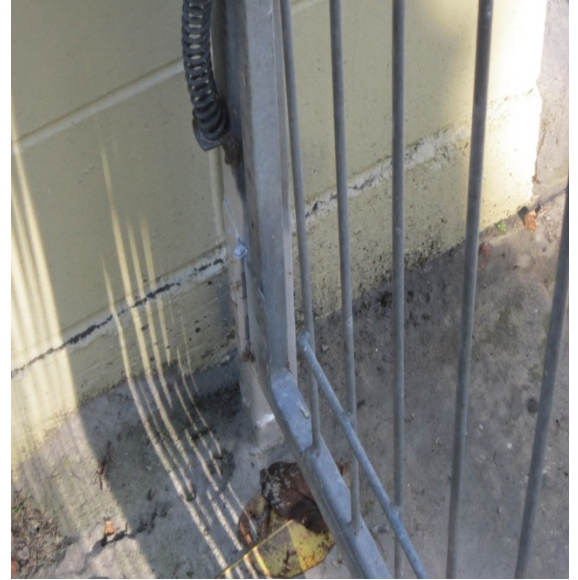
Photo 22: Gate ground connection on north side.

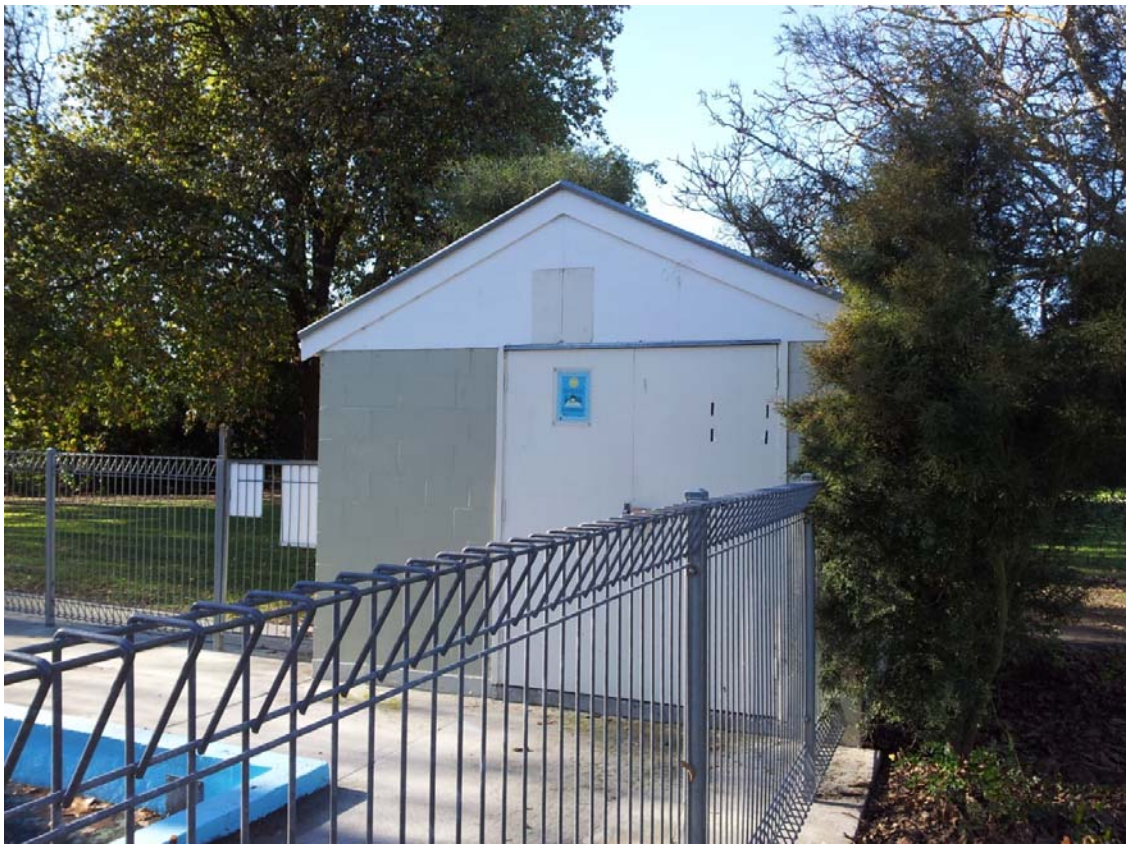
■ **Figure 7 Overview of structure**

The building is a masonry block construction with corrugated sheet metal roof and slab on grade foundation. The paddling pool appears to be poured in-situ concrete, with a surrounding concrete slab. There was some damage to the gutter on the northern side of the building; otherwise no apparent structural damage was noted during the external site inspection. There was little or no evidence of liquefaction around the site. However, this is most likely due to a significant lapse of time between the seismic event and the external site walkover undertaken, as there is some evidence of liquefied material ejected at surface from the aerial photographs. No land damage was observed during the site walkover.
