Yaldhurst Domain Tennis Pavilion
PRK 1642 BLDG 002 EQ2
Detailed Engineering Evaluation
Quantitative Report
Christchurch City Council

Detailed Engineering Evaluation Quantitative Report

Date: October 2012
Reference: 6-QUCCC.96
Status: Final

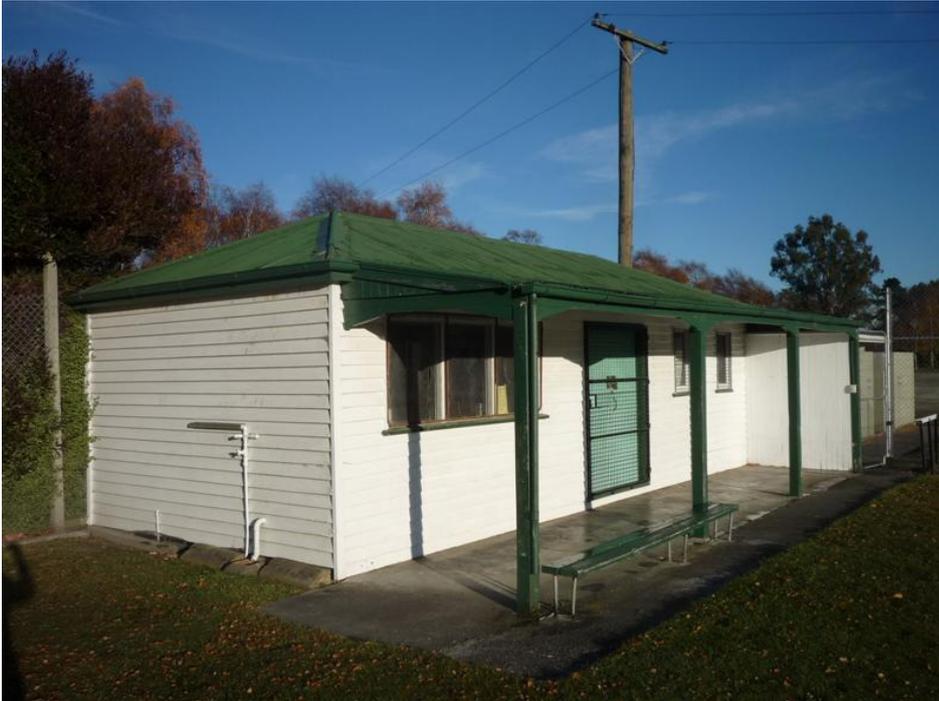
Photo 1: Building frontage and side wall

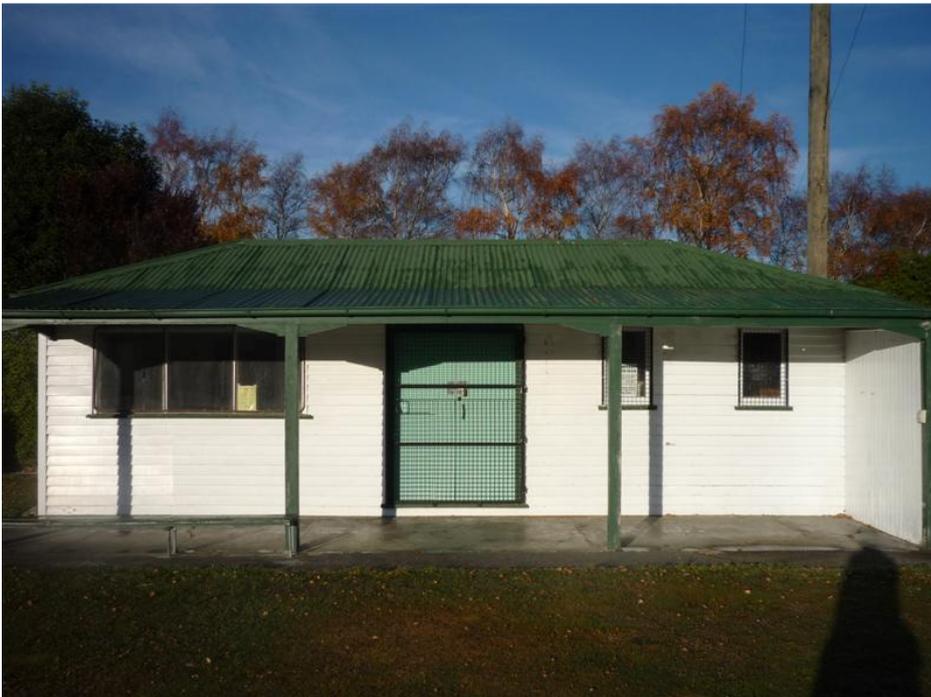
Photo 2: Building frontage

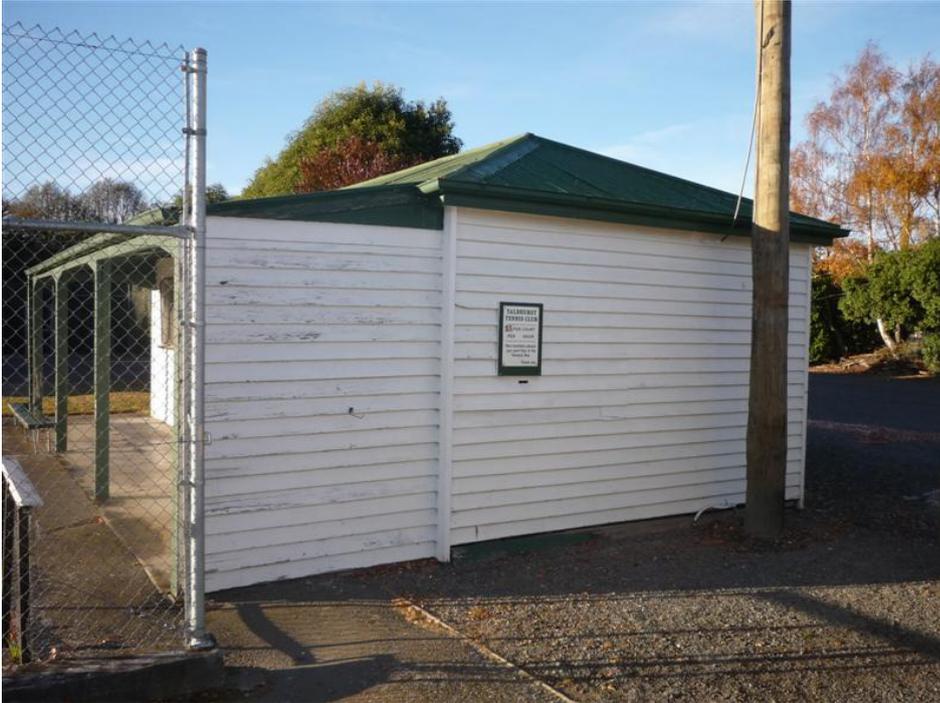
Photo 3: Building side wall

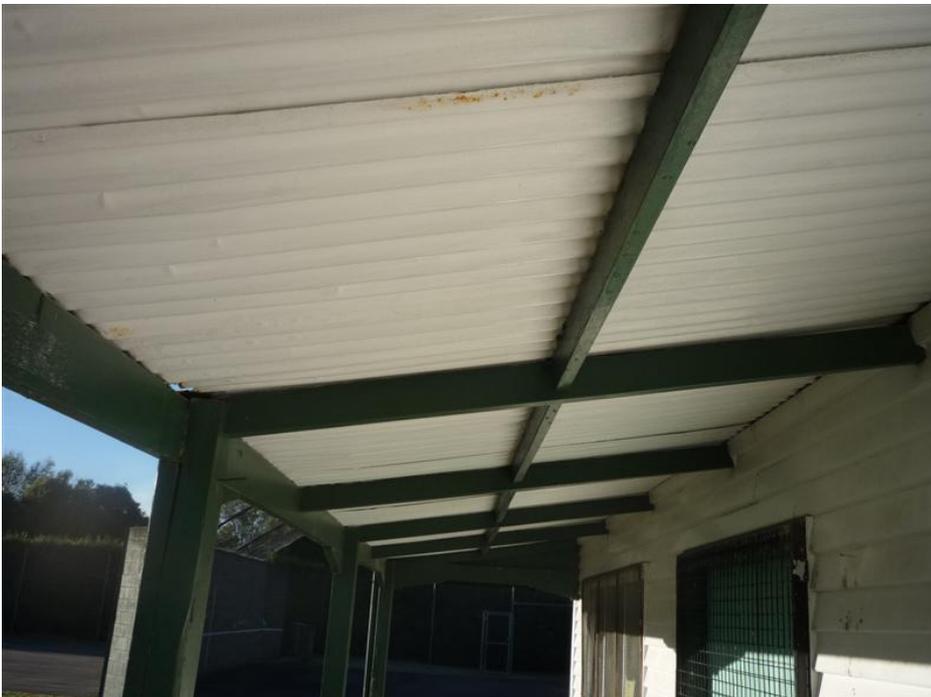
The roof front extension has no roof plane bracing to effectively transfer roof loadings back to the building front wall.

Photo 4: Roof extension detail

- (a) The bracing capacity of the wall linings be addressed to increase the seismic capacity to at least 67% NBS.
- (b) That the front canopy roof plane be braced or strengthened.
- (c) Intrusive investigations be undertaken to determine the capacity of the foundations.

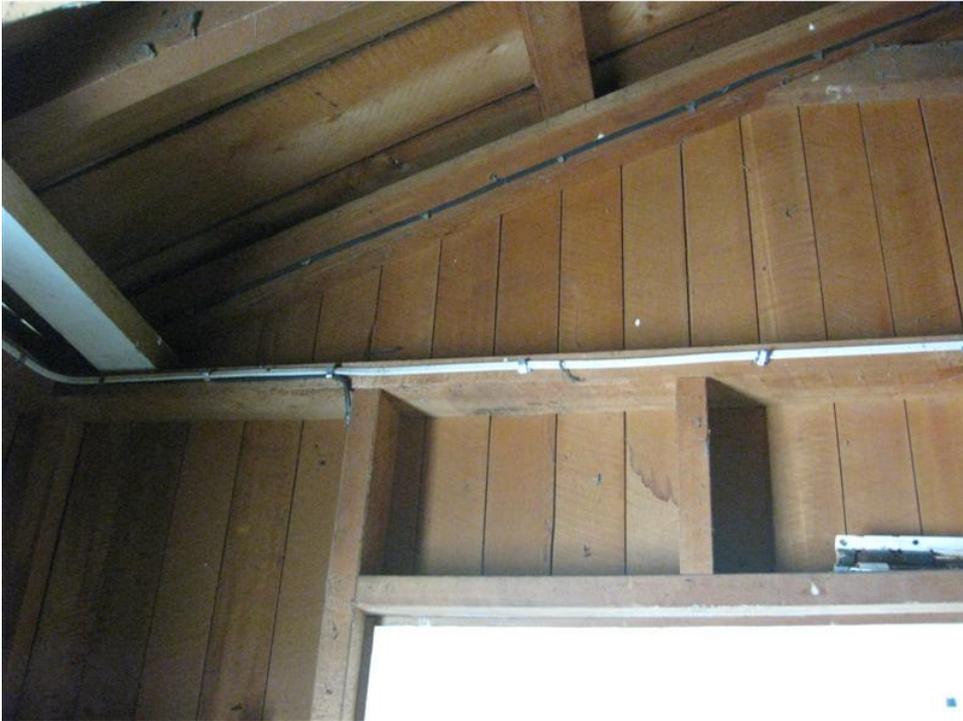
Lateral resistance for the structure is likely provided in the social room from the vertical tongue and groove internal lining. The presence of any cut-in diagonal timber bracing could not be confirmed without intrusive investigation. The store rooms have no diagonal bracing and are reliant on the limited bracing capacity provided by the weatherboard.

Photo 5: Typical social room vertical tongue and groove lining

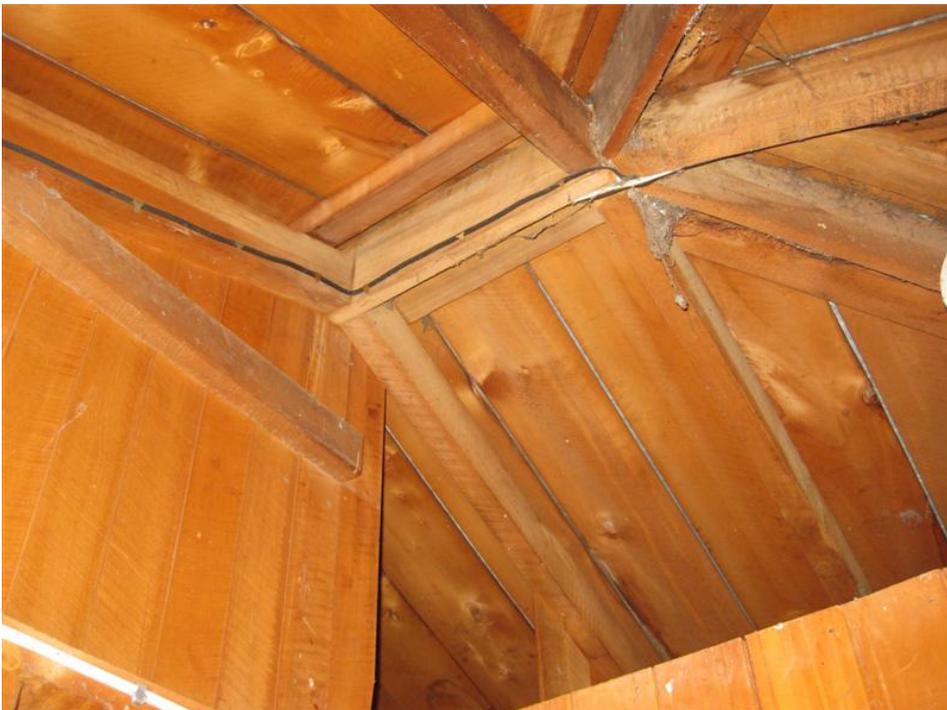
Photo 6: Typical roof detail and wall junction
