**Date:** 24/10/2019  
**From:** Jennifer Rankin – Project Manager  
**To:** Mayor, Councillors and Linwood/Central/Heathcote Community Board  
David Adamson – GM City Services  
**Cc:** Richard Osborne – Head of Transport  
Helen Beaumont – Head of 3Waters  
**Subject:** **Sumner 22-10-19 Flood Event**  
**Reference:** 19/1245772

- 1.1 The purpose of this memo is to provide background and information on the flooding that occurred in Sumner Village on 22<sup>nd</sup> October 2019.

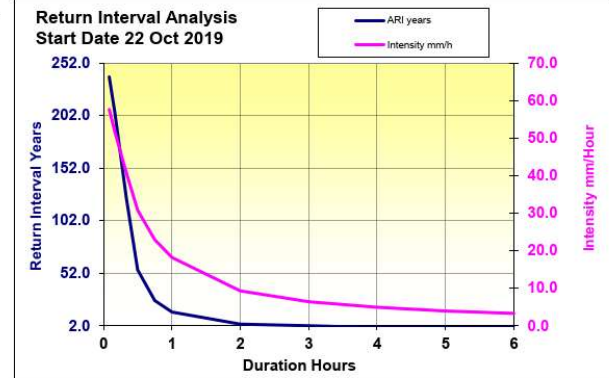
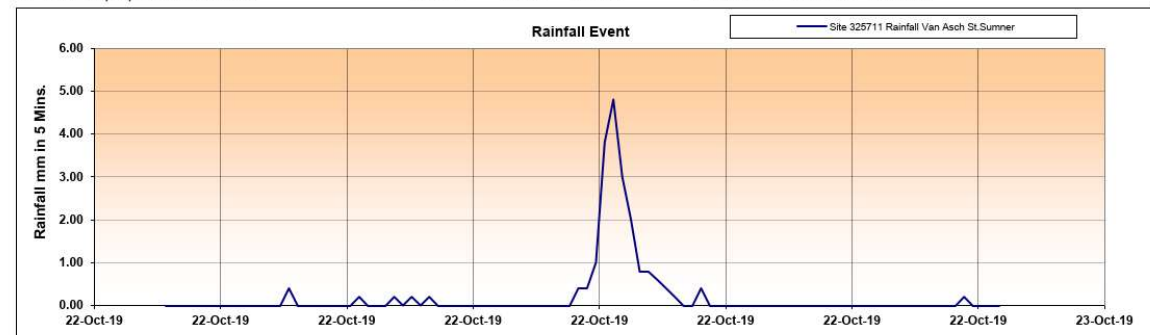
2.6 This indicates that:

- the 1hr duration rainfall equated to a 1 in 15 year event
- the 30min duration rainfall equated to a 1 in 55 year event
- the 10min duration rainfall equated to a 1 in 204 year event

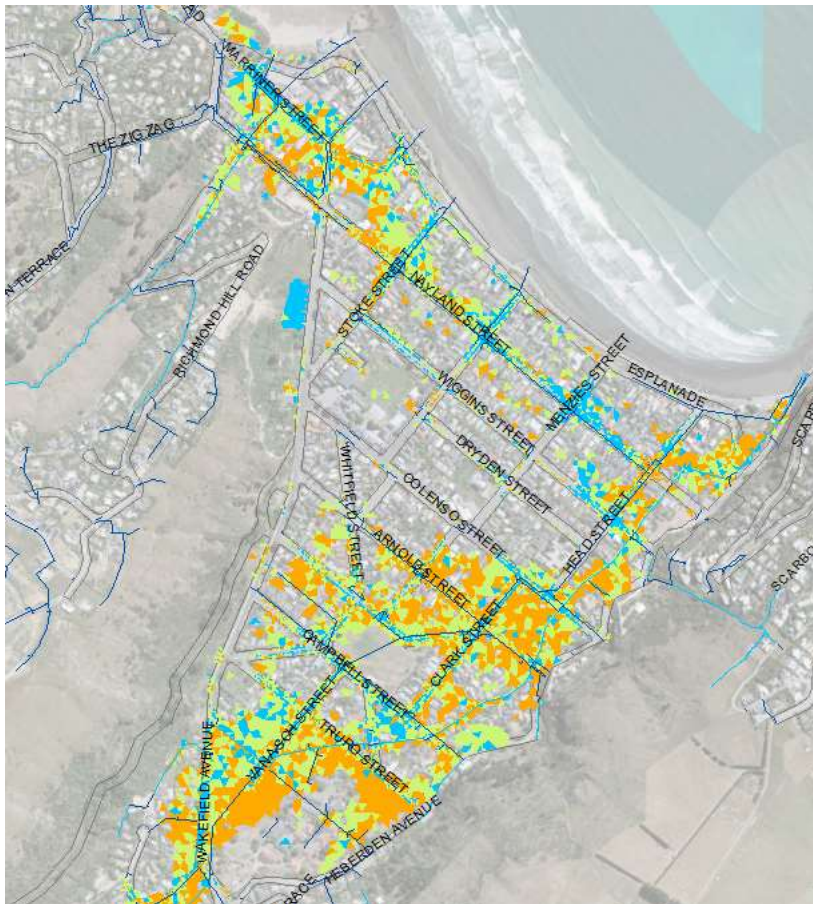
- 4.2 The City Wide Modelling project has completed the Sumner catchment model. A comparison of the pre- and post-earthquake results shows the variable change in flood risk across the catchment. The difference in flood depths between pre- and post-earthquake are shown below for the 2% annual exceedance probability (AEP) event (equivalent to a 50 year average return interval) with the present day climate and no sea level rise.

- 4.3 Blue colour indicates an increased flood depth post-earthquake and a reduction is shown in orange. Green indicates no change.

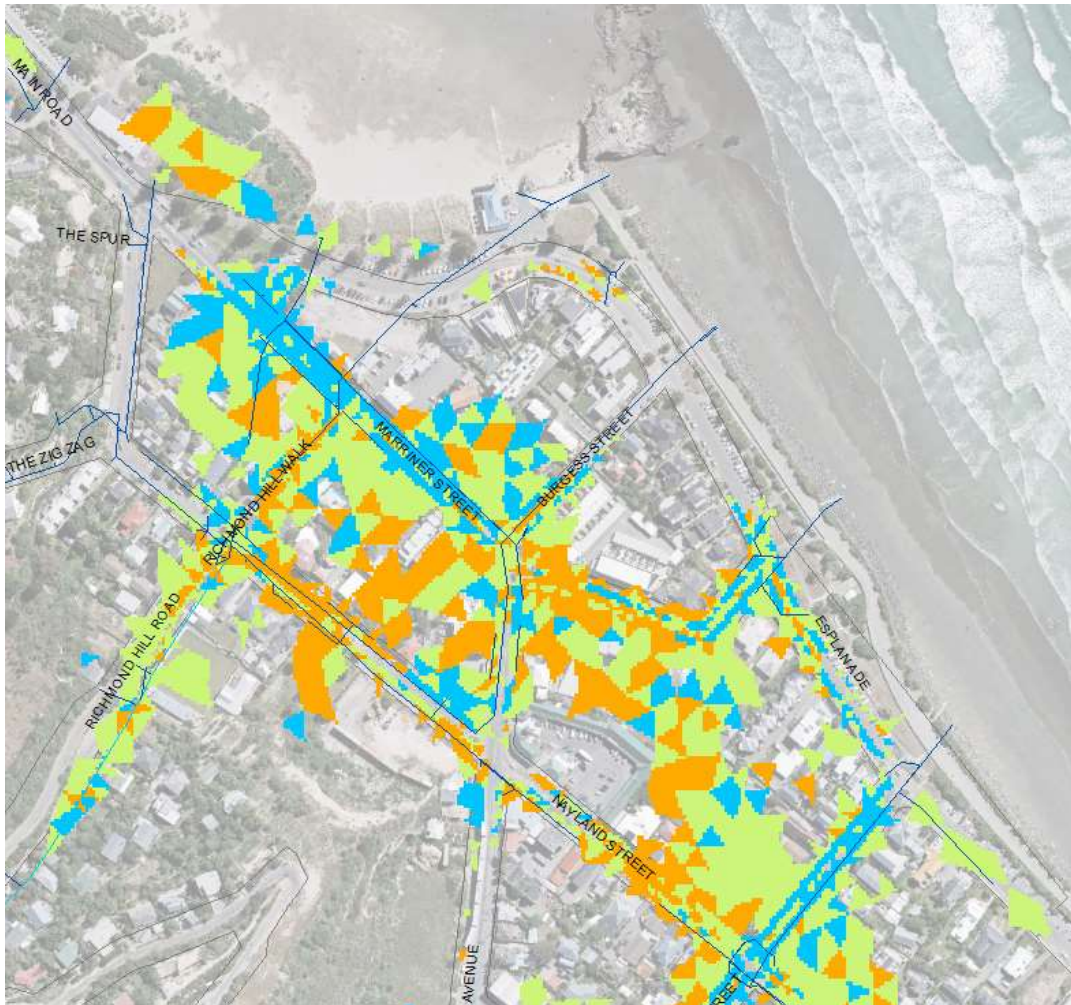
- 4.4 For the area affected by flooding on 22 October 2019, there has been a similarly variable change in flood risk, as shown in the image below for the same model scenario as above. There is an increase in flood depth along Marriner Street, but generally no change or a reduction away from that area.

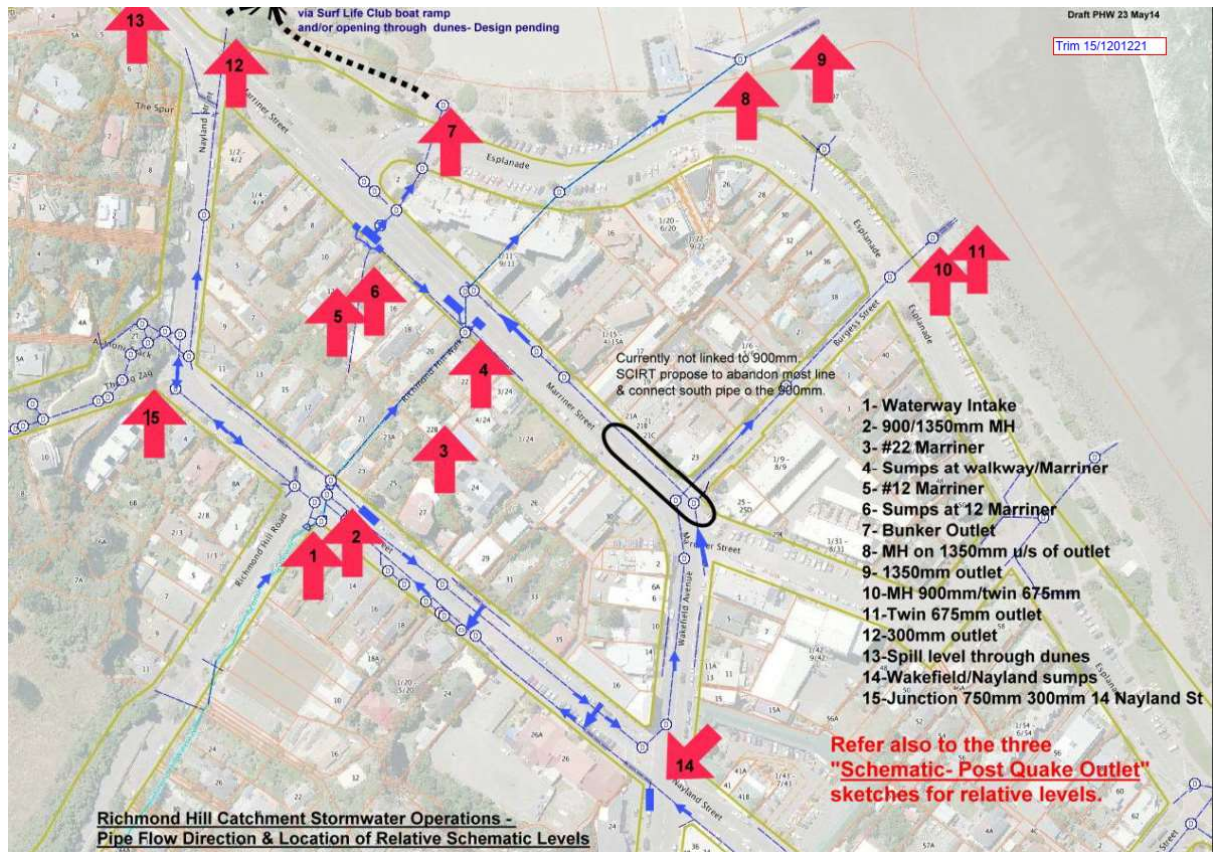
- 5.1 The design of the masterplan considered appropriate stormwater and roading design for the area. The stormwater system was designed to meet the 1 in 5 year stormwater event criteria as is normal for all roading projects.
- 5.2 The design took into consideration the current stormwater situation and its existing problems and it was designed so that there was no negative impact on the system.
- 5.3 The stormwater system outside the shops is connected to the existing 225 diameter pipe which feeds into the Cave Rock outfall. This is shown as arrows 8 and 9 on the plan below.
