# STORM REPORT

17 & 18 July 1999

Collated by Ken Couling  
Water Services Unit  
Christchurch City Council  
September 1999

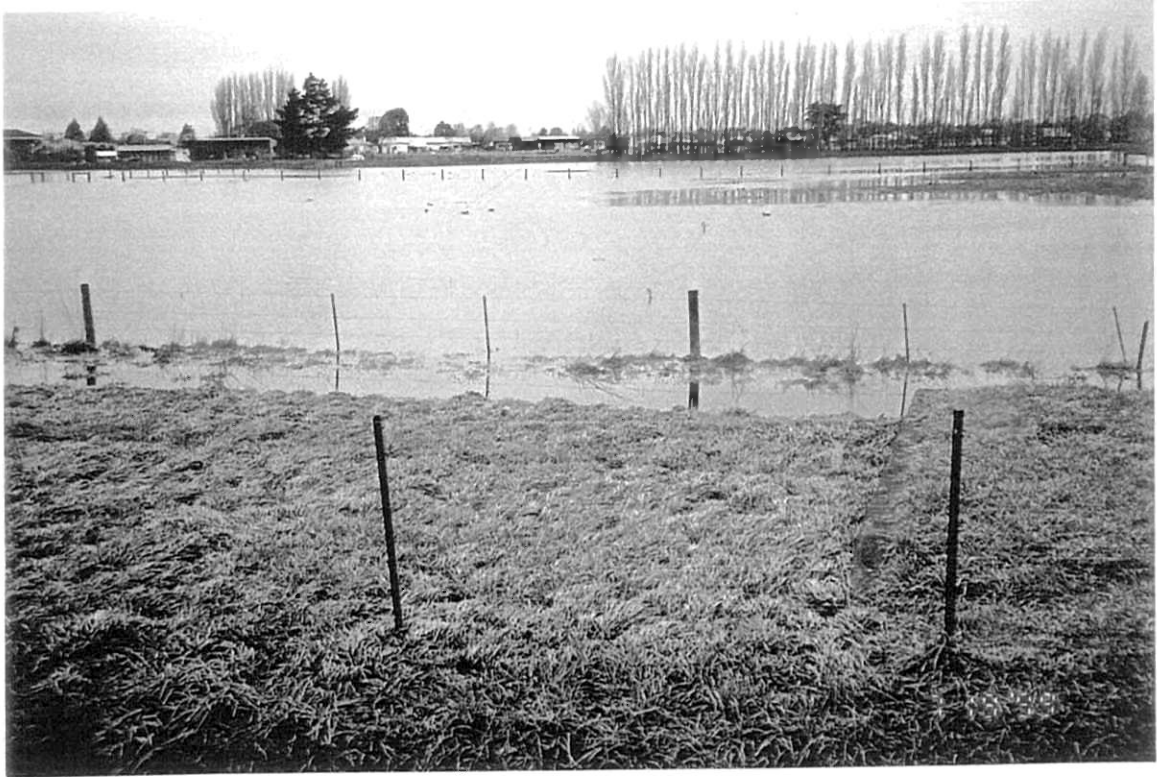
Winters Road Ponding Basin  
19 July 1999  
Flood Level 14.12m  
Maximum Flood Level 14.22m

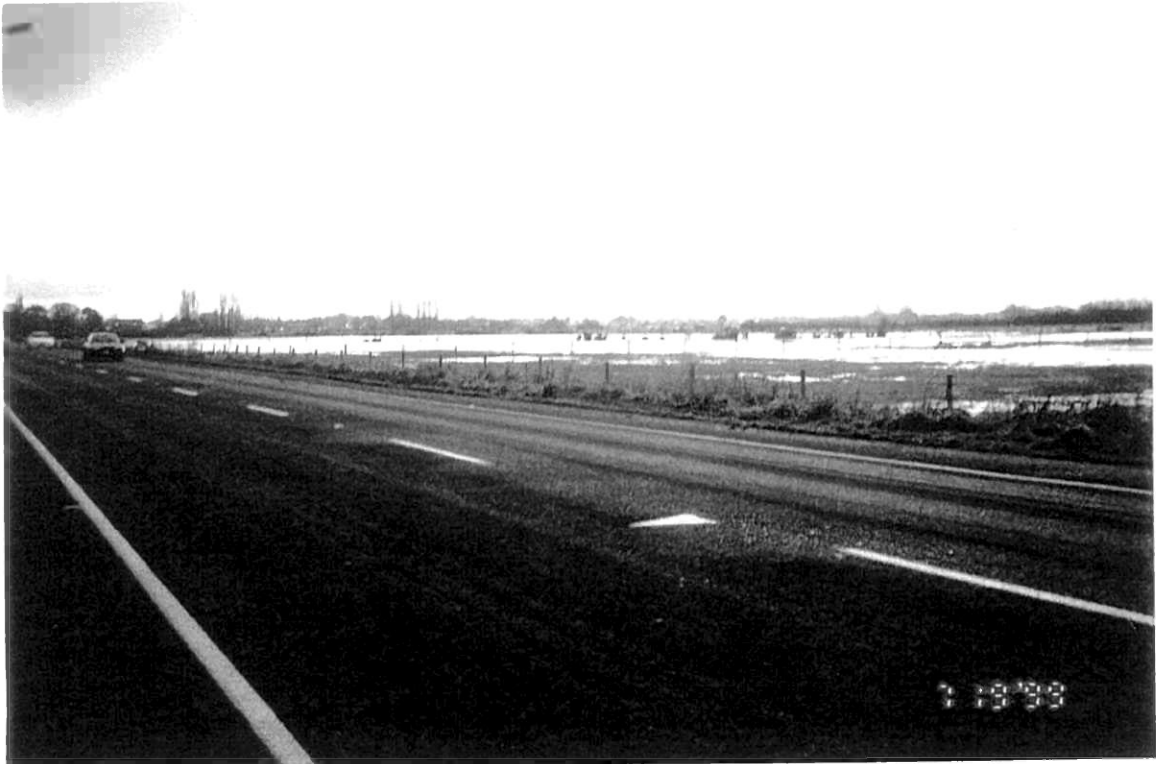
Ponding north side Winters Road  
Rossiters/Horners Drains  
19 July 1999

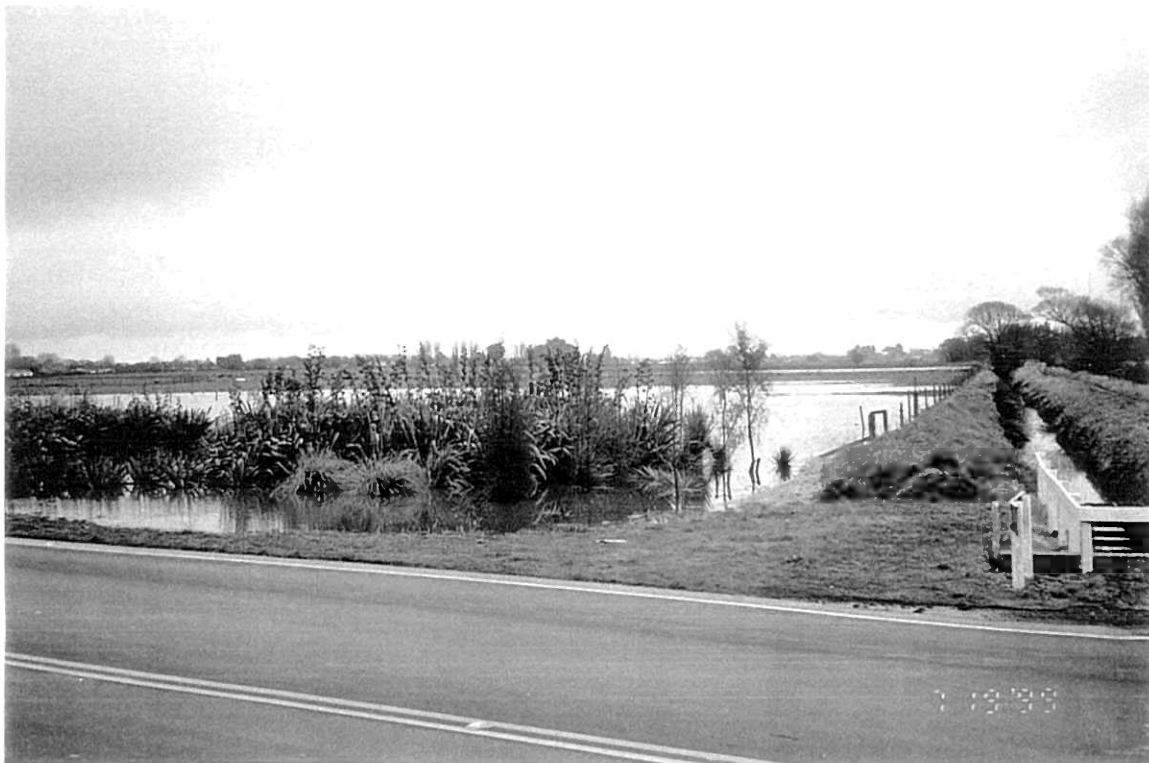
Winters Road/Horners Drain  
19 July 1999

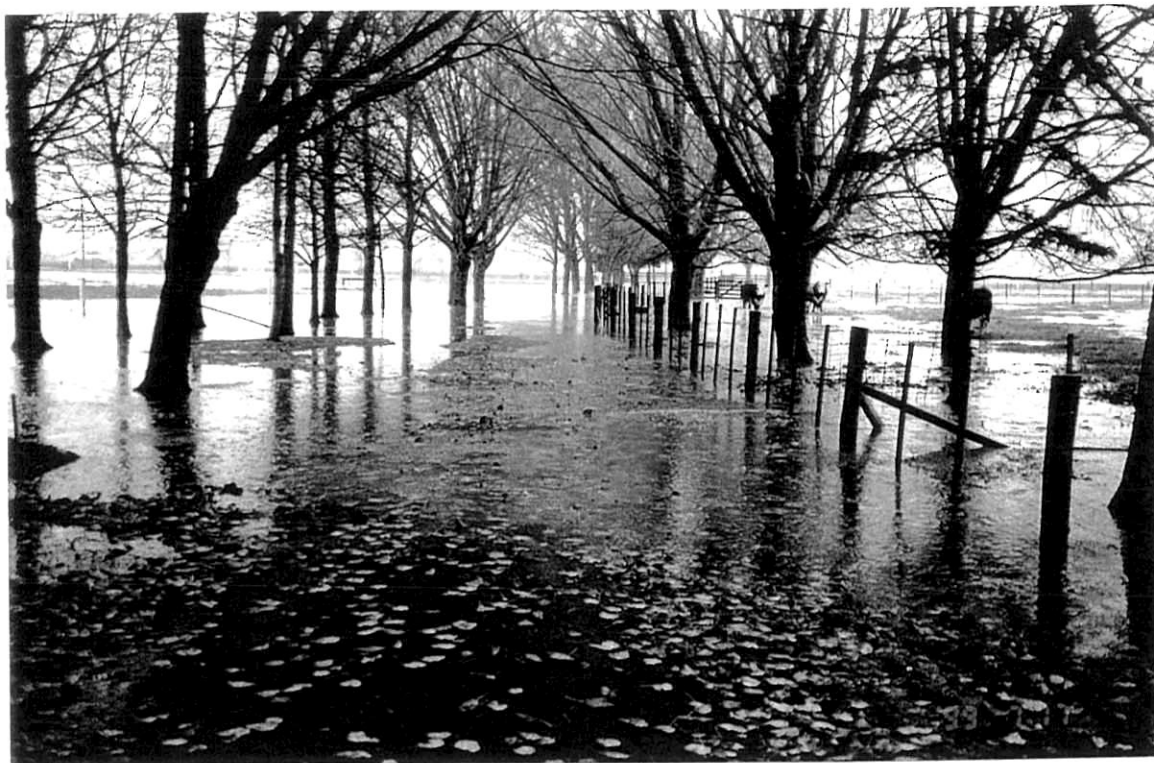
Topps Drain and Winters Road  
17 July 1999

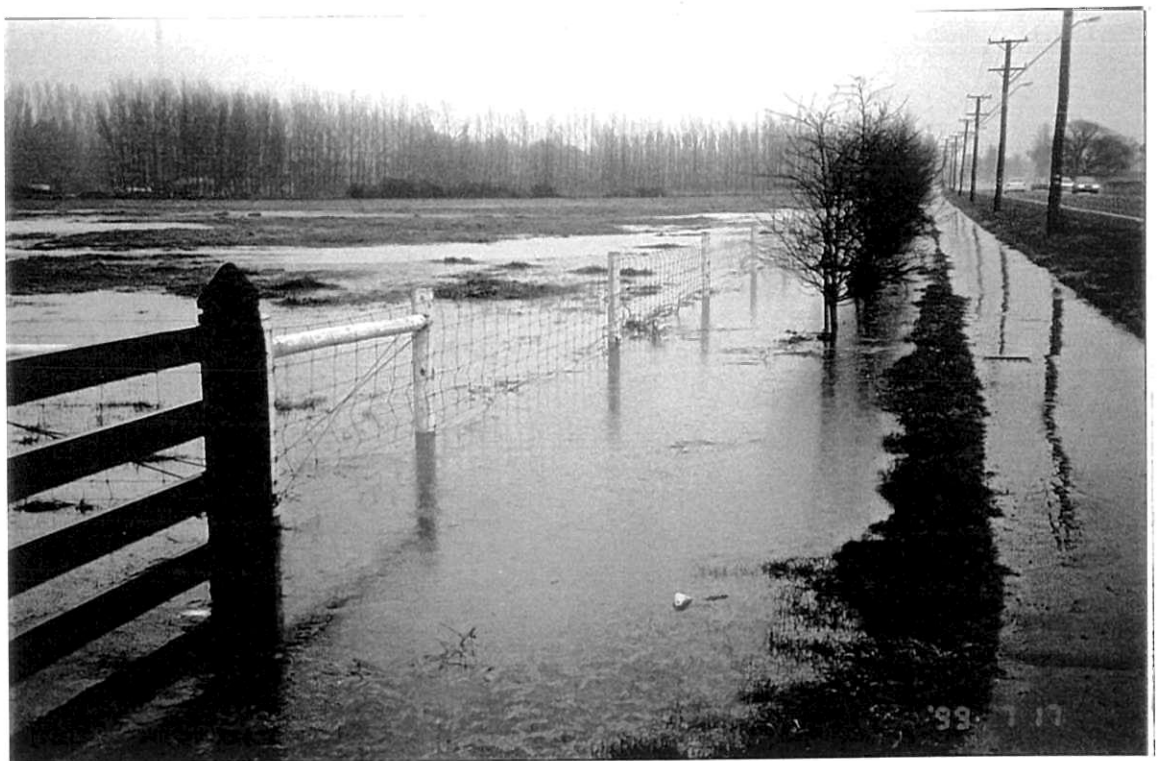
Ponding south side Winters Road  
towards Buller's Drain  
17 July 1999
