LOWER RICHMOND HILL CATCHMENT 12 OCTOBER 2000 FLOODING INVESTIGATION NOTES

Report
Prepared By
John Walter & Peter Wehrmann
City Design

December 2000

Lower Richmond Hill Catchment: 12 October 2000 Storm

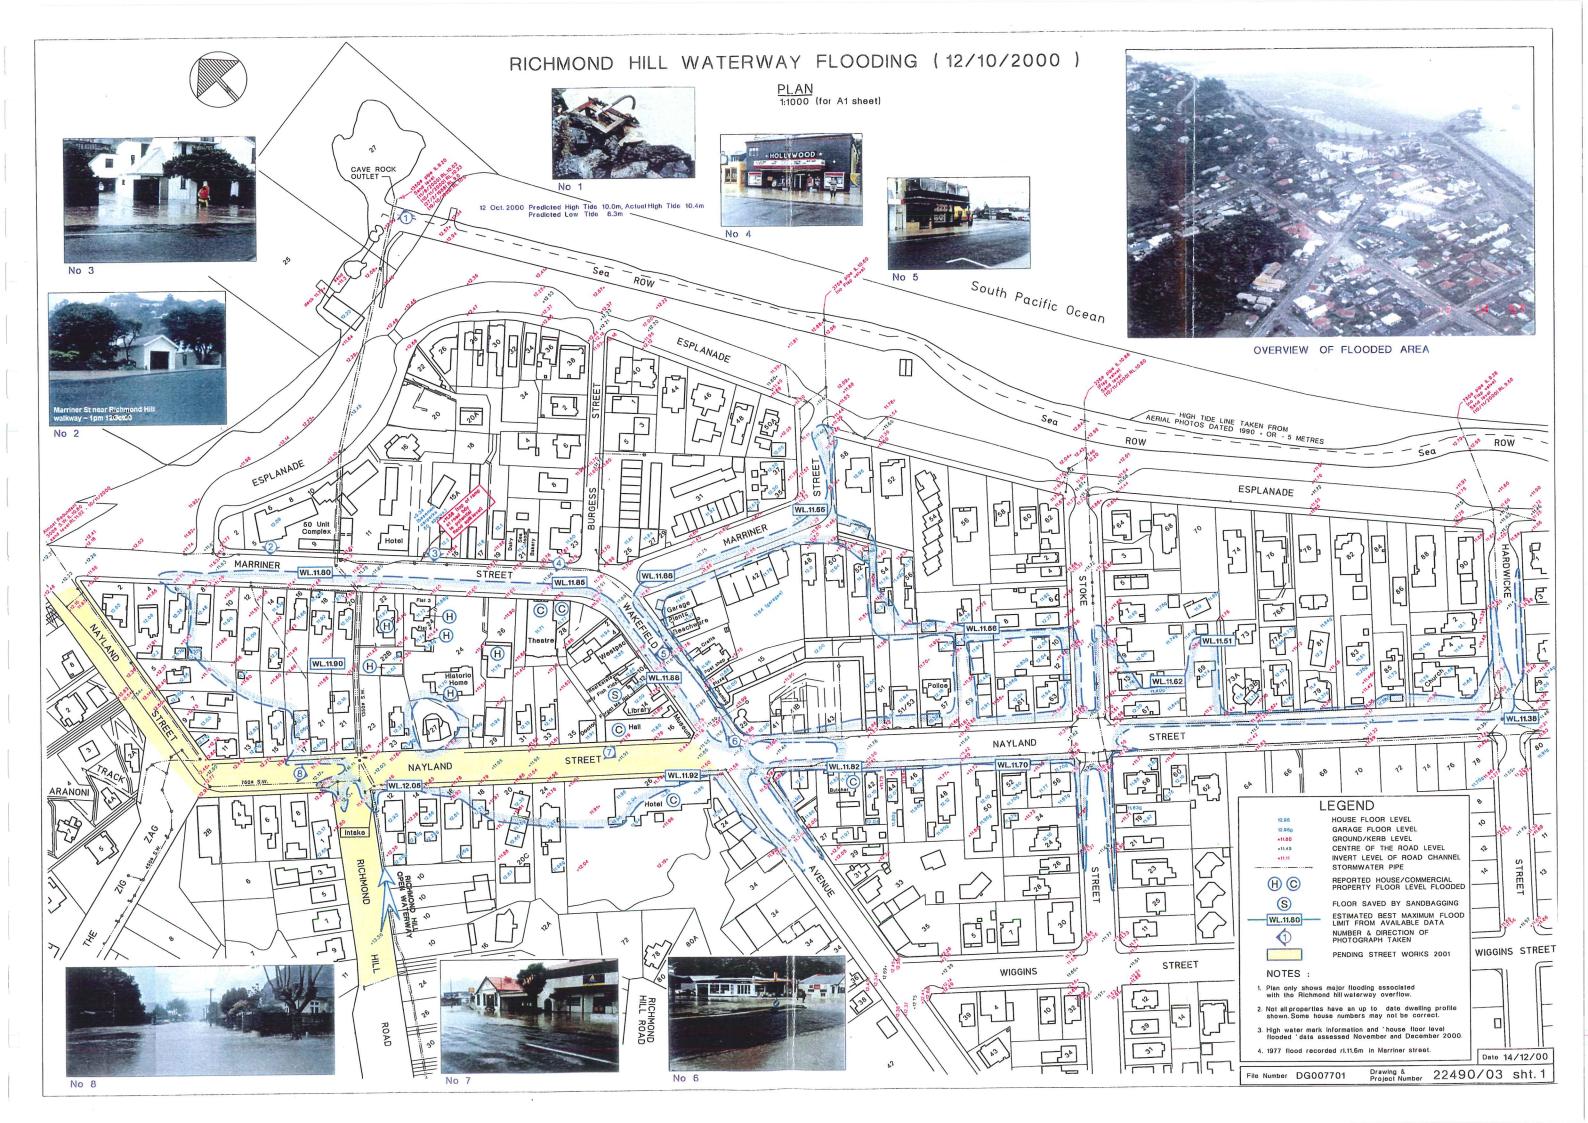
Refer to the attached 22490/03-plan sheet 1. During the 12th October storm, some of Nayland St, Wakefield Ave and Marriner St area experienced flooding. Several houses and commercial properties had floodwaters enter above floor level. About twelve properties had water at or above floor level. Structural flooding ranged from minor seepage just above floorboards to over 100mm above floor level.

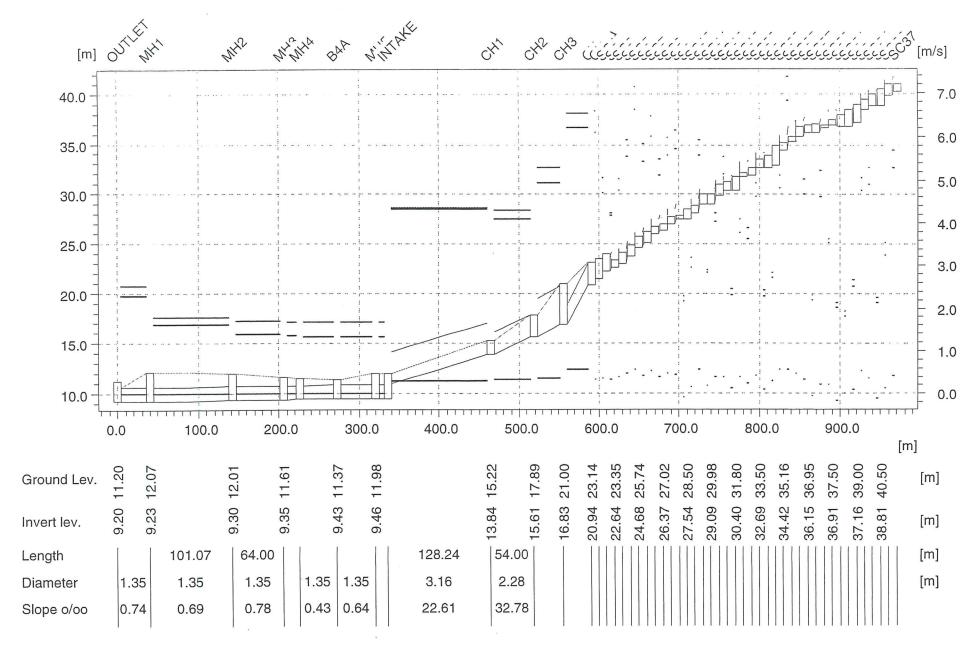
VELOCITY BRANCHES - 12-10-2000 12:30 Oct00htu.prf

When the Hydraulic Model was run using the Tunnel Road rainfall data, the model indicates the intake/pipeline is at capacity and the intake is overwhelmed which would cause flooding. Overtopping of the Intake occurs on the Thursday 12th October at three times during the morning. First occurring at 7.45am, 9am and again at 10.45am. The model shows the cummulative volume of overflow is approximately 1500m³.
