# STORM REPORT

Marine Tavern, Sumner

11 – 13 OCTOBER 2000

Compiled by Ken Couling  
City Solutions  
Christchurch City Council

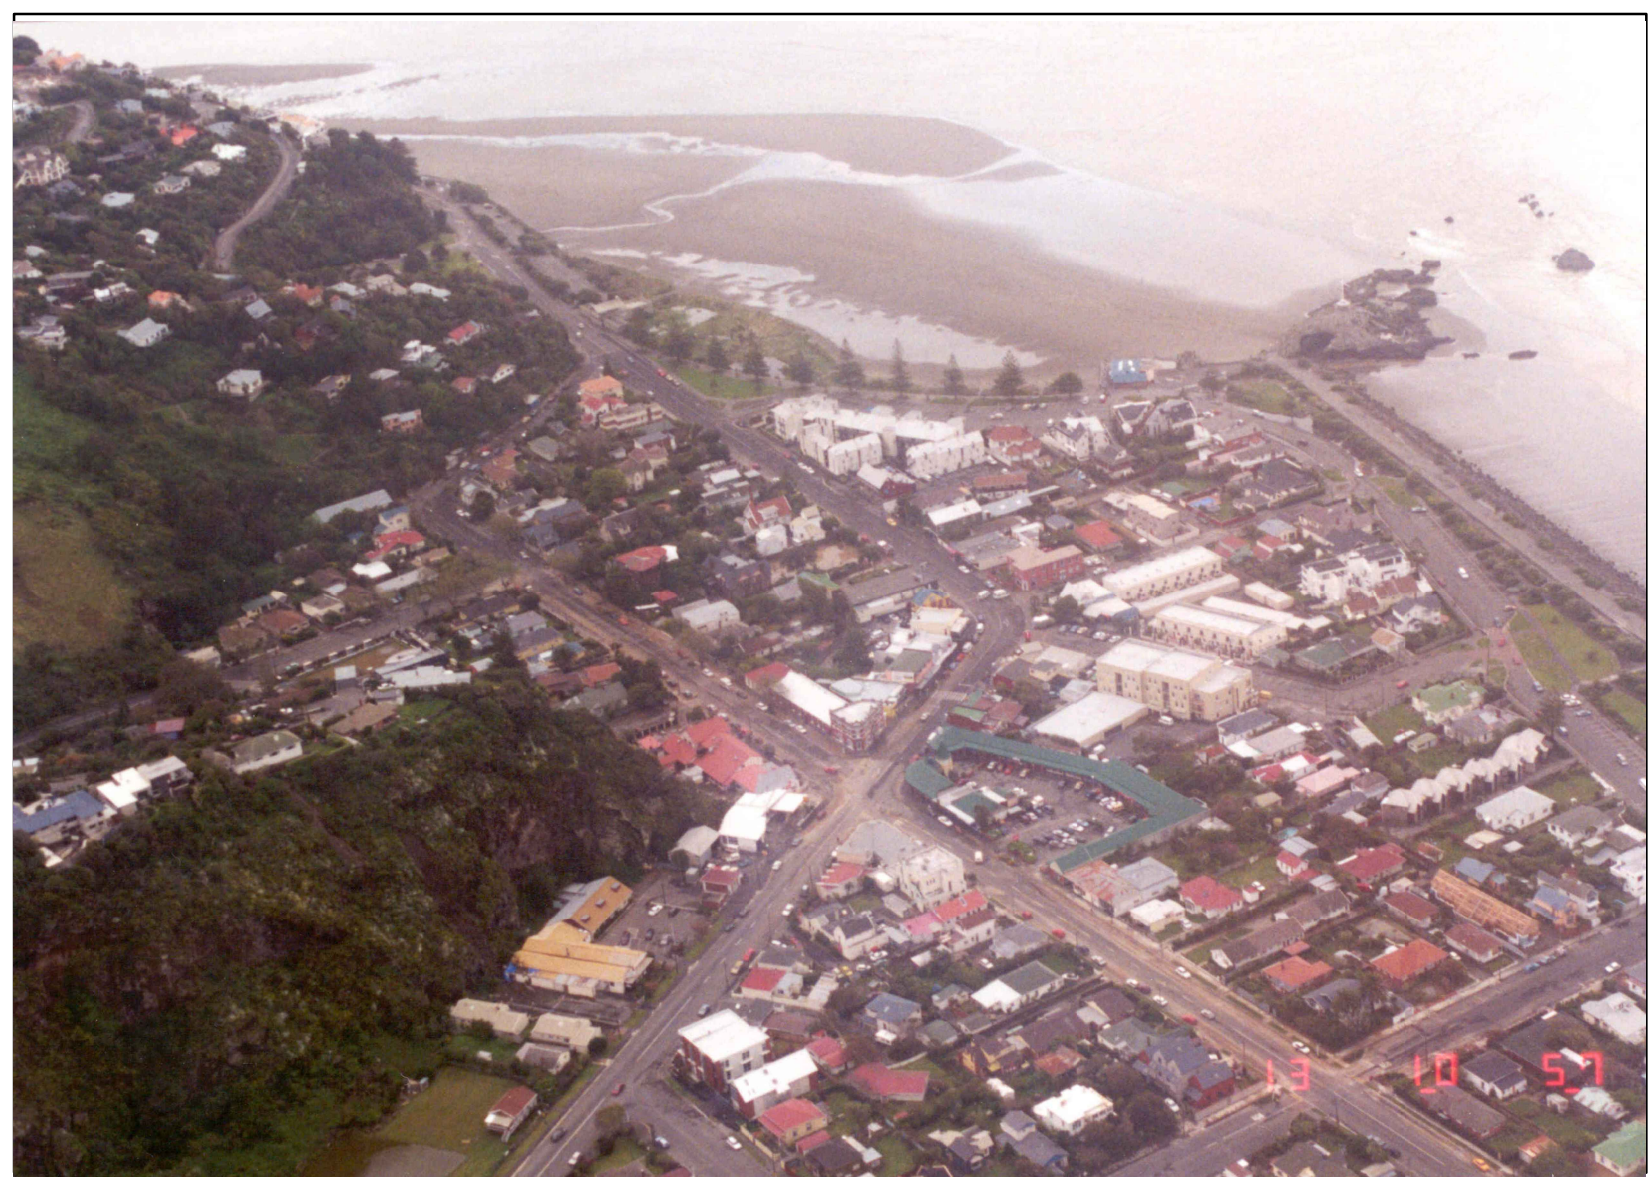
OVERVIEW OF FLOODED AREA  
13/10/2000 (One day after storm)

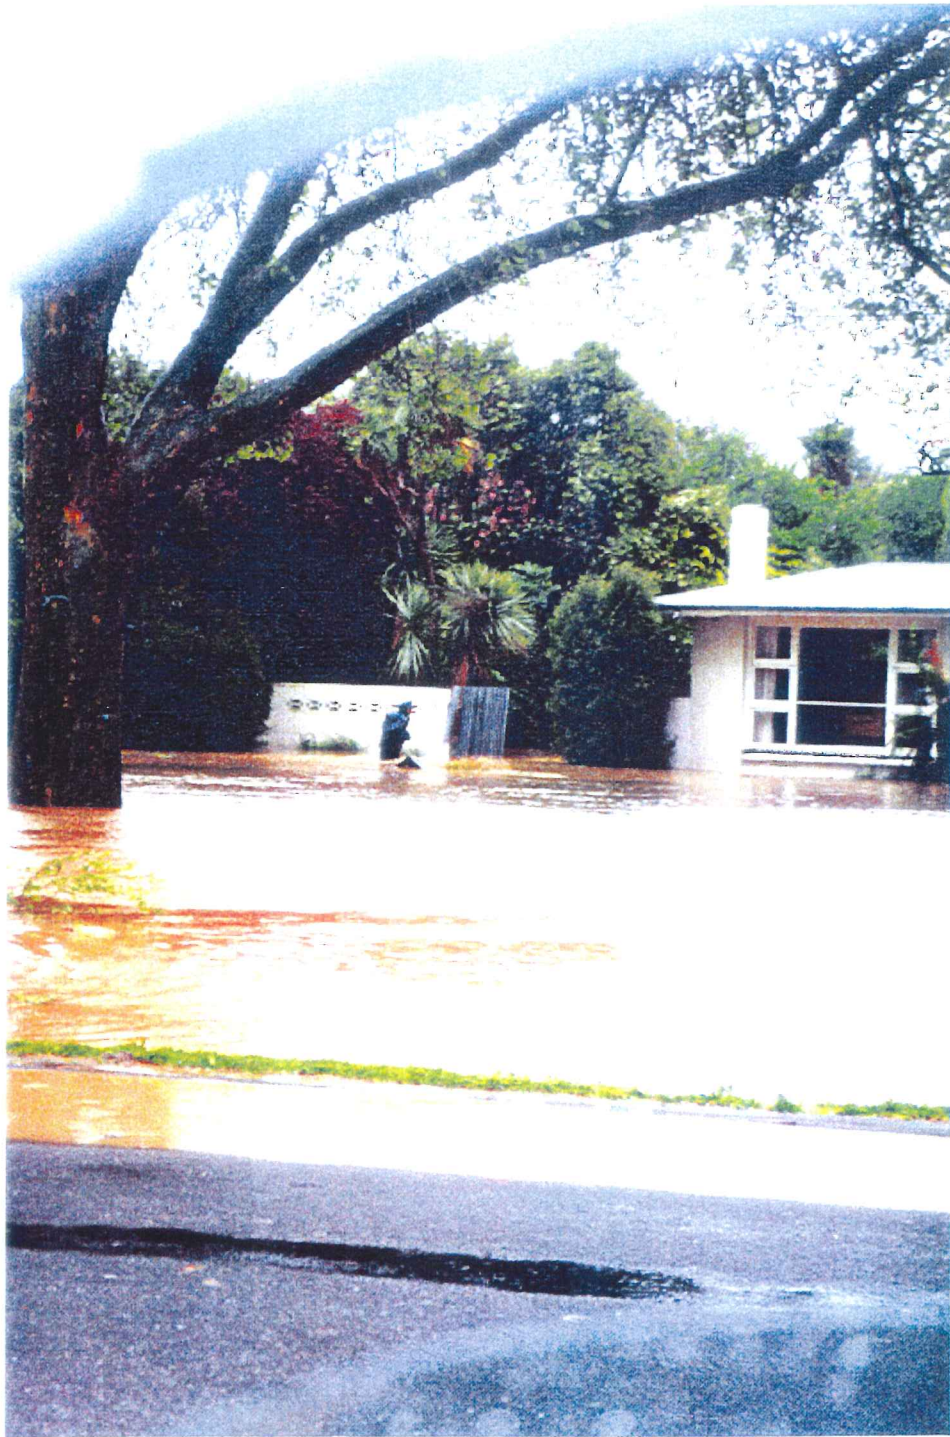
Heathcote River at Eastern Terrace downstream Bowenvale Avenue  
12 October 2000 at 1400 hrs

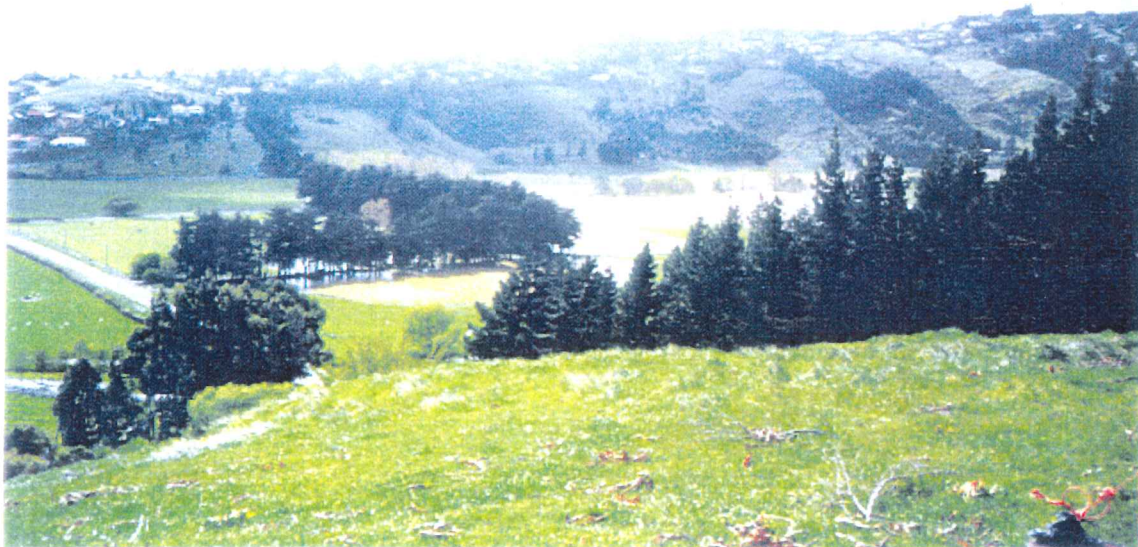
Cashmere/Wolsleys Basin 13 October 2000 at 1115 hrs  
(close to max W.L.)

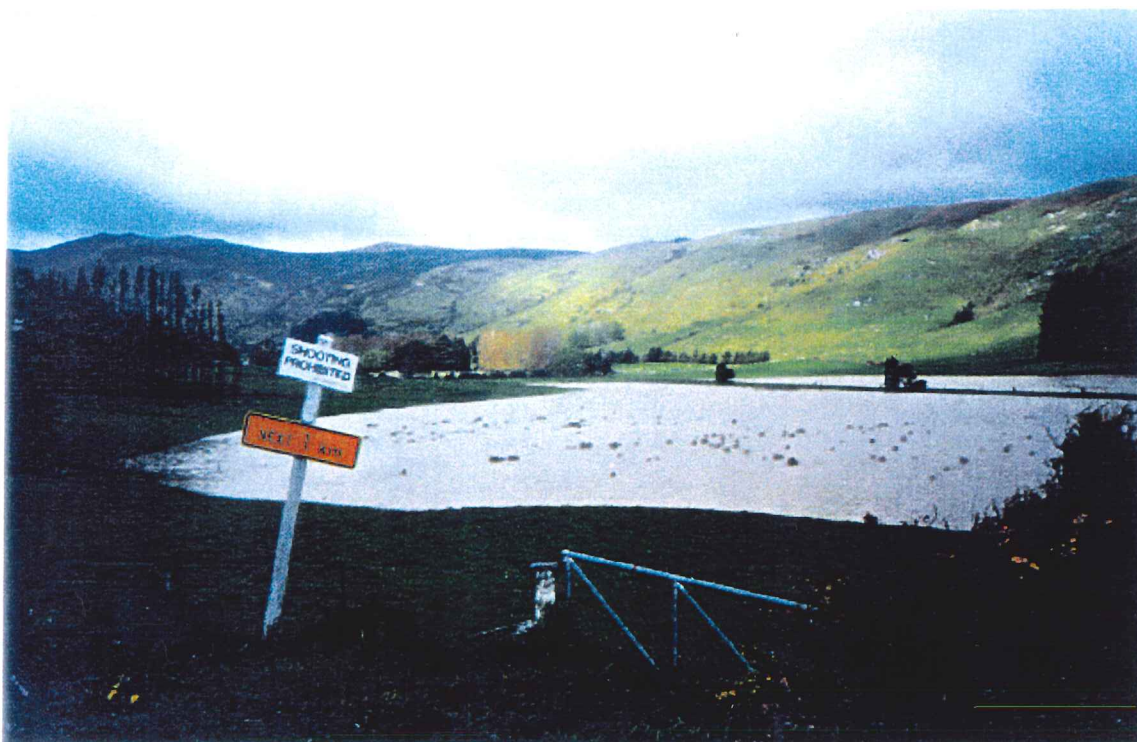
Hoon Hay Basin 13 October 2000 at 1215 hrs

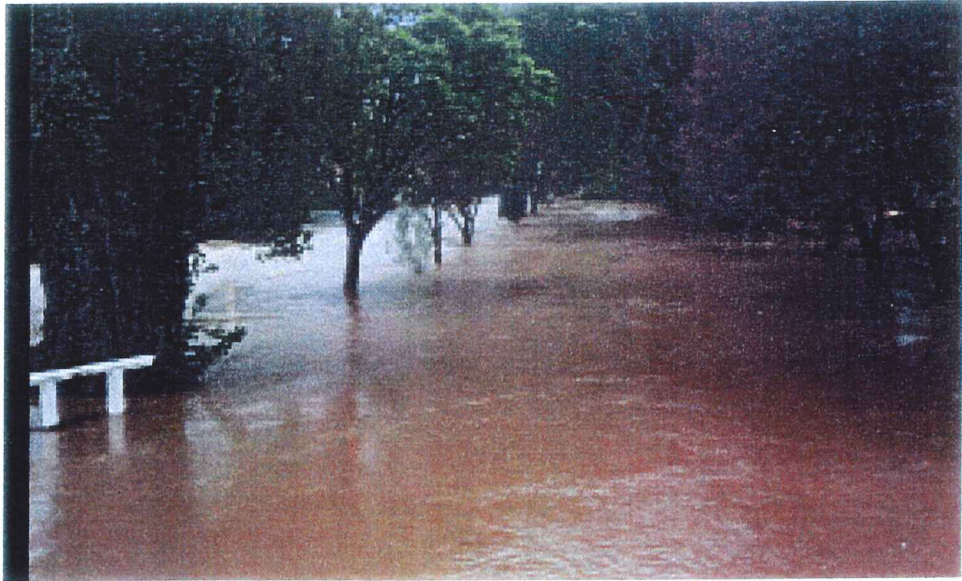
According to a flow gauging carried out on the Heathcote River at Buxton Terrace by Environment Canterbury staff at approximately 1pm on 12 October the observed flood water level was approximately 300mm higher than expected for the discharge calculated.

Fallen trees across the river downstream are considered to be the most likely cause for this elevation in flood level, however this conclusion needs to be confirmed by ongoing investigations. Alternative hypotheses are that the river bed level may have risen during the recent years, Environment Canterbury miscalculated the discharge or denser planting on the riverbanks over recent years has increased the 'roughness' of the flood channel.

Heathcote River at Buxton Terrace looking downstream  
12 October 2000 at 1630 hrs  
Staff gauge 12.7m

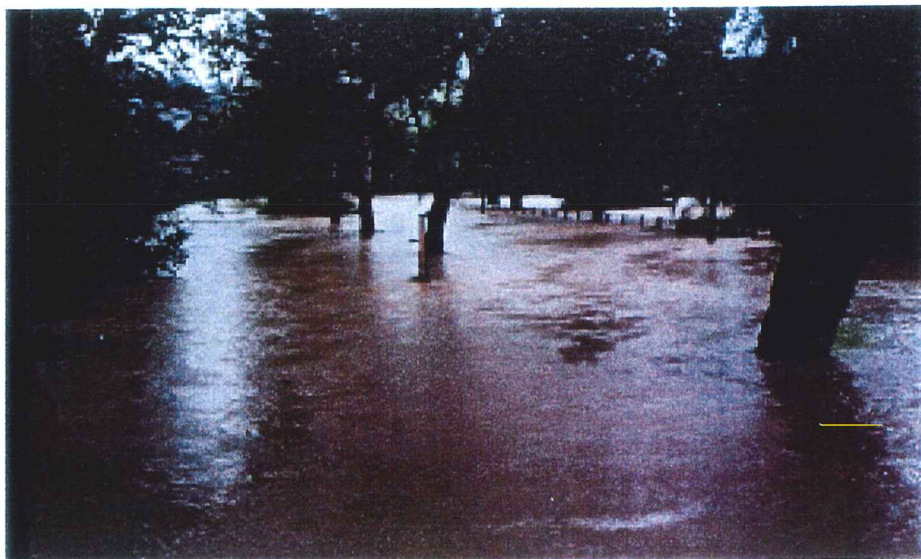
Buxton Terrace looking upstream

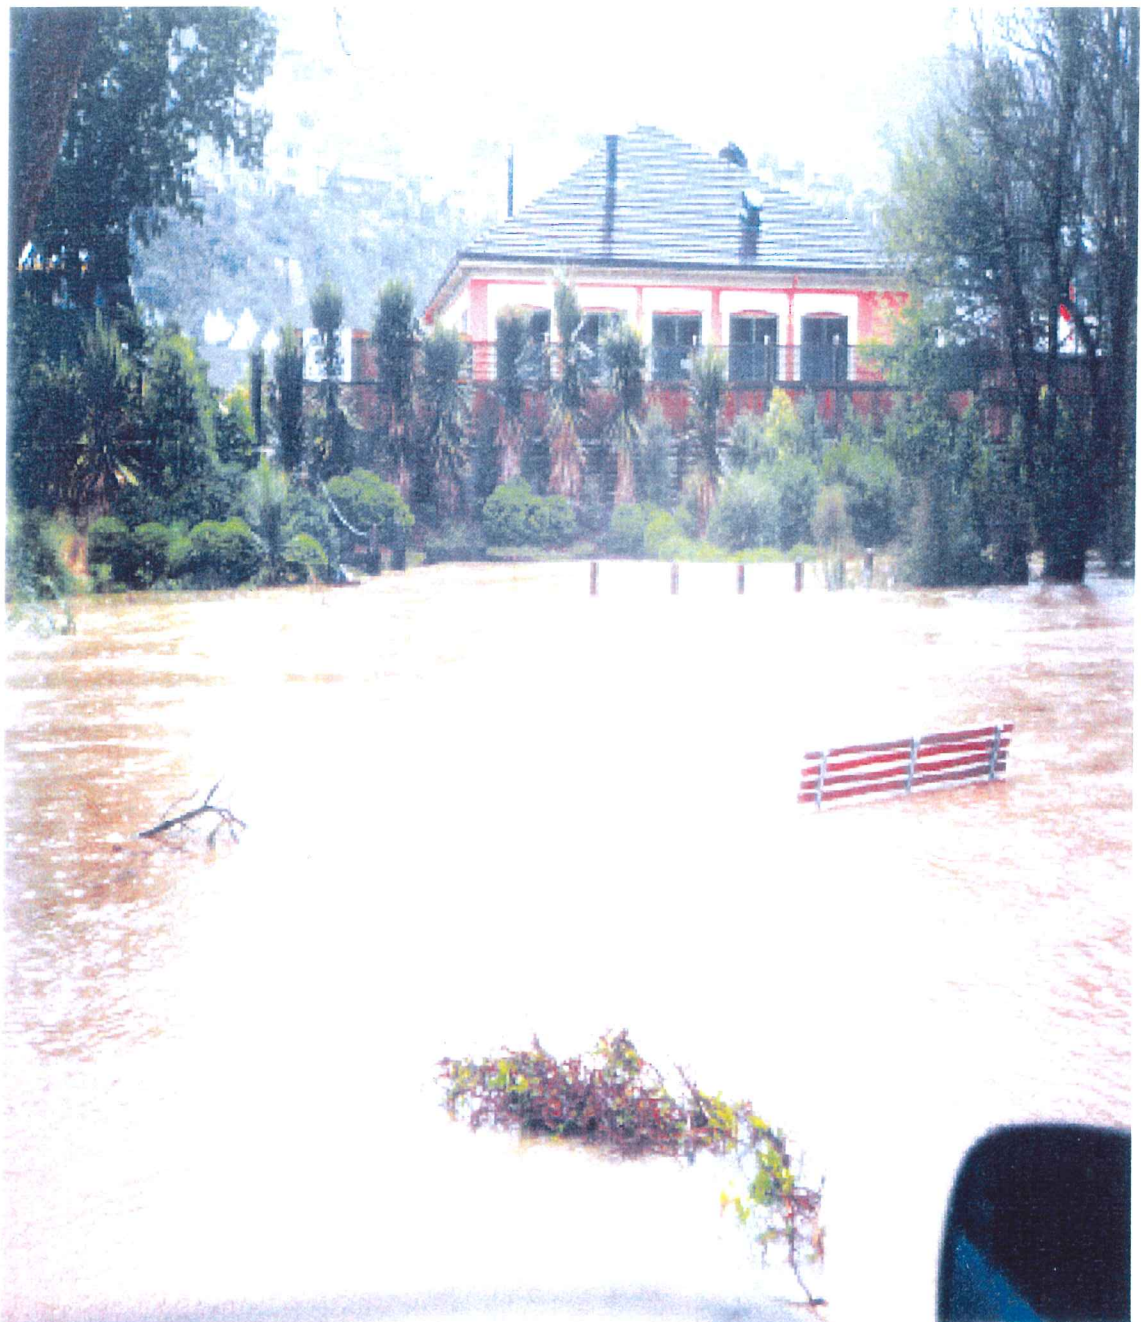
Heathcote River at Farnley Reserve  
12 October 2000 at 1400 hrs

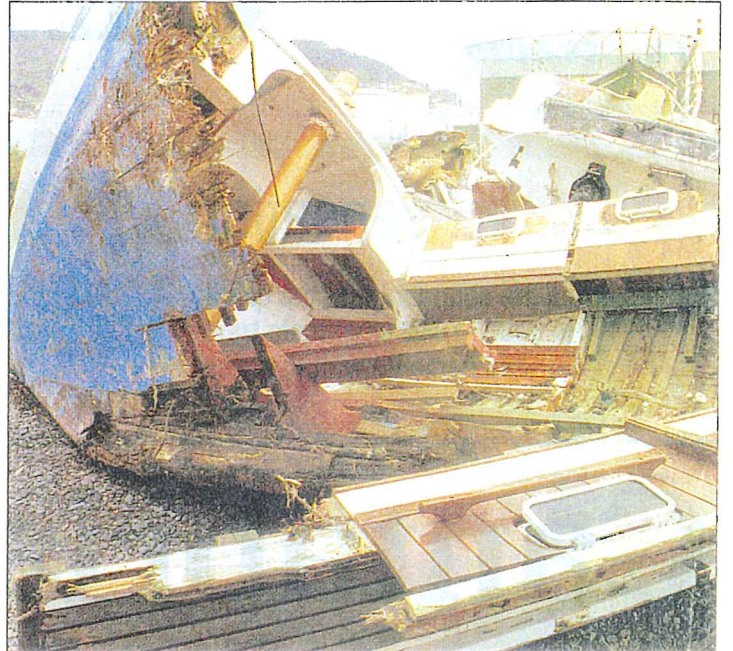
What remains of boats damaged in last month's storm lie in the Lyttelton marina. The insurance bill for boats that were lost or needing repair is between \$1.5 million and \$2 million.

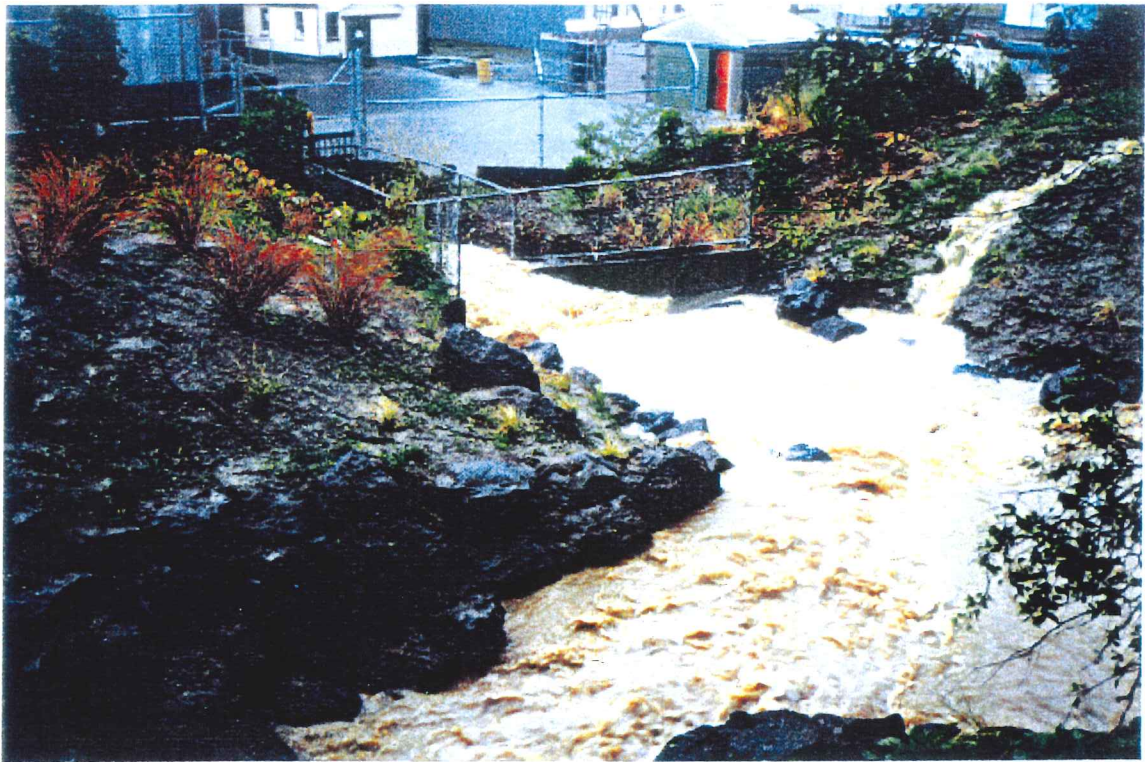
Typical hill waterway pipeline inlet conditions during the storm

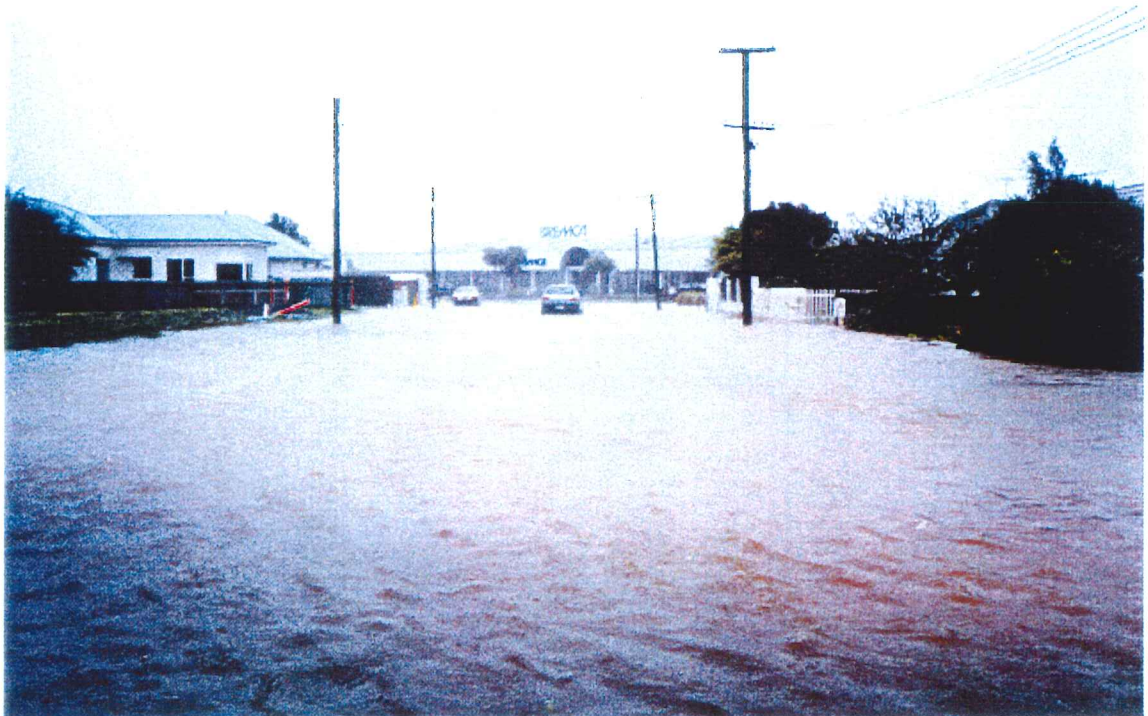
Street flooding, Kennedy Place, Opawa

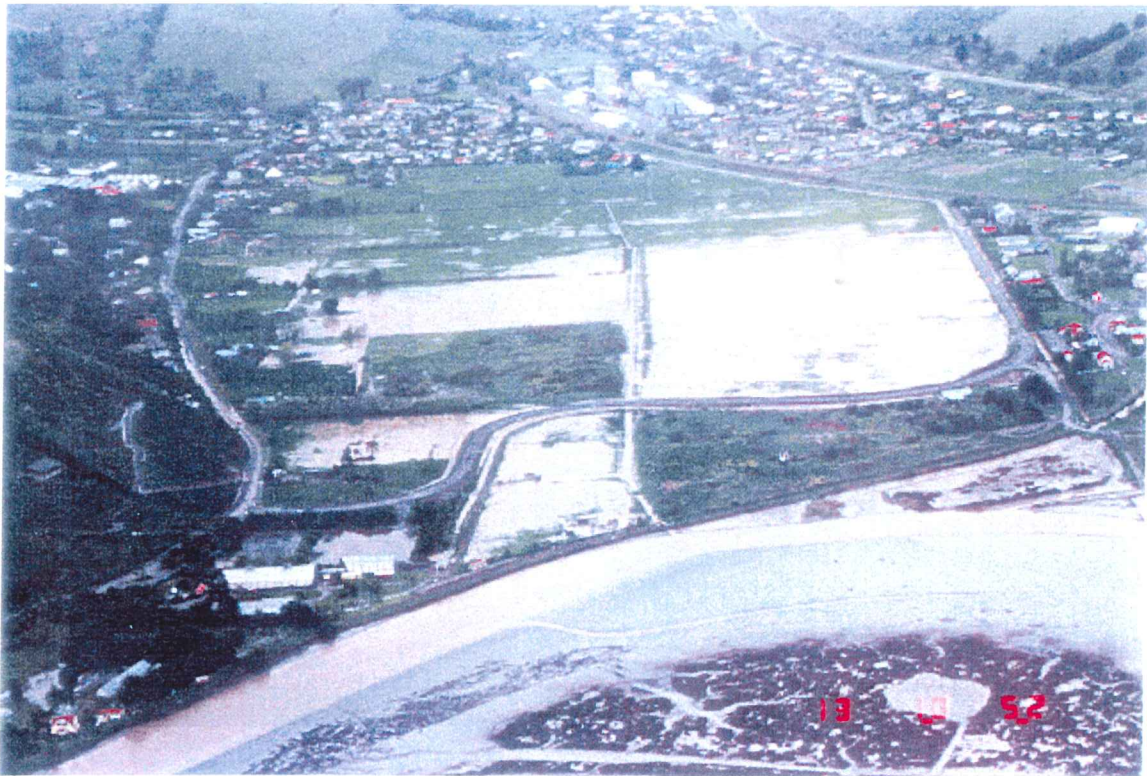
Heathcote River (foreground) and Heathcote Valley ponding (middle foreground)

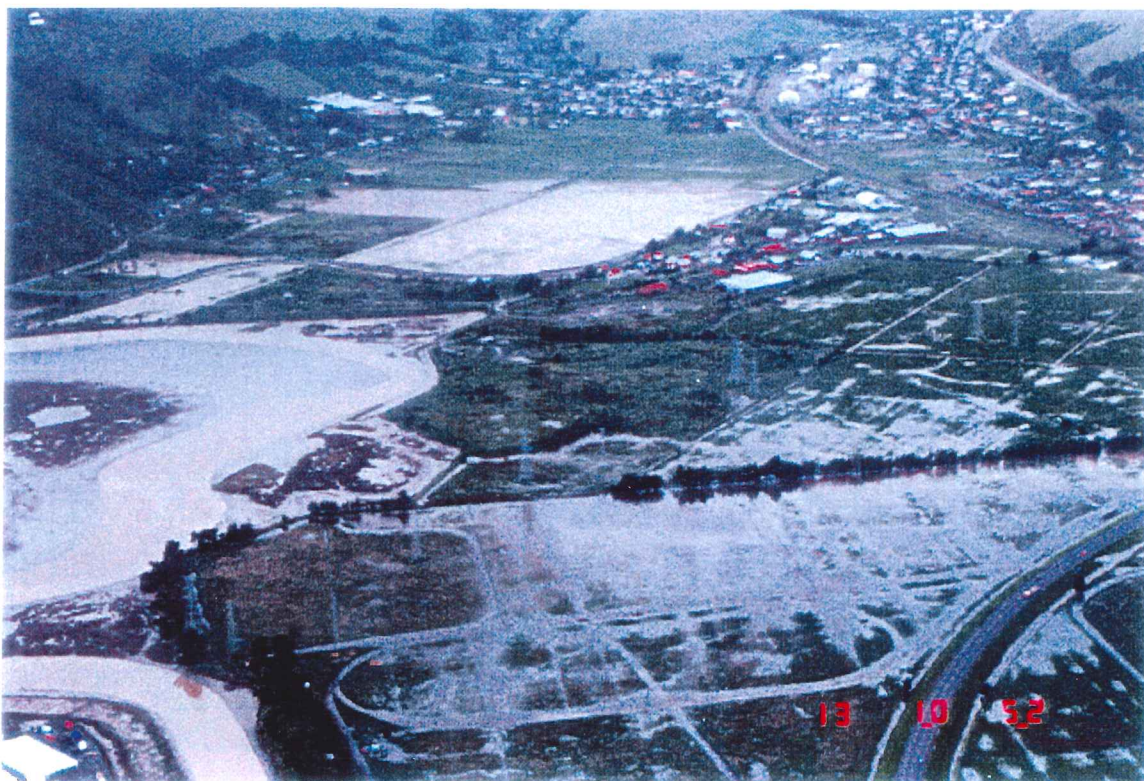
Ponding between Heathcote River and Tunnel Road,  
Heathcote Valley, 11am 13 October 2000

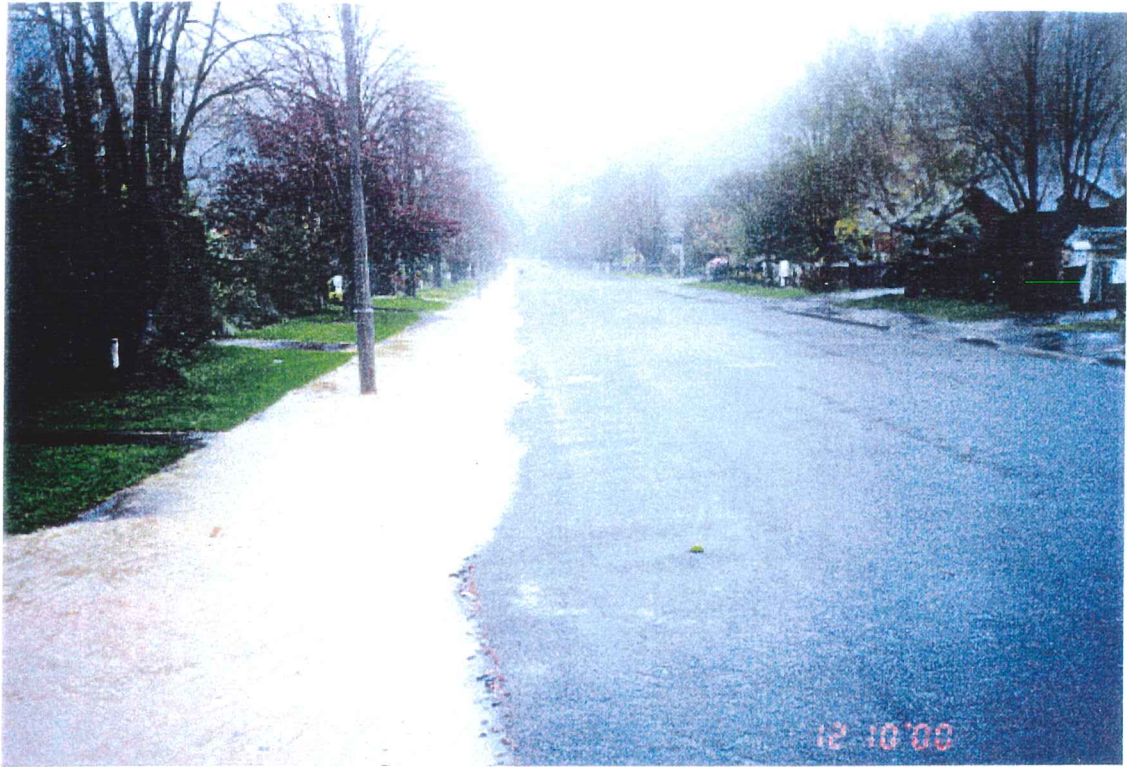
Secondary flow down Bowenvale Avenue, Sibleys Drain catchment  
12 October 2000

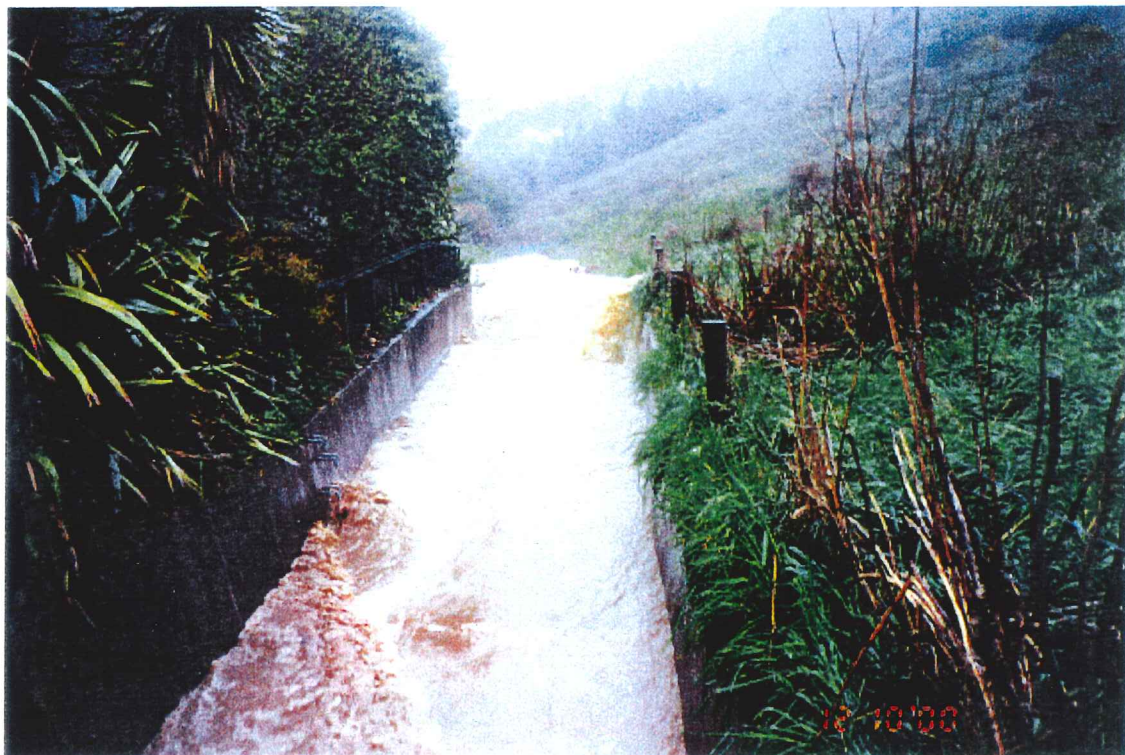
Sibleys Drain, Bowenvale Avenue below flume  
12 October 2000

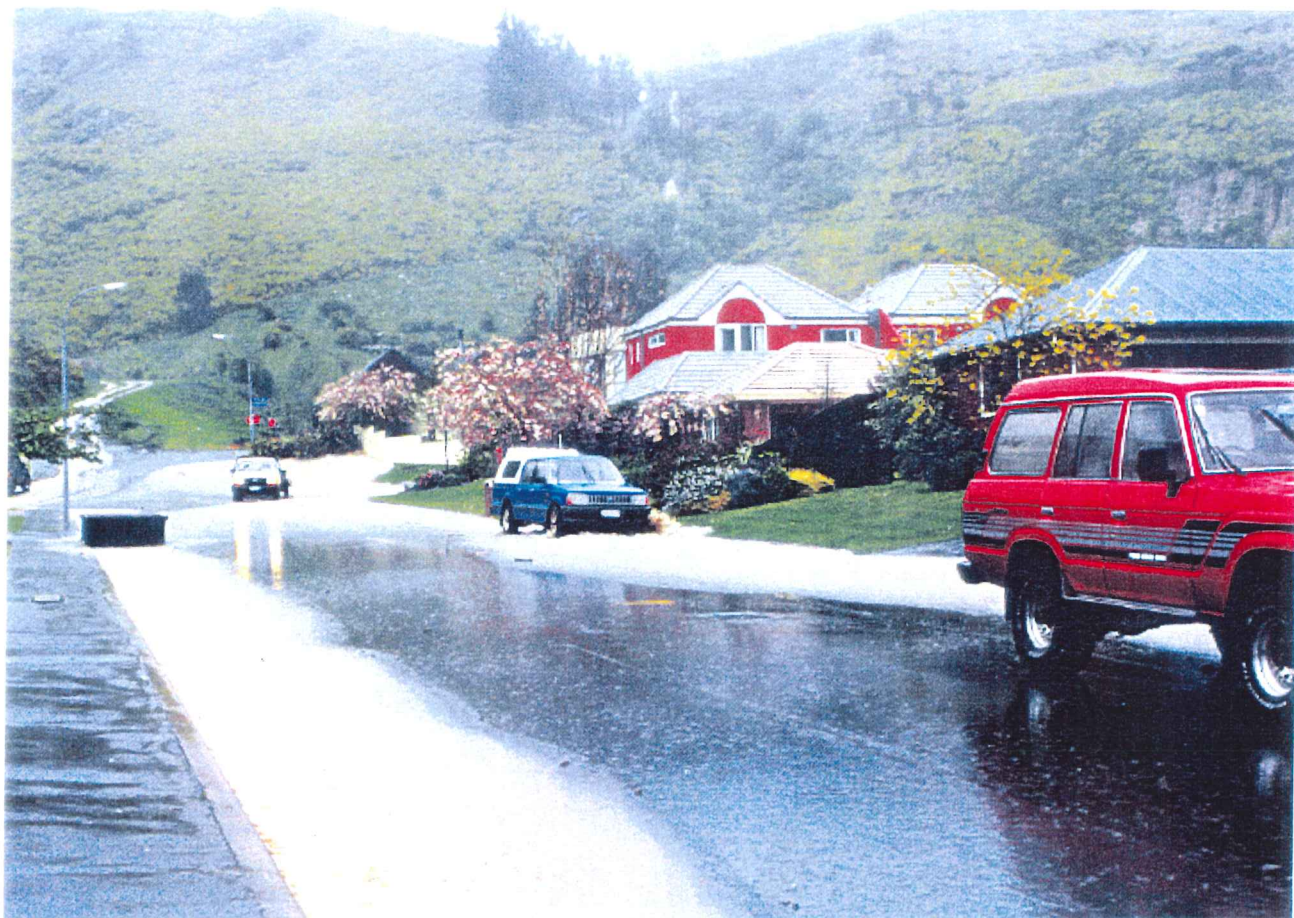
Alderson Avenue  
2pm 12 October 2000

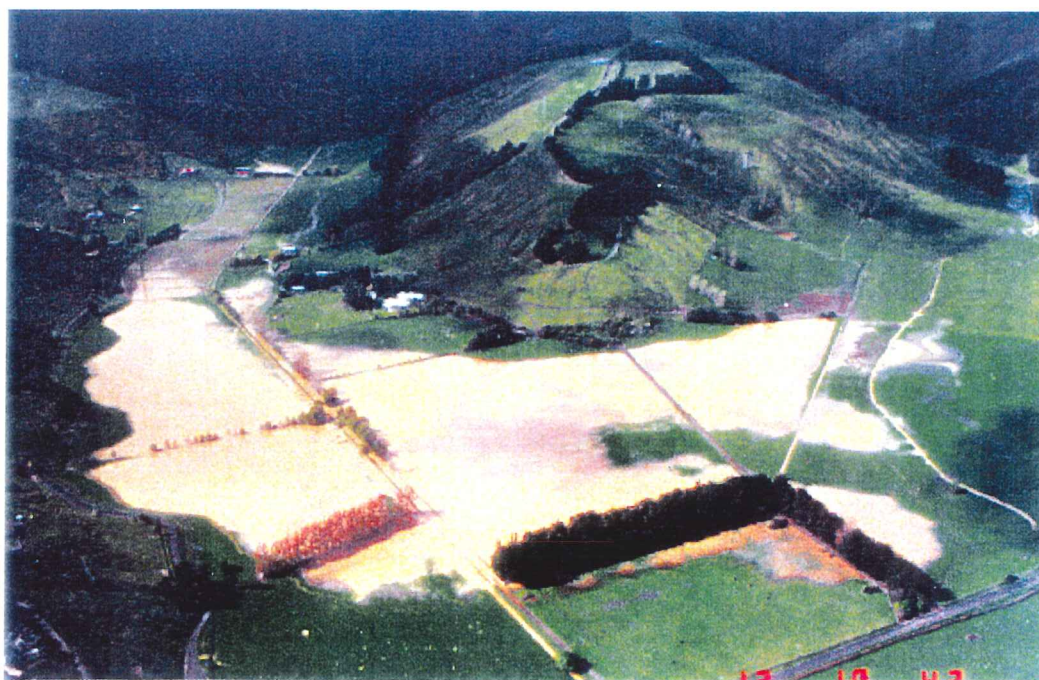
Cashmere and Worsleys Valleys ponding area  
10.45am 13 October 2000

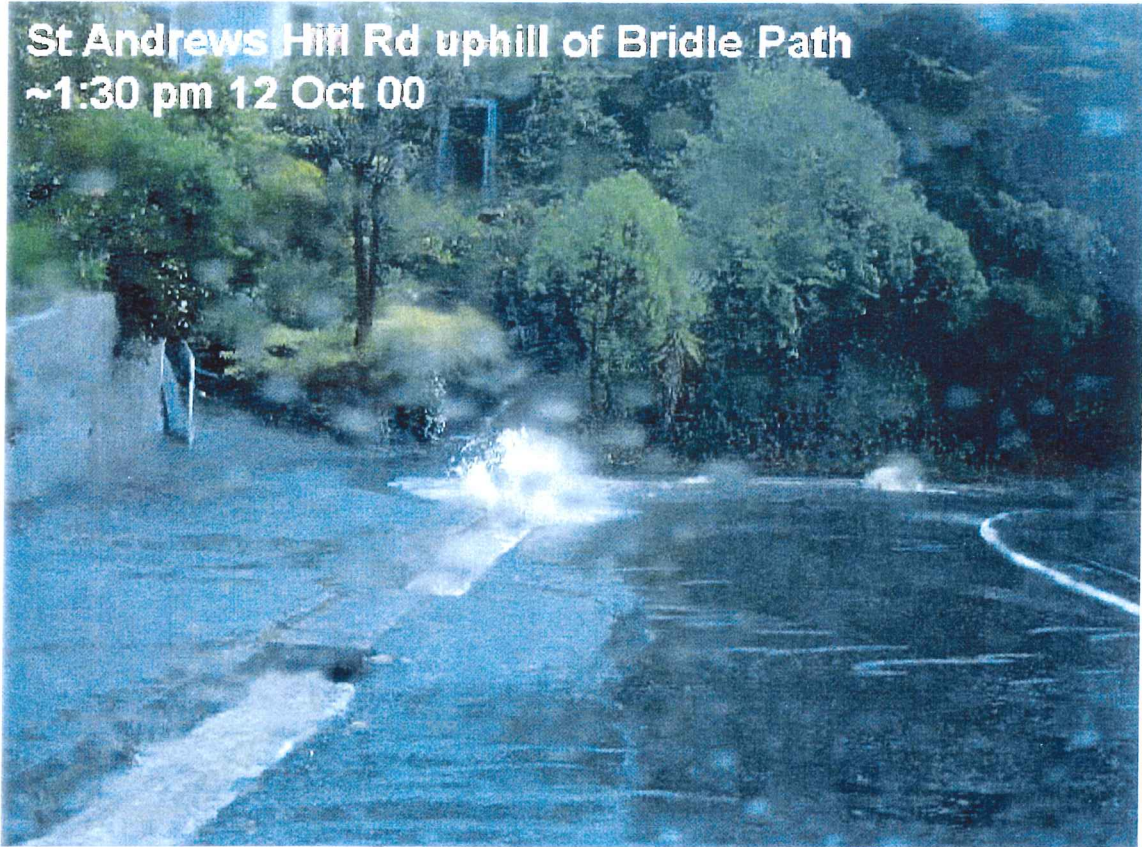
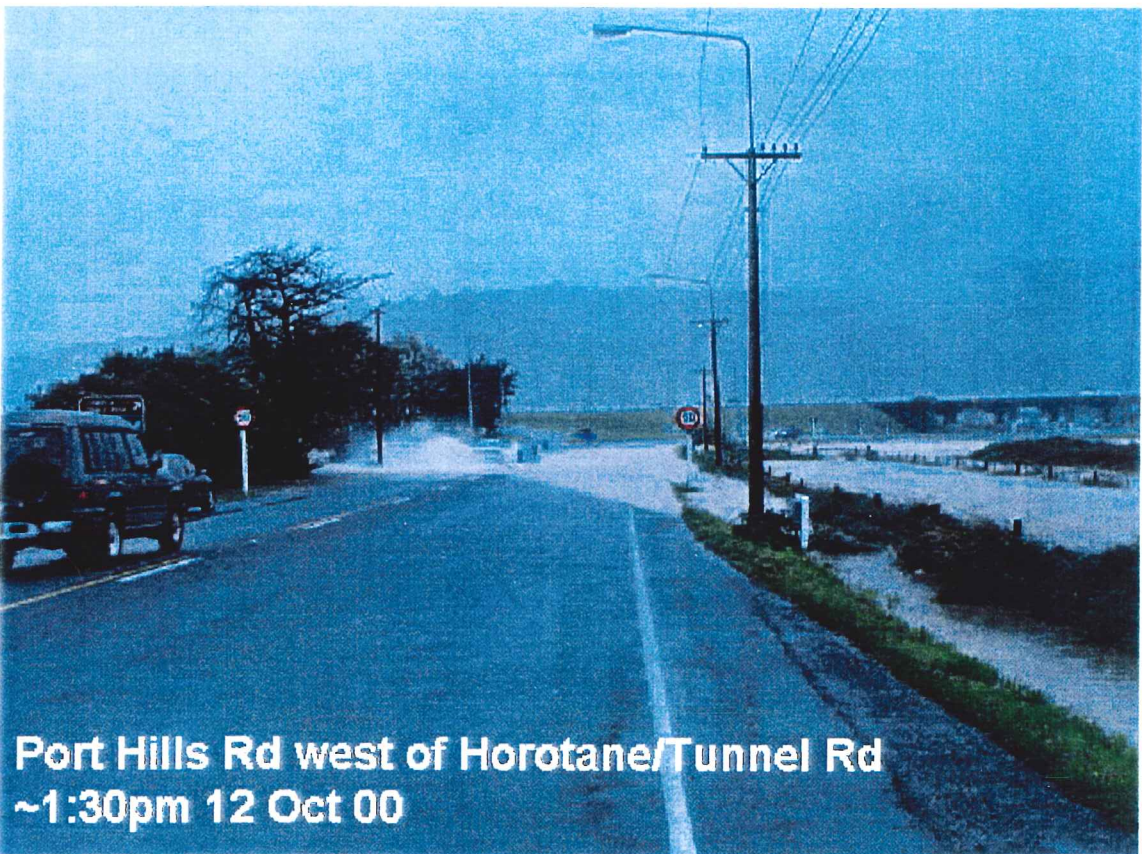
**Port Hills Rd west of Horotane/Tunnel Rd  
~1:30pm 12 Oct 00**
