**CHRISTCHURCH DRAINAGE BOARD****STORM ON 7 JULY 1986****1. INTRODUCTION:**

This report provides a general description of the storm which occurred on Monday, 7 July 1986, and its effect on catchments within the Board's district.

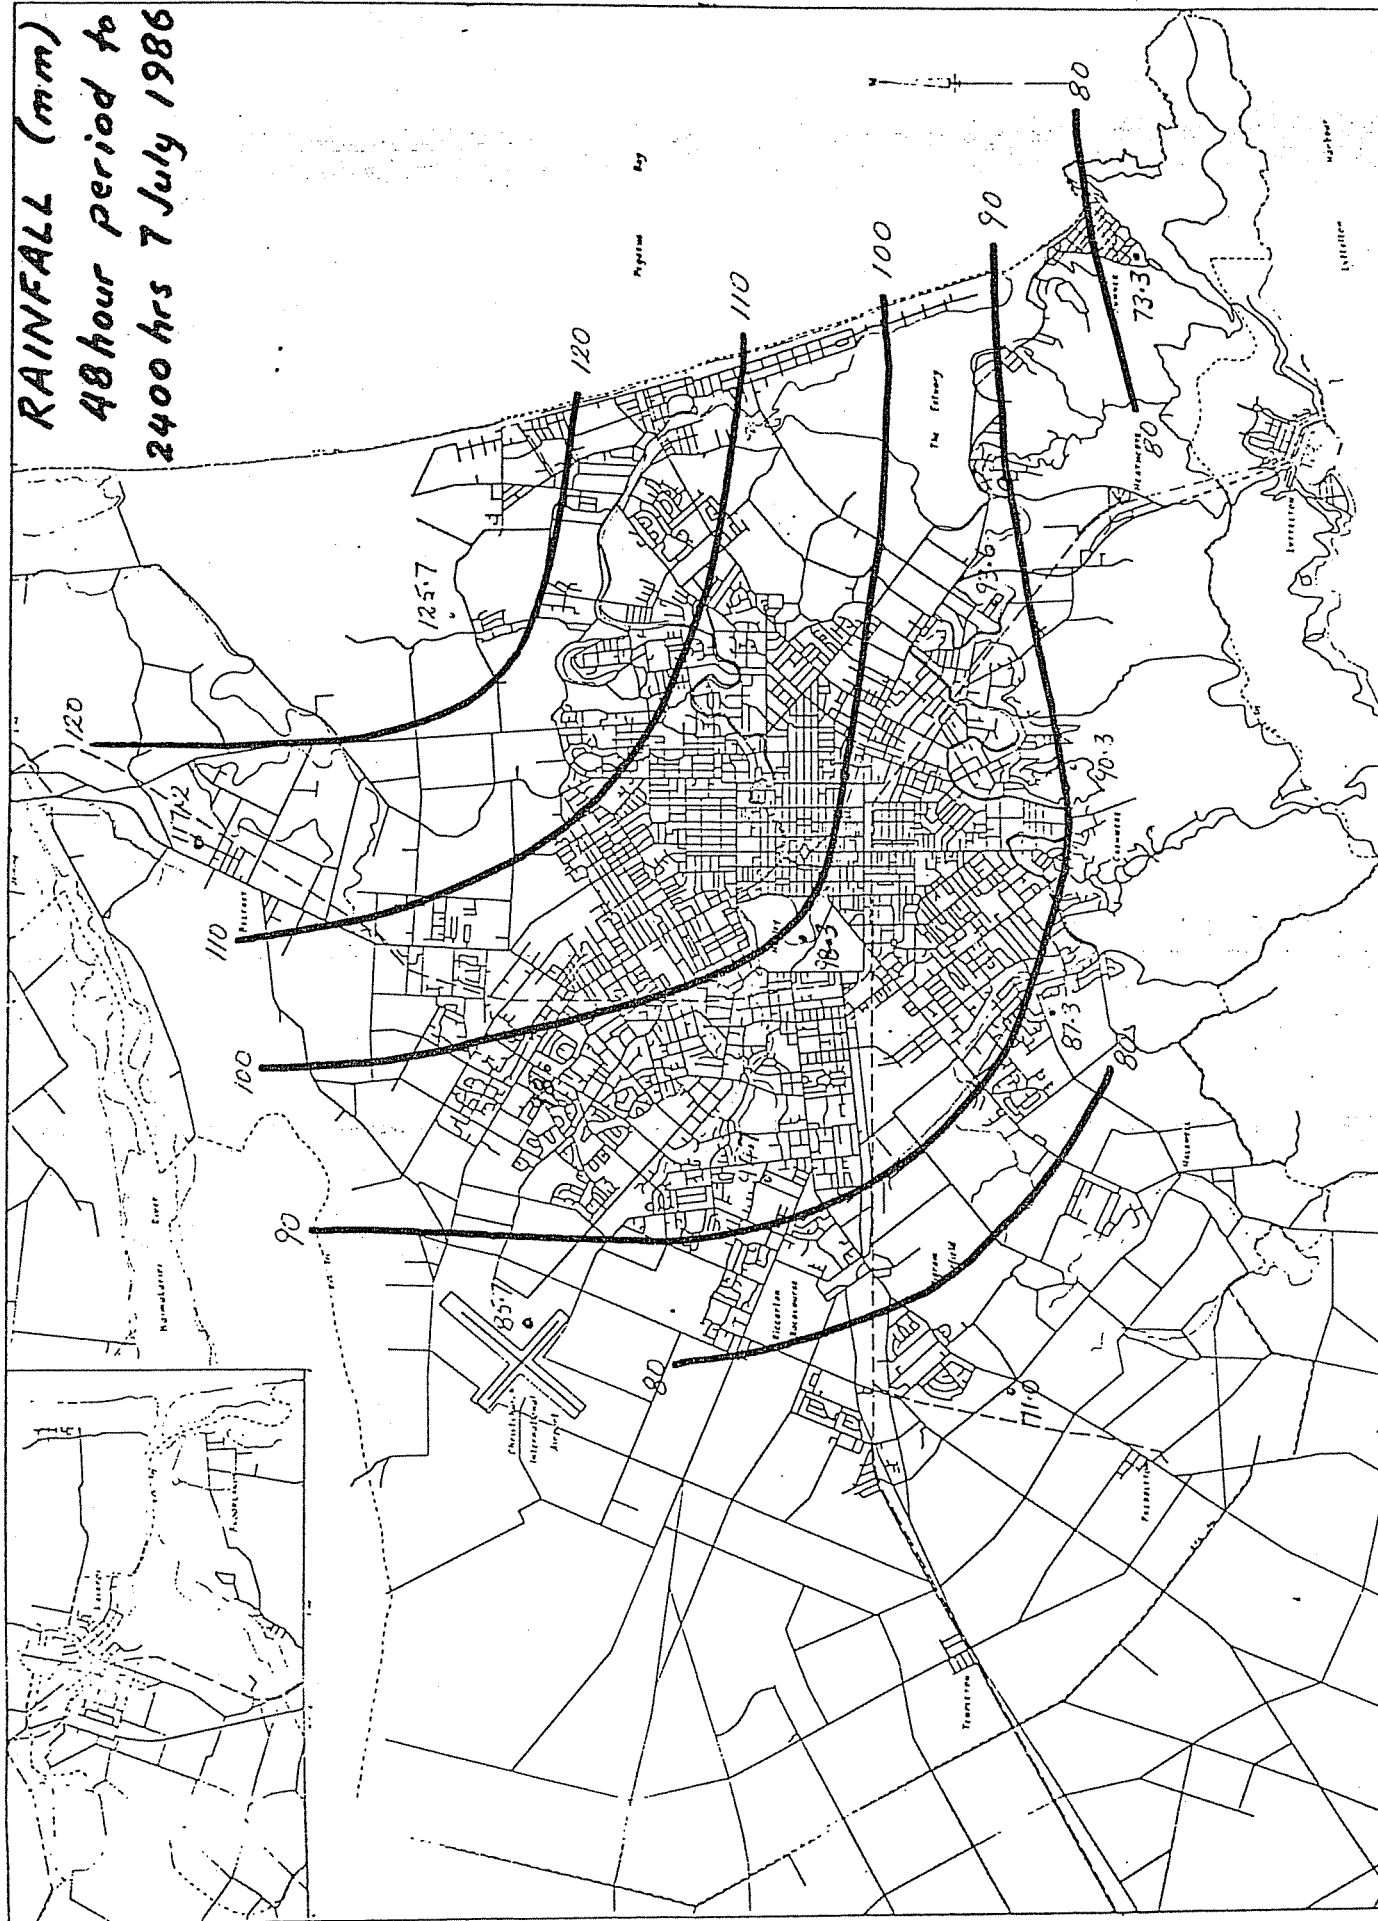
RAINFALL (mm)  
48 hour period to  
2400 hrs 7 July 1986

A rainfall distribution map is attached. High rainfall areas appear to coincide with the areas observed to have the worst flooding.

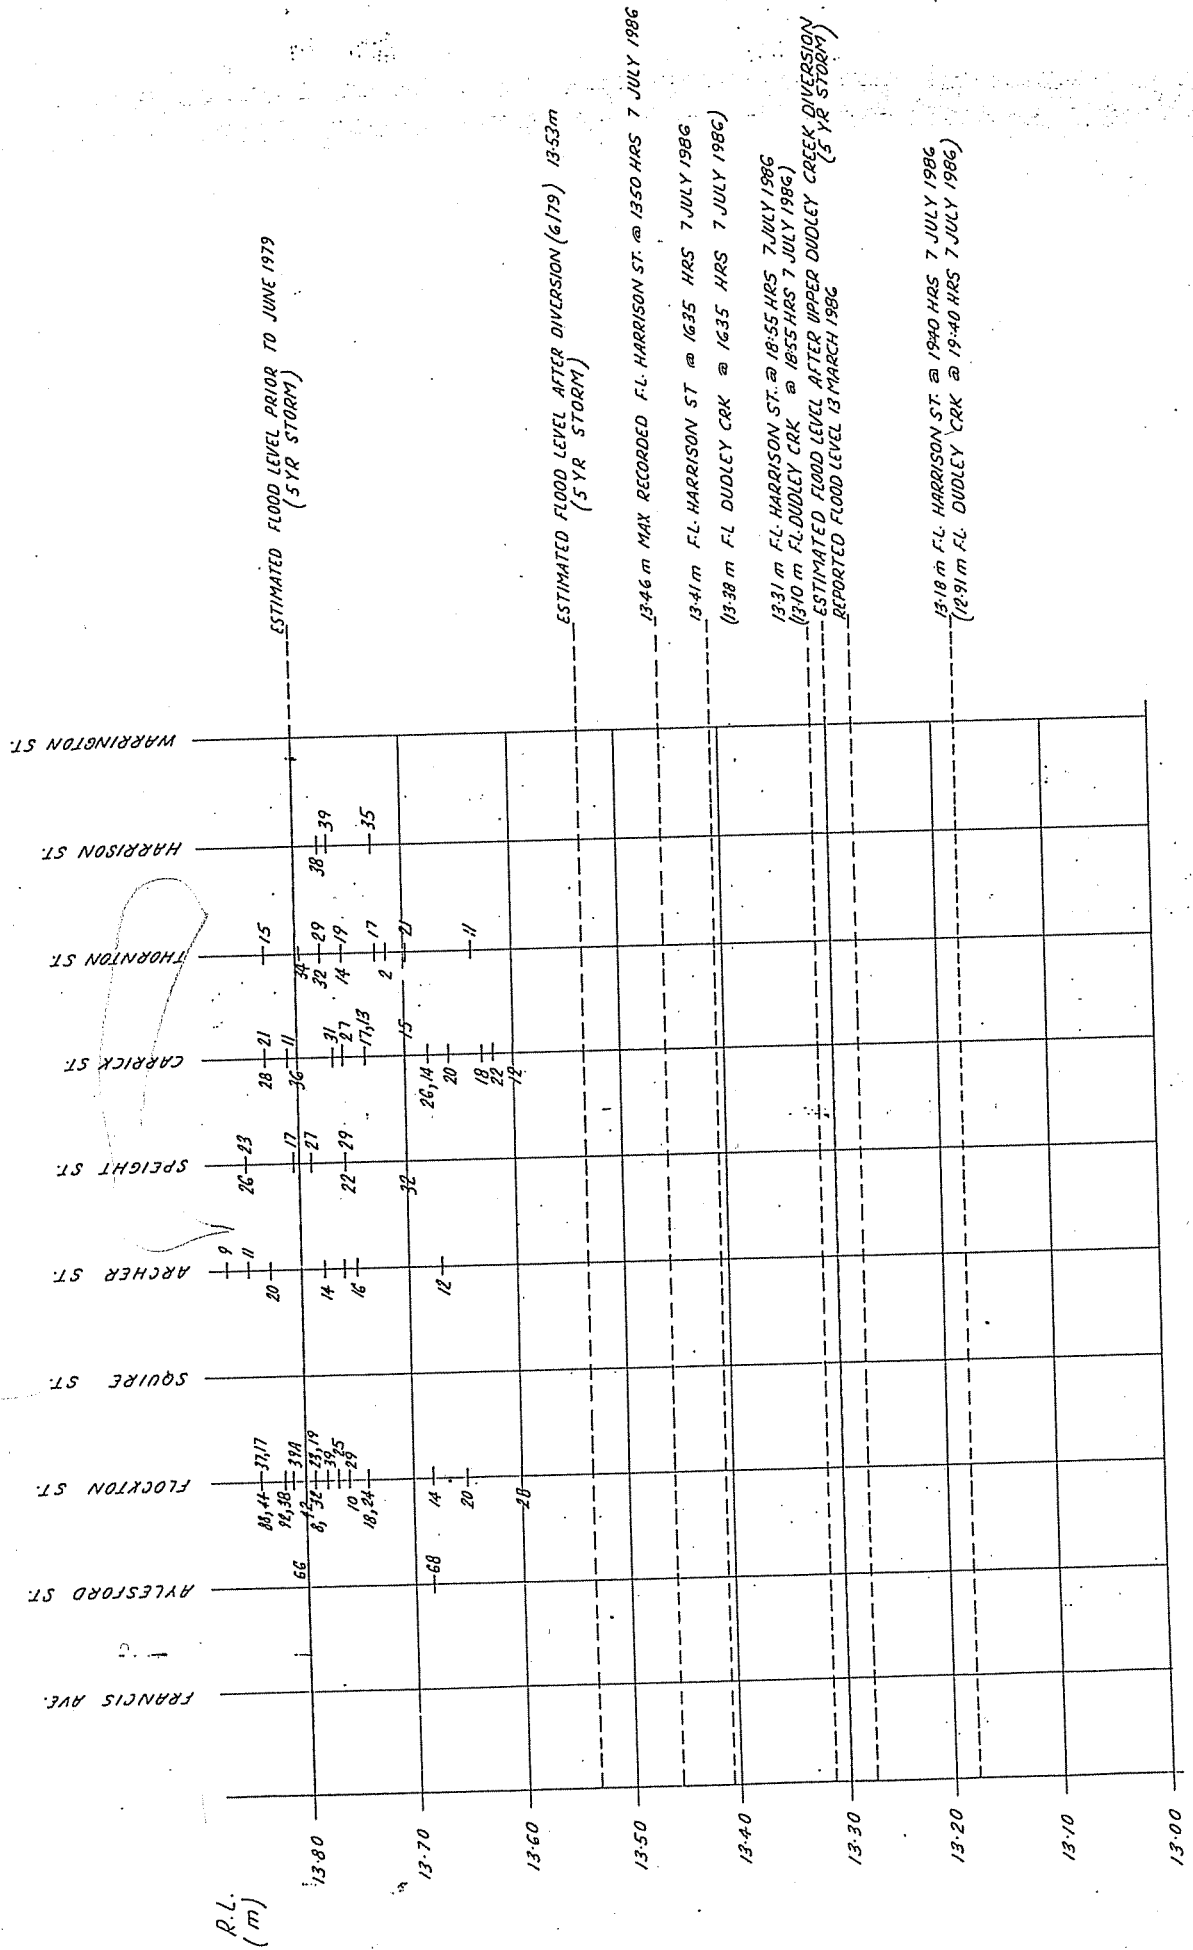
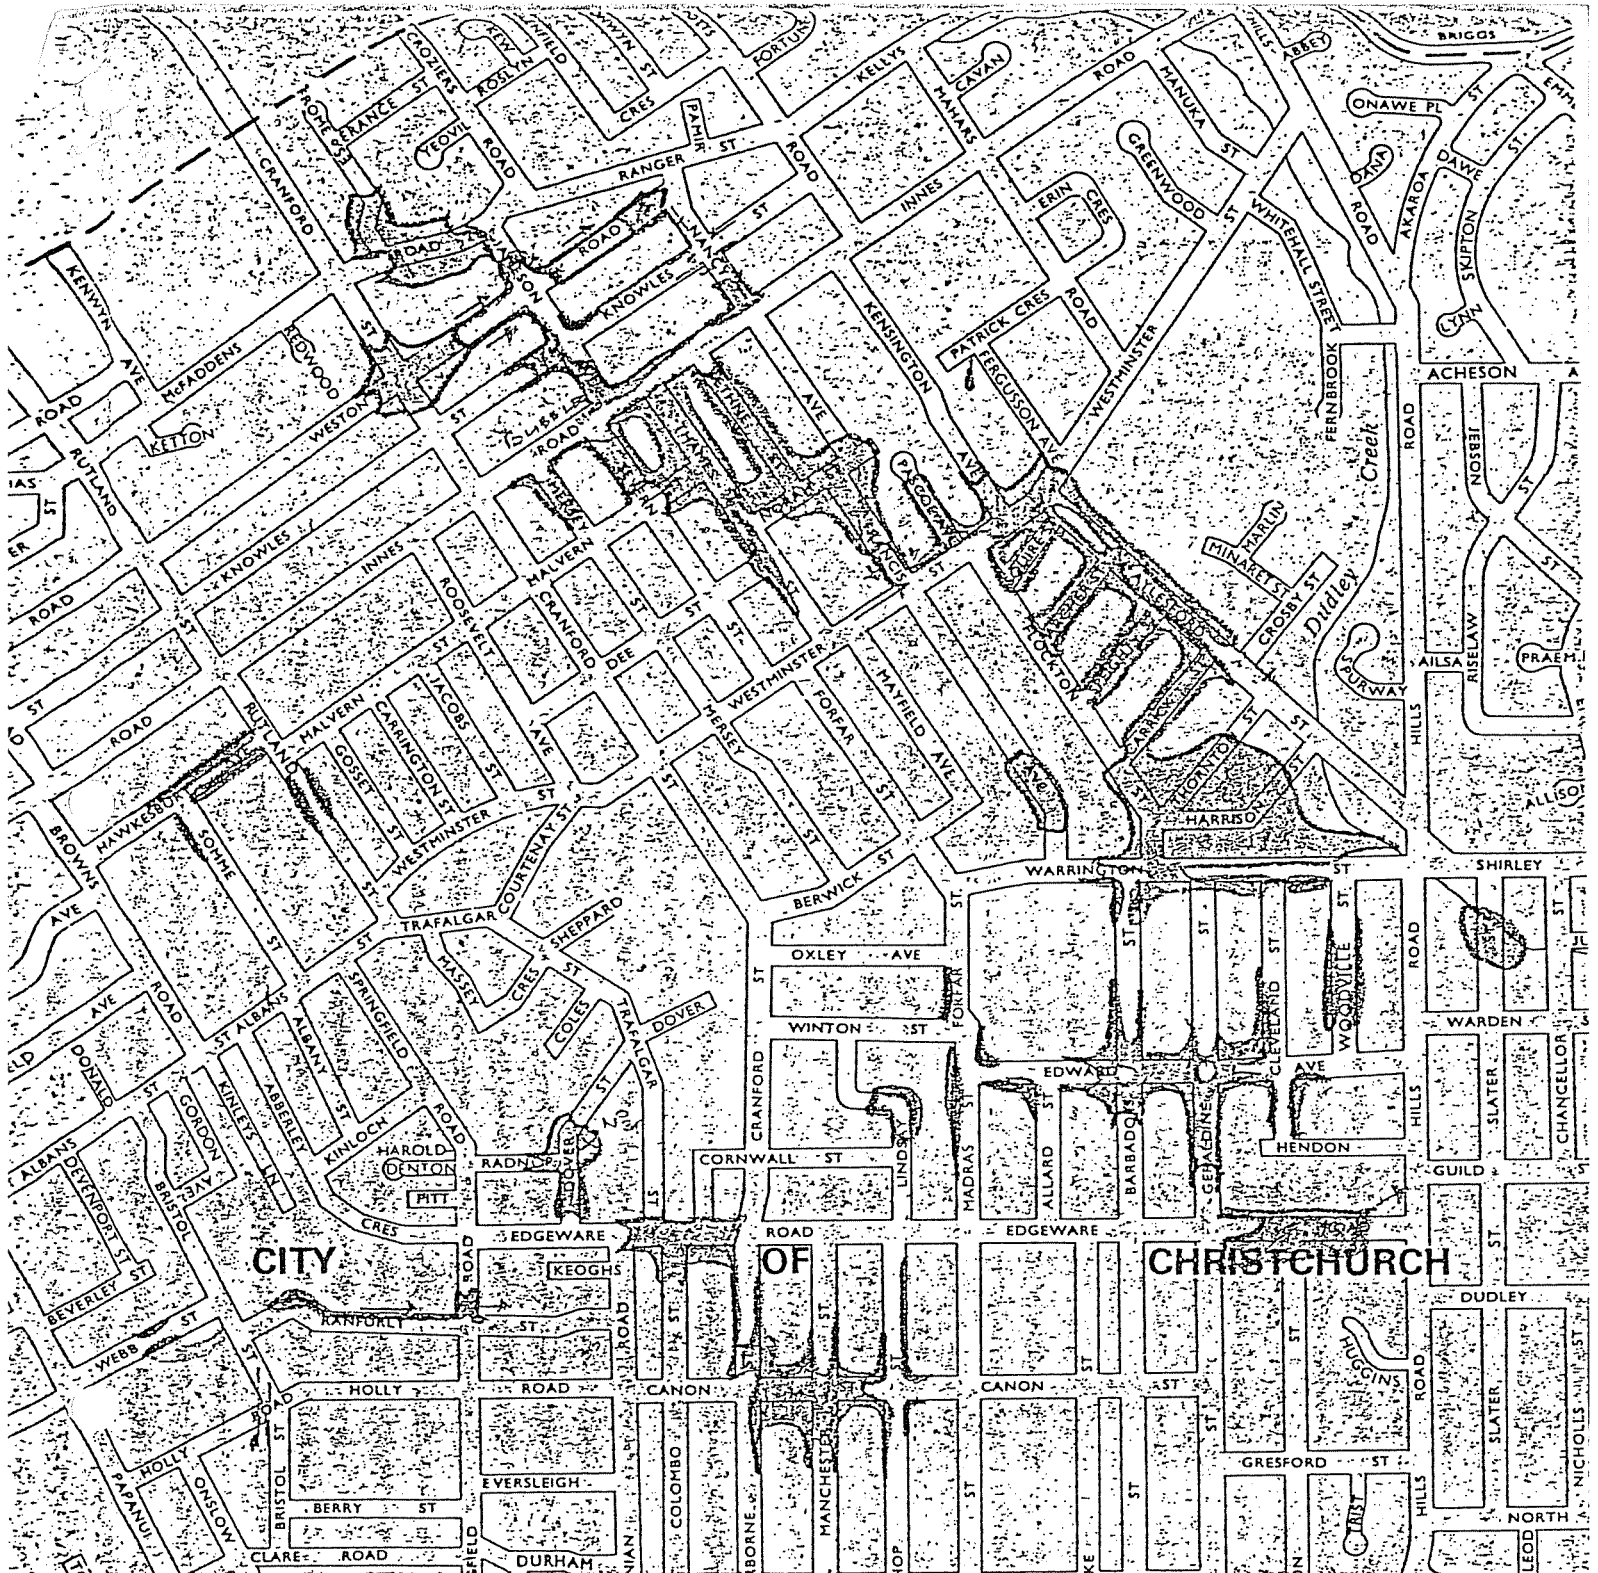
# FLOCKTON STREET BASIN

Most properties within the block from Aylesford Street to Flockton Street and Carrick Street to Warrington Street were flooded. Several houses were within 100 mm of having water enter them (see attached sheet which gives details of flood levels relative to house floor levels for the Flockton Street basin). Five houses were evacuated as a precaution against water levels rising and entering them.
