Structural Report to Accompany Assessment of Environmental Effects & Resource Consent Application

Quoin Structural Consultants Level 2, 138 Victoria Street Christchurch 8013 PO Box 25 438	Project	Harley Chambers & Worcester Chambers Buildings
Christchurch 8144 03 968 4925 quoin.co.nz	Client	Lee Pee Limited
	Address	137 Cambridge Terrace, Christchurch & 69 Worcester Boulevard, Christchurch

13 December 2017

Harley Chambers Building, 137 Cambridge Terrace, Christchurch & Worcester Chambers Building, 69 Worcester Boulevard, Christchurch

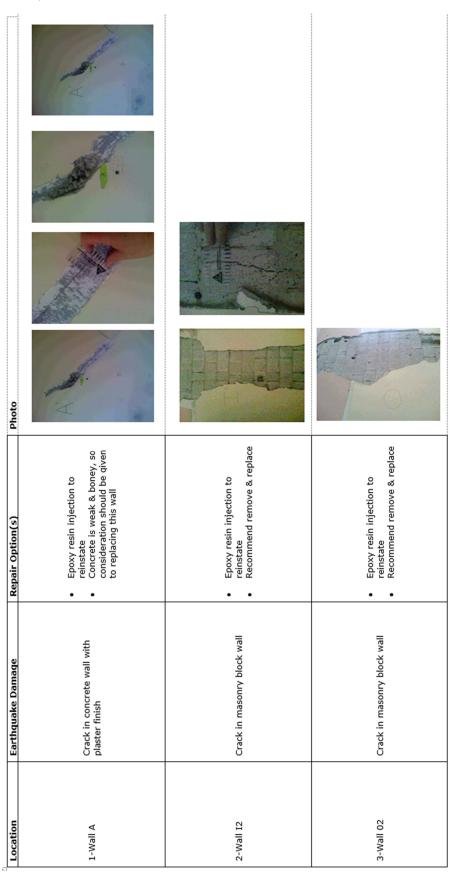
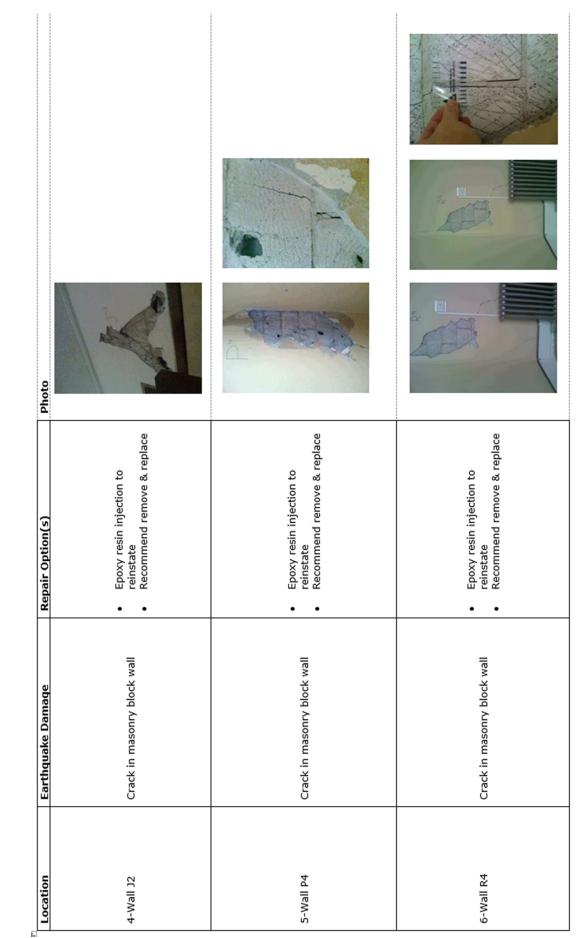
Appendix B: Summary of Earthquake Damage to North Section of Building

The building has suffered significant earthquake damage as summarised in Appendix B and D. Most of the significant damage occurred to the superstructure in the north section of the building together with differential settlements across the full footprint of the building.

(a) The unreinforced brick walled lift shaft suffered significant damage above the roof level and was subsequently temporarily secured following the 26 December 2010 earthquake and then deconstructed following the 22 February 2011 earthquake.

- (b) Differential settlement of the foundations across the full footprint of the building, with some severe settlement occurring at the north-east corner of the building. This may be due to some liquefaction occurring in subsoil layers and/or the result of a spring being activated near this corner due to the earthquakes.

- The construction joint between the north and south sections of the building has suffered differential movement that has caused a 10-20mm gap to open up along the line of the joints over the full height of the building.

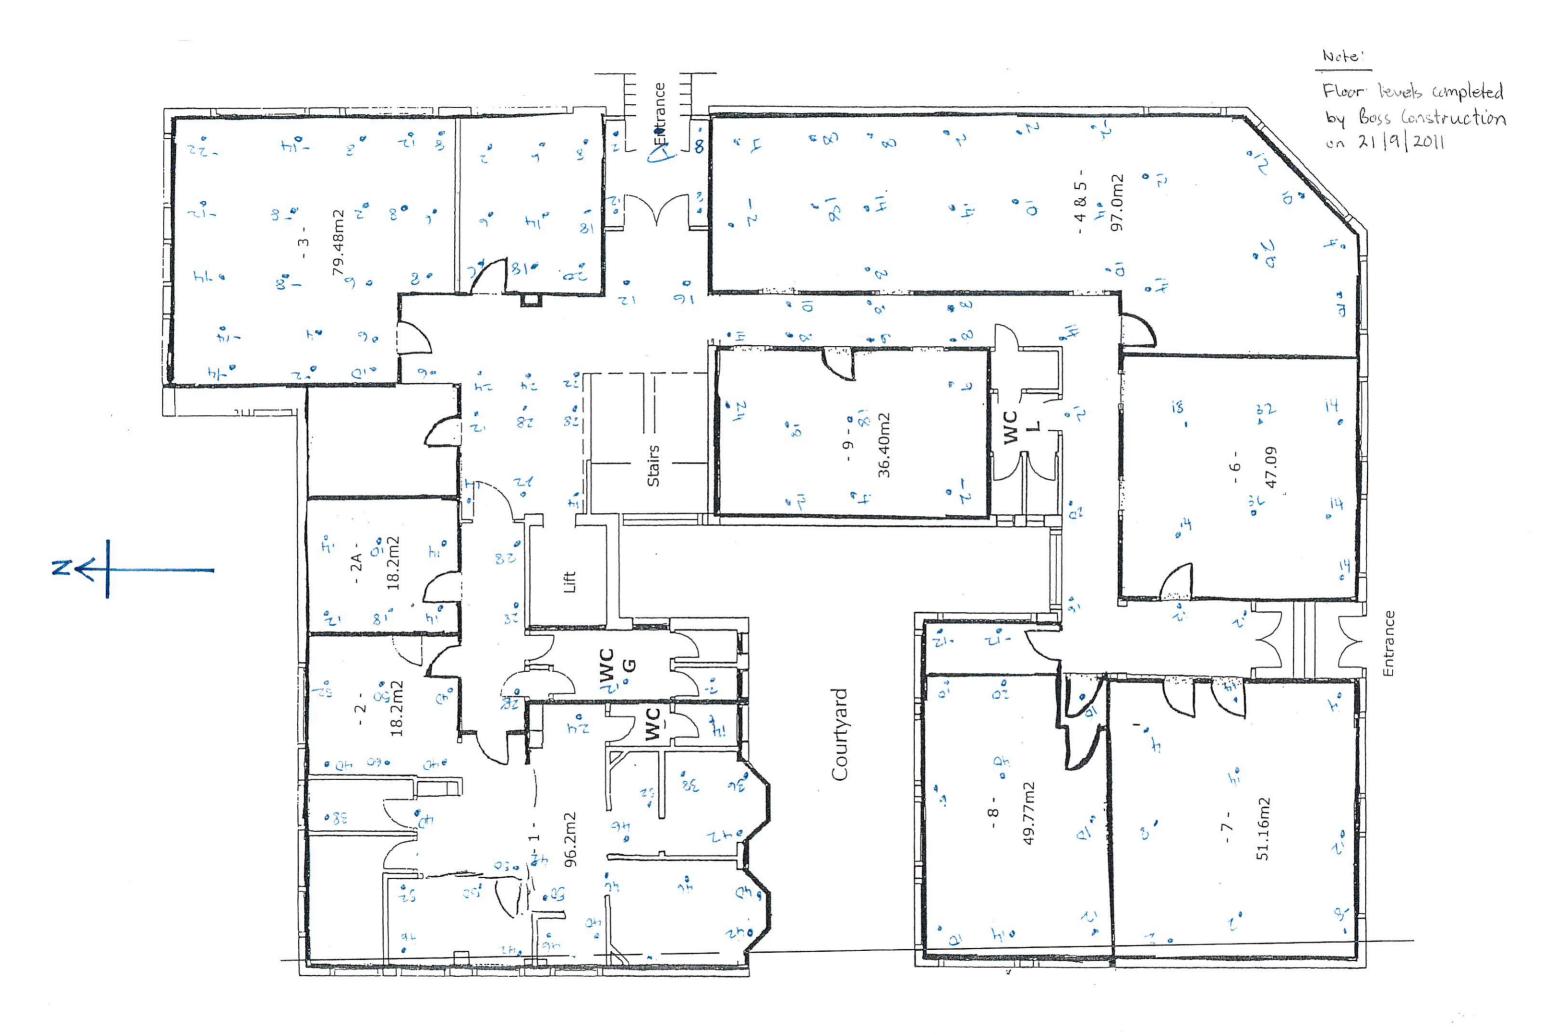
1000	Project
Floor Levels on Existing Ground Floor Plan	SK8	10490
5		0
Drawing Title	Drawing No.	Issue

- A floor level survey of the first and ground floors to both the north and south sections of the building. (Refer Appendix C).
 - Removal of some of the carpet floor finishes in the north section of the building to review the cracks in the ground floor suspended concrete floor slab over the north side of the basement.

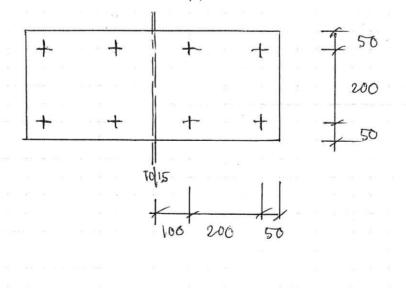
project	HARVEY CHAMBERS	date	24-7-2015	-	Q Quoin
file	12088	by	btte	ref	SKRI 8

(iv) Remove loose plaster bricks etc in vertical separation gaps between North & South buildings. Connection detail between the two will require more detailed investigation and design. For pricing purposes a suggested connection system is to use 150 x 150 x 10 steel angles or 300 x 10mm steel flats, each 300mm long with 4 – 18mm dia holes for M16 bolts to be epoxy fixed into either side of the gap, that is into either building half. It is estimated three such connections at each wall join for each floor plus at least two such joins into the parapets. That is approx 40 such connections in total.

above proposed repairs: (a) Use 300×10mm steel thats, each <u>700mm</u> long. The

additional length is to ensure suitable edge distance to the bolts, plus have 4 bolts each side of joint

- (b) Bolts to be epoxied 200mm into concrete beams and columns. Use Hilti RE500. At locations where bolts coincide with the floor stabs and not the beam, extend bolt through stats and provide 30×80×6 washer and nut
- (c) Allow to recess the sheel plates into the concrete and have top of bolts flush with theor slabs or column/beam face. Recess approximately 30mm, typical, Growt fill recess.
- (d) Further to (b) & (c) above, estimate that have: 16 into columns (including parapet piers) 24 at edge beam / floor slab
- (e) Allow to remove and remotete roof cladding and membrane, and remotate at roof level.
- (f) The following copy of lan Harrison & Assoc estimate to be updated for the above Quoin adjustments

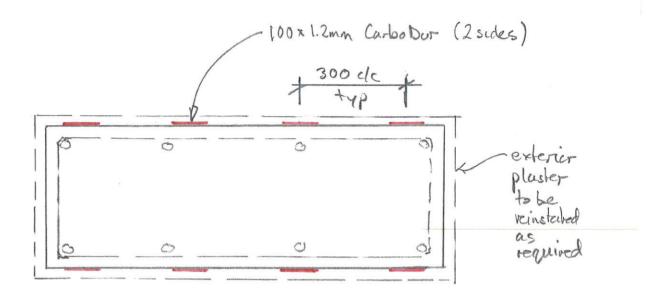
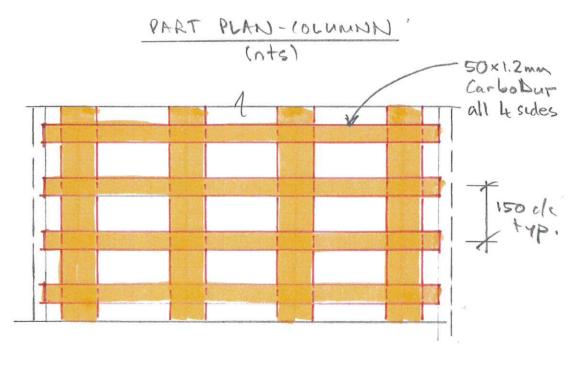
PERIMETER COLUMN STRENGTHENING

- (d) The unreinforced brick walls to the lift shaft above the roof level were a critical structural weakness and subsequently removed.
- (e) In its current state, the north-east corner column that has suffered severe cracking damage and is a critical structural weakness.
