HARLEY CHAMBERS

**137 CAMBRIDGE TERRACE
CHRISTCHURCH**

HERITAGE IMPACT ASSESSMENT

Report Prepared by
SMART ALLIANCES LTD
for
LEE PEE LTD

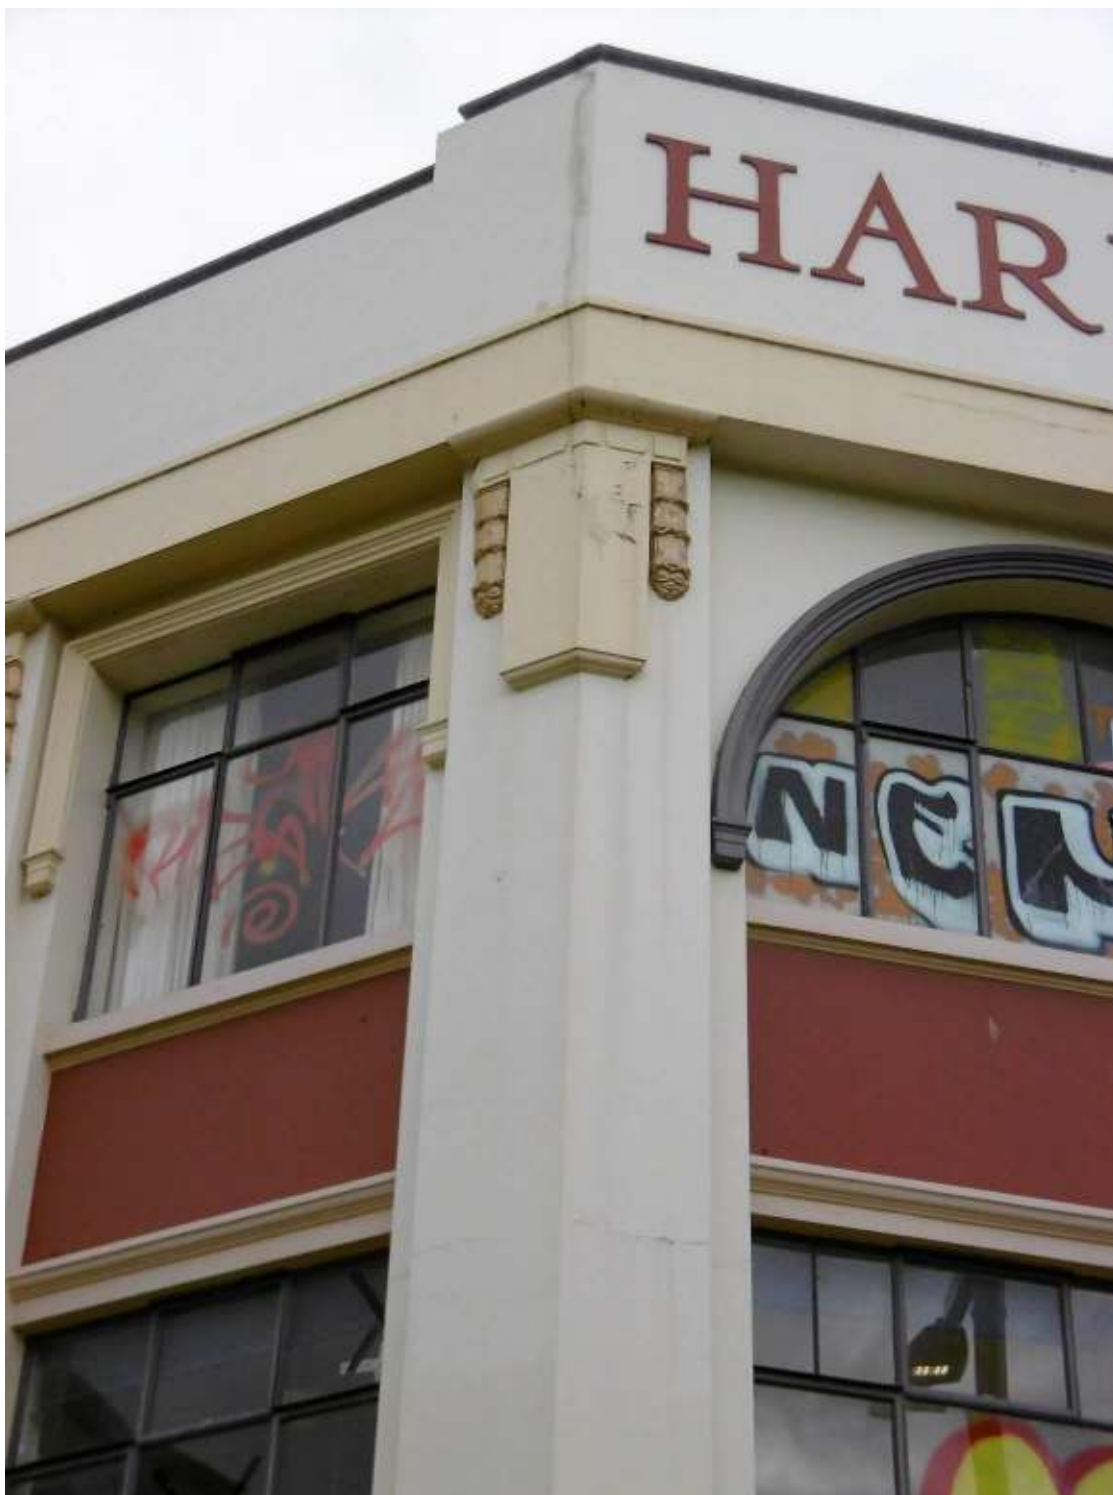
UPPER DETAIL OF THE SOUTH EAST CORNER, SHOWING CRACKING TO THE PARAPET

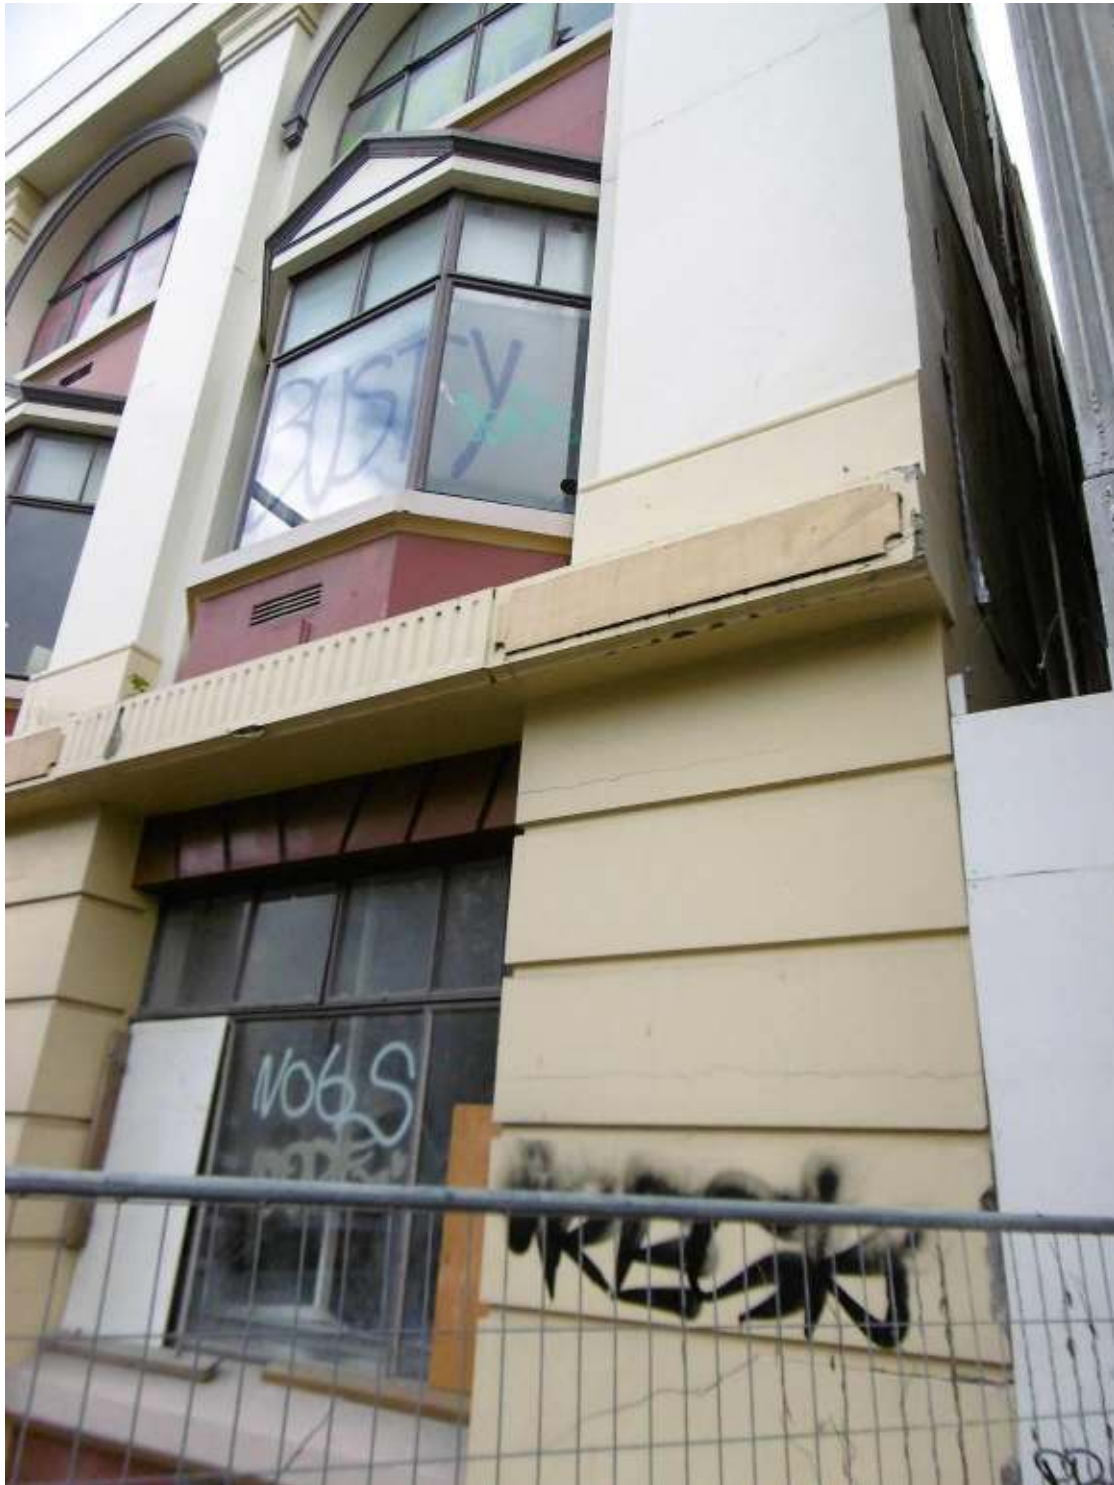
GENERAL VIEW OF NORTH EAST CORNER COLUMN, SHOWING HORIZONTAL CRACKING IN THE PLASTER WORK, AND CORRUGATED IRON COVERING THE DEMOLISHED PANELS IN THE NORTH WALL

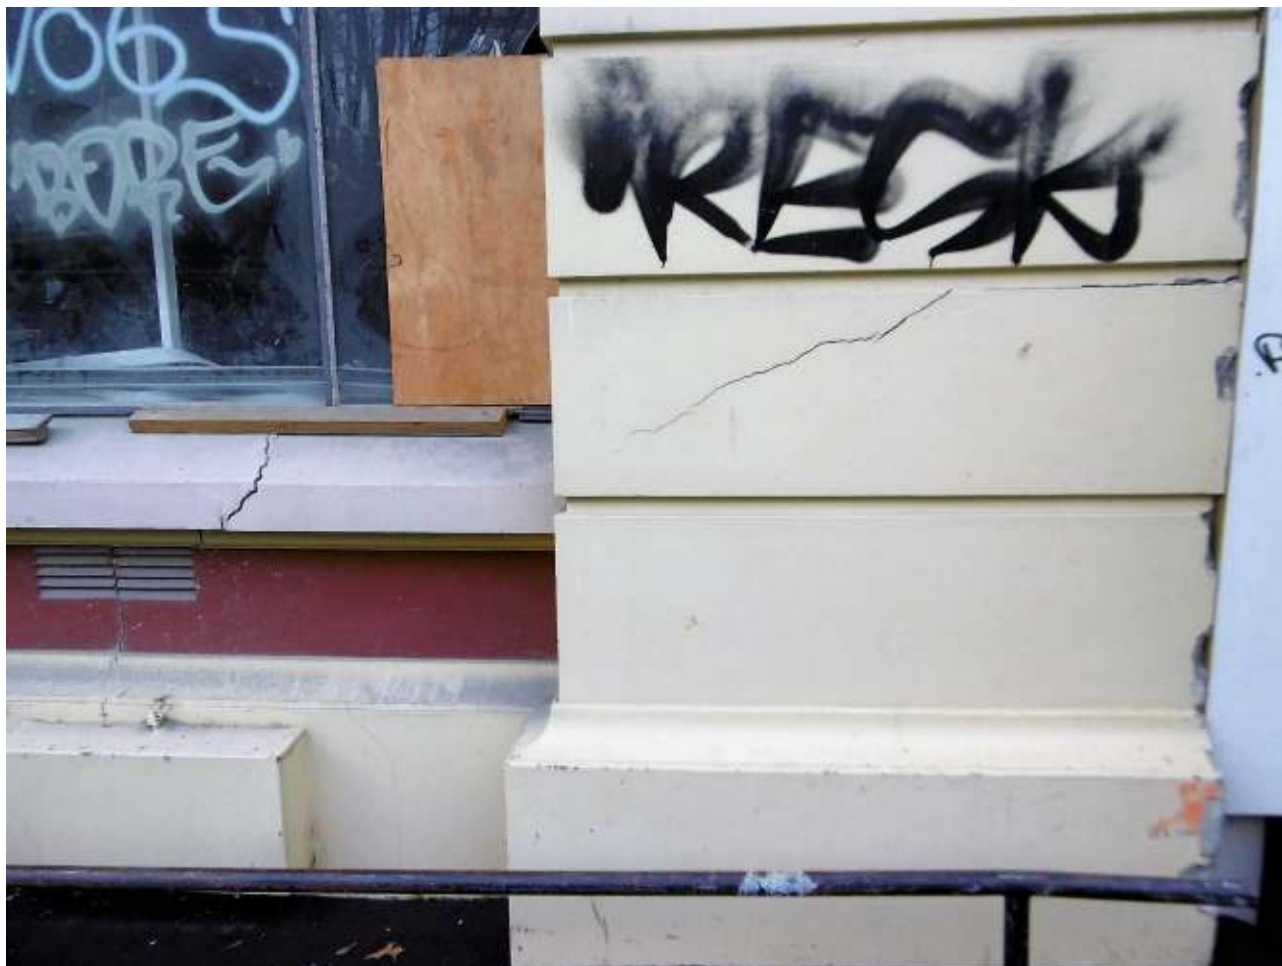
DETAIL OF CRACKING IN THE NORTH EAST CORNER

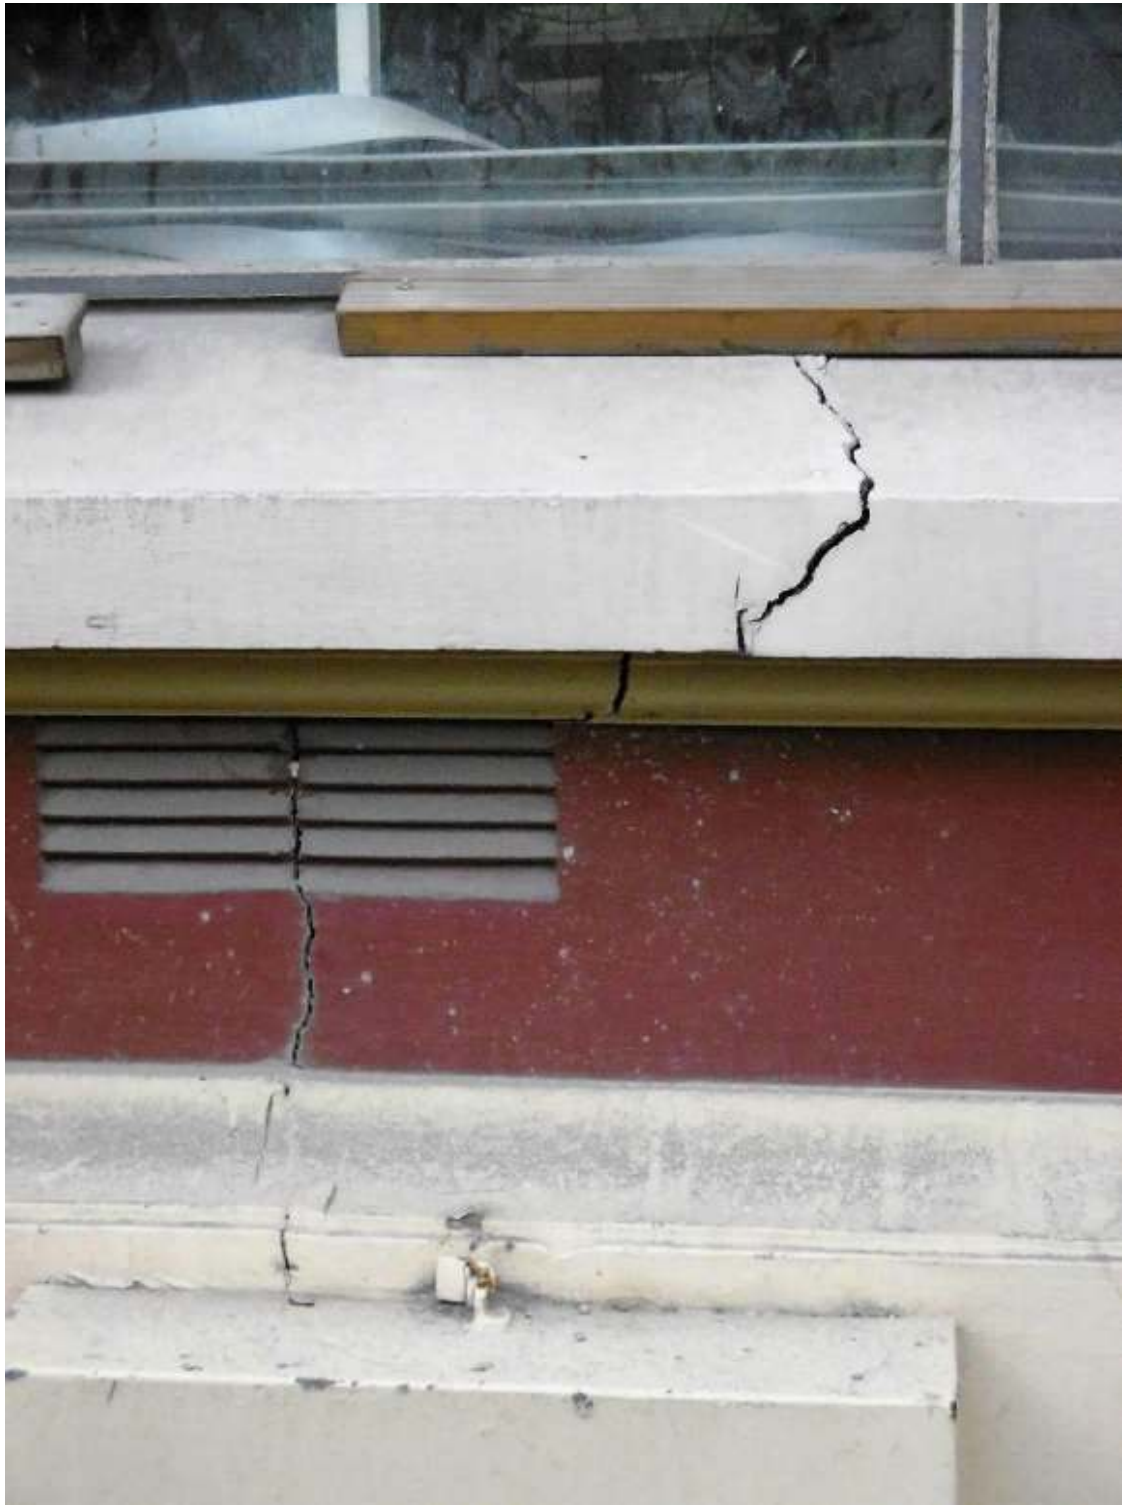
**CLOSE-UP OF EARTHQUAKE INDUCED CRACKING TO THE SILL AND INFIL
PANEL BELOW THE WINDOW, NORTH EAST CORNER OF HARLEY BUILDING**

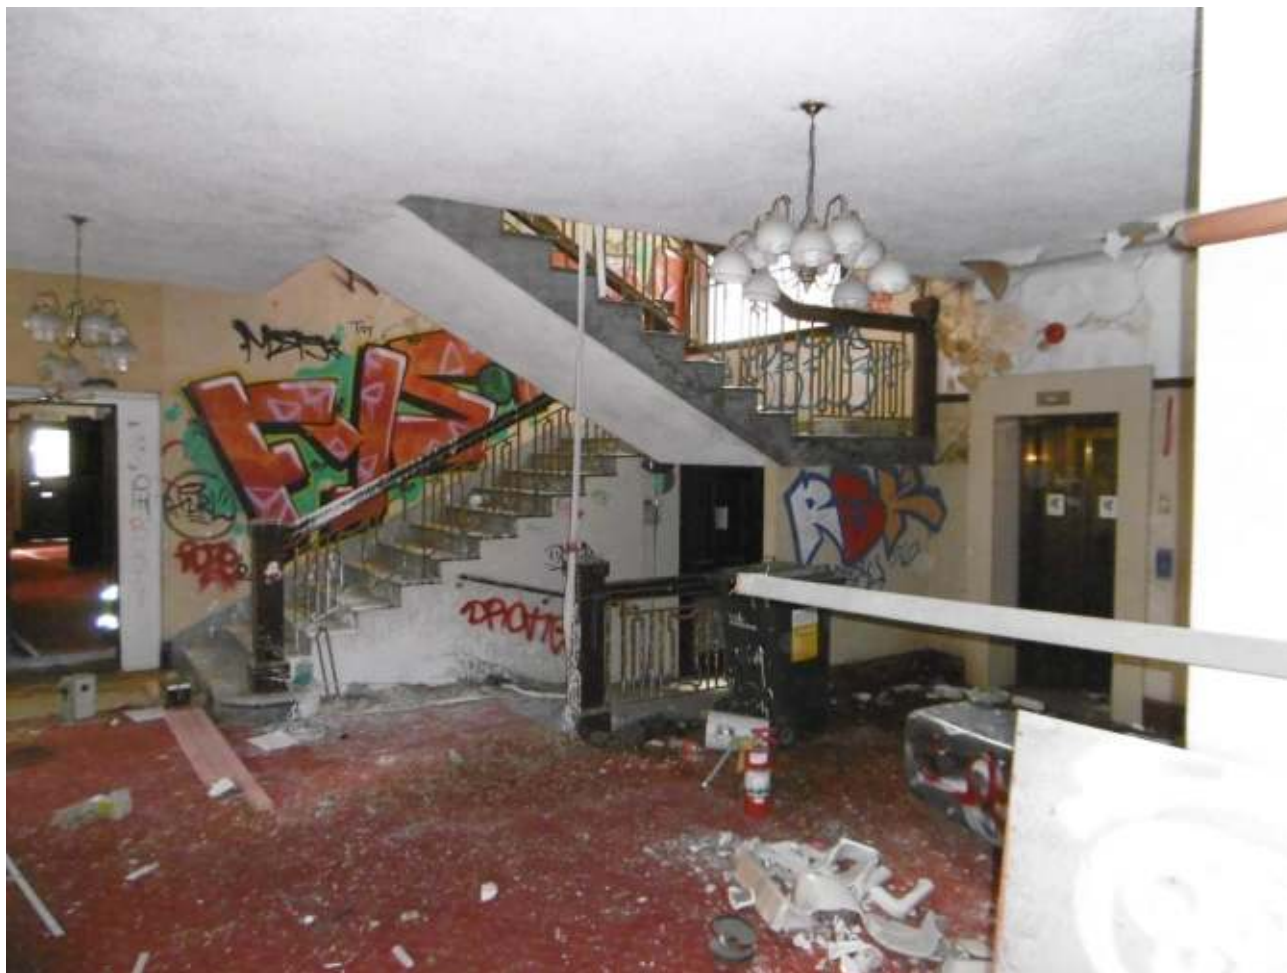
MAIN STAIR FOYER GROUND FLOOR, LOOKING SOUTH. NOTE THE VANDALISM TO THIS AREA.

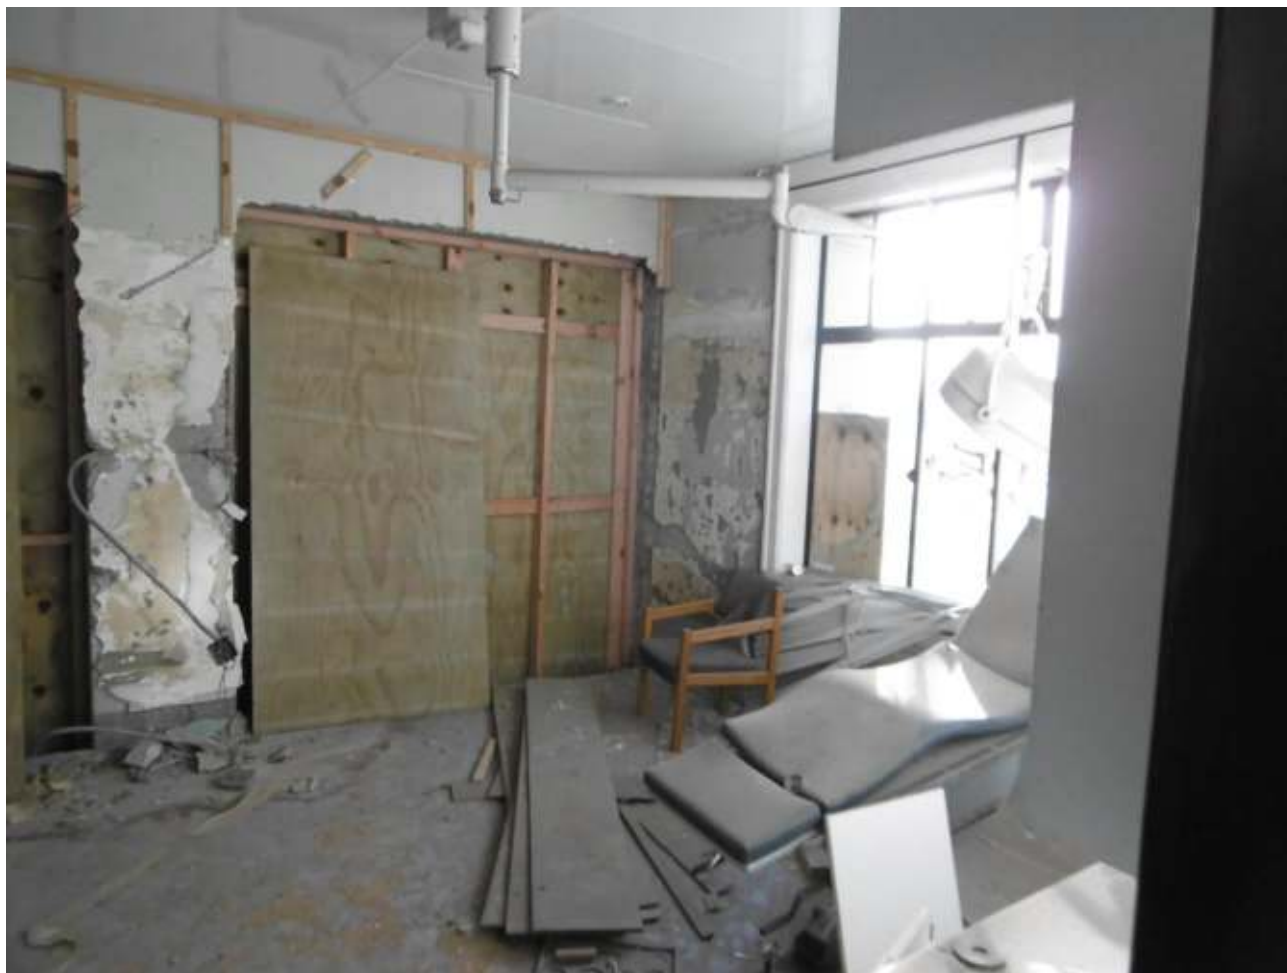
INTERIOR OF NORTH EAST CORNER OF BUILDING, GROUND FLOOR, SHOWING COLUMN CRACKING AND BRICK INFILL PANELS REMOVED

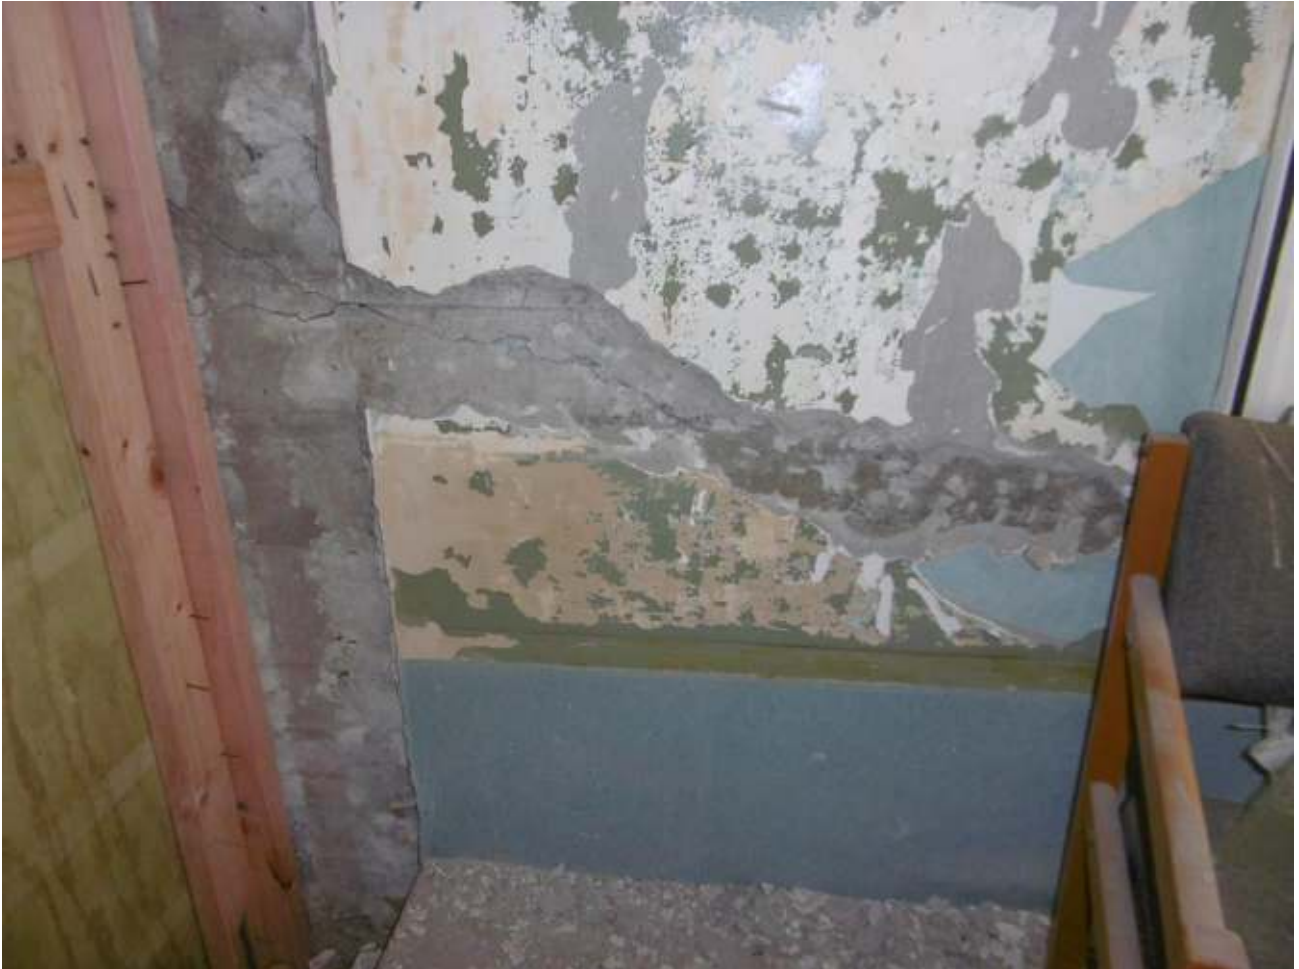
DETAIL OF NORTH EAST CORNER COLUMN CRACKING

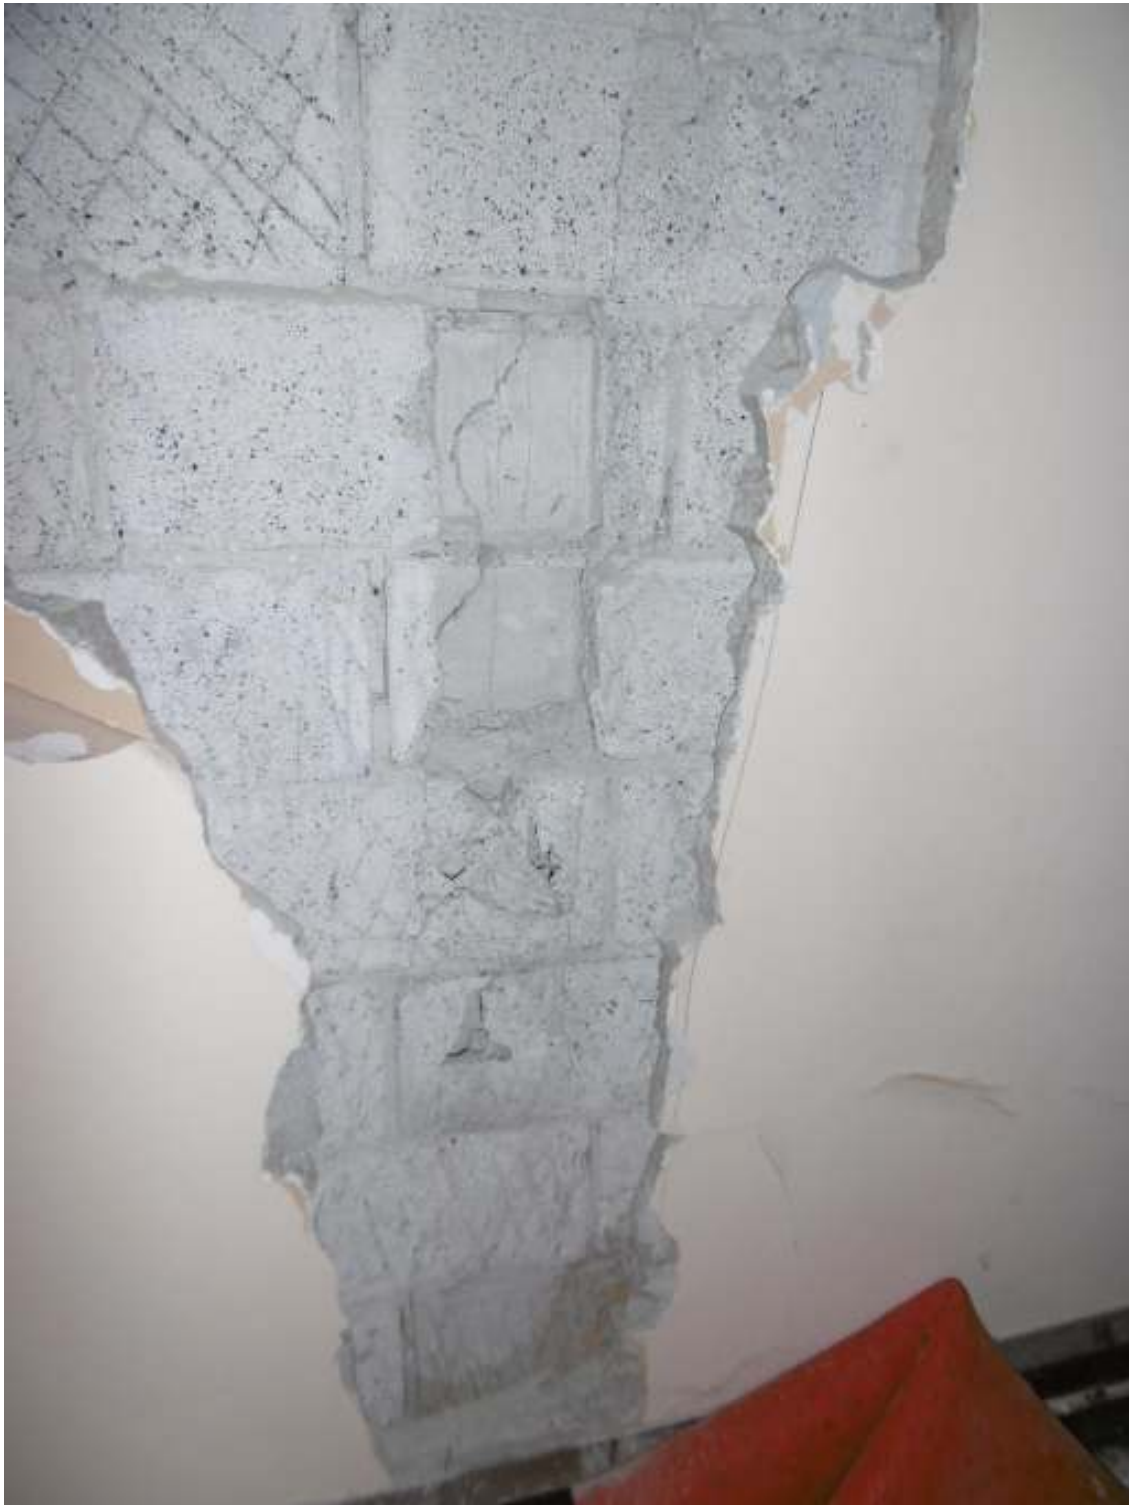
TYPICAL INNES BELL BLOCK INTERIOR WALL, GROUND FLOOR, SHOWING EARTHQUAKE INDUCED CRACKING

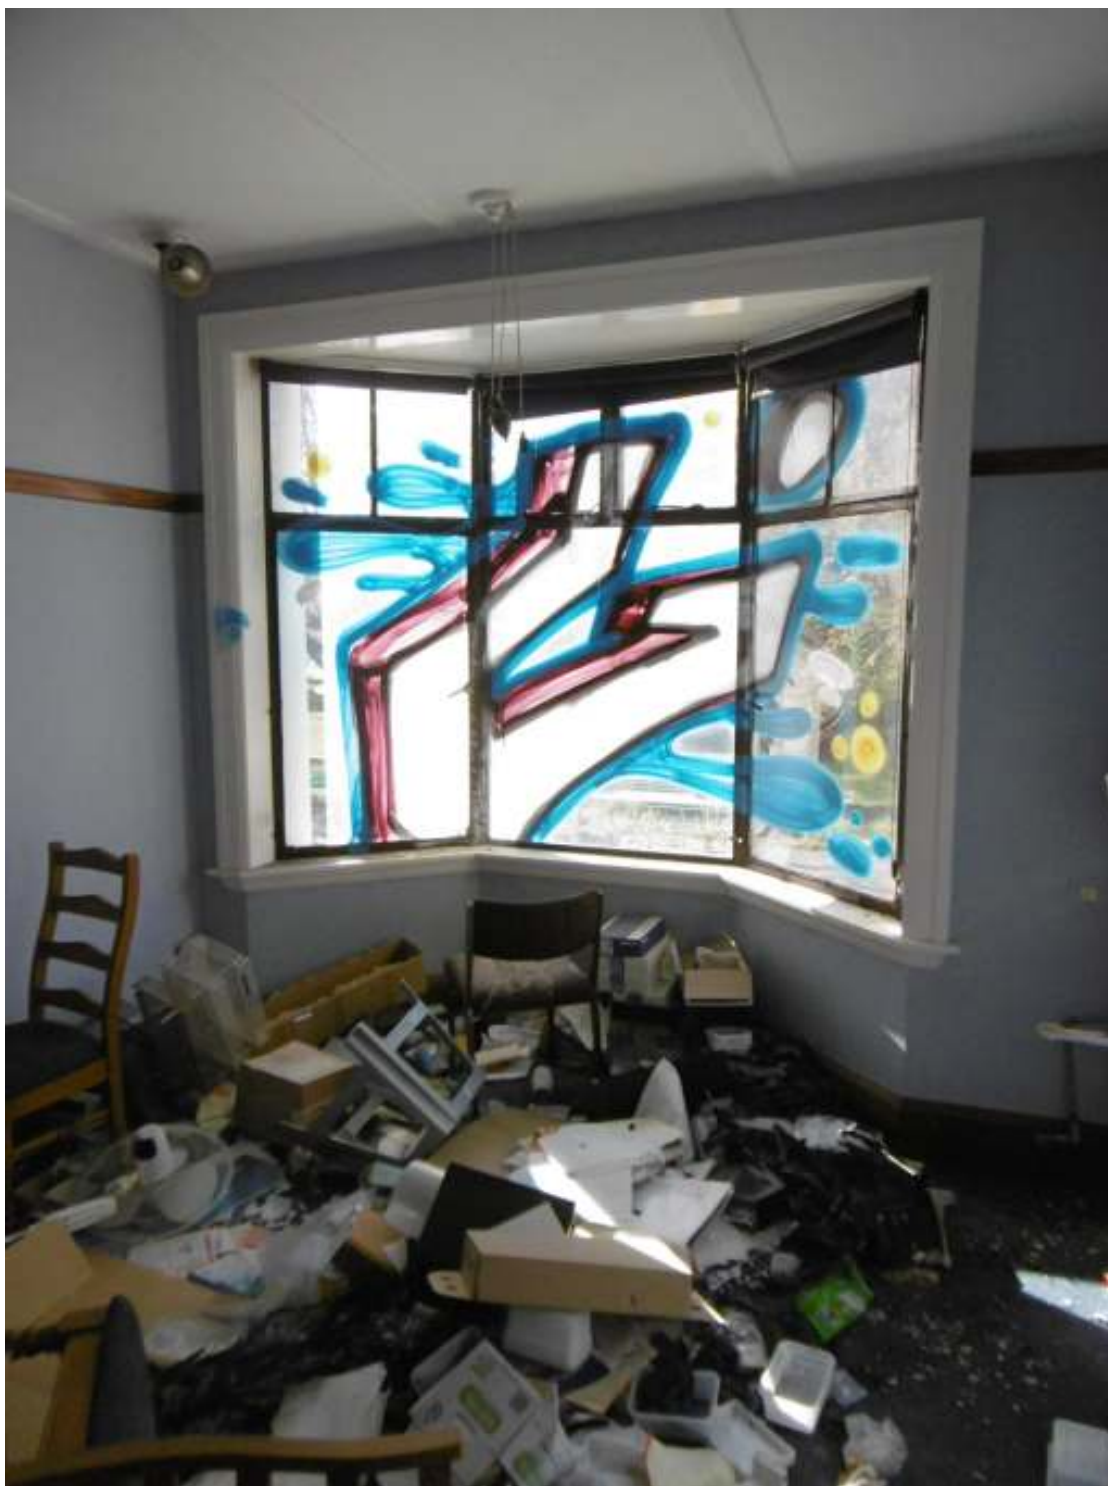
TYPICAL RANSACKED FIRST FLOOR ROOM, WITH GRAFFITI TO WINDOWS

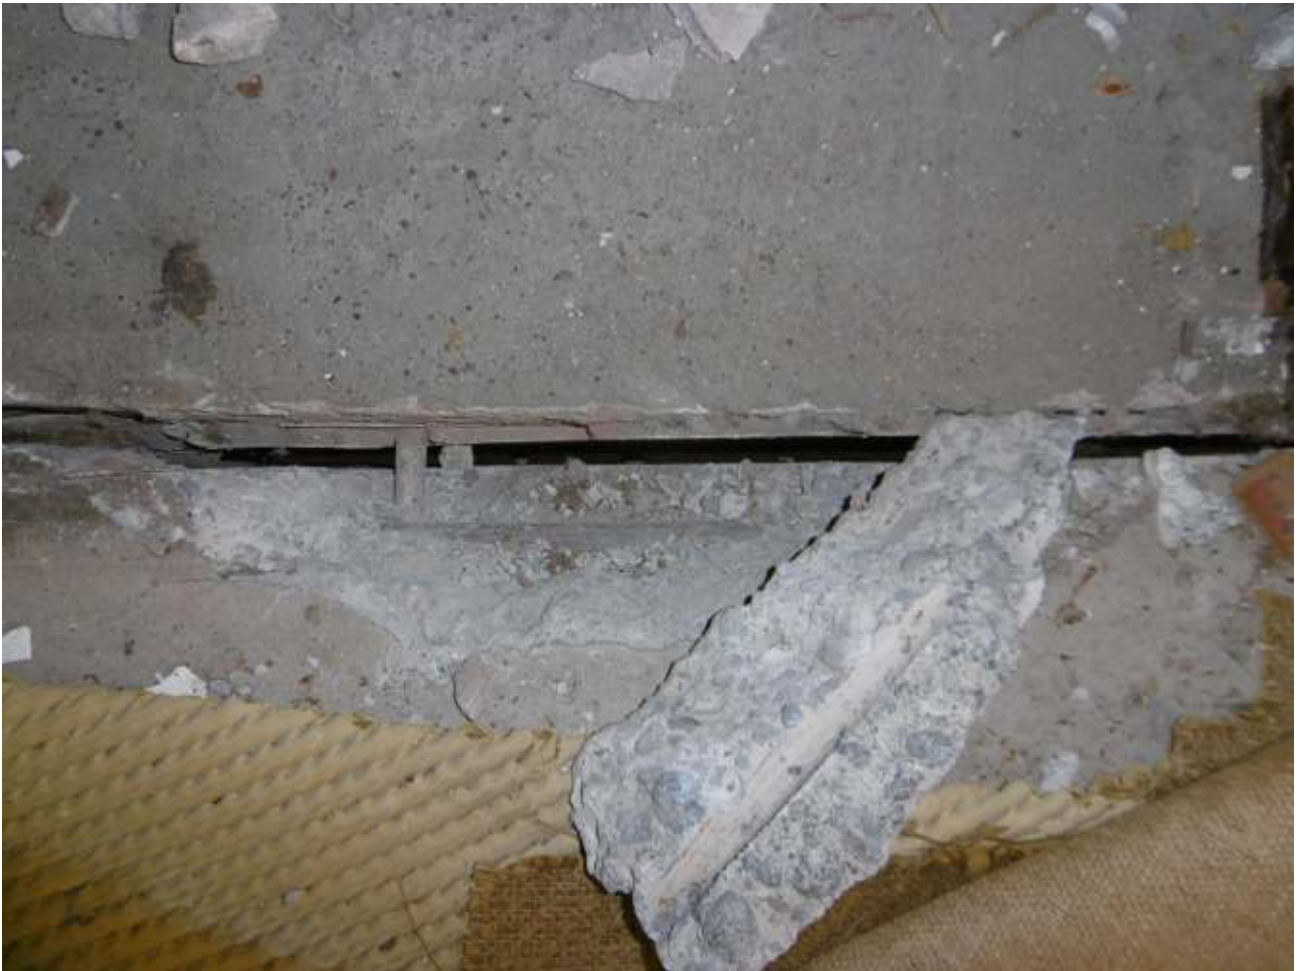
THE GAP IN THE FLOOR BETWEEN THE NORTH AND SOUTH STRUCTURES, AT THE FIRST FLOOR, CAUSED BY THE EARTHQUAKE EVENT

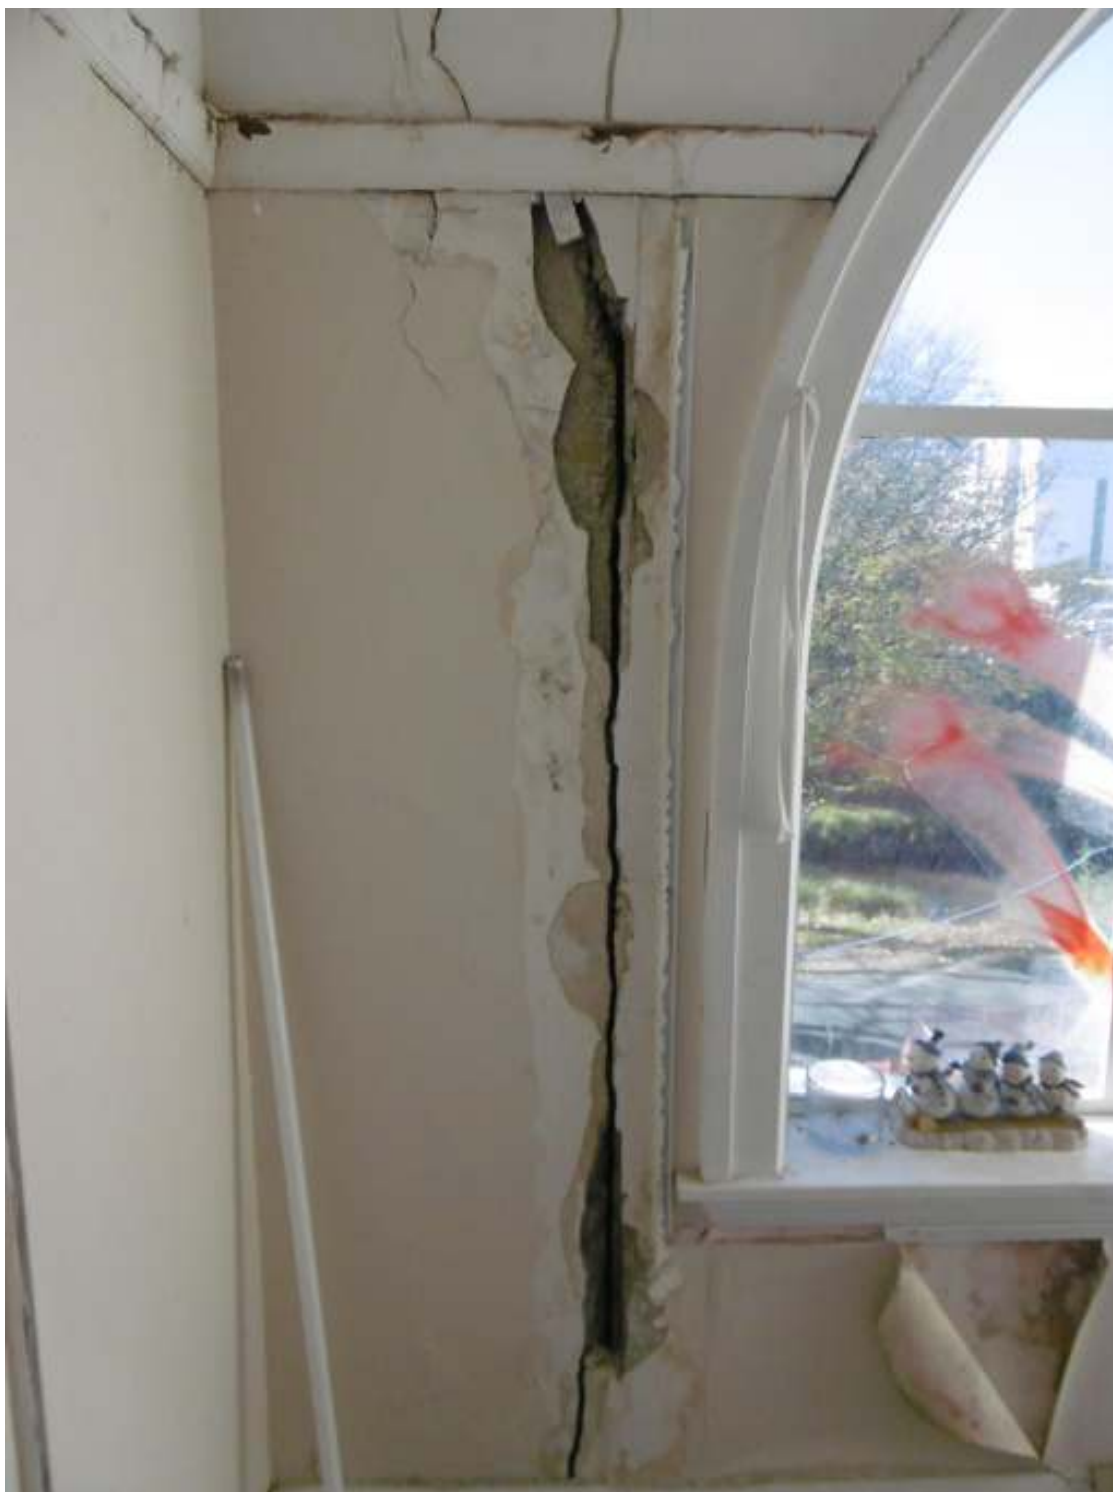
THE VERTICAL GAP IN THE EAST EXTERIOR WALL BETWEEN THE NORTH AND SOUTH STRUCTURES, AT THE FIRST FLOOR, CAUSED BY THE EARTHQUAKE EVENT

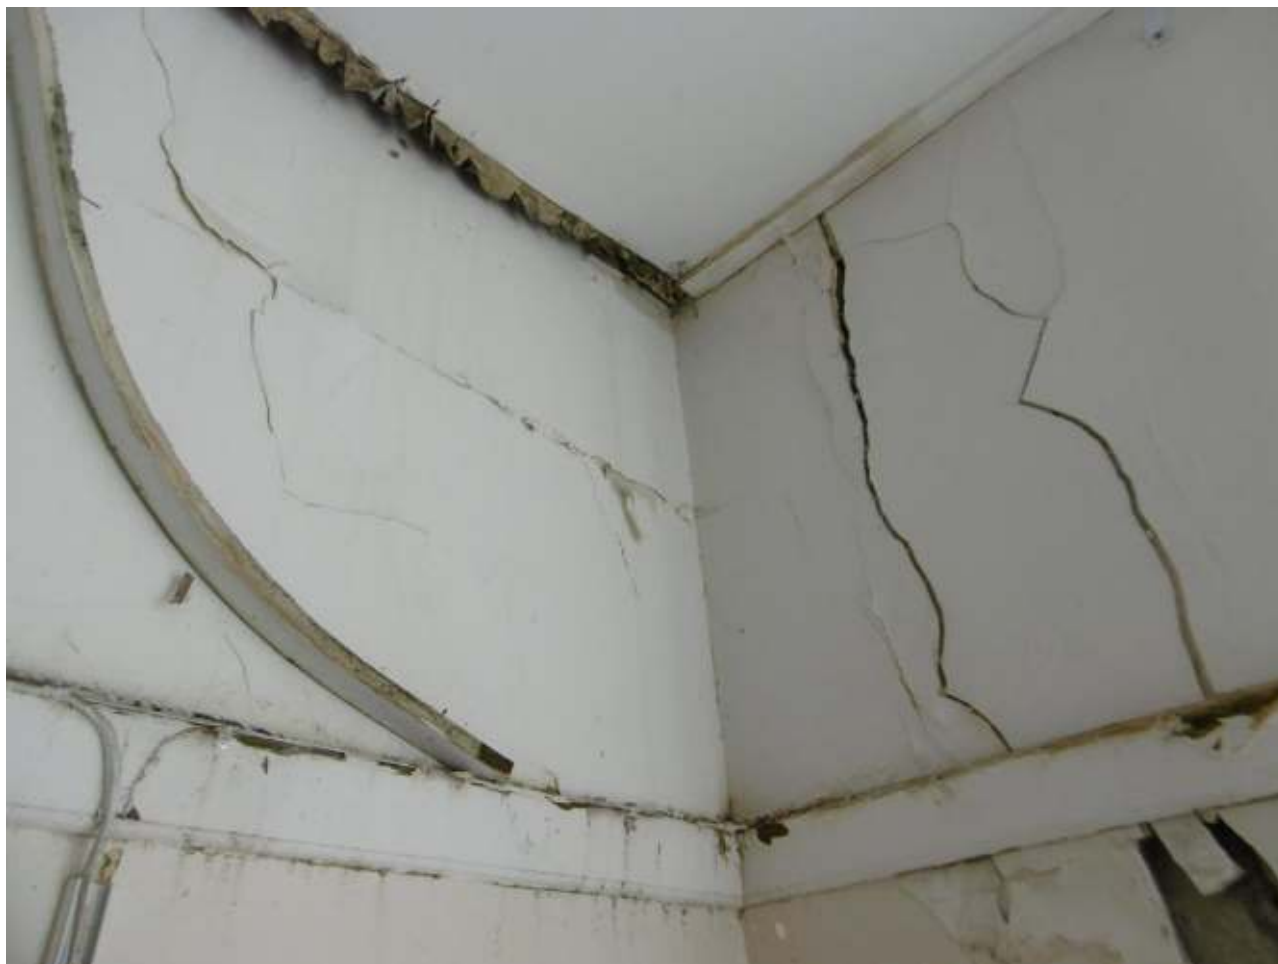
UPPER WALL DAMAGE COUSED DURING THE EARTHQUAKE EVENT

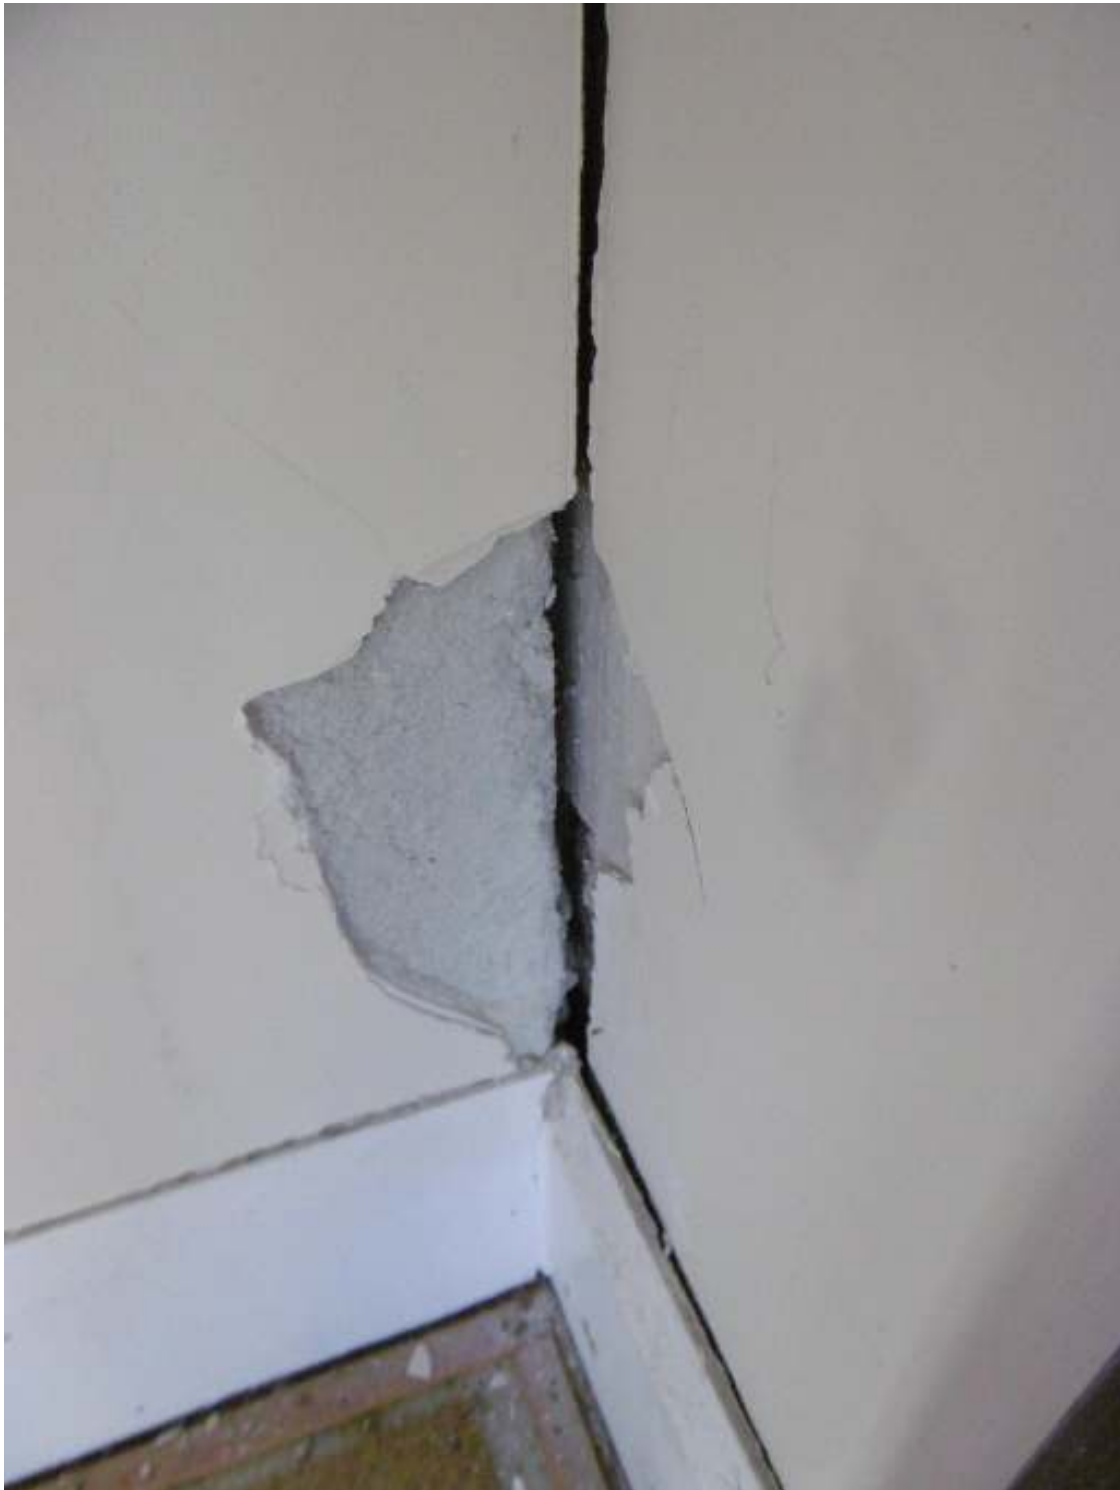
WALL SEPARATION BETWEEN THE NORTH AND SOUTH STRUCTURES AT THE GROUND FLOOR

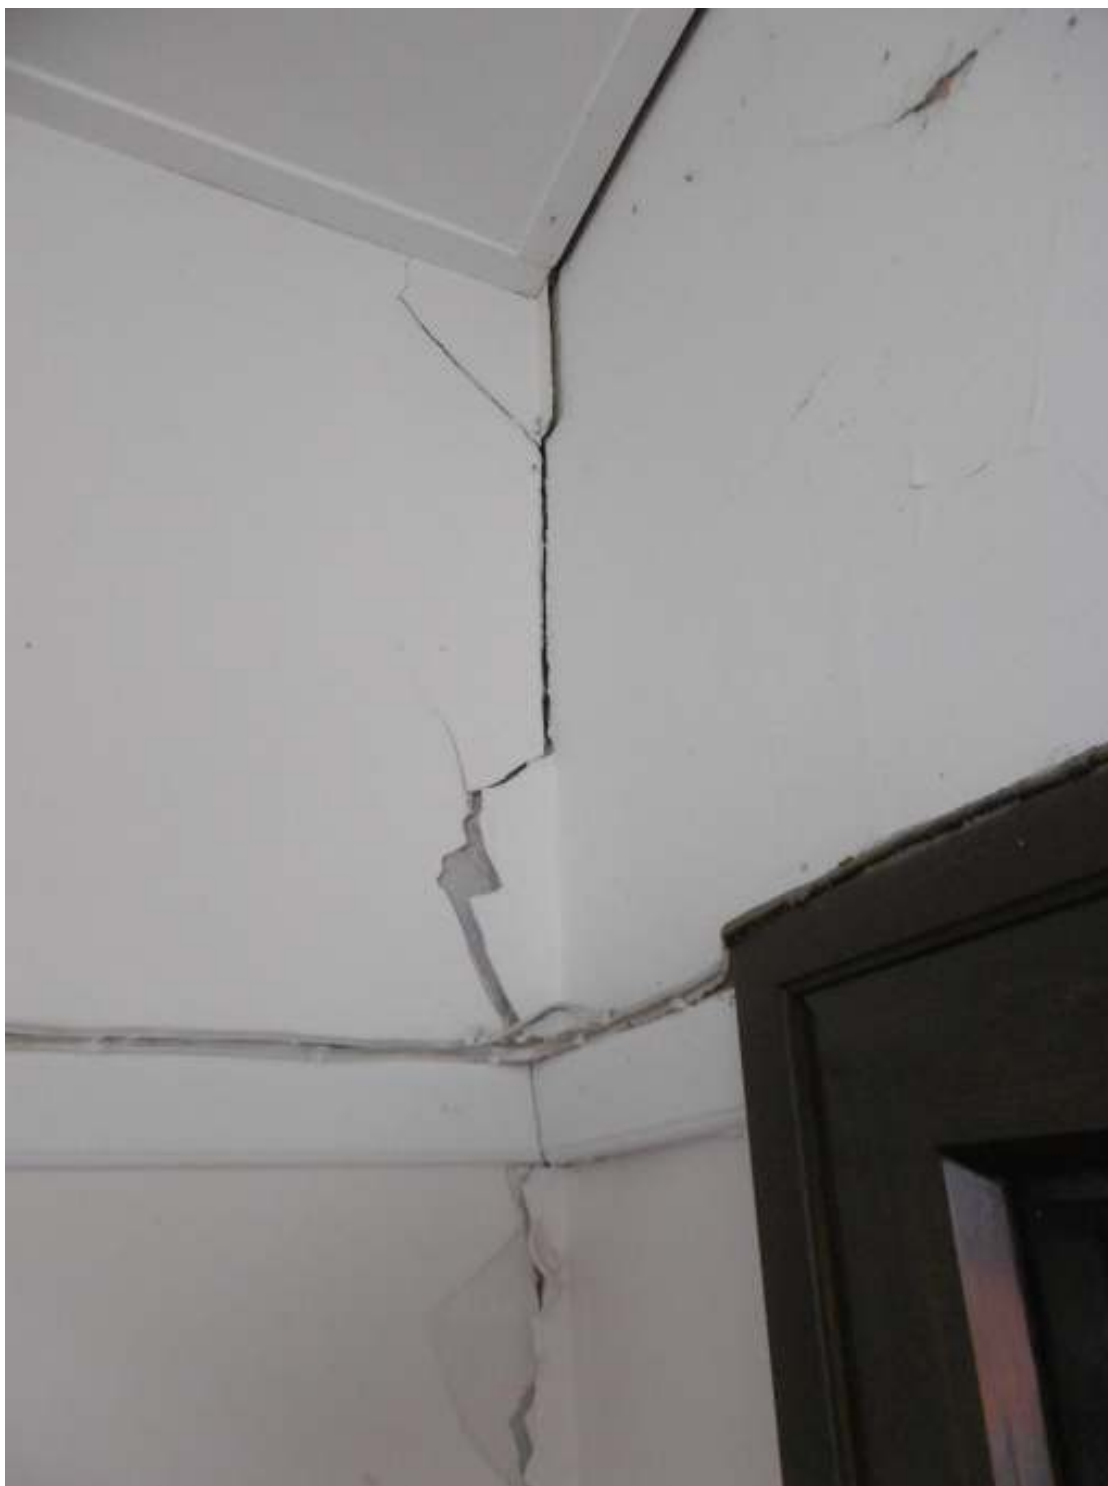
**FURTHER WALL SEPARATION BETWEEN THE NORTH AND SOUTH STRUCTURES
AT THE GROUND FLOOR**

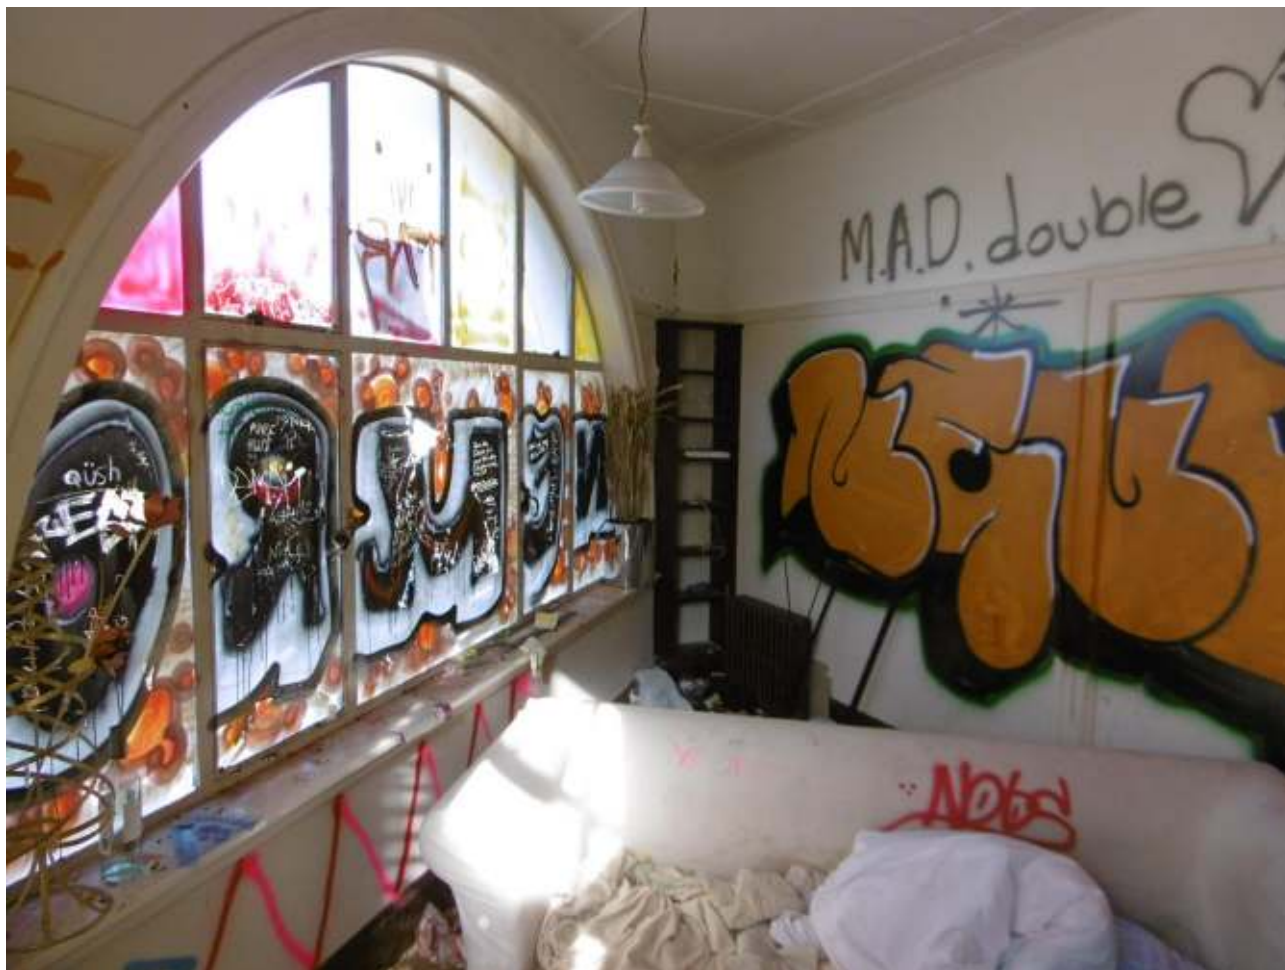
VANDALISM AT THE UPPER FLOOR
