HARLEY CHAMBERS

**137 CAMBRIDGE TERRACE
CHRISTCHURCH**

HERITAGE IMPACT ASSESSMENT

Report Prepared by
SMART ALLIANCES LTD
for
LEE PEE LTD

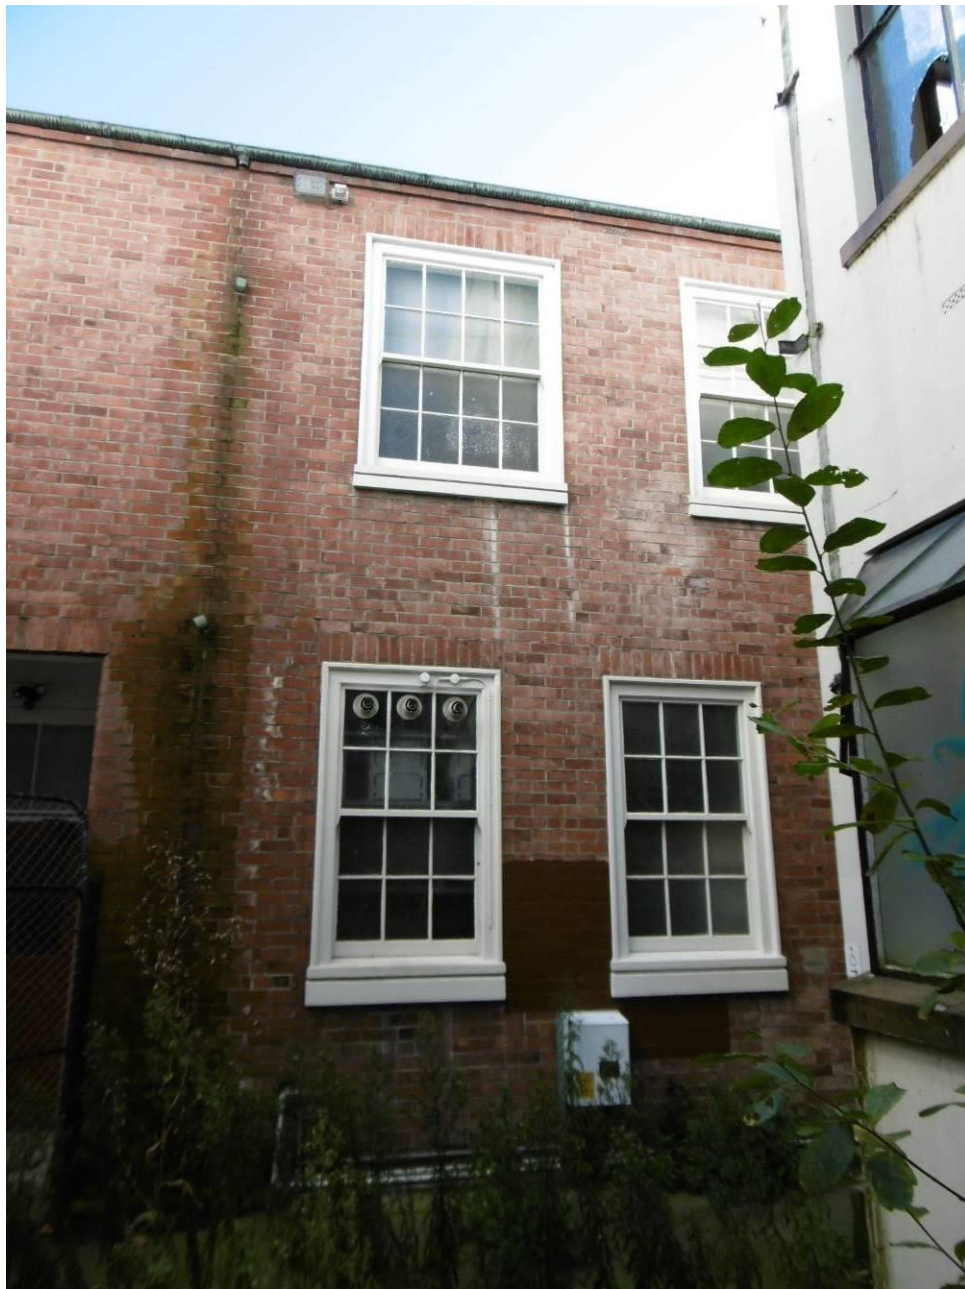
MID SECTION OF THE EAST ELEVATION WITH THE FIRE EGRESS LOBBY TO THE LEFT. THE DOWNPIPES HAVE BEEN REMOVED FROM THE BUILDING, CAUSING WATER DAMAGE AND ALGAE TO THE BRICKWORK.
