Detailed Environmental Site Investigation

711 Johns Road

Harewood

13396.000.000_04

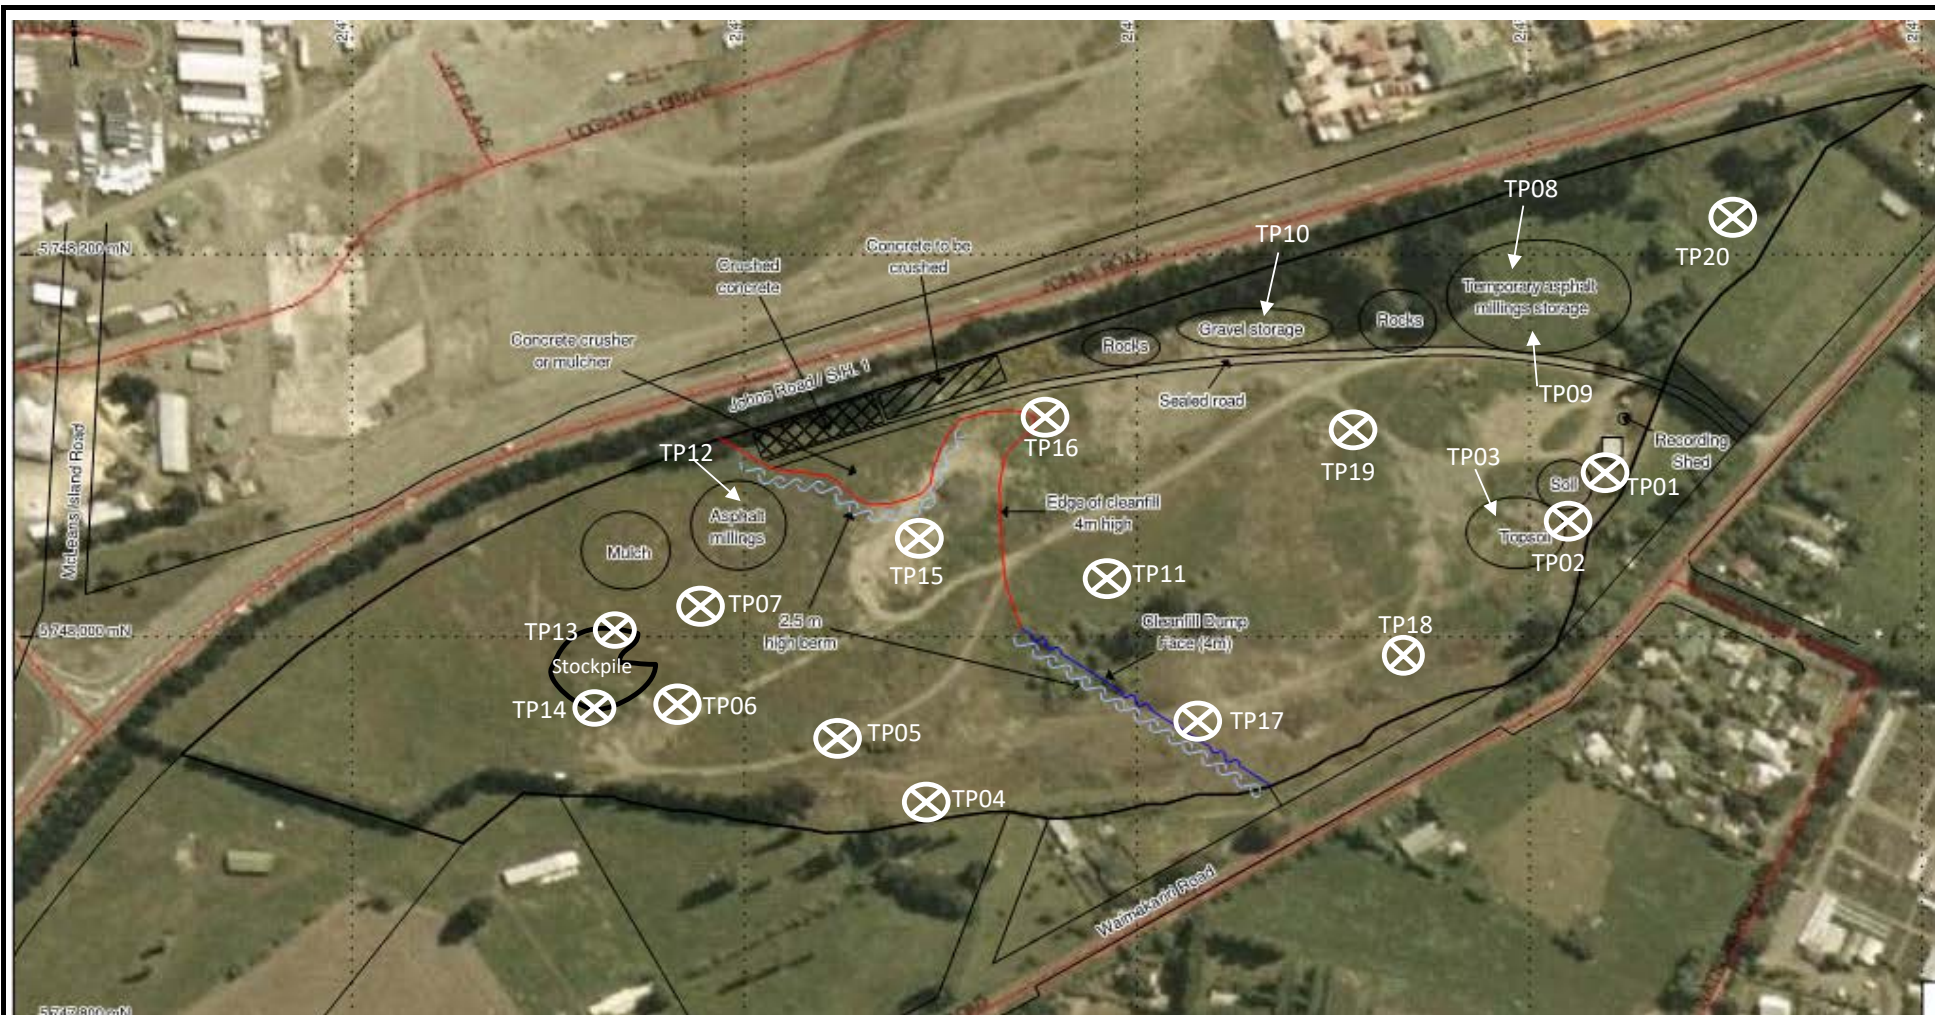
Date	June 2017	Client	McCracken & Associates Ltd		
Drawn by	CW	Project	711 Johns Road, Belfast, Christchurch		
Approved by	EM	Description	Sample Location Map		
Scale	NTS	Figure Number	1	Project Number	13396

Although chemical contaminants were detected below the adopted human health criteria, elevated lead levels were found at TP03 at 2.0, TP12 at 1.1 and 1.7 m bgl. Additionally, elevated BaP eq levels were found at TP05 at 2.0 m bgl, TP09 at 2.6 m bgl, and TP18 at 0.5 m bgl. For both of these contaminants, “elevated” was defined as being above the residential human health criteria.

It is our understanding that the soils from the above locations/depths are to remain on-site. As the site is near a drinking water protection zone, we recommend a toxicity characteristic leaching procedure (TCLP) test is carried out on a subset of the samples mentioned above to assess the potential for contaminants to leach to underlying groundwater.

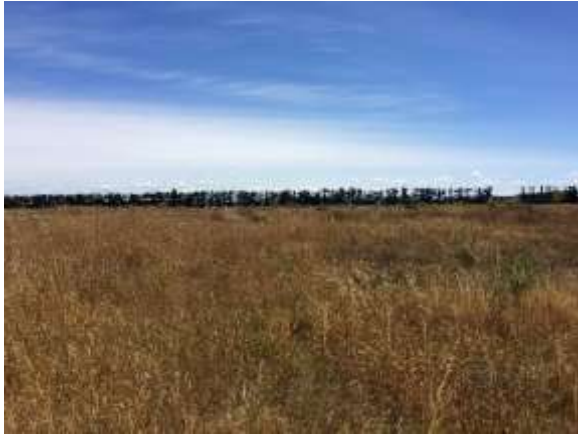
Photo 1: View from south site boundary facing north

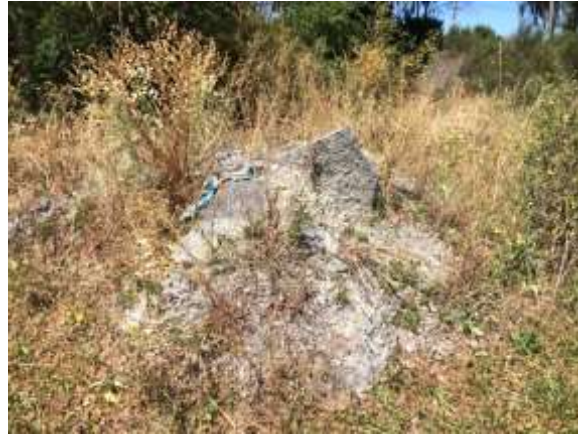
Photo 2: Stockpiled soil with concrete debris

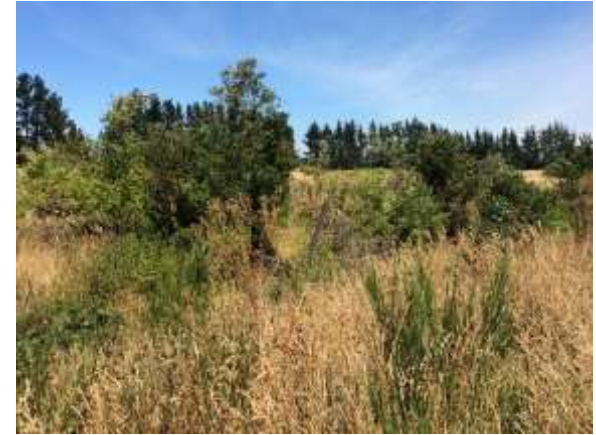
Photo 3: Dense vegetation bordering ditch

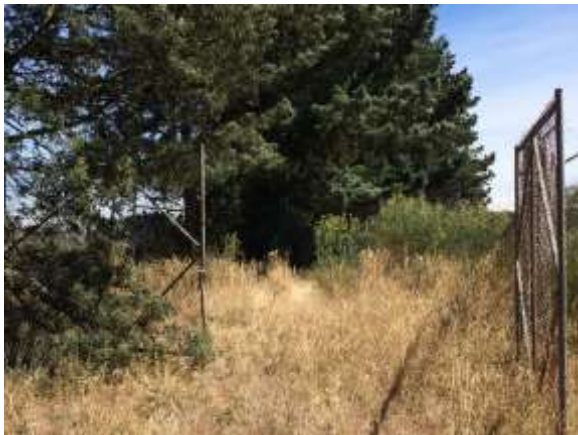
Photo 4: Chain link fence enclosure

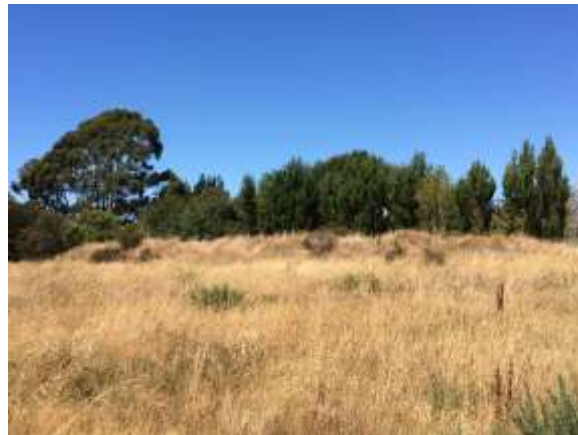
Photo 5: Earthen bund along southern site boundary

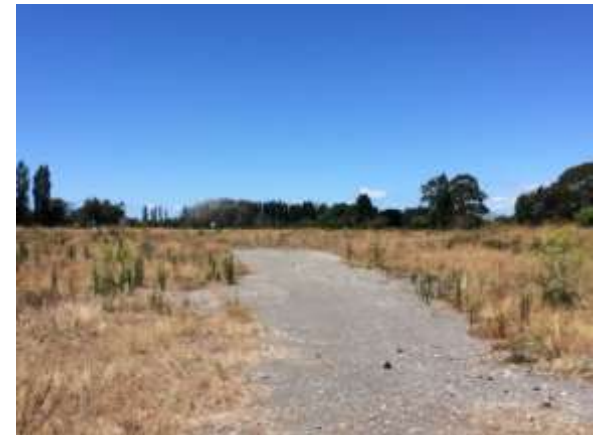
Photo 6: Gravel pathway through site
