# Ecological Assessment Report

# **Ecology of the upper Kruse's Drain; and impact of baseflow reduction and stormwater treatment from the Foodstuffs SI development site**

Foodstuffs South Island Limited

AEL Report No. 162

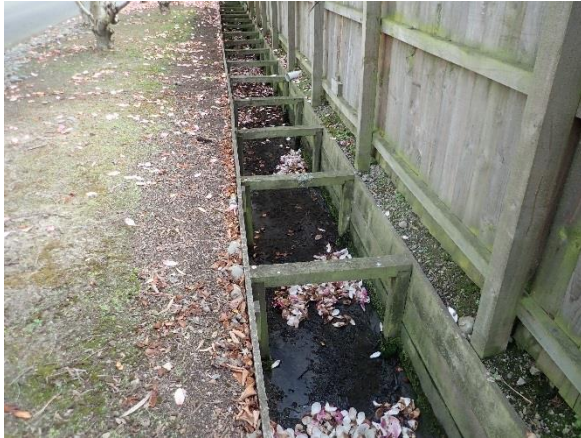
**Figure 2.** Lydia Street Drain east of Lydia Street. The drain base was wet with a trickling baseflow.

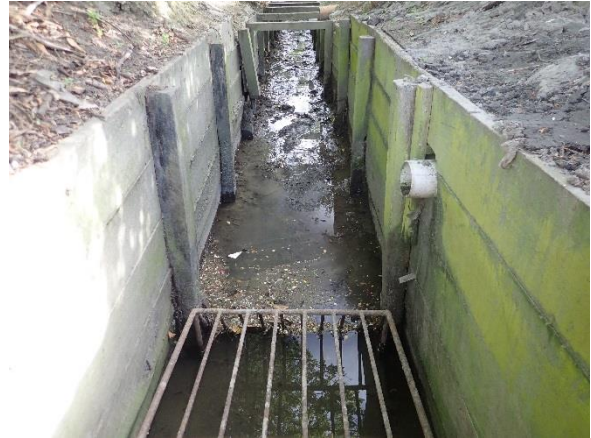
Lydia Street Drain is subject to apparent gross pollution. Hydrocarbon films were observed near the drain's trash rack outlet at Main North Road (Fig. 3), with one anthropogenic point source identified (Fig. 4) not attributable to Foodstuffs (SI). Another hydrocarbon film (Fig. 5) was observed in the waterway near Lydia Street. While the source of the hydrocarbons was not determined, it was clear that it was not attributable to a discharge from Foodstuffs. This is because there are no stormwater inputs from Foodstuffs entering Lydia Street Drain at, or upstream, of Lydia Street (App. I, Fig. i).

**Figure 3.** A hydrocarbon film (not from foodstuffs) was evident upstream of the trash rack at Main North Road.

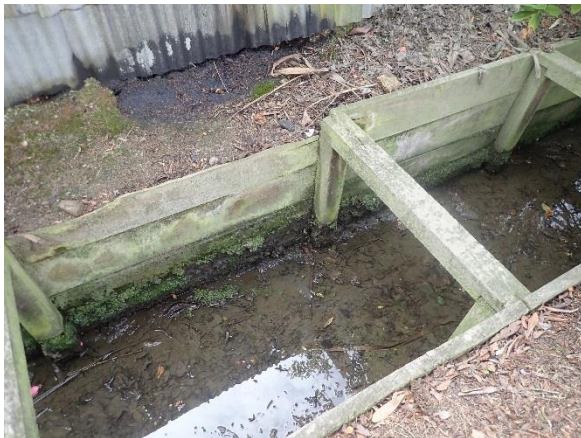
**Figure 4.** Local ground contamination beside Lydia Street drain. This was sourced to a neighbouring property north of the Foodstuffs site. A hydrocarbon film was also present in the water.

Surrounding ground near the proposed culverted reach was found to be contaminated with hydrocarbons originating from a source outside of Foodstuffs property. Thus, given ground contamination, I recommend that the Lydia Street Drain baseflow is best served by culverting the baseflow through it. The culverting option would provide more net benefit to the downstream ecology, by preventing ground contaminants from entering the channel baseflow, with only a negligible loss of (contaminated) baseflow.

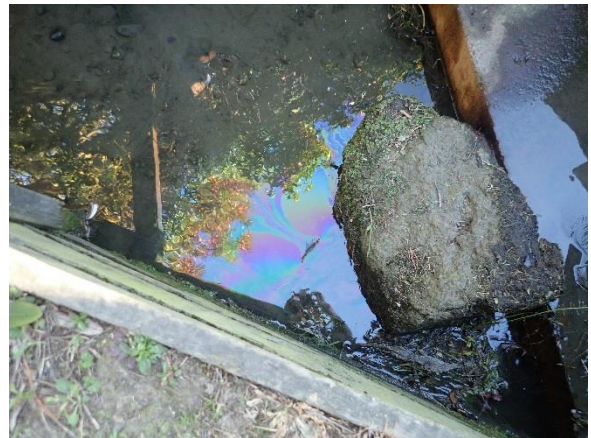
**Figure 5.** Hydrocarbon films were observed upstream of that in Fig. 4, but the source was not traceable.

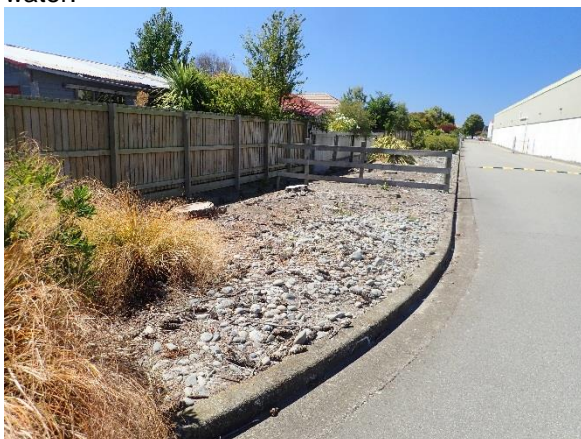
The February survey found that many of the large old trees shading Lydia Street Drain on the true right (south) bank had been felled because of the risk of either collapsing into the drain, thus creating a flooding hazard, or falling across the truck access route (R. Parrish, pers. comm, Fig. 6). Along the 200 m reach immediately downstream of Lydia Street, the drain bed was predominantly gravel of varying embeddedness into the surrounding silt (Figs. 7, 8). Further downstream, where water connectivity appeared to be permanent, the stream bed was more embedded, and common duckweed (*Lemna minor*) was prolific (Fig. 9). The presence of duckweed reflects the low summer base flow. The baseflow

**Figure 6.** Trees on the true right (south) bank of Lydia Street Drain have been recently felled.

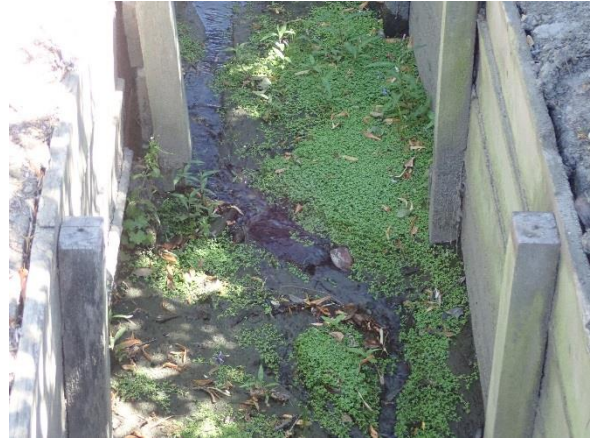
**Figure 9.** Duckweed and soft sediment in Lydia Street Drain.

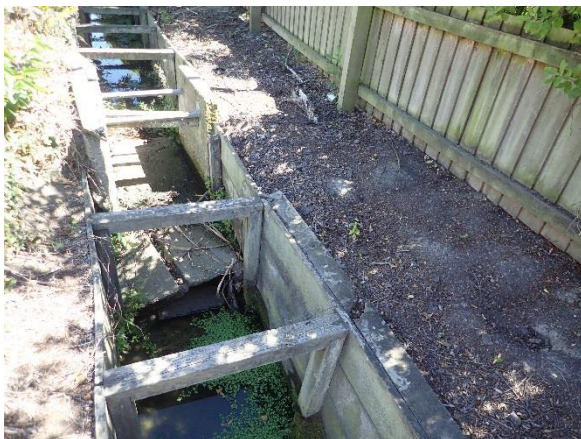
was clear, but only a few centimetres deep. At the time, some concrete blocks were found to be impounding water 240 m downstream of Lydia Street (Fig. 10).

**Figure 10.** Concrete debris damming water in Lydia Street Drain.

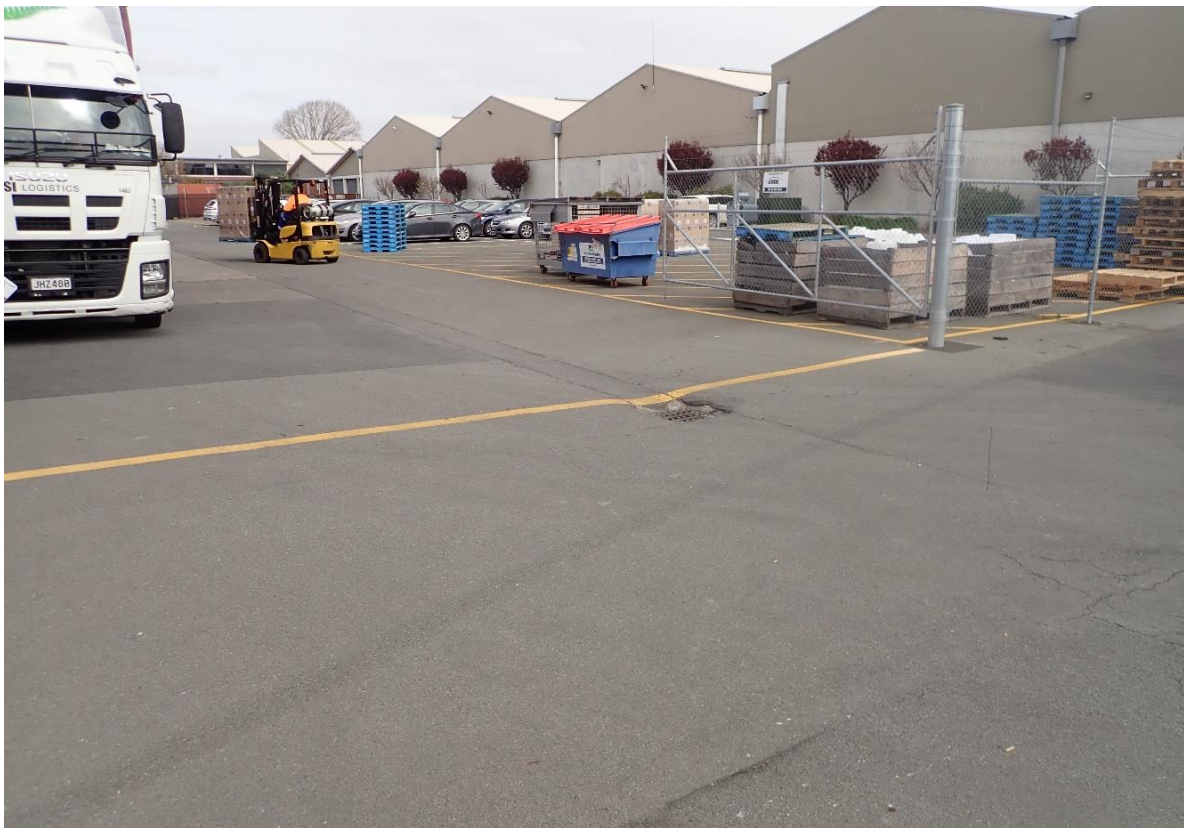
The existing hardstand to the west of the proposed supermarket (Area C) is subject to extensive tyre scrub from fork-lift operation and parking trucks, and presently has no stormwater treatment (Fig. 11). It is not feasible to pipe stormwater from Area C into the proposed bio-retention systems to the east of the supermarket. Instead, the raised ground level in this area will allow sufficient hydrostatic head for a propriety cartridge filter-type device (e.g. Stormwater 360 StormFilter or equivalent) before discharge to the existing 7500 stormwater drain to the south of the development. The space required for the roof stormwater attenuation tank on the south wall of the supermarket prevents further treatment of stormwater downstream of the cartridge filter.

**Figure 11.** Stormwater drainage from existing busy hardstand areas, which drain to Lydia Street Drain, will be treated to remove contaminants.
