Inspection of Diamond Harbour Wharf

Prepared for Christchurch City Council

26 August 2020

Calibre Consulting Ltd

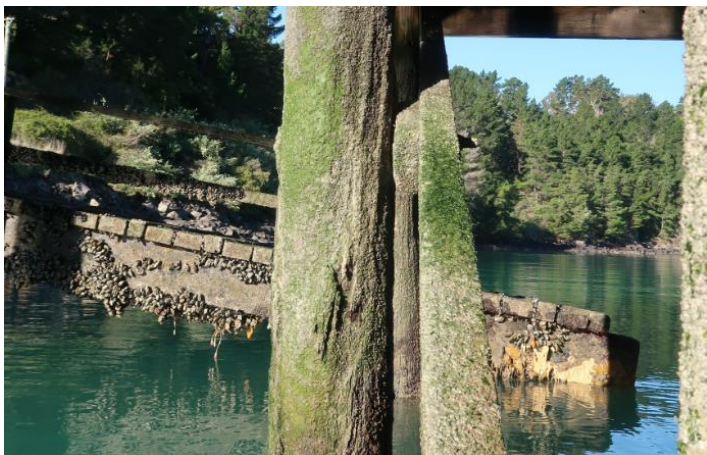
During the low tide inspection, it was noted the ramp along the south eastern side of the wharf finishes 300mm above the low water line, a photograph of the ramp is provided in Figure 1. This will make using the ramp to launch boats difficult around low tide, we recommended extending the ramp is considered as part of the proposed wharf improvements. There is space beyond the existing end of the ramp for an extension although proximity to the proposed pontoon access would need to be considered.

Figure 1: Bottom of ramp, around 1 hour after low tide still above the water

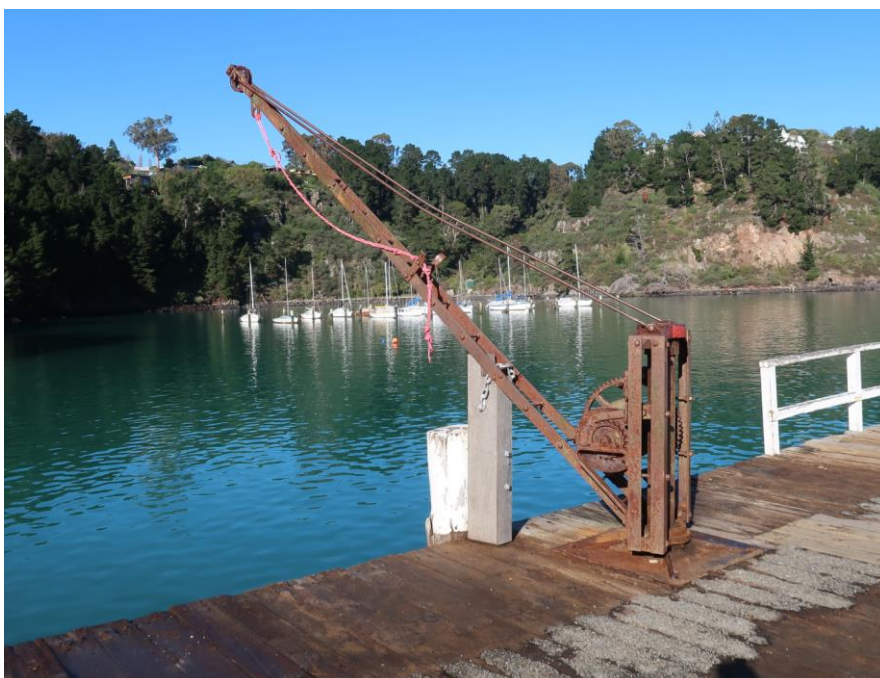
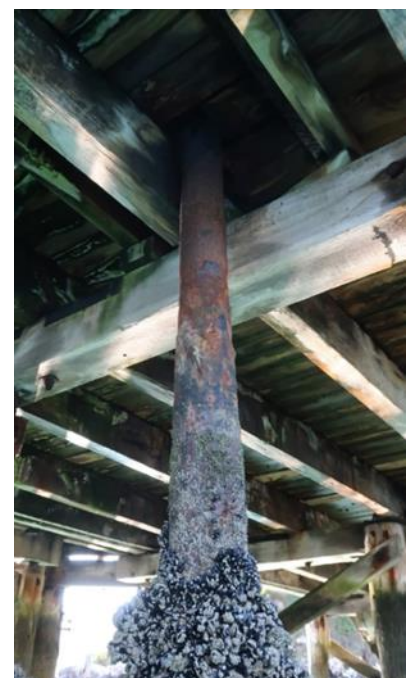
Figure 2 The derrick crane on Diamond Harbour Wharf, the pole below is at least 4m long and corroded.

The relocation of the crane is complicated by the presence of a 4m long pole connected to the underside of the crane. It is recommended that this pole is removed permanently as it is in poor condition. If the crane is to be kept intact whilst being relocated, a significantly larger crane would be required as the crane would need to be raised at least 4m vertically for the pole to be lifted clear of the wharf deck. It is recommended the relocation and potential modification of the crane is discussed with CCC's heritage team.

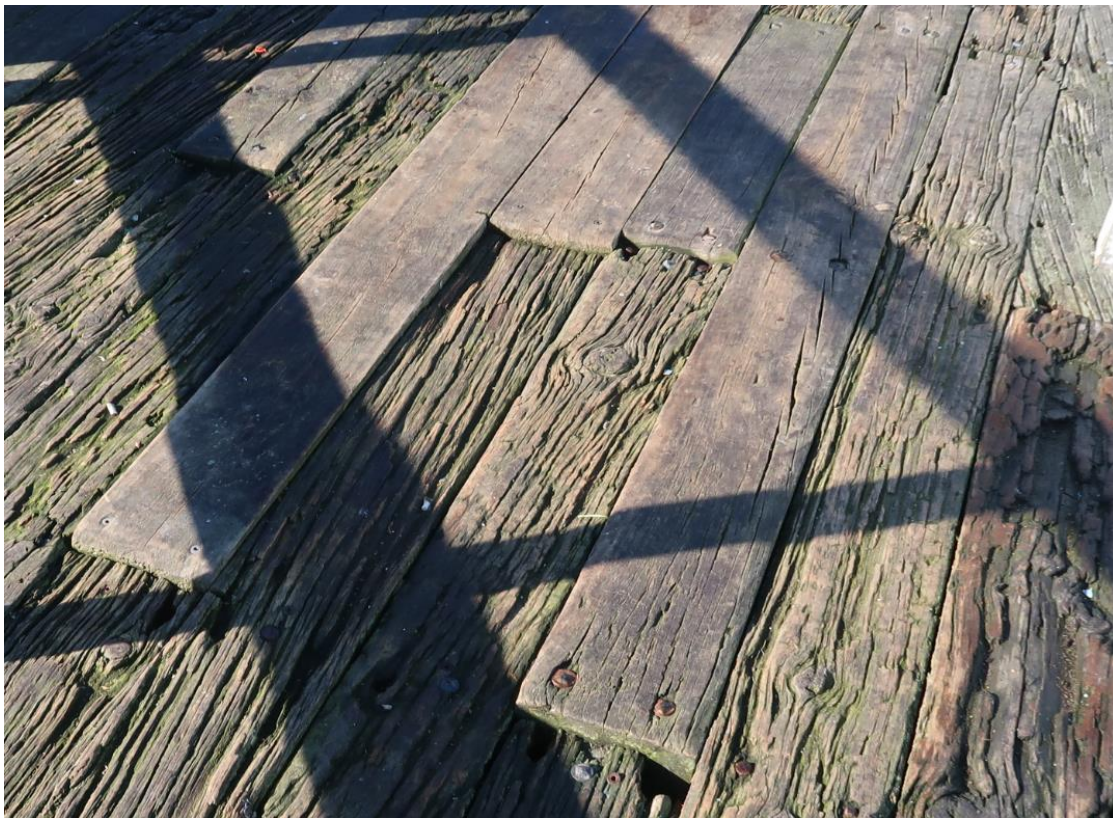
The condition of some decking timbers is poor, much of the decking has been replaced and the older timber is typically well worn. The worn decking is a trip hazard and allows fresh water to settle over the structural timber below accelerating deterioration.

Figure 3: Mixture of old and new decking timber, with 15-20mm difference in height

1. Replace the old decking timber and install a similar anti-slip coating to that already used at the start of the wharf.
2. Level the decking timbers by replacing the thicker decking or install plywood on shallower decking. Then apply anti-slip coating

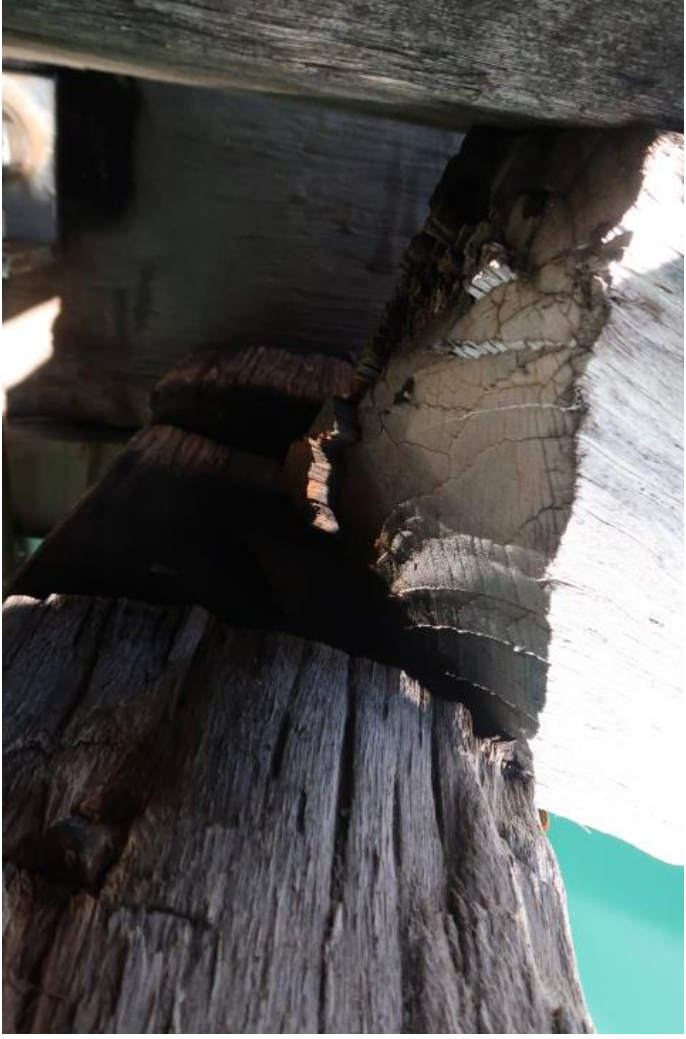
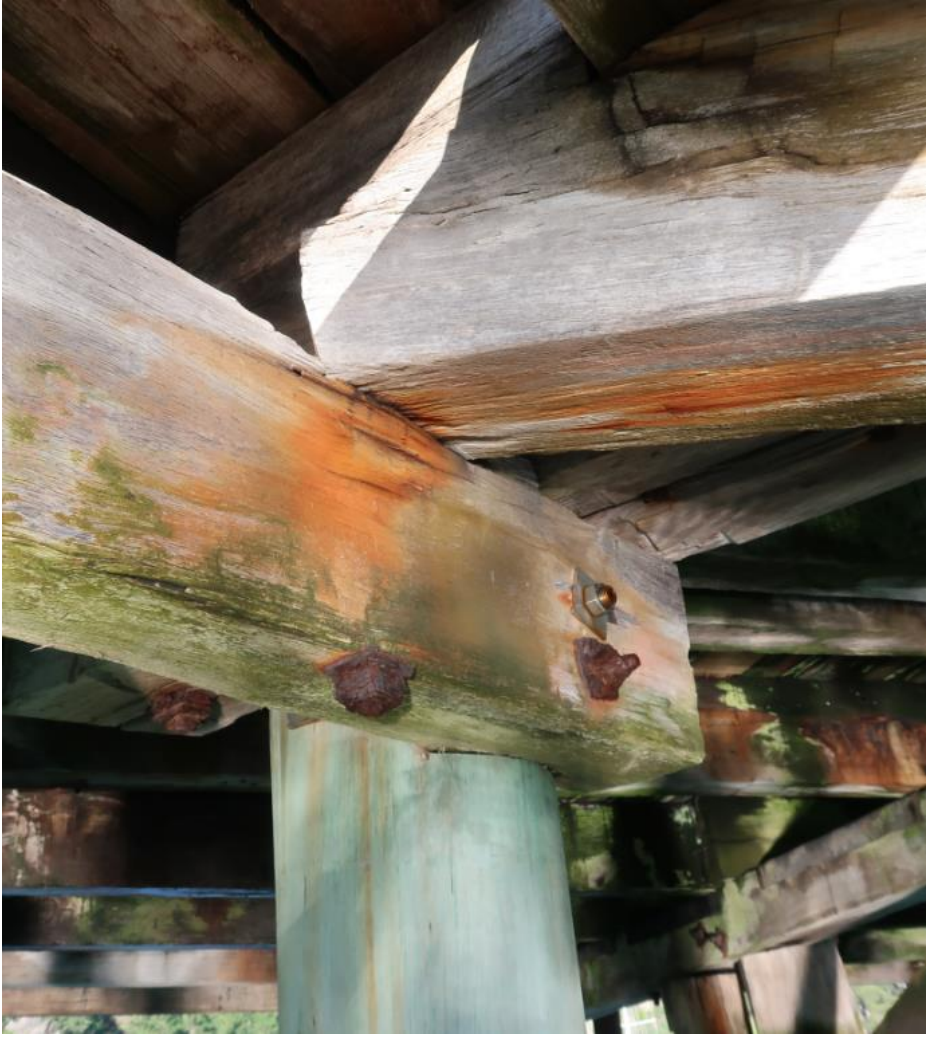
Photo Reference	Item Reference	Description	Photo Reference	Item Reference	Description
A	1	Poor seating to stairs on capping beam spanning between piles 7D – 7E	B	1	Poor seating to stairs on capping beam spanning between piles 7D – 7E

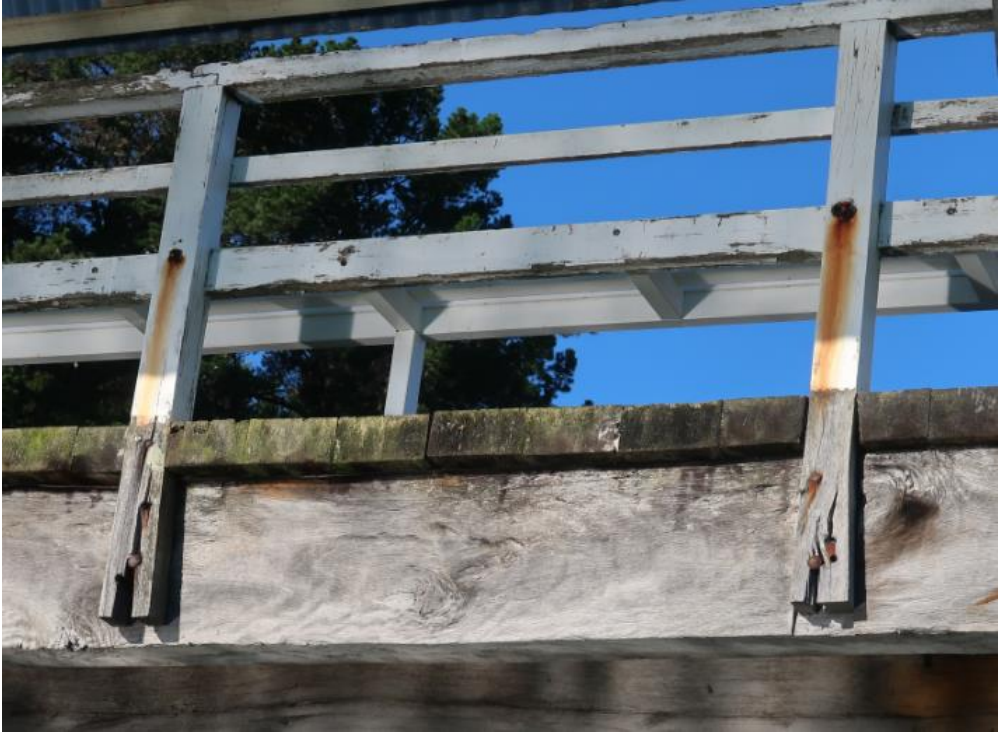
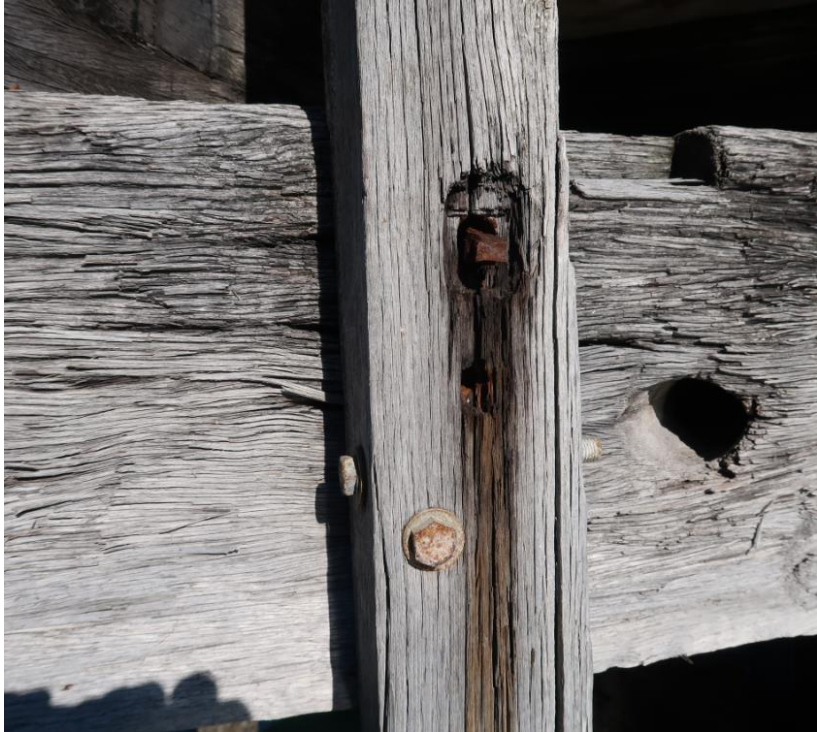
Photo Reference	Item Reference	Description	Photo Reference	Item Reference	Description
C	2	Handrail posts requires replacement due to splitting (below canopy, northern side of approach)	D	2	Failed fixing to handrail post, (post to capping beam between pile 8D & 8G)

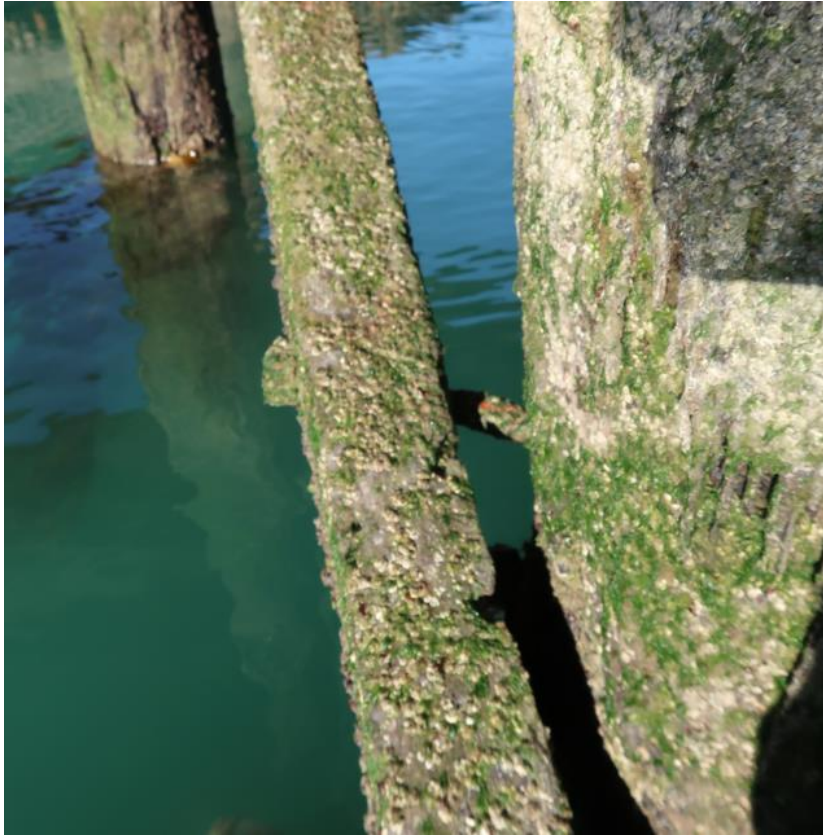
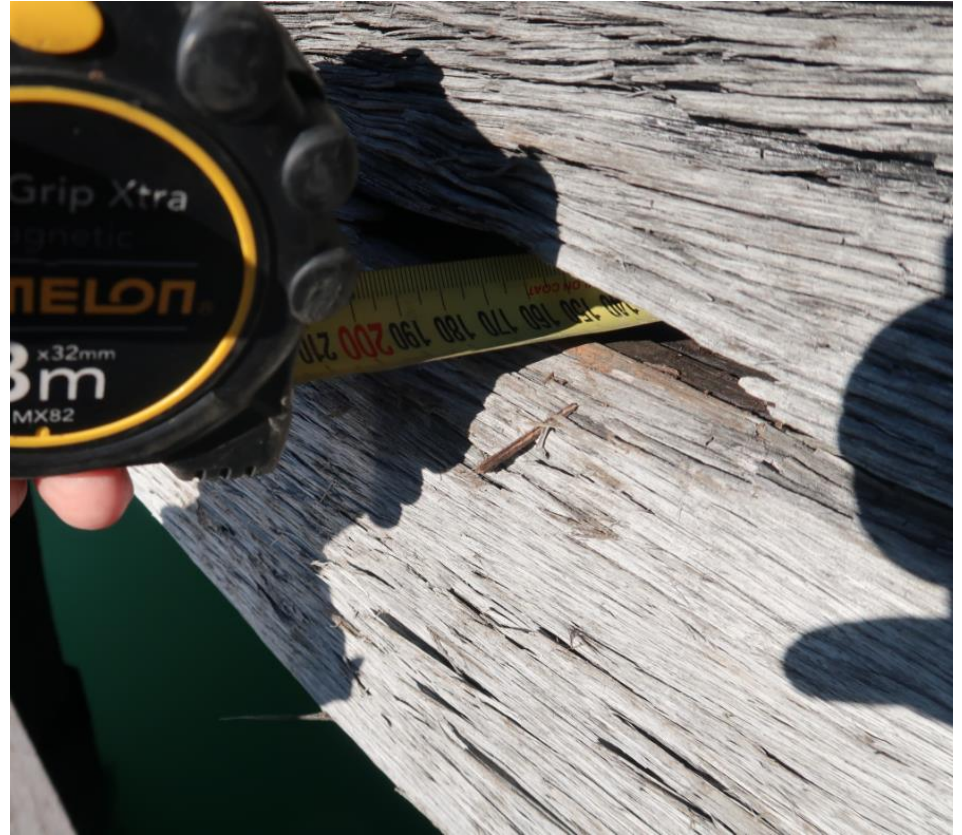
Photo Reference	Item Reference	Description	Photo Reference	Item Reference	Description
E	3	Replace bent fixing, reseal bracing flush to pile and install new bolt	F	4	Split to capping beam spanning piles 8D-8G

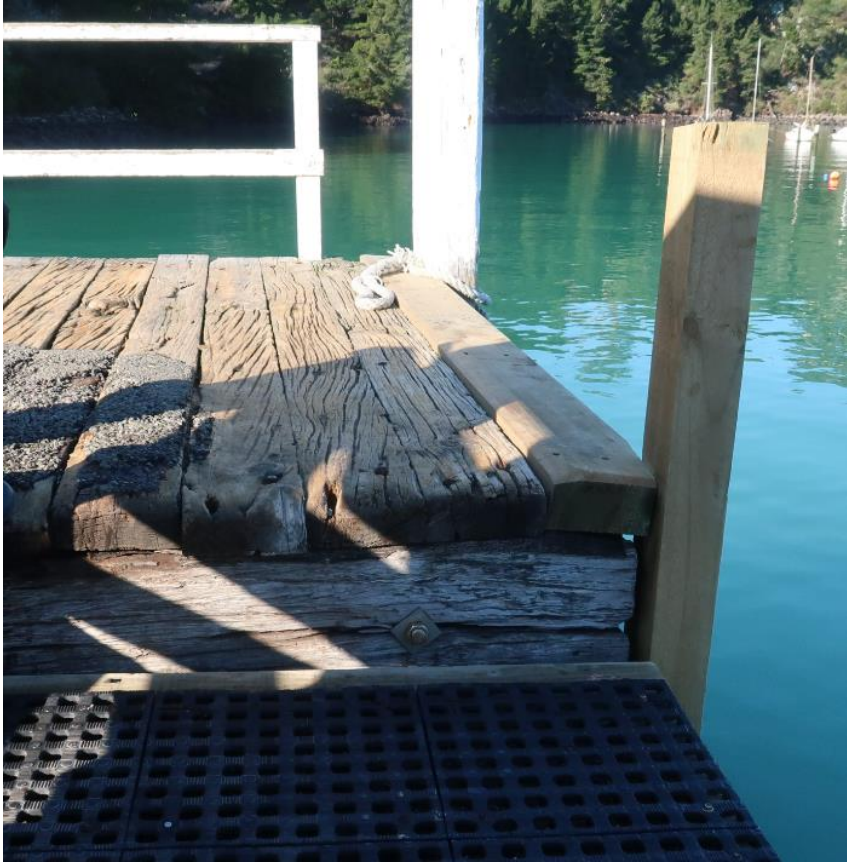
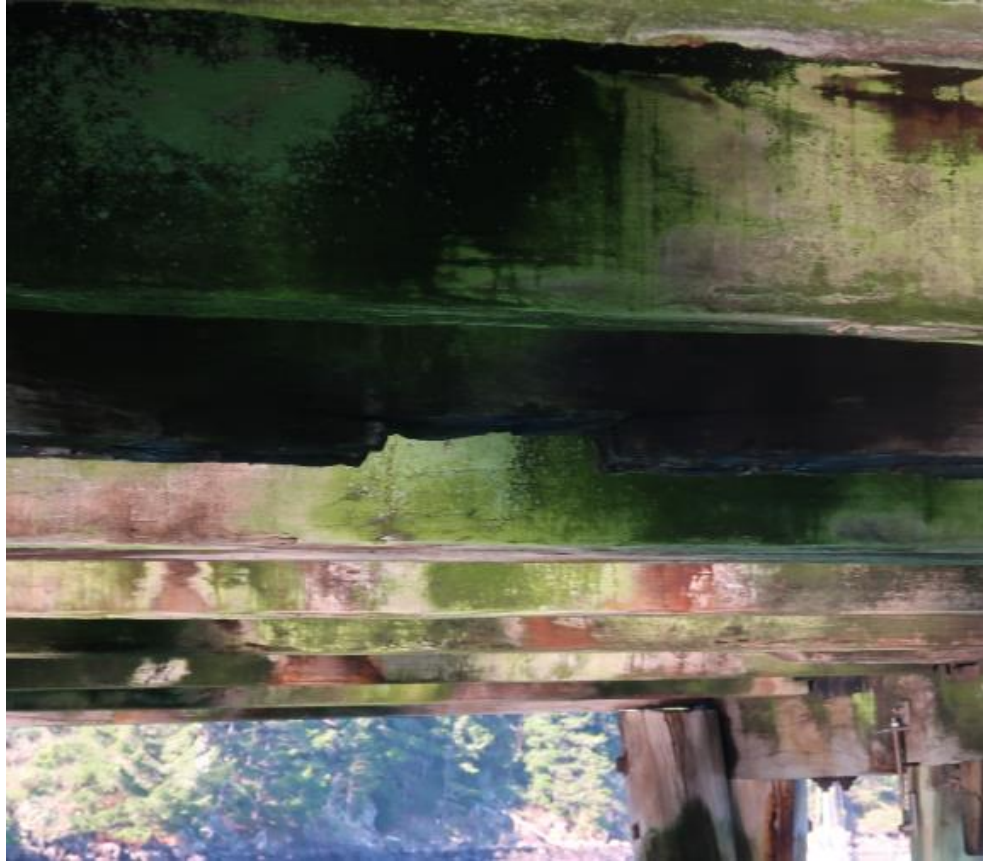
Photo Reference	Item Reference	Description	Photo Reference	Item Reference	Description
G	5	Cut fender backing timber at deck and install mooring cleat.	H	7	Existing stringer has notch near centre, new stringer to be installed alongside.

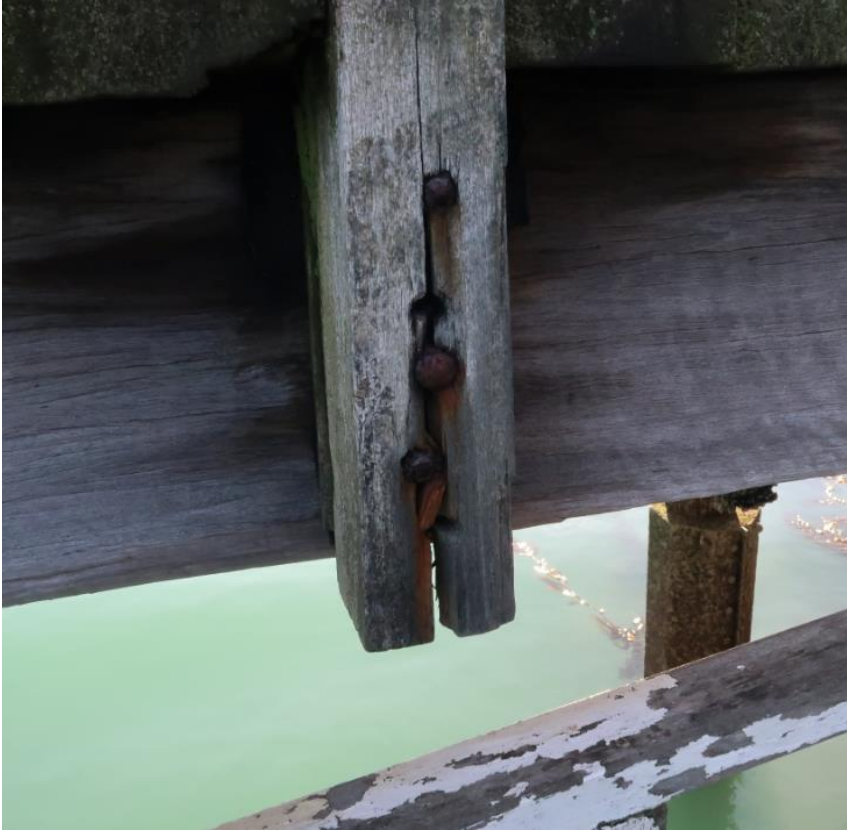
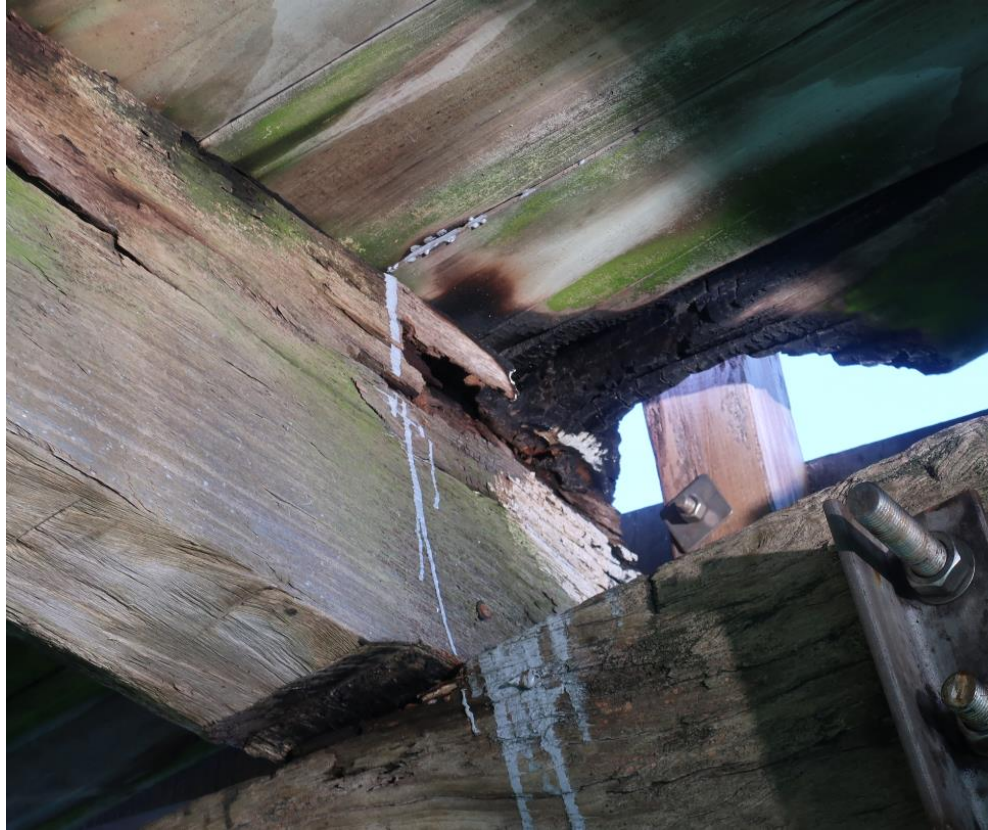
Photo Reference	Item Reference	Description	Photo Reference	Item Reference	Description
I	2	Handrail post to be replaced, post located near to 5B	J	9	End of stringer bearing on cap beam along grid 9 is rotten and has fire damage, top ¼ of stringer has lost integrity.

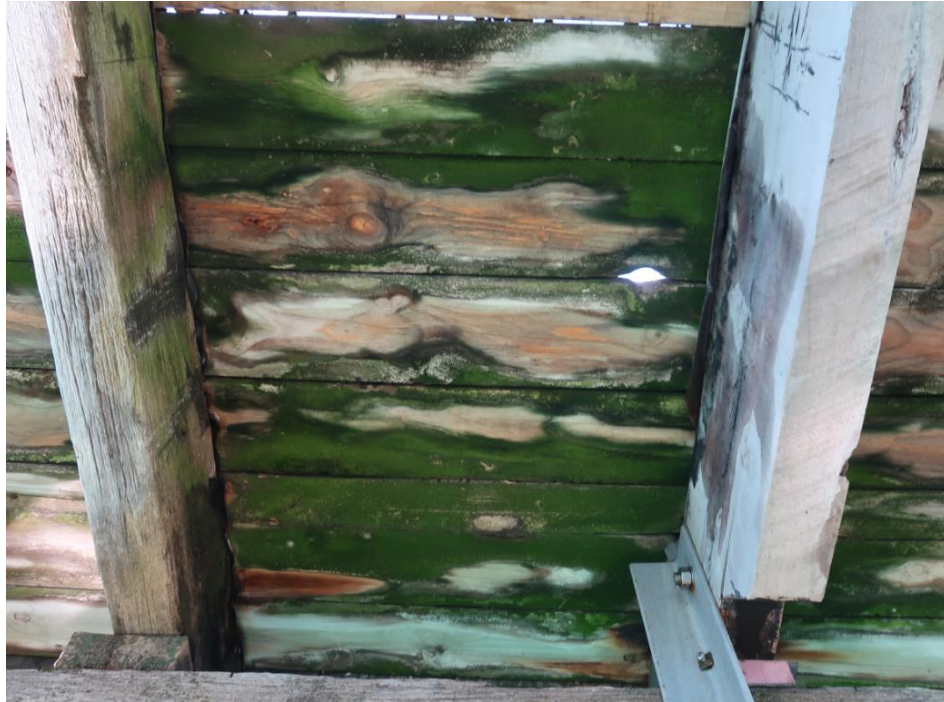
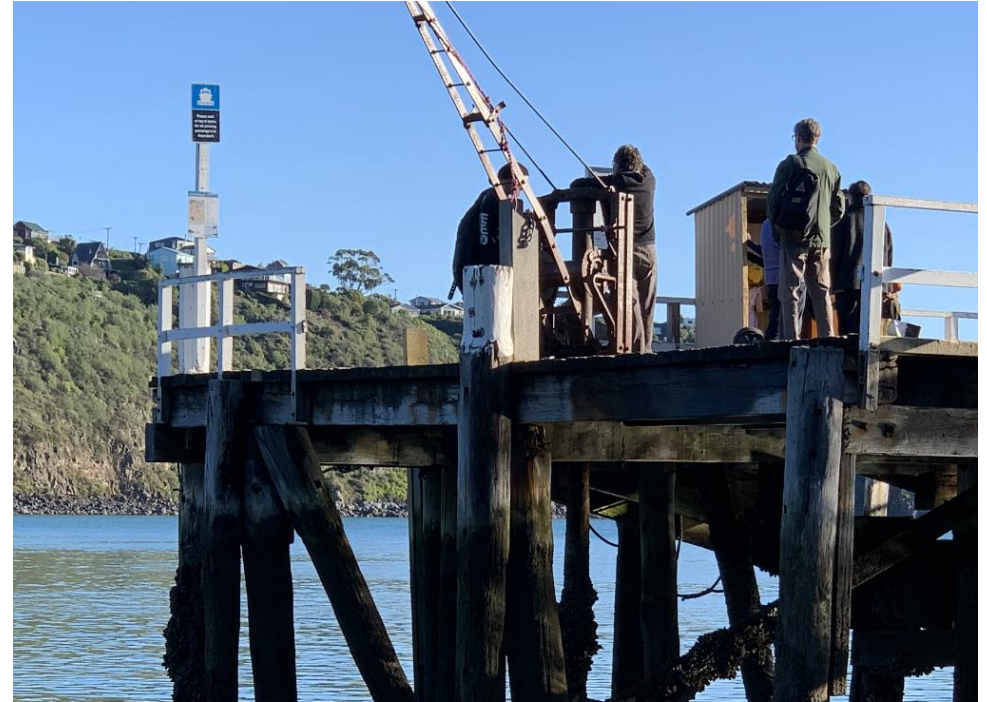
Photo Reference	Item Reference	Description	Photo Reference	Item Reference	Description
K	10	Install blocking for relocated crane	L	11	The pontoon ramp will be installed approximately where the derrick crane is currently located. A handrail will need to be installed

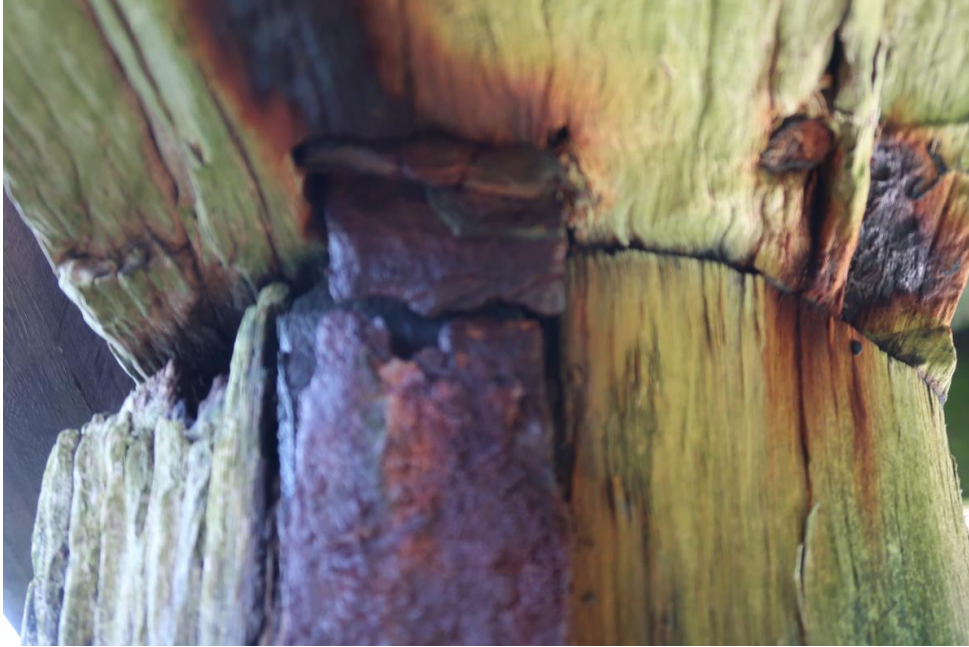
Photo Reference	Item Reference	Description	Photo Reference	Item Reference	Description
M	12	Fixing between pile 9E and corbel below stair stringer has failed and requires replacement.	N	13	Poor connection between pile 7A and capping beam

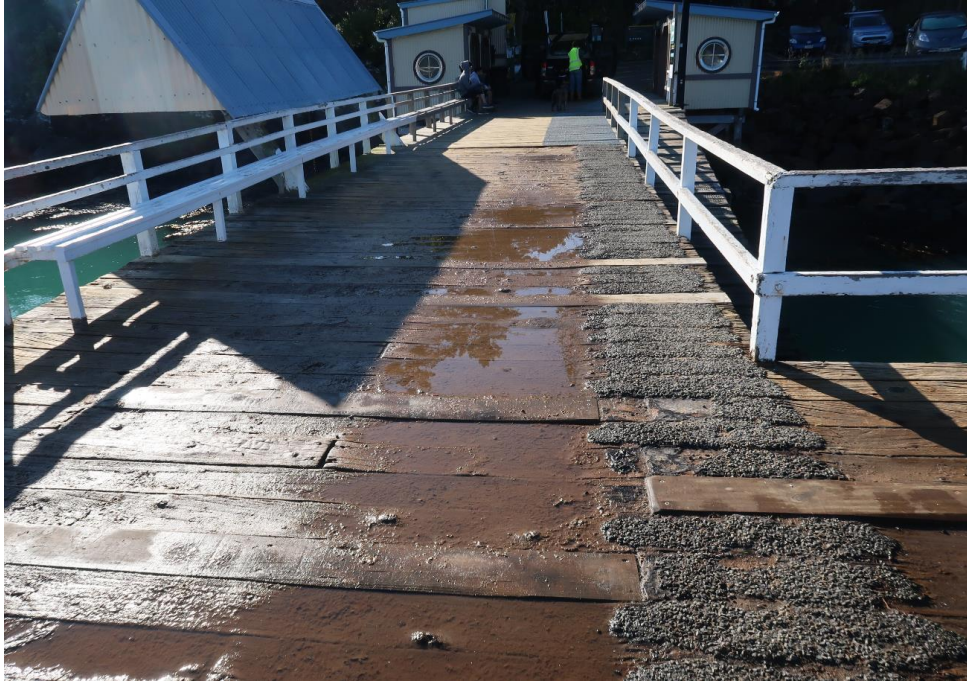
Photo Reference	Item Reference	Description	Photo Reference	Item Reference	Description
O	16	Worn decking members, some previously replaced and asphalt covering in moderate - poor condition.	P	12	Connection between pile 8C1 and capping beam has failed and requires replacement.

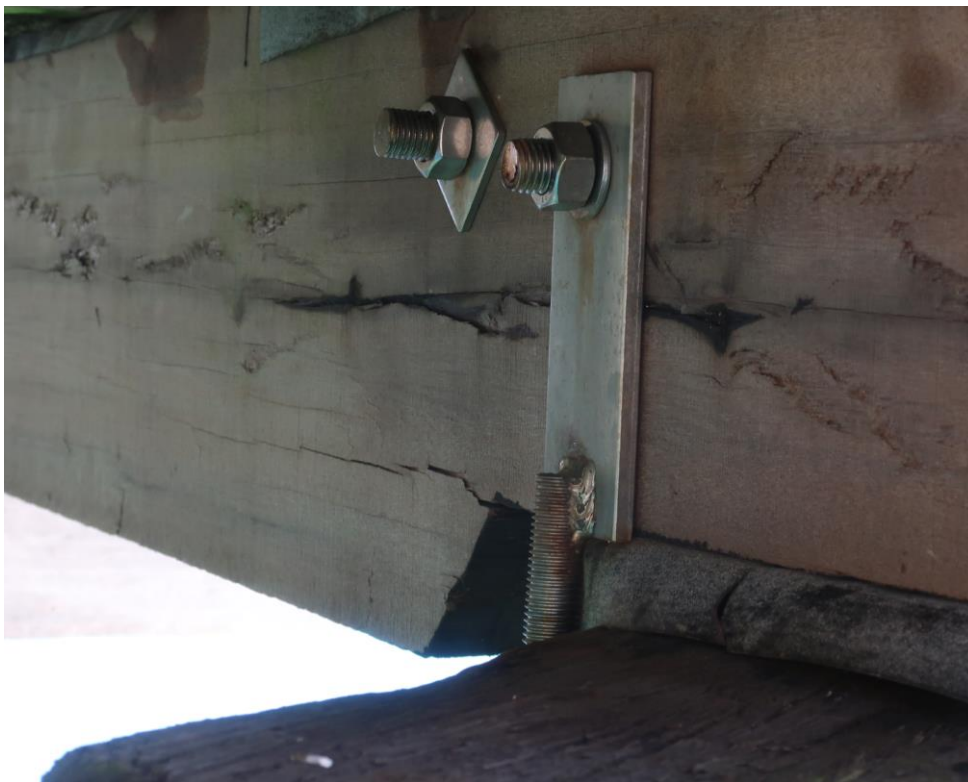
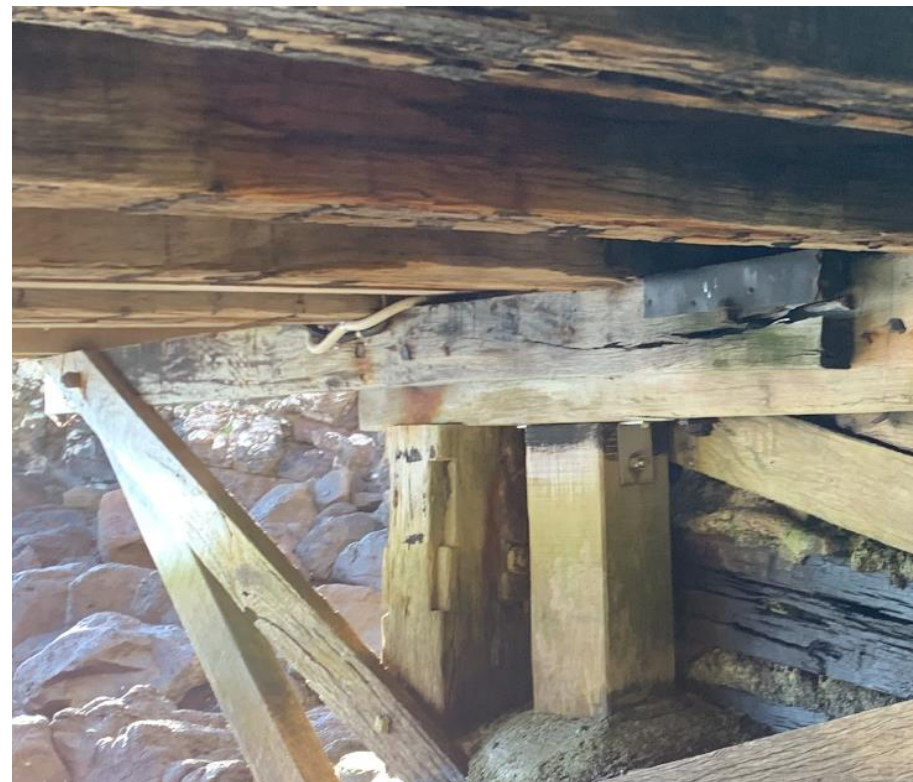
Photo Reference	Item Reference	Description	Photo Reference	Item Reference	Description
Q	17	Horizontal split in stringer n, between bents 8 & 9. Crack to be monitored with a splitter bolt installed if the crack develops.	R	18	Outrigger supporting northern shelter, attached to bent 1 capping beam is split. Note diagonal bracing to outer end provides support to outer.
