Damage Assessment Report

Grand National (Public) Stand

Client: Canterbury Jockey Club

Job No.: 60332326

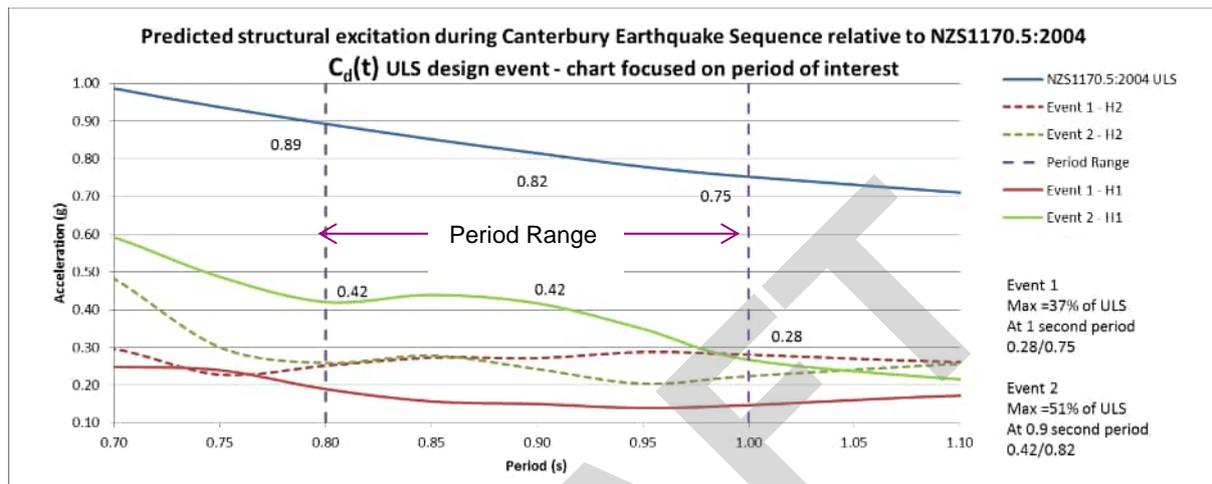
Figure 3: Ground Motion Excitation

A comparison of the plots for the pSa from Riccarton High School for both the September 2010 and February 2011 events against the NZS1170.5 horizontal design coefficient shows that the site did not experience a ULS design level earthquake.

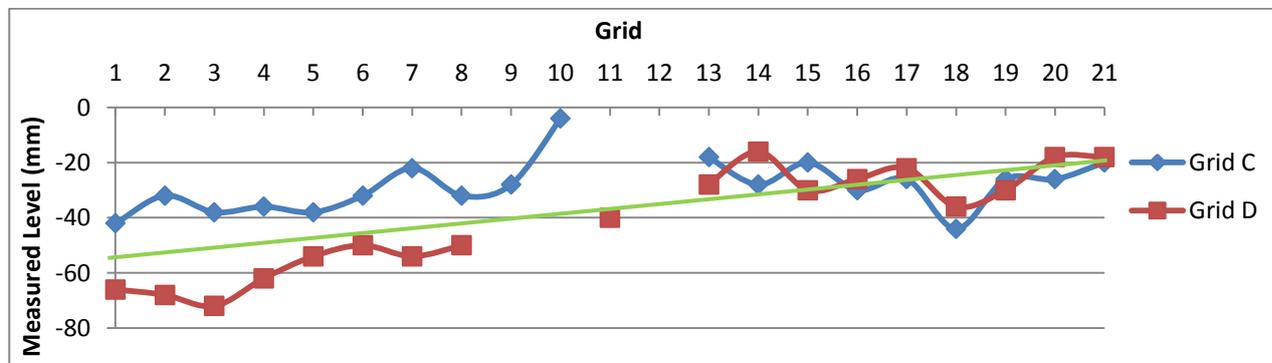
Figure 17: Ground Level Change in Floor Level along Grids

Figure 17 shows that the grids located at the western end are lower than the grids at the eastern end. It is also shows that the measured levels around the perimeter beam wall, grid D, is lower than interior measured levels.

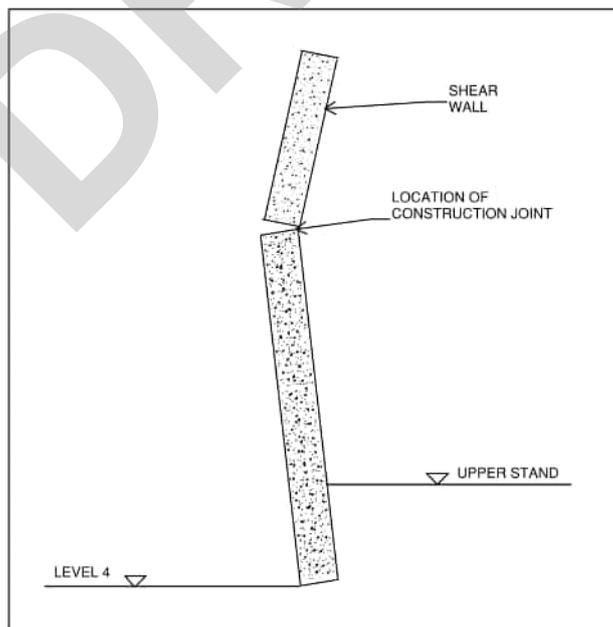
Figure 30: Hinging inferred from verticalities and crack patterns

There is a noticeable difference between verticality measurements taken at the top of the wall and measurements taken at the bottom of the wall. This is likely due to hinges forming along a horizontal crack on the cold joint, which is around mid-height, running the entire length of the wall, both on the interior and exterior faces, see Figure 30.

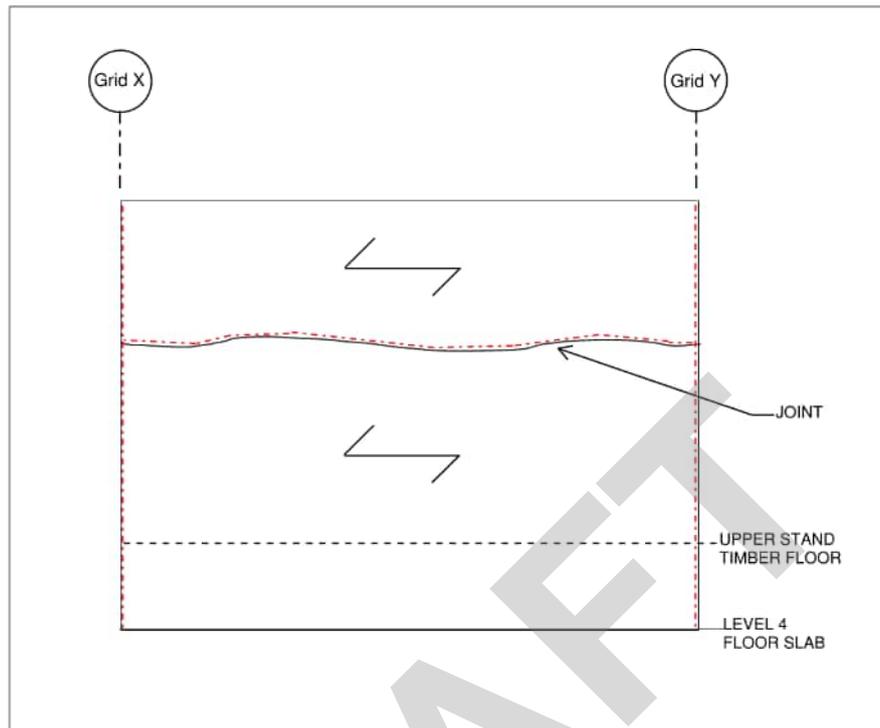
Figure 36: Observed Yield Line Pattern

The observed damage can be analysed using yield line theory. The roof trusses are restraining the wall at each grid line, seen in red in Figure 31. As the wall is not well reinforced, these restraints act as pinned connections with the length of wall between each connection acting as individual panels, free to rotate about the points of restraint, as shown in Figure 34. This causes cracks to form at the restraints, and an expected yield line pattern as shown in Figure 35. However, as discussed above, the observed cracking to each panel is on the location of the cold joint. This is likely due to the cold joint being a plane of weakness and therefore the first place a crack will form. This leaves the top and bottom parts of the wall spanning horizontally, with cracks forming at the restraints, see Figure 36. These vertical cracks have occurred on some, but not all of the panels.

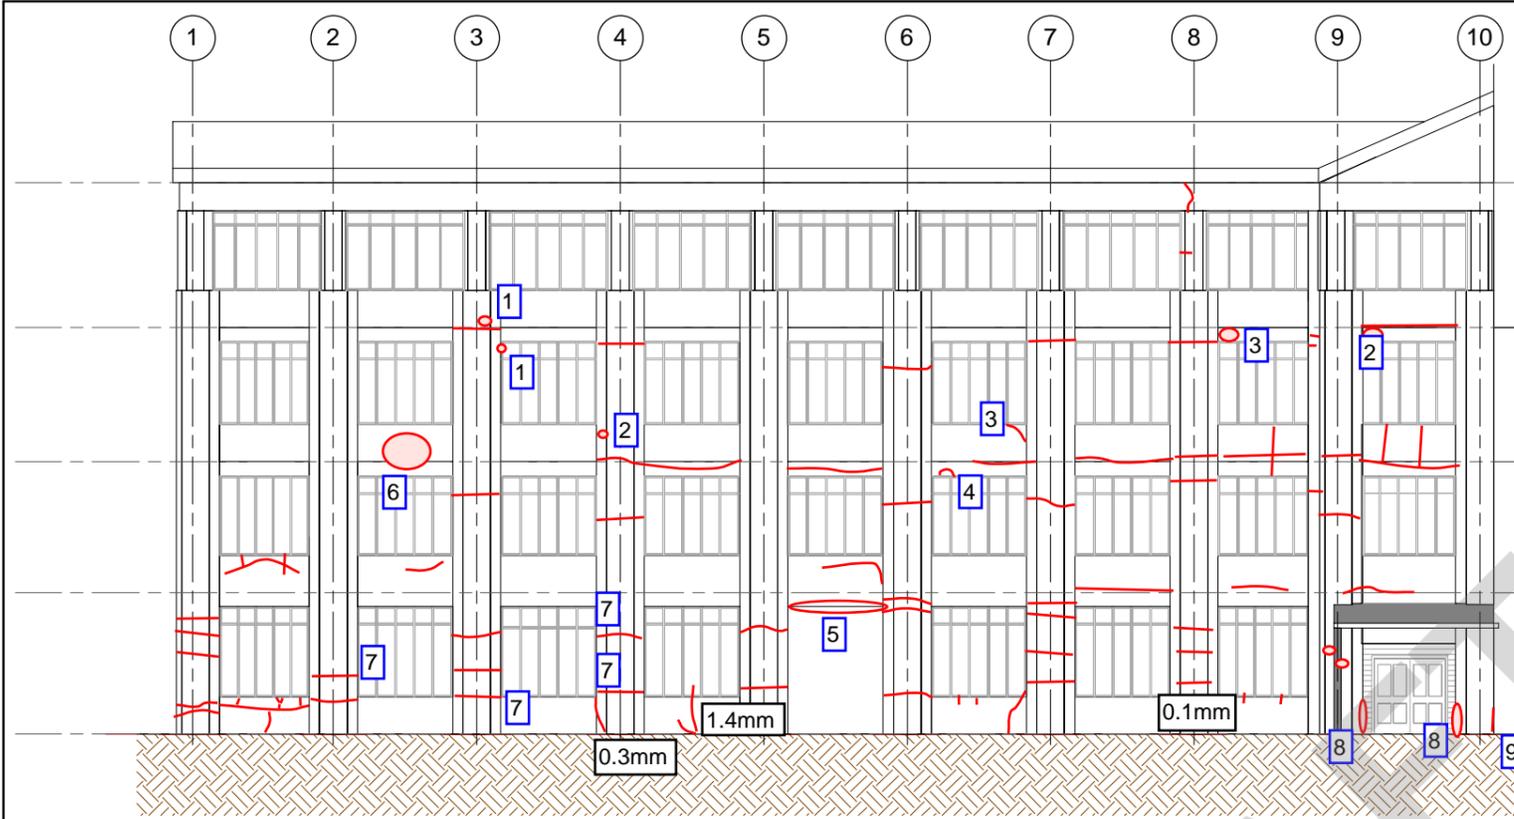
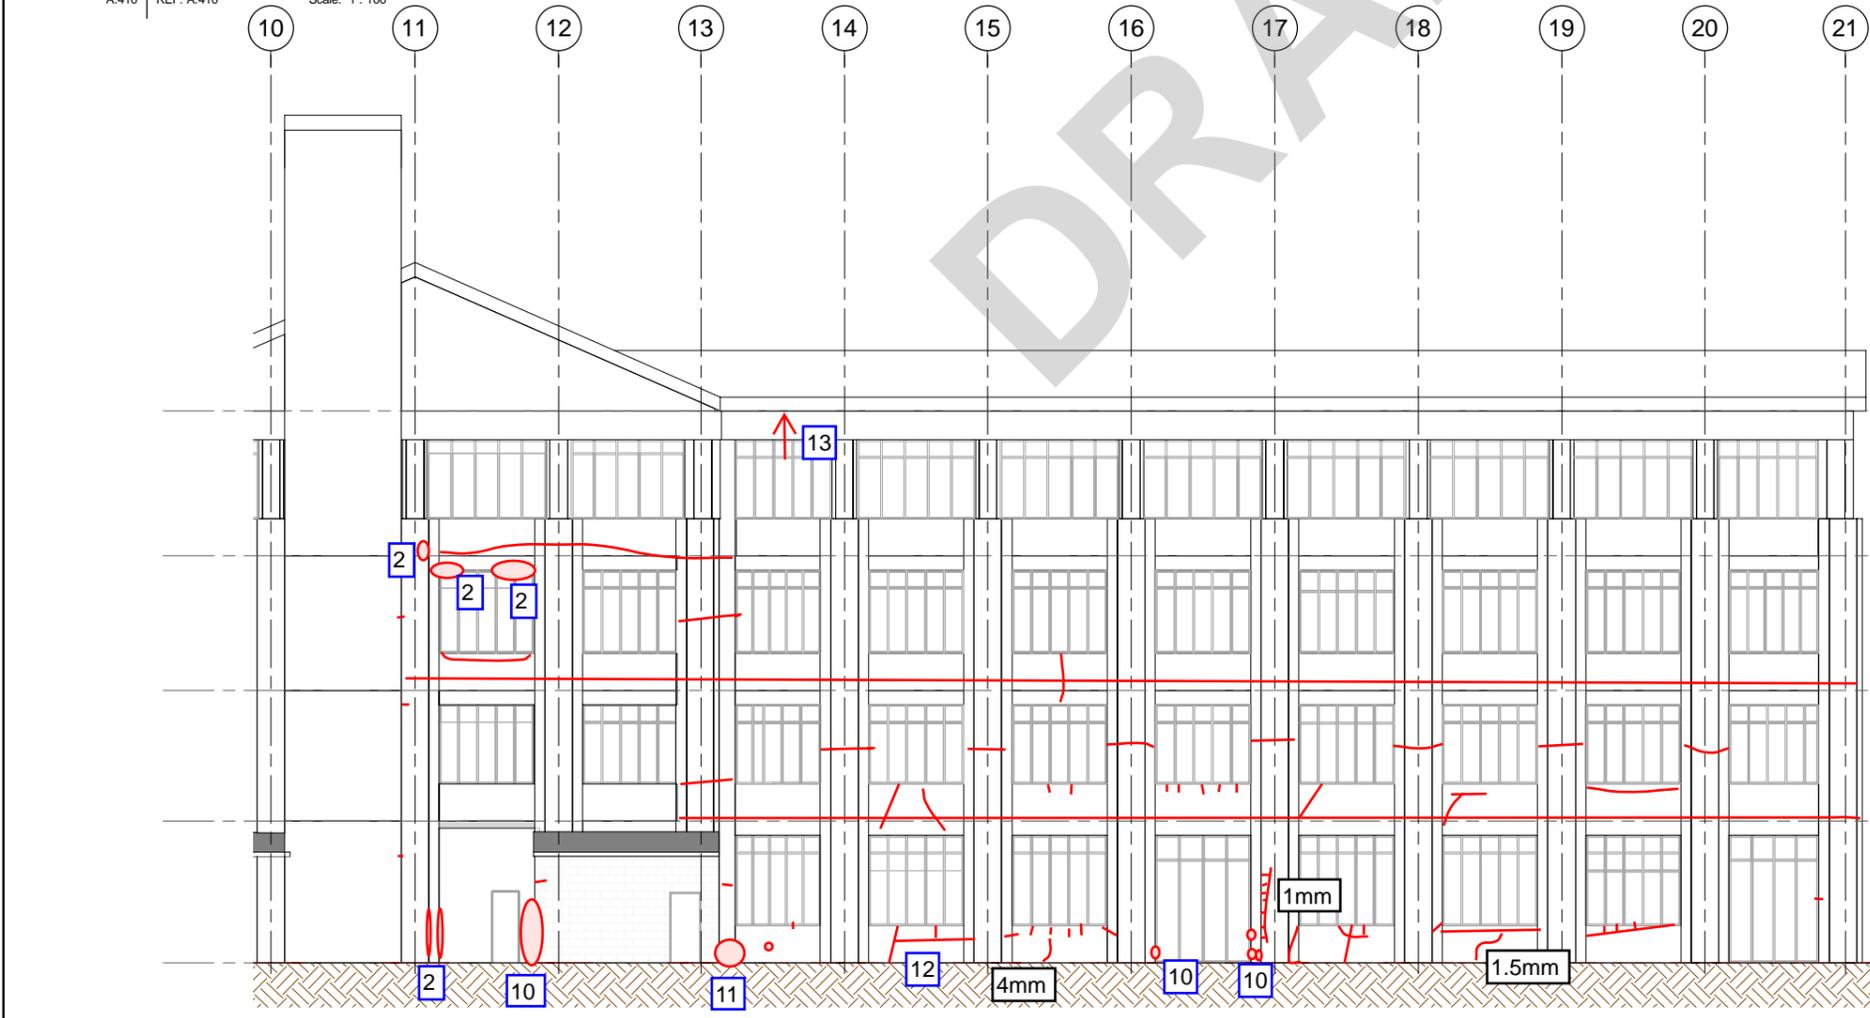
1. Spalling exposing rebar
2. Spalling
3. Exposed rebar
4. Patch repair
5. Render cracking off
6. Typical cracking to render
7. HC whole way around column
8. Evidence of historical repair
9. Separation between column and wall
10. Damage to the corner
11. Stormwater pipe WD
12. 2mm cracking through window sill
13. Damage to the soffit

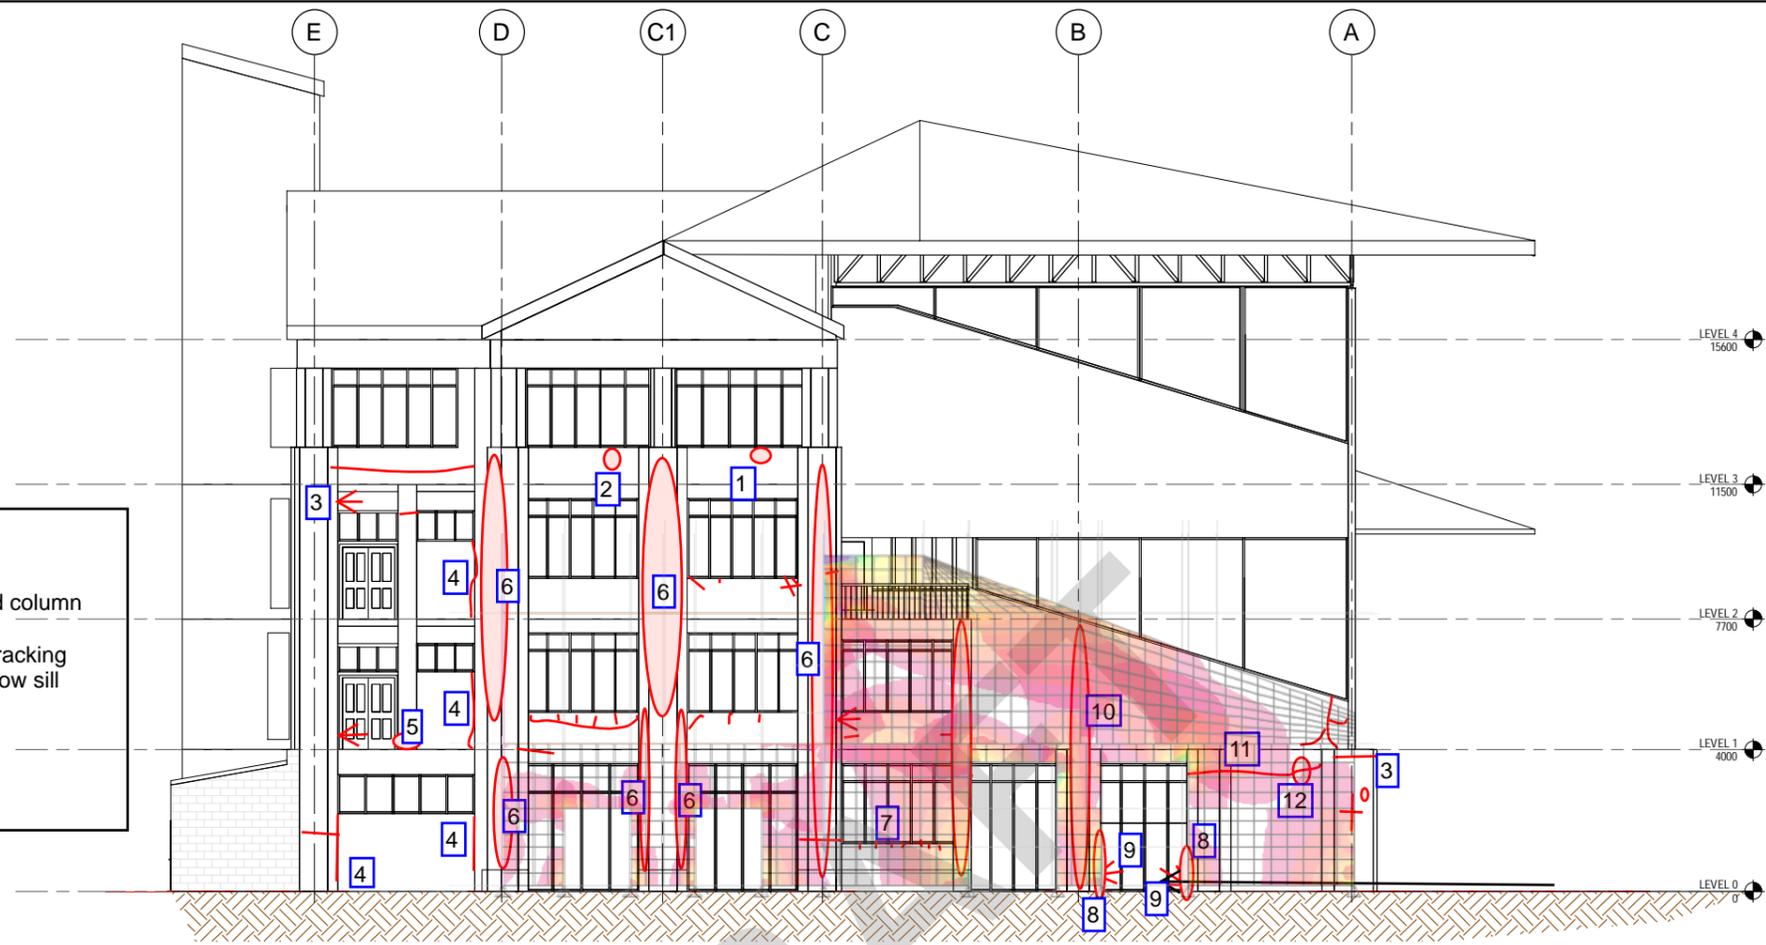
DAMAGE ON ELEVATIONS - ELEVATION EAST
(See A.111 For Location) Scale: 1 : 100

- Legend - East Elevation**
1. Crack damage
 2. Orange stain
 3. Spalling
 4. Separation between wall and column
 5. Cracking around handrail
 6. Dark stain with spider web cracking
 7. Multiple cracks through window sill
 8. Cracked corners
 9. Exposed rebar
 10. Recess in concrete WD
 11. Significant crack inside
 12. Broken out

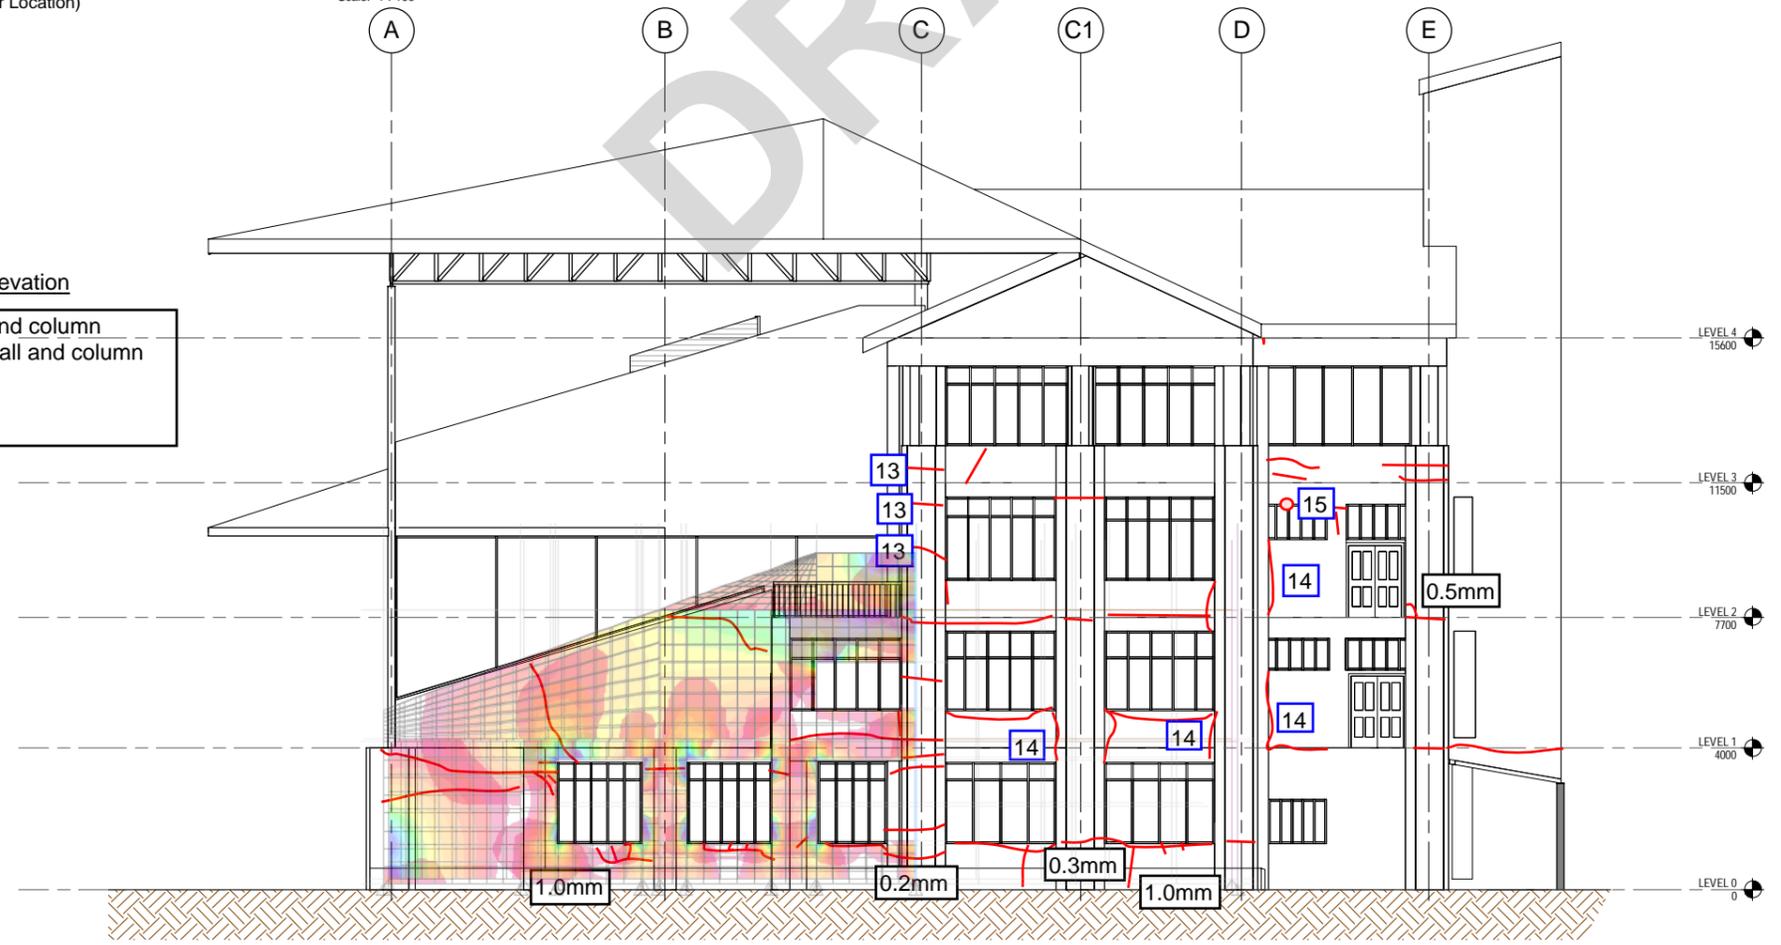
DAMAGE ON ELEVATIONS - ELEVATION WEST
(See A.110 For Location) Scale: 1 : 100

- Legend - West Elevation**
13. Crack whole way around column
 14. Separation between wall and column
 15. Render chipping off

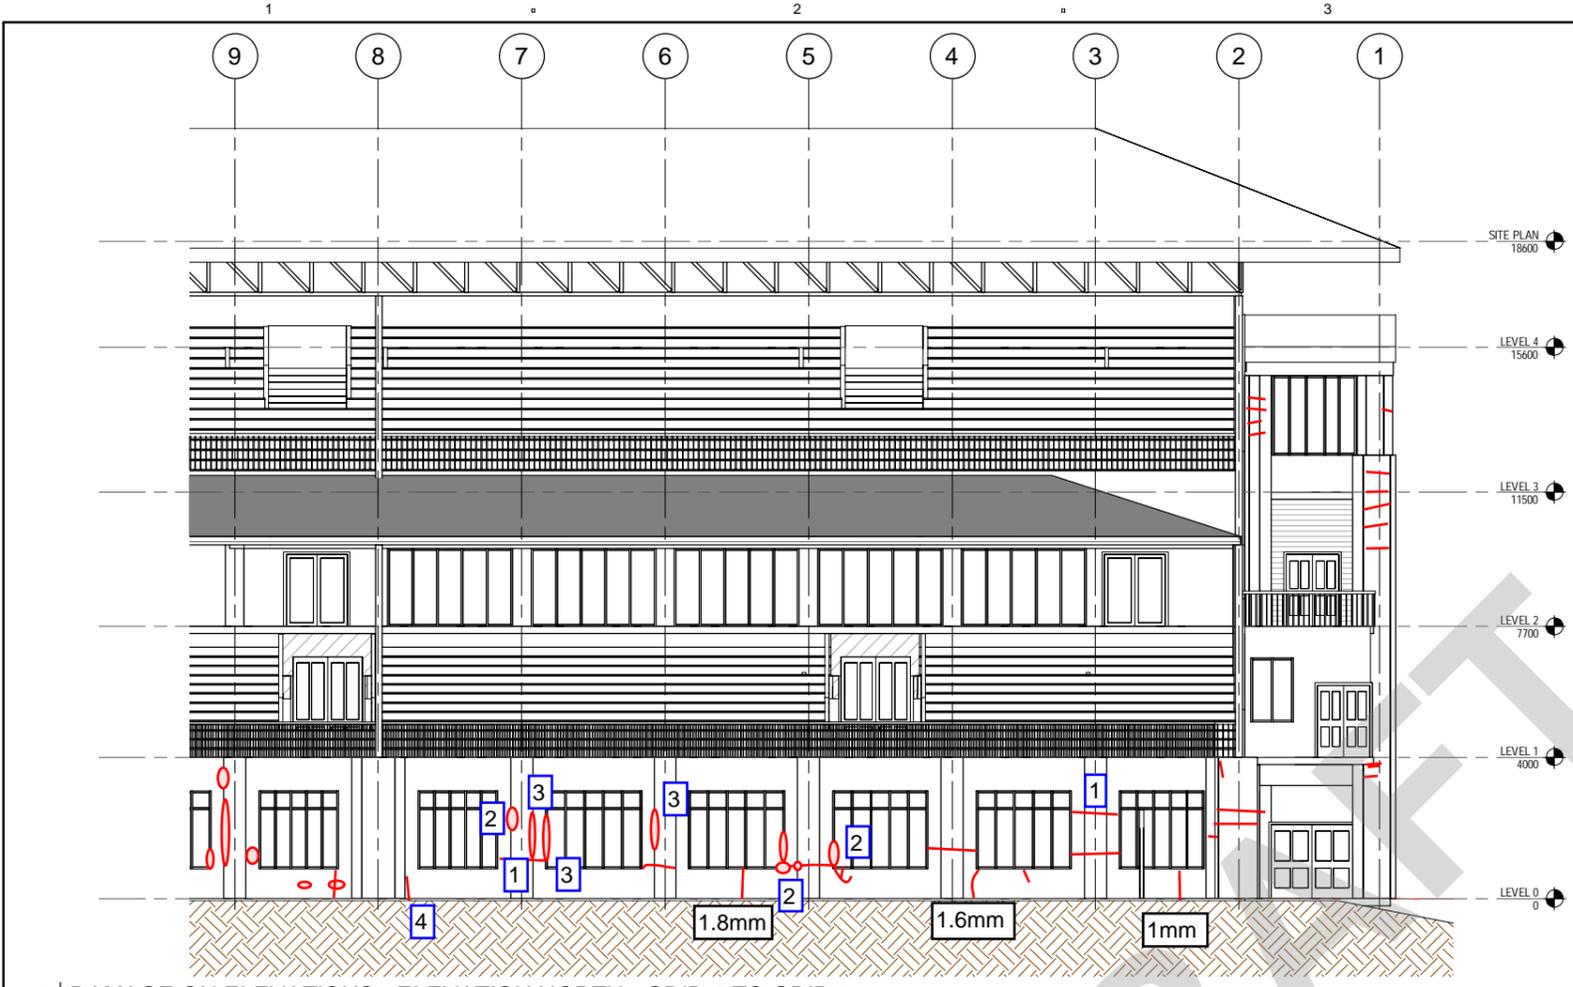
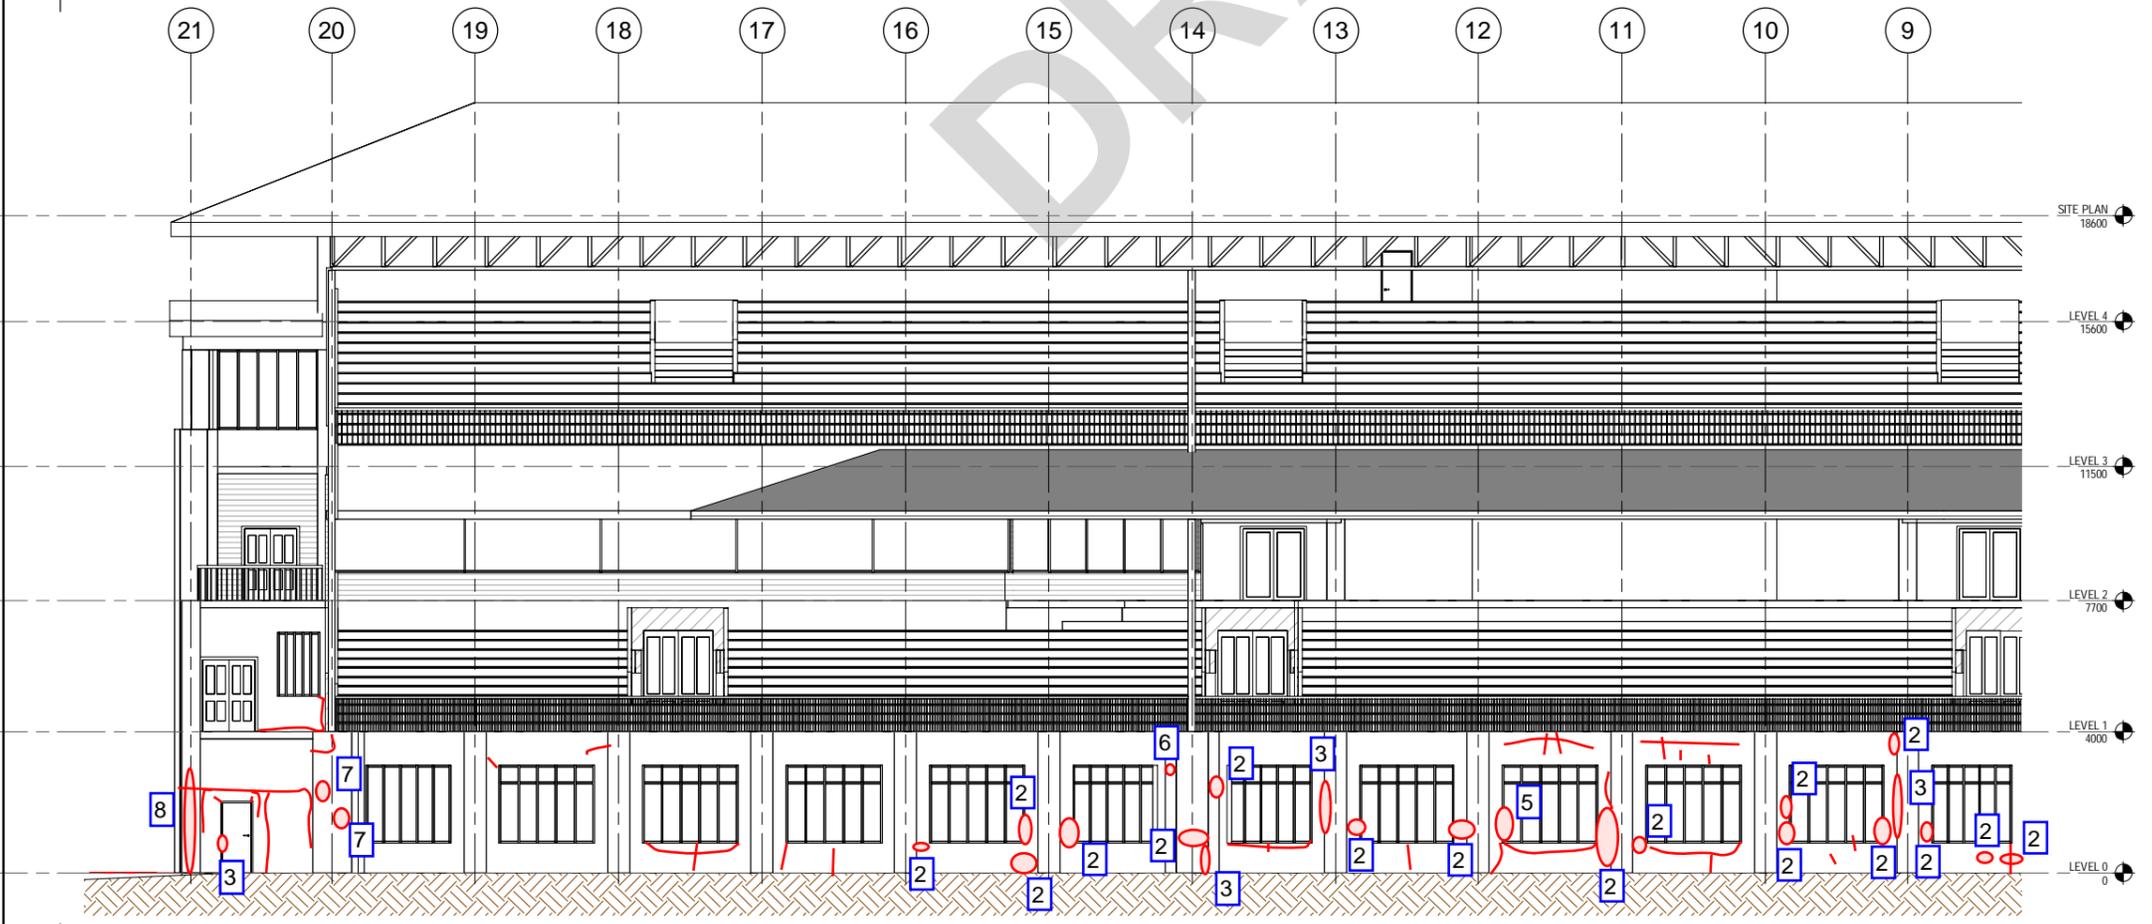
- Legend**
1. Crack at CJ
 2. Poor quality concrete
 3. Corner chipped away
 4. Separation between wall and column
 5. Poor quality concrete rebar exposed
 6. Exposed wire
 7. Damaged render
 8. Dark patches with cracks

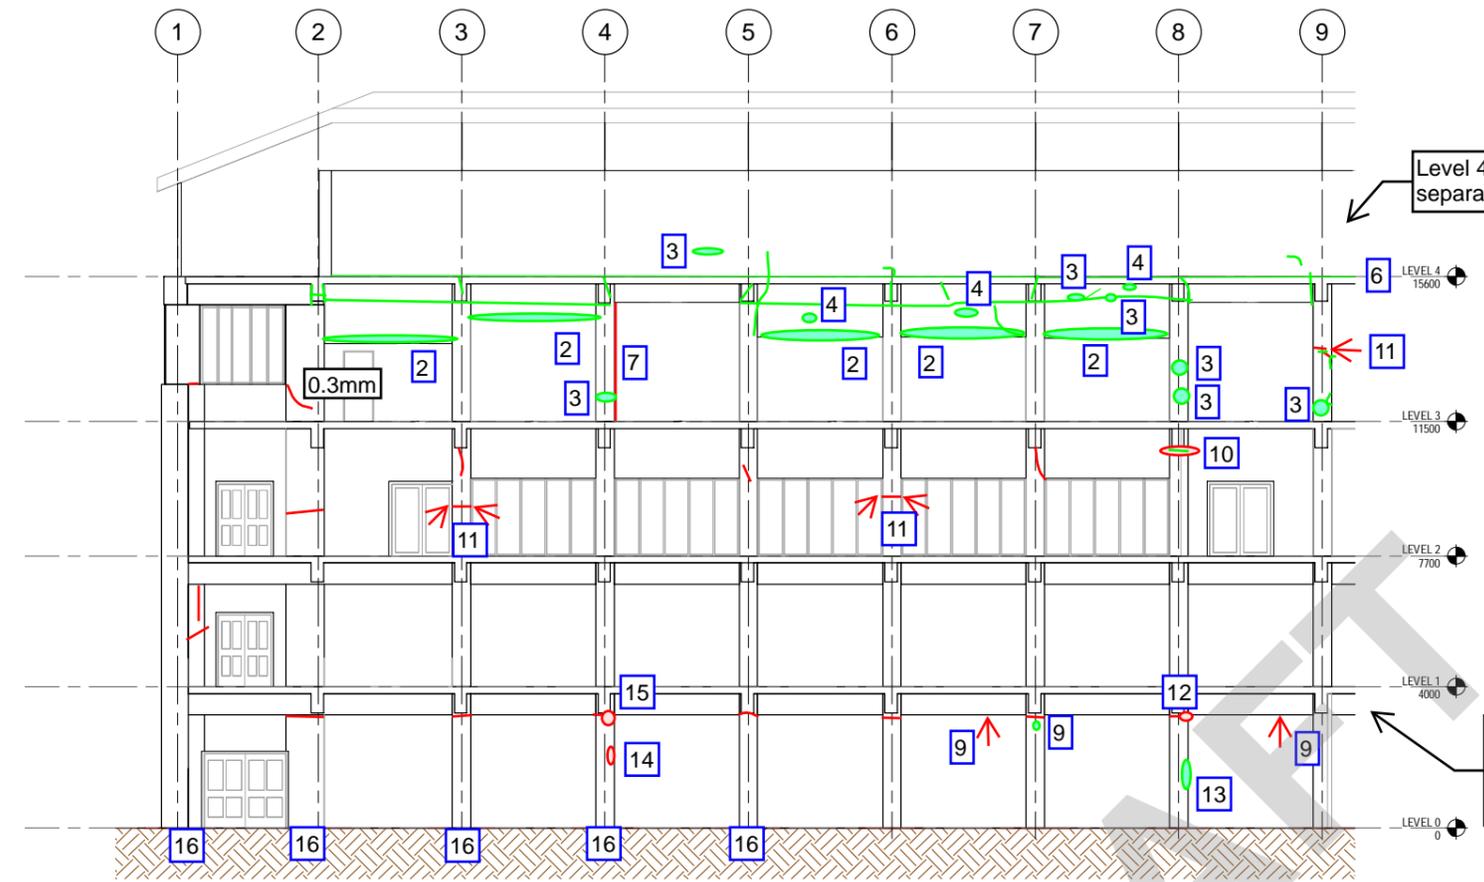
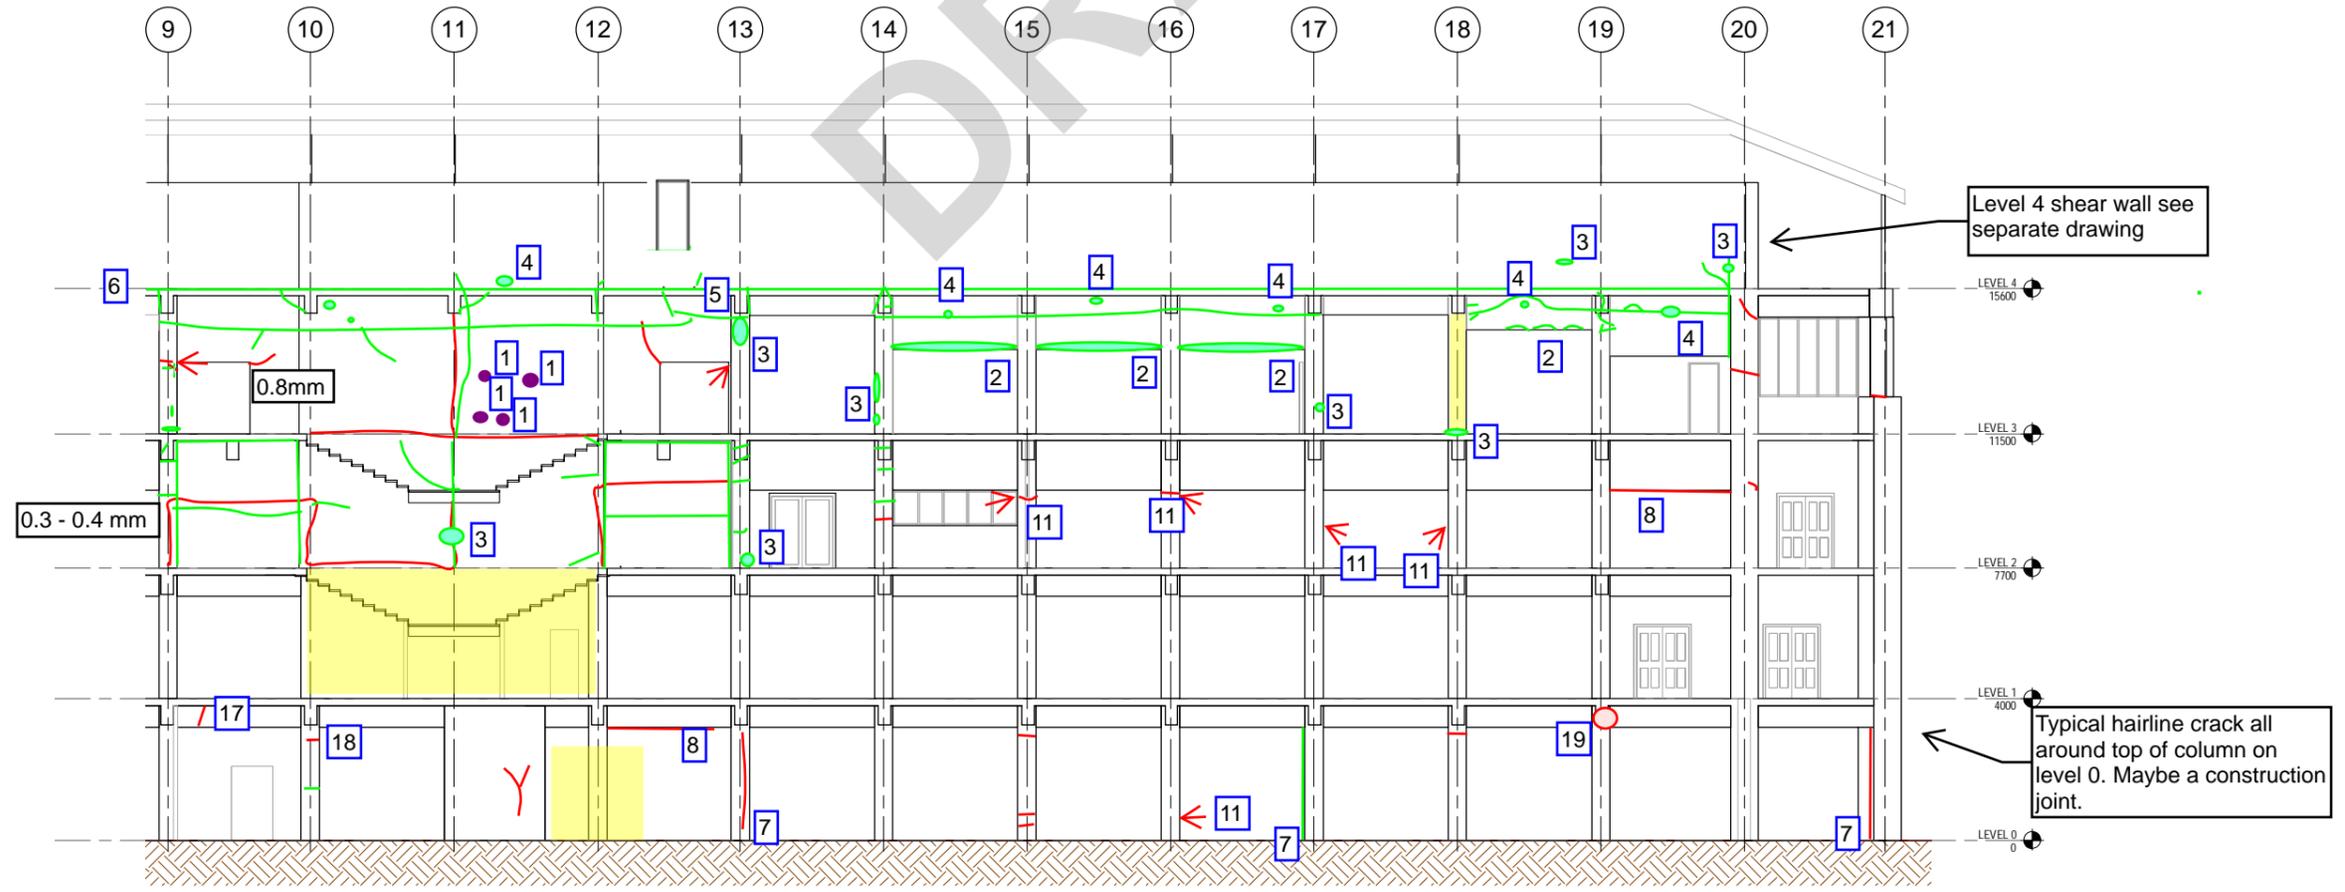
- Legend**
1. Core samples
 2. Broken out for void opening
 3. Spalled concrete
 4. Broken out hole with spalling
 5. WD through crack
 6. Full length crack through CJ
 7. Separation between column and wall
 8. Separation between beam and wall
 9. Drilled hole
 10. Plate in column
 11. Hairline crack around sides
 12. Chipped corner
 13. Piece of timber in concrete
 14. Broken out
 15. Poor compaction
 16. Timber boards nailed into column
 17. Significant crack
 18. Notch in column
 19. Minor crack damage

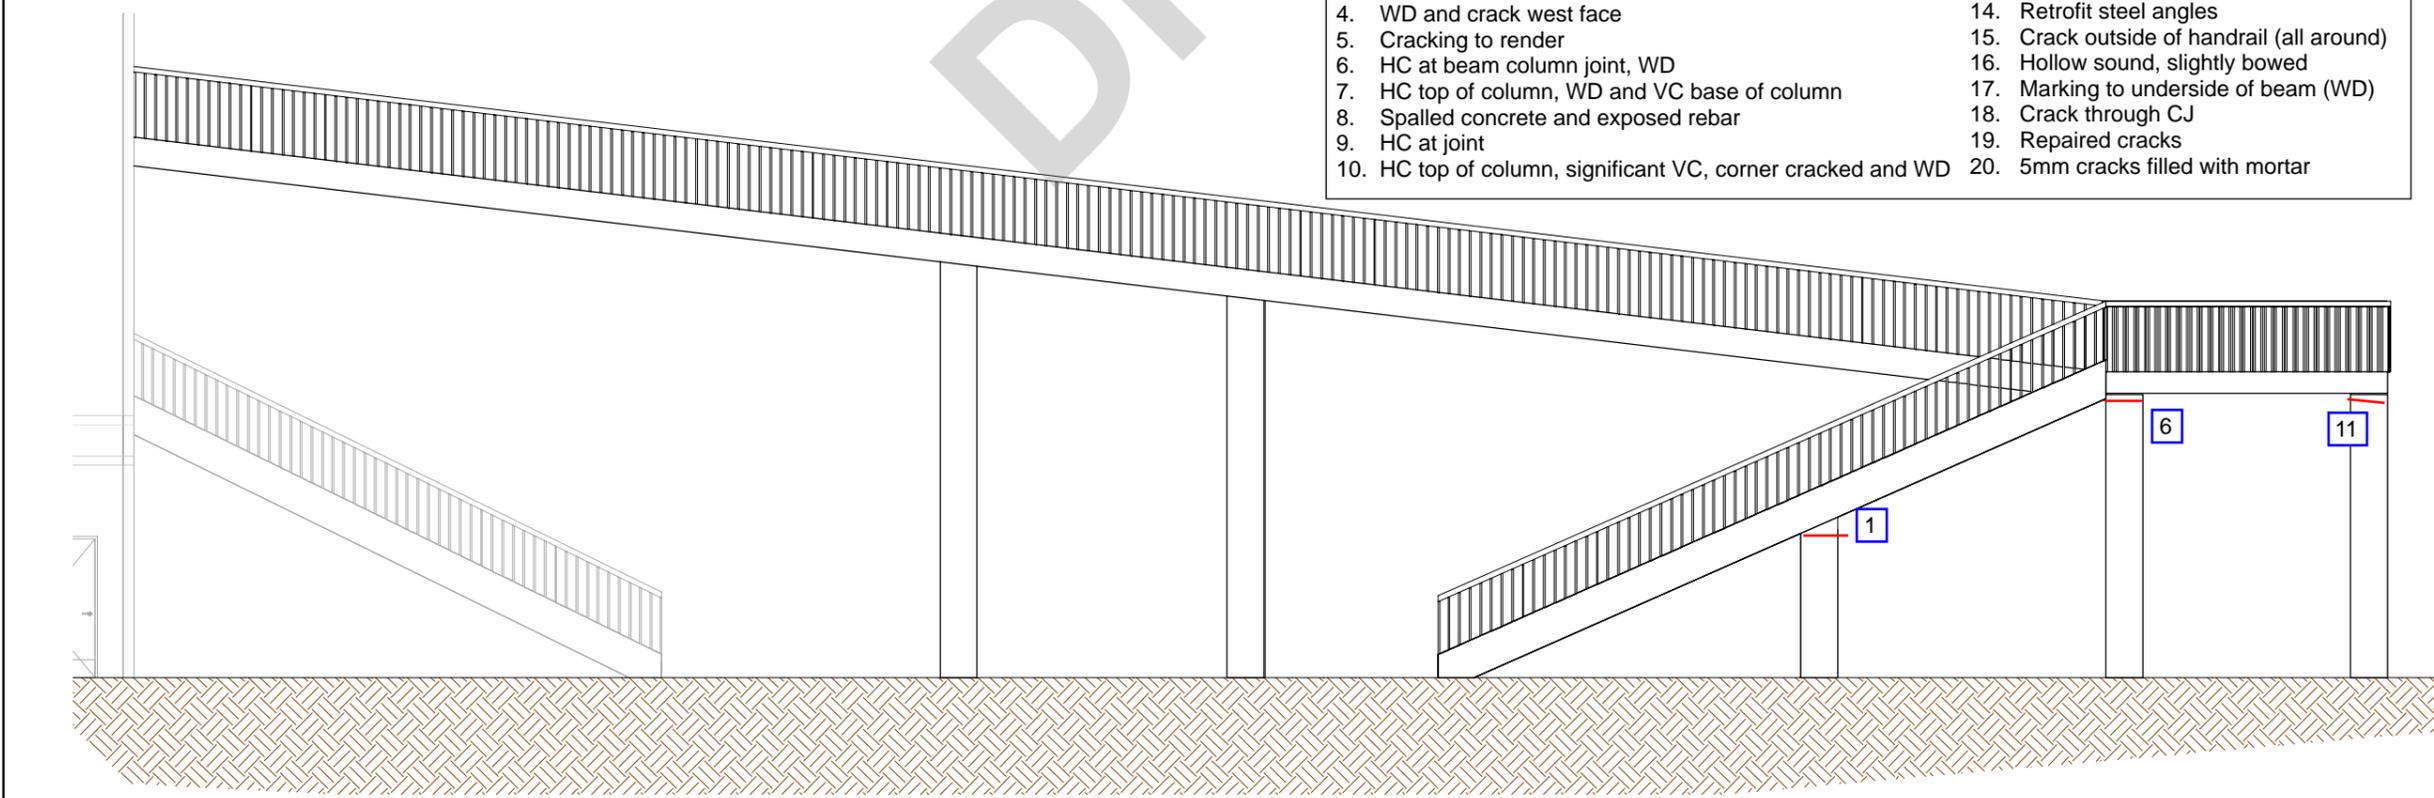
EAST RAMP DAMAGE ASSESSMENT - ELEVATION

1. Crack (0.5mm) whole way round column	11. HC all around the top, VC two faces
2. Crack to top of column on north face	12. Spalled concrete around hand rail
3. WD south face	13. WD with apparent leaking
4. WD and crack west face	14. Retrofit steel angles
5. Cracking to render	15. Crack outside of handrail (all around)
6. HC at beam column joint, WD	16. Hollow sound, slightly bowed
7. HC top of column, WD and VC base of column	17. Marking to underside of beam (WD)
8. Spalled concrete and exposed rebar	18. Crack through CJ
9. HC at joint	19. Repaired cracks
10. HC top of column, significant VC, corner cracked and WD	20. 5mm cracks filled with mortar
