Massey, C. I.; Della Pasqua, F.; Lukovic, B.; Yetton, M. D.; Archibald, G.; Ries, W. 2014. Canterbury Earthquakes 2010/11 Port Hills Slope Stability: Risk assessment for Clifton Terrace. *GNS Science Consultancy Report 2014/76*. 125 p. + Appendices

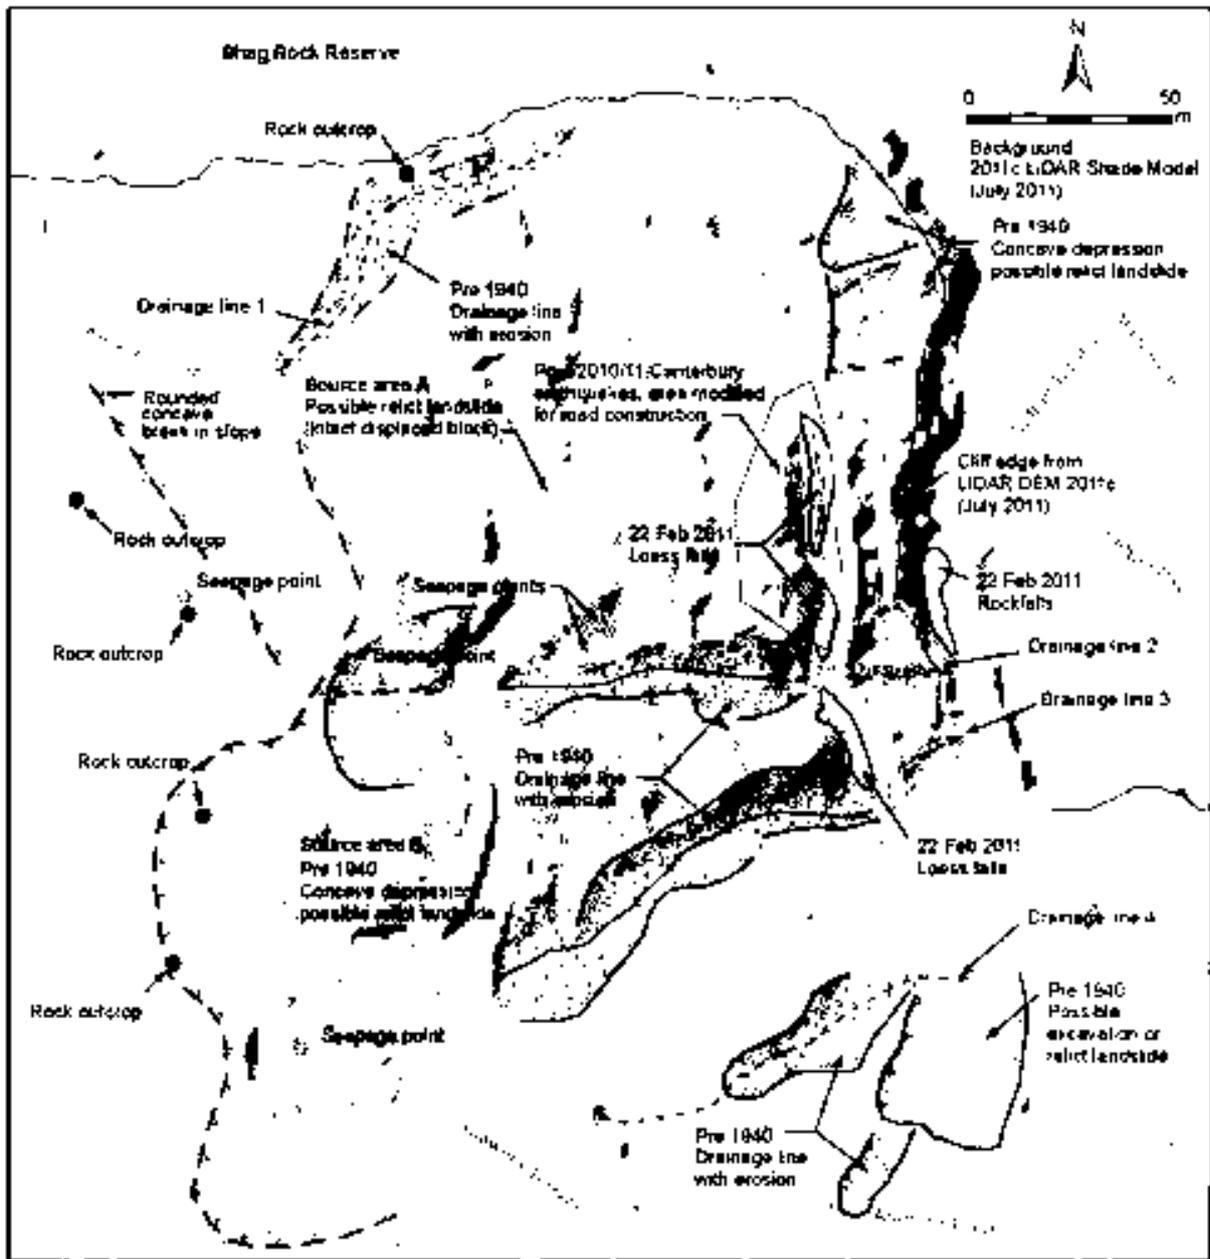
**Figure 5** Main features identified at the Clifton Terrace site from field mapping and interpretation of aerial photographs.

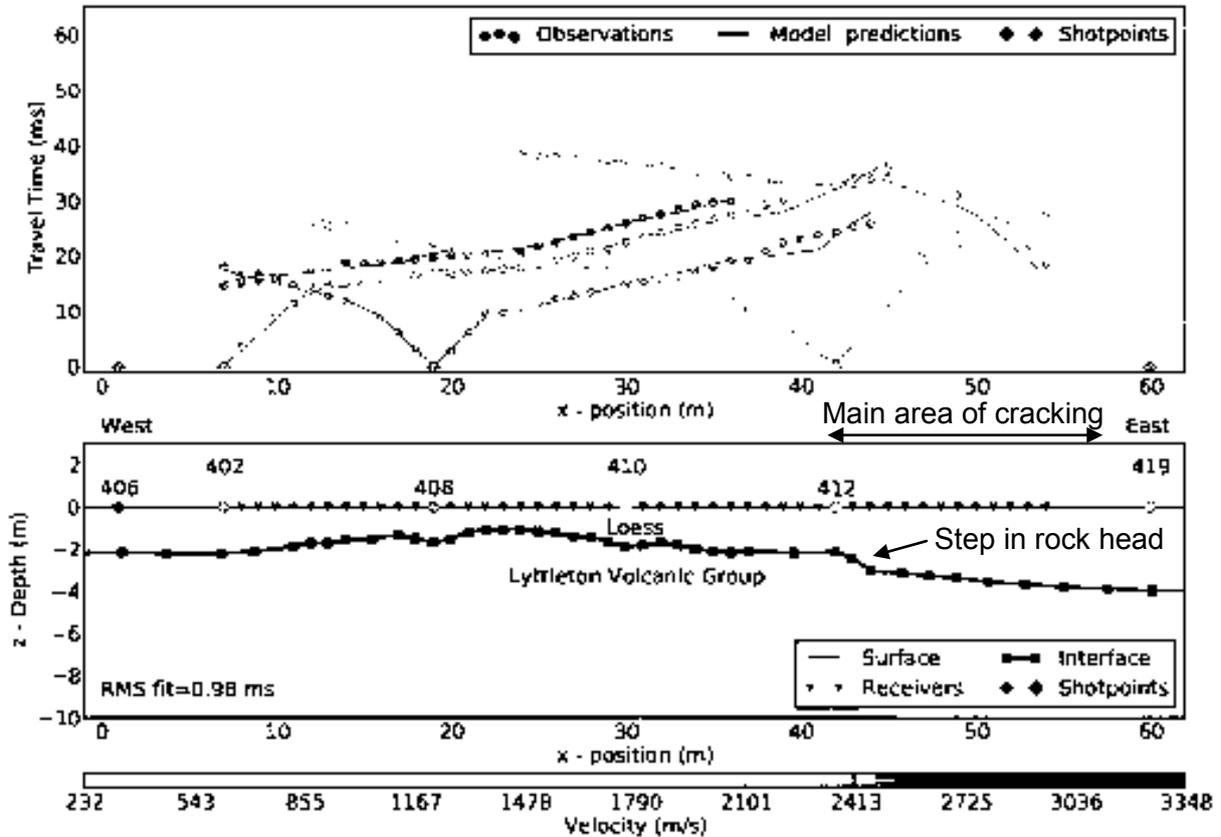
**Figure 15** Results from the refraction seismic collected across the head scarp of assessed source area A (Clarke, 2012). The location of the survey line is shown in Figure 6. The data shown are taken from Clarke (2012) and are Inversion models adopting the root mean squared fit. Note: from x-position 0 to 7 m and from 55 to 60 m there is no data.
