# Christchurch Tide Gates and Other Fish Barriers

September 2025

Prepared for: Christchurch City Council

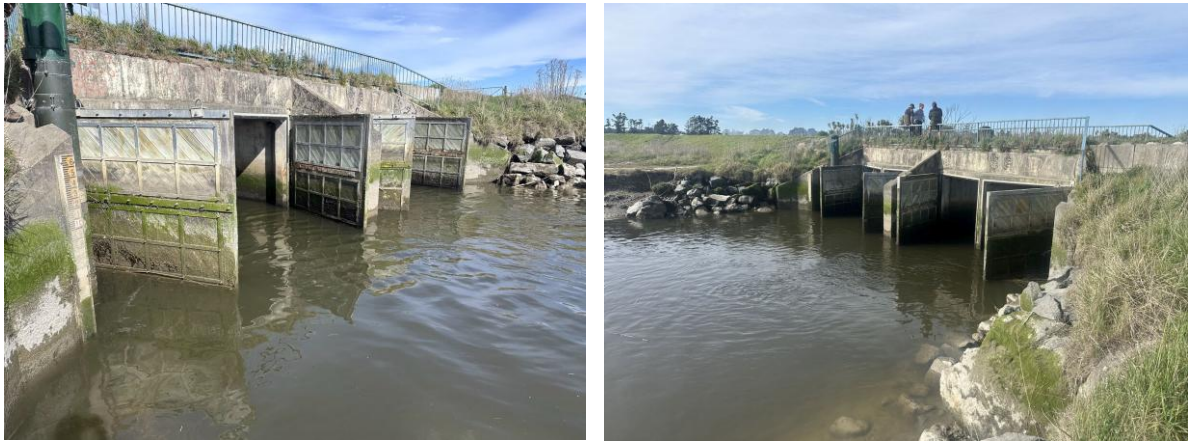
The Pūharakekenui–Styx River main tide gates are located at the outlet of the Styx River, near where the waterway discharges into Brooklands Lagoon. The structure features four, large, side-hinged gates (Figure 2). During a site visit on 2 September 2024, the gates appeared to be in good condition and were functioning as intended.

Observations from Steve Leiataua (CCC), suggest that the gates shut very slowly on the incoming tide, taking several hours to fully close. During our September site visit, water was actively flowing upstream on the incoming tide, while the gates remained almost completely open. Once closed, they remain in this state for approximately six hours, or half the tidal cycle (i.e., the gates are closed approximately 50% of the time; Pers. Comm. Steve Leiataua, CCC, September 2024).

Figure 2: The tide gates in the Styx River, near the outlet into Brooklands Lagoon.

Based on the observations described above, fish migration is likely to be substantially impacted by the gates, approximately 50% of the time. When the gates are open, fish have free passage upstream. Weak swimming and climbing inanga (*Galaxias maculatus*) are known to be abundant upstream of the structure, and the waterway supports a productive whitebait fishery. When the gates are closed, there is no alternative passage, and all fish species are likely impacted, including upstream and downstream migrants.

- Further study is required to confirm temporal impacts of these gates, including confirmation of the duration during which they are closed, and potential velocity barriers that may occur during different stages of the tidal sequence.

- A telemetered river height gauge is located immediately downstream of the structure<sup>3</sup>. A review of the associated data was undertaken; however, no clear patterns were identified that could be used to infer gate operation. Targeted monitoring of the gates would therefore be required to confirm their operation.

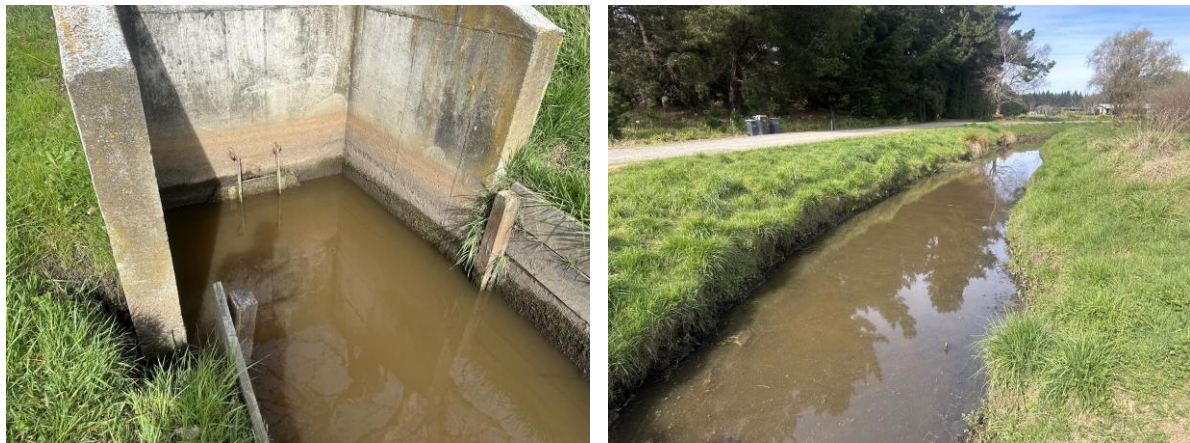
Sheppards Drain flap gate is located at the confluence of Sheppards Drain and the Styx River, approximately 5 km upstream from the Styx main tide gates. The structure includes a single top-hung flap gate, on the downstream end of the culvert under Lower Styx Road. The gate is in poor condition, and there is some active erosion around the concrete headwall (Figure 3). The gate was heavily imbedded in the surrounding fine sediments at the time of our site visit on 2 September 2024 and was unable to be moved, thus, it was not functional. The bolts associated with the flap gate hinge were replaced in September 2025; however, at the time of writing, it was not known whether the accumulated sediments have continued to impact gate operation (Pers. Comm. Colin Hill, September 2025). We understand that CCC's maintenance team is investigating this issue.

Figure 3: The Sheppards Drain flap gate (left) and Sheppards Drain upstream of the structure (right).

At the time of our site visit, the gate was jammed in a closed position, which would prevent passage of most fish, in both directions. Small eels may be able to find passage through gaps around the gate, while upstream migration of inanga is likely limited, and downstream migration of large eels may be prohibited. A fish survey in March 2023 (Instream Consulting 2023a) confirmed that the structure is excluding inanga from the upper reaches of the waterway, while shortfin eels (*Anguilla australis*) and At Risk longfin eels (*A. dieffenbachii*) were abundant upstream. With the gate currently jammed closed, adult eels may be trapped upstream, unable to migrate to the ocean to complete their life cycles, unless during high flood conditions, if the banks overtop.

- **Condition and renewal:** Given the condition of the flap gate, and the scouring around the concrete headwall, it may require remedial work in the future. CCC's asset management team have confirmed that there is scope for the replacement of this structure (Pers. Comm., Emily Tredinnick, CCC, September 2025).

- Based on the assessment above, further investigation of options 5 (partial chocking) and 6 (orifice installation) is recommended. As the flood-control function of the gate is essential, hydrological modelling will be required to assess potential flood impacts.
- Any effects on upstream water levels, including within the Sheppards Stream wetland, must be considered. If a control structure is required to maintain water levels, a ‘fish-friendly’ rock riffle weir could be installed.

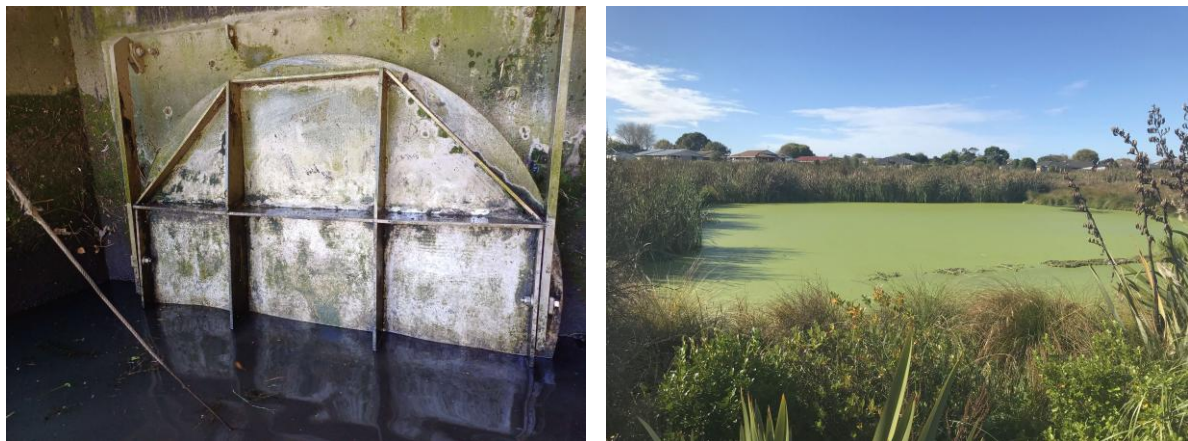
The Bells Creek flap gate is situated at the end of Bells Creek, at the confluence with the Ōpāwaho–Heathcote River. The structure includes a single, top-hung gate. Bells Creek receives stormwater from the surrounding residential area, via Te Oranga Waikura stormwater wetland (Figure 4). Located between the wetland and the flap gate outlet is a stormwater treatment facility, including a pumpstation (SwPump 83). A schematic of this facility is provided in Appendix 1.

Figure 4: The Bells Creek tide gate (left; photo provided by Colin Hill, CCC) and the upstream Te Oranga Waikura stormwater wetland (right).

During baseflow, flows are conveyed directly into the Heathcote River, via a culvert under Richardson Terrace. The culvert terminates in a top-hung flap gate, which seals shut when the water is high in the Heathcote River (i.e., during higher stages of the tidal sequence, and during stormflow). When the gate is shut during Heathcote River stormflows, water accumulates in the piped section of Bells Creek and in the wet well of the treatment facility. Once a critical height is reached in the wet well, and 2 mm of rain has fallen<sup>5</sup>, three impeller pumps are activated. These drive flows through a contaminant filtration system, before discharging into the Heathcote River. A recent review of this system confirmed that the pumpstation was functioning in response to the triggers described above, as intended (Pers. Comm., Iris Brookland, CCC, October 2024).

The Bells Creek pump station poses a significant risk to downstream-migrating eels. Eel migrations are known to coincide with rainfall events (Mitchell 1996). Given the large eel population upstream in Te Oranga Waikura, it is likely that many attempt to migrate downstream during stormflows. However, as noted in Section 2.3.1, this passage is blocked during such events due to the flap gate closing in response to elevated Heathcote River levels.

- Due to the high costs associated with the potential remediation options, further investigation and quantification of the potential risk to fish is recommended. This could involve setting traps upstream of the pumps during baseflow and stormflow, to assess the relative number of fish attempting to migrate under each of these conditions.

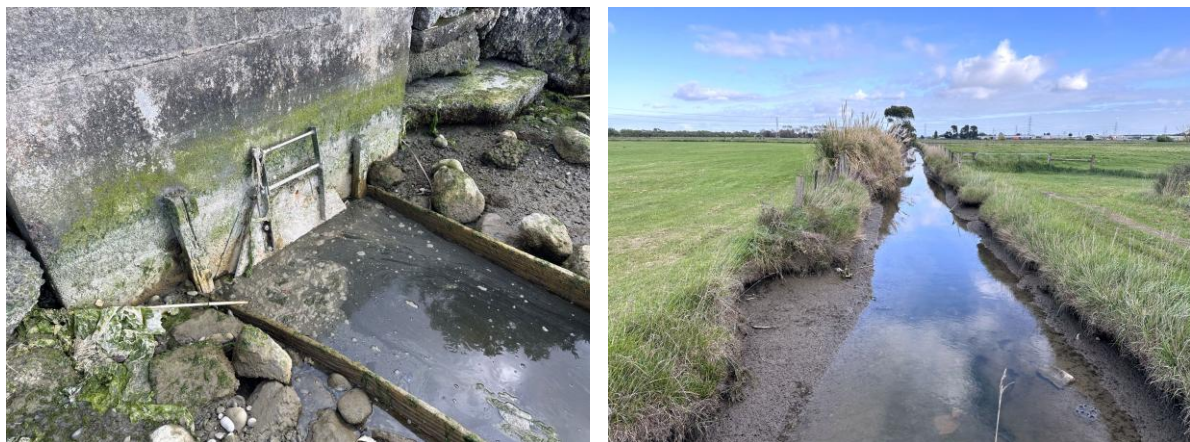
The Lovetts Drain and Charlesworth Drain tide gates are located at the outlet of their respective waterways, where they discharge into the Ihutai–Avon-Heathcote Estuary. Both structures feature single, top-hung flap gates (Figure 5, Figure 6). Both flap gates were confirmed to be operating as intended; i.e., opening on the outgoing tide, and closing on the incoming tide. However, we understand that the Charlesworth flap gate is in poor structural condition and CCC is investigating its renewal (Pers. Comm., Colin Hill, CCC, October 2024). The earth banks around the upstream headwalls of both culverts were actively eroding.

Figure 5: The flap gate outlet of Lovetts Drain (left) and upstream habitat (right), during the October 2024 visit (incoming tide).

- **Condition and renewal:** Both structures were in functional, but structurally poor condition, including erosion around the upstream headwall. If the structures are unable to be removed, renewal may be required.

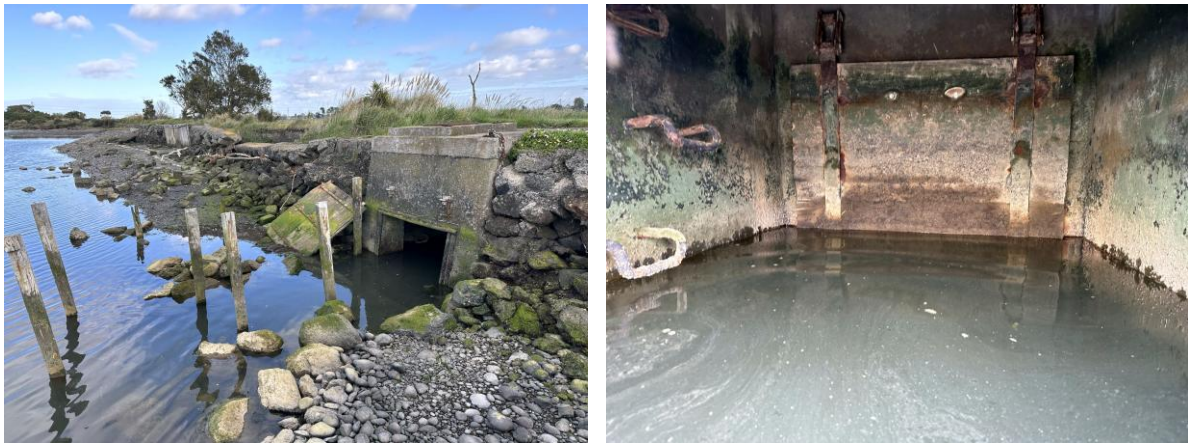
Figure 6: The culvert outlet of Charlesworth Drain (left) and internal flap gate (right), during the October 2024 visit (incoming tide).

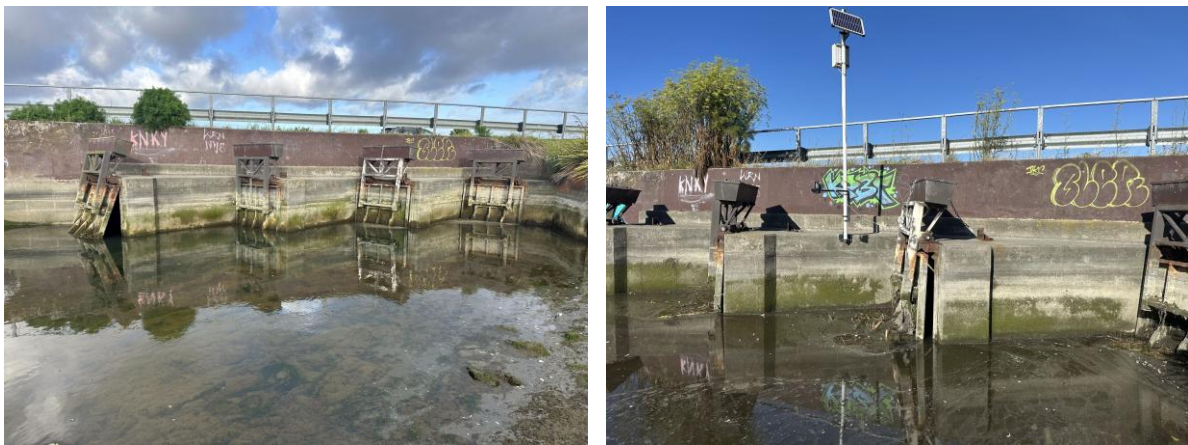
The Linwood Canal tide gates are located at the outlet of Linwood Canal, where it discharges into the Ihutai–Avon–Heathcote Estuary. The structure comprises four, top-hung gates including counterweights (Figure 7). The gates are in poor condition, and CCC is currently investigating their renewal as part of a Linwood Canal restoration project. To inform this proposed renewal, a trial is underway to understand how these gates currently operate, and to assess the potential impacts of remediation options on fish passage and stormflow conveyance. This trial involves sensors monitoring gate angle and water levels upstream and downstream of the gates (Figure 7).

The ongoing investigation confirmed that the gates are not functioning as intended and are in poor condition. Several are leaky and fail to seal fully on the incoming tide. Most notably and until recently, the true right gate left a 420 mm gap during incoming tides (Pers. Comm., Colin Hill, CCC, January 2025). It was later discovered that this gate had been intentionally jammed open with a wooden structure, without CCC's knowledge (Pers. Comm., Colin Hill, CCC, February 2025).

This gate appears to have been leaky for several years and was identified in 2018 as the main source of tidal ingress (Orchard 2018). Without CCC intervention the obstruction was removed and the gate resumed closing on the incoming tide. At the time of writing, the largest observed gap was associated with Gate 3 (third from the true right), which remains at least 100 mm open throughout the tidal cycle. Monitoring of the gates is ongoing and will be reported independently.

Figure 7: The tide gates in Linwood Canal (left), including the water level and gate angle sensors associated with the ongoing study (right).

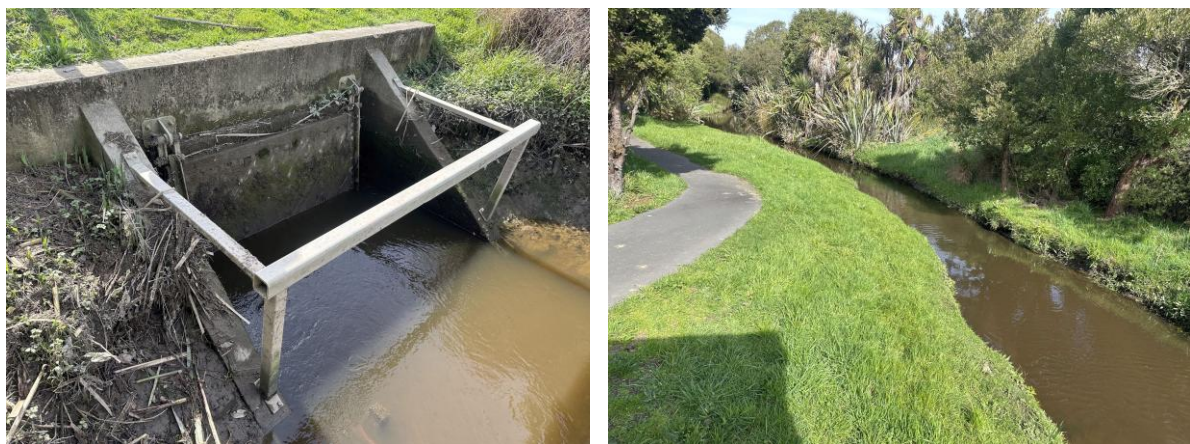
Corser Stream and Lake Kate Sheppard flap gates are located at the outlets of their respective waterways, where they discharge into the Ōtākaro/ Avon River. The Corser Stream structure involves a top-hung flap gate, which appeared to be in functional condition during our site visit on 2 September 2024. At the time of this site visit, the tide was outgoing, and Corser Stream was discharging into the Avon River. Despite this, the gate hung almost completely vertical, with water flowing around the gate via two approximately 150 mm wide gaps at either side of the gate. Due to the heavy construction of the gate, and the moderate flows in Corser Stream, it is unlikely that the gate opens much wider than this under baseflow conditions.

Figure 8: The Corser Stream flap gate (left) and Corser Stream, upstream of the flap gate (right).

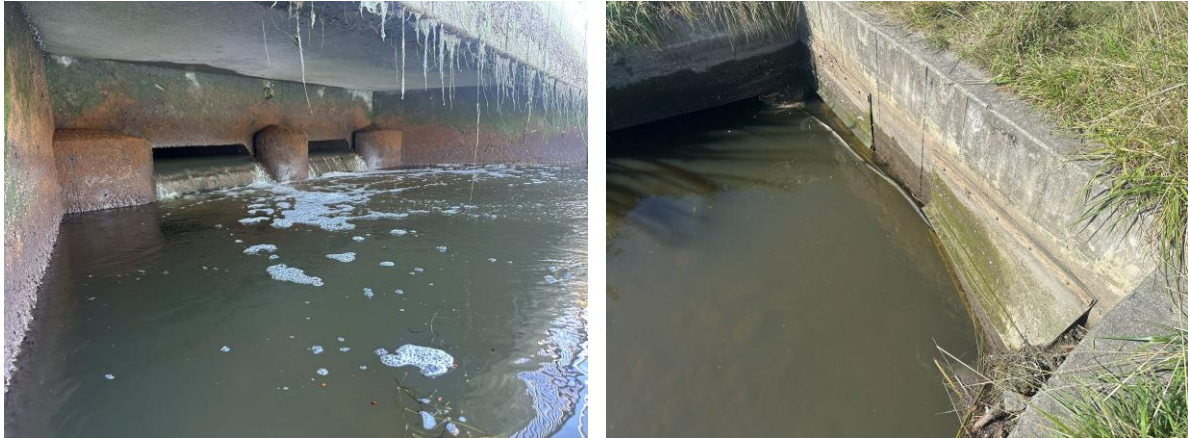
The Lake Kate Sheppard outlet involves two culverts that run under New Brighton Road. At the upstream end of these culverts, there are two rubber flaps that are approximately half the height of the culvert inlets, restricting the outflow from Lake Kate Sheppard. Two aluminium flap gates are located internally within the structure, which are controlled by a float and trigger mechanism. These flap gates are activated when Lake Kate Sheppard reaches a relative level of greater than 10.6 m (Beca 2017); however, under baseflow conditions, these gates default to an open position. At the downstream end of the culvert are two stop-logs, which moderate the tidal influence from the Avon River. At high tide these are submerged, while a drop-off forms at lower stages in the tidal cycle (Figure 9).

Figure 9: The Lake Kate Sheppard outlet structure, including the discharge into the Avon River (left) and the upstream flow-restricting flaps (right).

During higher, incoming, stages of the tidal cycle, these stop logs are inundated, and water flows freely into Lake Kate Sheppard. Under these conditions, the structure presents a low risk to fish passage. How long this structure excludes fish is currently unknown; however, based on our field observations, it is likely to be over half the tidal cycle. Both structures have the potential to exclude weak swimming fish species during certain times in the tidal cycle when velocities are high. This risk is heightened by the flow restrictive nature of their designs.

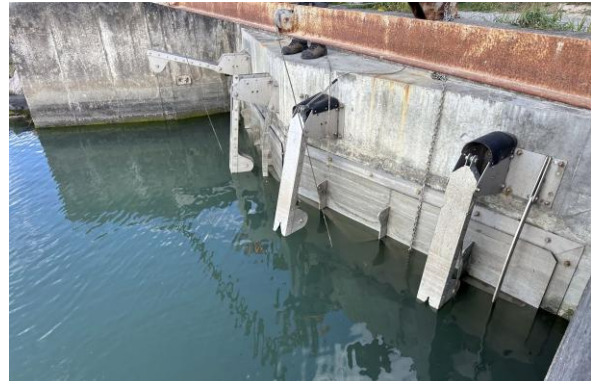
Structure 2: Avoca

This structure includes two ‘fish friendly’ tide gates installed in June 2017, involving a cantilever design. At the time of our site visit (10 October 2024), three of the four counterweight cables were broken and thus, they were not effectively delaying gate closure. We understand that the cables on these tide gates have been replaced twice previously (Pers. Comm. Colin Hill, CCC, October 2024). A 2018 study including these gates found that they were effective at providing for fish passage when functional (Instream Consulting 2018). Solutions to prevent future cable breakages are required to ensure their ongoing function.

Hill, CCC, October 2024). However, this has been inadequate to prevent the ongoing loss of salt-marsh vegetation (Pers. Comm, Andrew Crossland, CCC, October 2024). Saltwater intrusion is currently further limited, due to the non-functioning cantilevers, which could lead to additional losses in salt-marsh vegetation, if not remediated.

- The Avoca tide gates (Structure 2 above) are currently not effective, due to broken cantilever cables.
  - This has been an ongoing issue, and options to prevent future breakages should be considered. Potential solutions include strengthening the cable design by increasing cable gauge and identifying and addressing sources of wear.

- Where structures are required to maintain stormwater function (e.g., Avoca tide gates), options for improving the level of salt-water ingress under baseflow conditions should be investigated. Potential options include:

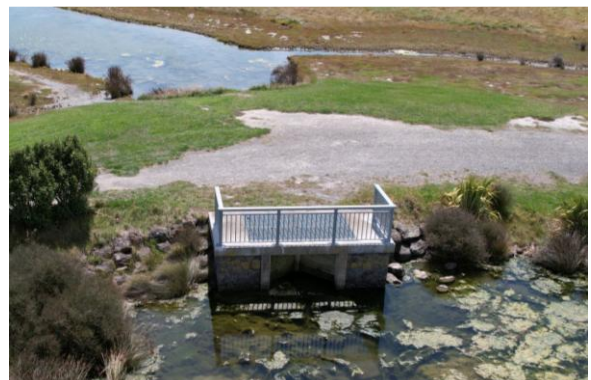
Structure 4: Matuku

This structure includes a single 'fish friendly' tide gate, involving a cantilever design. The gate was in functional operating condition during our site visit on 10 October 2024. It has been shown to effectively provide passage for all fish species, during targeted fish surveys (Instream Consulting 2025c, Instream Consulting 2018). However, Instream Consulting (2025c) suggested that many fish that enter the waterway may fail to complete their life cycles, due to a lack of adult habitat upstream, a high risk of bird predation, and a lack of appropriate spawning areas for inanga. Options for the renewal of the lining of Truscotts Stream, or the piping of sections of the waterway, are currently being considered by CCC, and this structure may be removed or relocated as part of this project Instream Consulting (2025c).

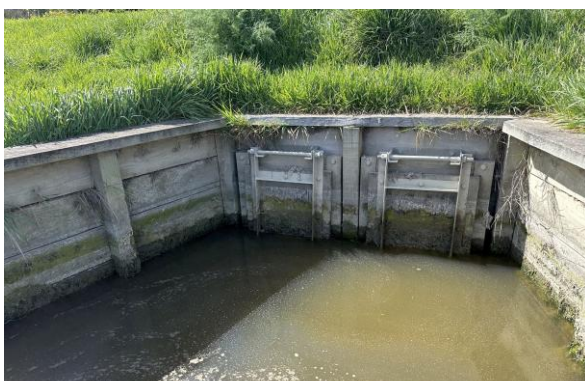
Structure 5: Munning

This structure includes two top-hung flap gates. At the time of our site visit (10 October 2024), they were moving freely and appeared to be functioning as intended. Under baseflow conditions, they rest in almost completely closed position and thus, they are a high risk to fish passage. Aquatic habitat is extremely limited upstream of the gates (Figure 11), and therefore, they are low priority for fish passage remediation. However, removal of these gates may increase saltwater ingress into the paddocks upstream, and facilitate the establishment of salt-marsh vegetation communities. While the removal of these gates is likely to improve ecological values in the area, through the promotion of salt-marsh vegetation, we recognise that the sections upstream are beyond the extent of the Ferrymead Park Development Plan Stage 2 (December 2023) and are currently actively grazed.

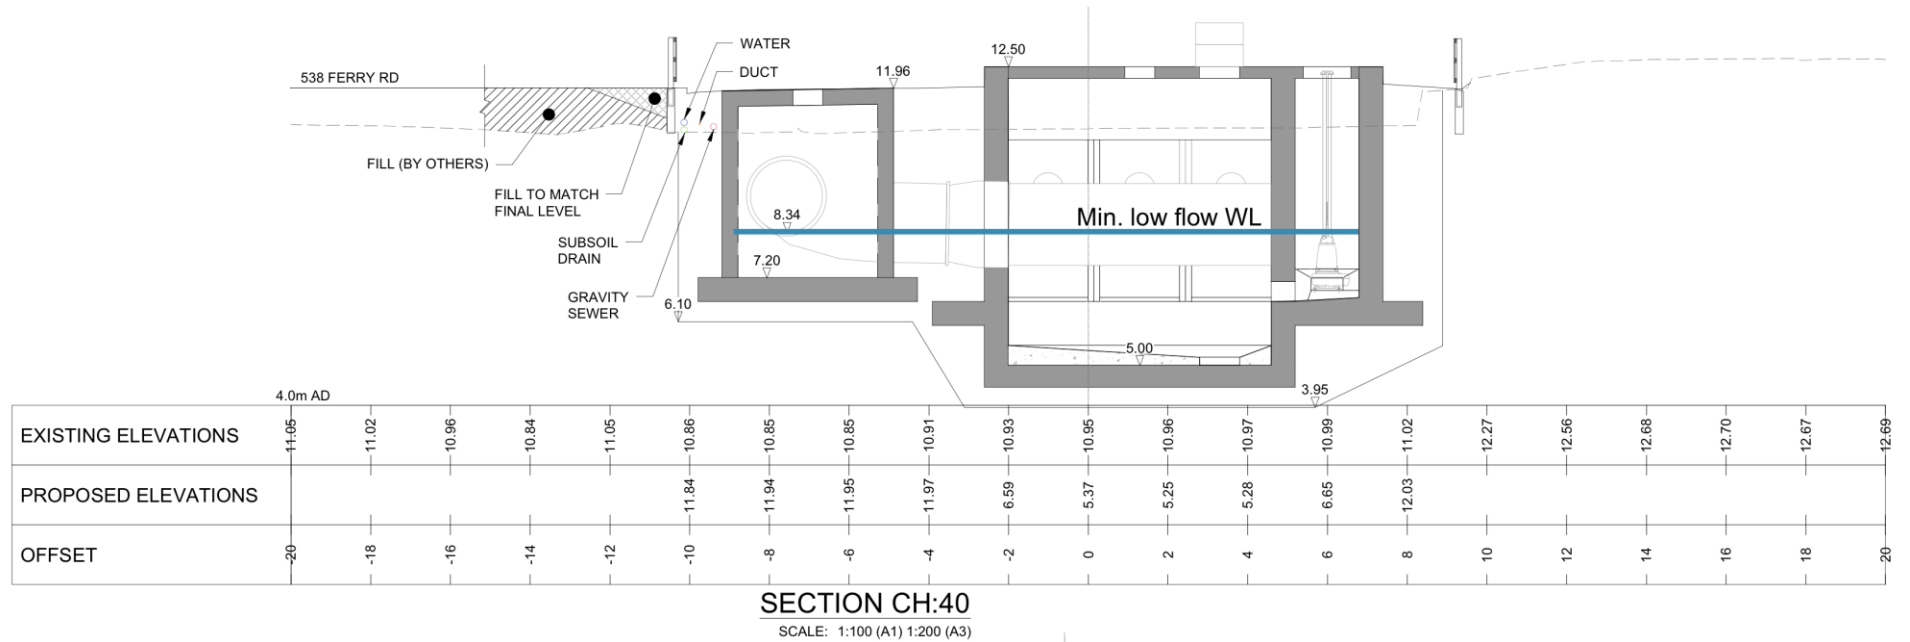
Furthermore, from our review of the pumpstation drawings and discussions with CCC staff, we understand that there is no mechanism to stop fish from entering the wet well and subsequently becoming entrained in the stormwater pumps. While the grit chamber associated with the pump station wet well is inspected monthly by CCC contractors, it has only been dewatered once in the past five years. During recent correspondence, the contractor confirmed that no fish have been observed during either the regular inspections or the dewatering event (Pers. Comm., Iris Brookland, CCC, November 2024). Provided they do not become entrained in the pumps, fish can move freely back out of the wet well and into Bells Creek (Pers. Comm., Peter Christensen, September 2025).

Figure 2: A profile view of the Bell Creek pumpstation. Note the direct connection between the piped section of Bells Creek (left chamber), and the pumpstation wet well (right chamber).
