Christchurch City Council Below Ground Water Well Head Repair Recommendations

For: Christchurch City Council - Reticulation Manager [Robert Meek]

By: Citycare Group [Water] Christchurch

Date: 21 August 2017

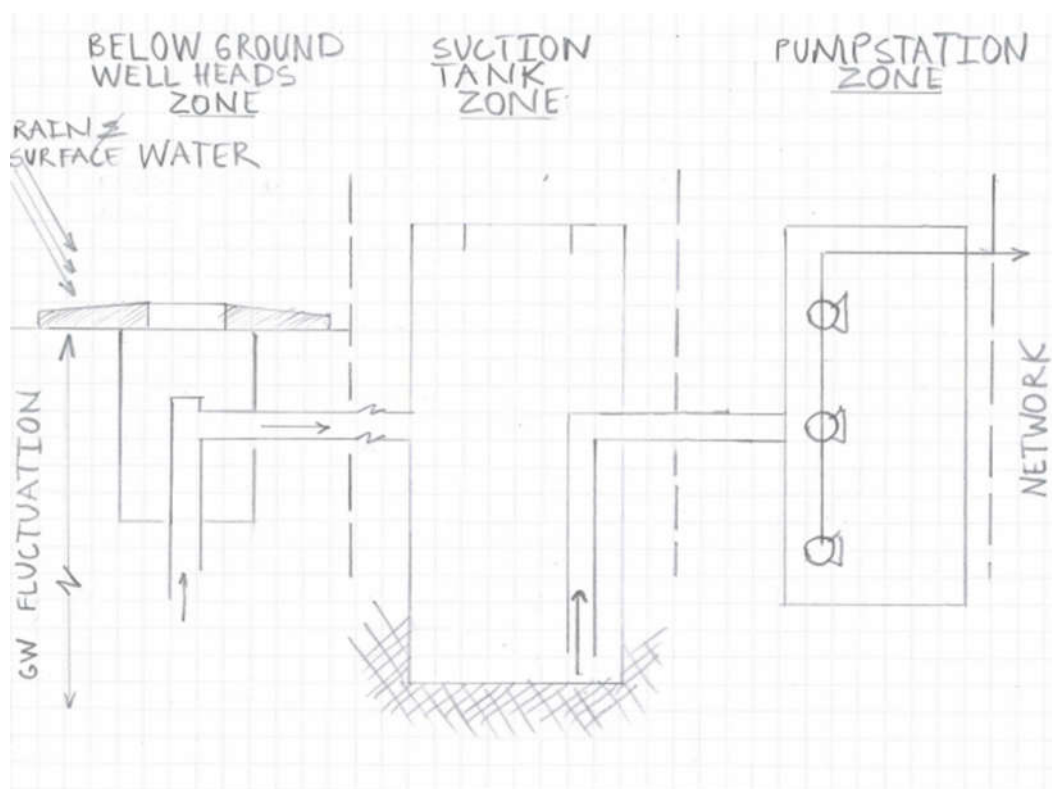
Figure 2 - Focus Area for Repair Work – Below Ground Well Head Zone Only

- 3.3.1 During the rainfall event of 20-22 July 2017, river water inundated a number of well heads, contaminating them with sewage wastewater which had been washed in via surcharged sewerage networks/pump stations.
- 3.3.2 High groundwater (above chamber base) and rainfall seepage are also considered to present the highest risk and therefore drive the most extensive and intensive action
- 3.3.3 The repair works focus on minimising the ingress of surface water and very shallow unsecure groundwater (~2 m BGL) into the below ground well head chamber/pipework. The extent of works will not however eliminate the potential for pathogen ingress into the water supply via connected pipes eg between the suction tank, deep groundwater and other vectors - Figure 2.

- i) Chamber inundation through higher than design rainfall events (river/waterway flooding)
 - ii) Further chamber wall deterioration resulting in severe acute groundwater ingress

- iii) No treatment barrier and monitoring in place for pathogen entry to the network via deep groundwater
 - iv) Contamination via other connected assets including well head pipes to suction tanks, suction tanks, pipes to pump station, pump casing and mainfolds to the network.
