Christchurch Water Supplies Drinking Water Incident Investigation Report

L'Aube Hill Reservoir

Christchurch City Council

April 2021

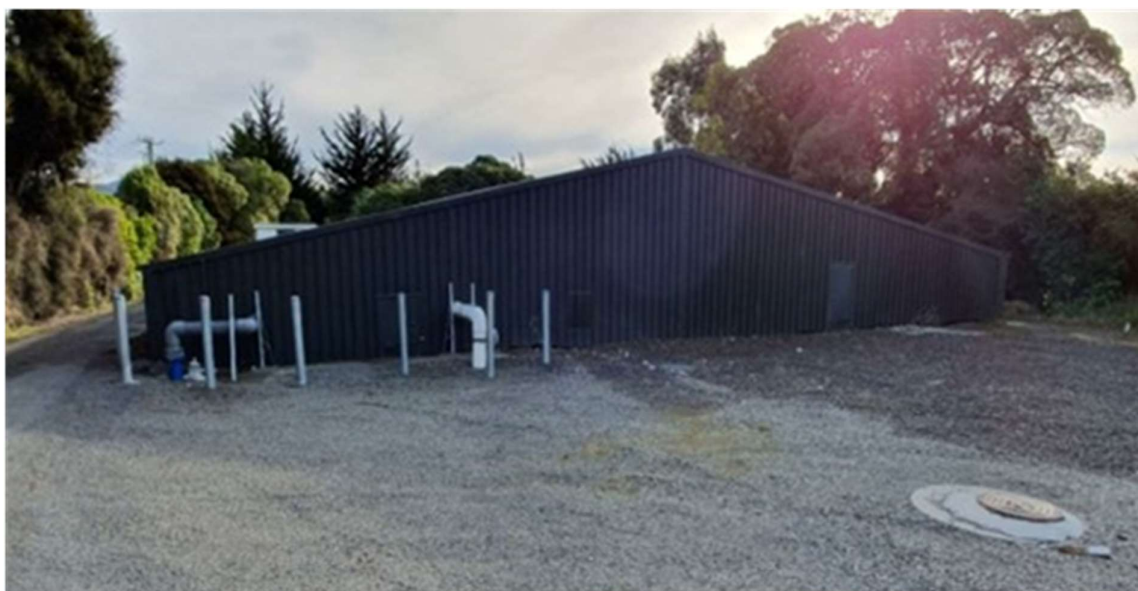
Figure 4.1: Treated Water Storage Reservoir

The largest reservoir is at L'Aube Hill – a 2080 cubic metre concrete structure with iron cladding forming the roof and upper walls (see Figure 4.1). The structure is partitioned into two tanks with volumes of 1660m³ and 420m³. The reservoir was built in 1974 and the lining of the concrete tank was upgraded in 2012.

Despite regular monthly checks by CityCare there was a failure to identify critical maintenance tasks. This was evidenced by an independent report in late 2020. Poor condition of the exterior, small gaps in metal flashings and the lack of awareness of any overflow pipe all contributed to animal accessing the reservoir.

A condition assessment of the (now located) overflow pipe (in February 2021) indicated the cast iron pipe was at the end of its life and this pipe has since been replaced.

Undertake a condition assessment of the reservoir and evaluate the options for upgrade or replacement.

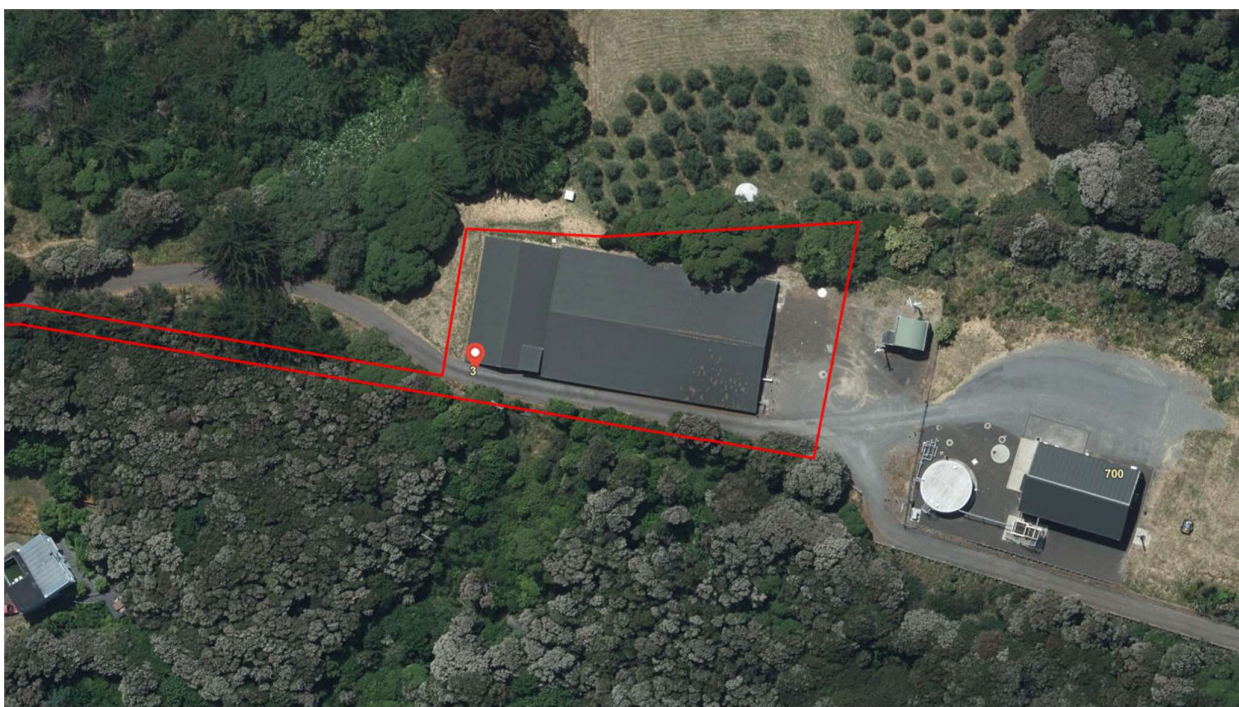
Figure 4.2: Location of Treated Water Storage Reservoir

The post-treatment reservoir is located within close proximity to L'Aube Hill Reserve and is surrounded by areas of bush (see Figure 4.2). The bush is in close proximity to the reservoir with a number of trees overhanging the roof.
