Akaroa Main Wharf Replacement, Akaroa Archaeological Assessment

Prepared for Christchurch City Council

Status: Final

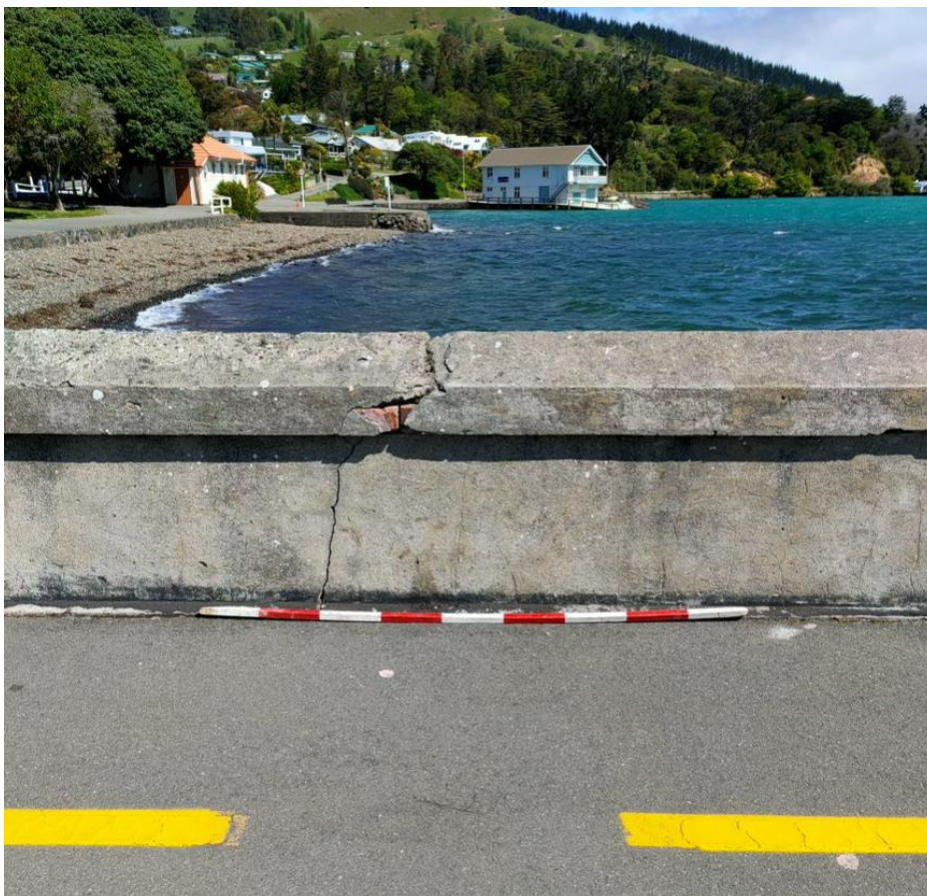
Figure 71. View of cracked portion of concrete parapet wall. Cracked portion of chamfered pier caps suggests it is composed of red brick with concrete render overlay. Image was taken looking south. Source: SIA 2021.

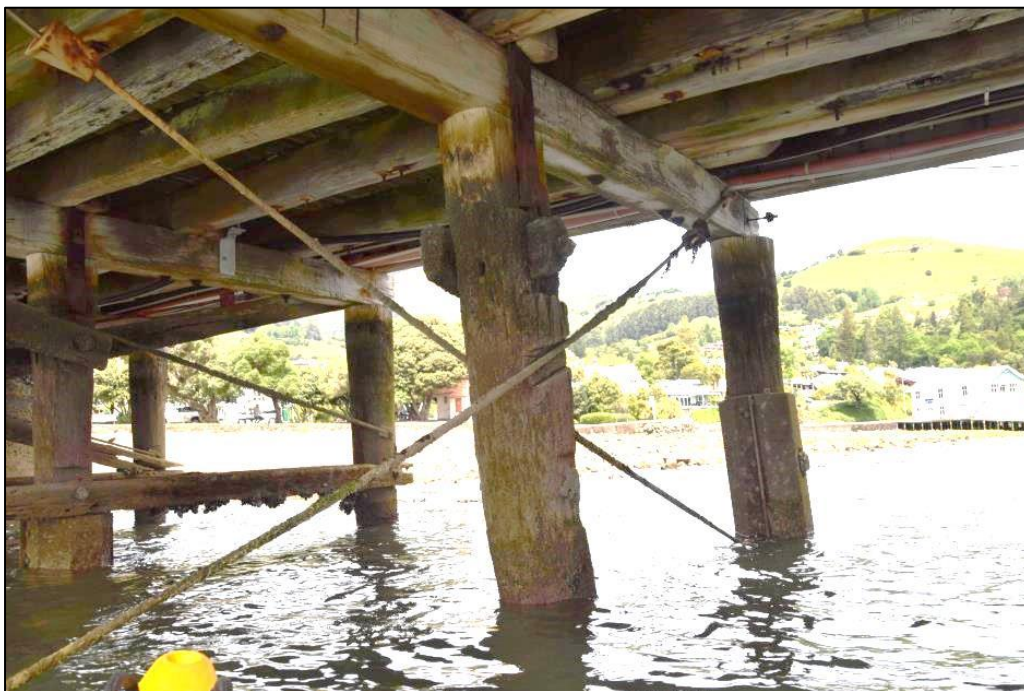
Figure 77. An example of repairs and alterations to a bent – original timber bracing cut off either side of the central pile; diagonal steel braces installed; and a steel jacket added to the right-hand pile (Origin 2021)

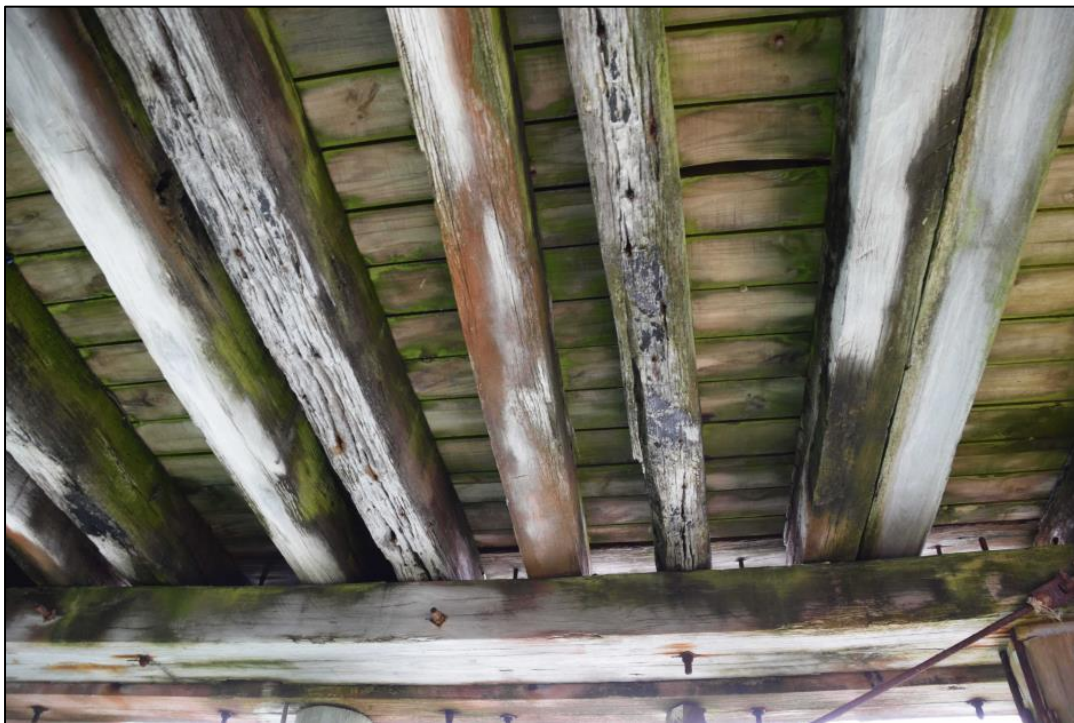
Figure 78. Additional stringers inserted to strengthen the deck at the western end of the wharf. There is considerable erosion and decay in many of the stringers here (Origin 2021).

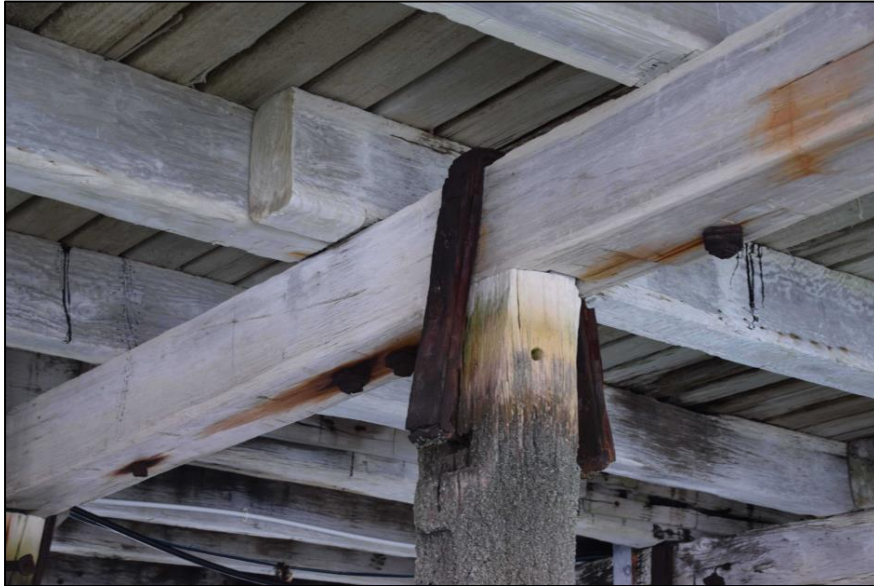
Figure 81. Close-up of the pile head showing the original wrought iron strap connection with the pile cap beam – now corroding/delaminating and separated from the pile head (Origin 2021).

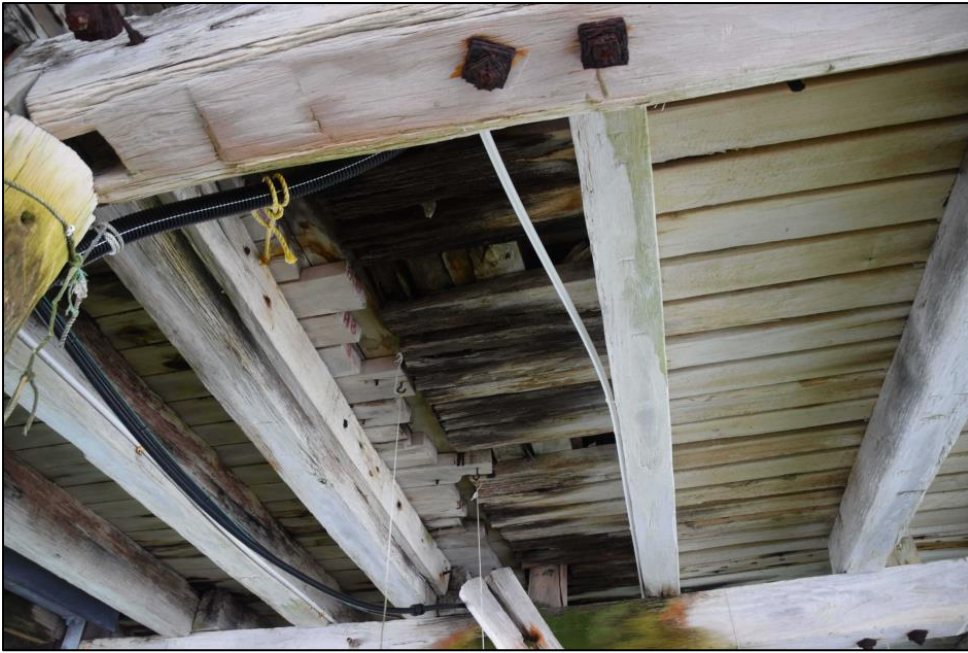
Figure 83. Decay in decking boards beneath the existing deck finish. Corrosion to original iron bolts and nuts (Origin 2021).

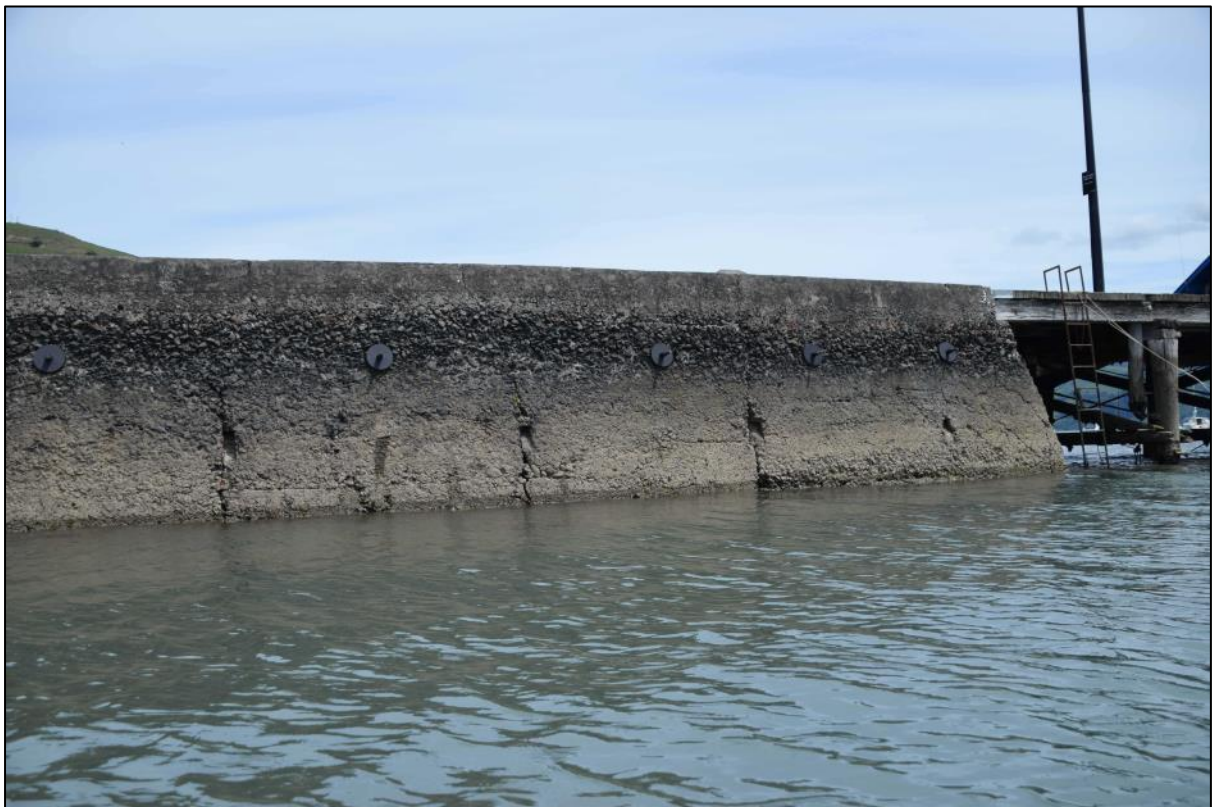
Photo 3 The outer north wall of the abutment with drainage holes, circular pattress plates to the end of the tie rods and many cracks in the masonry.

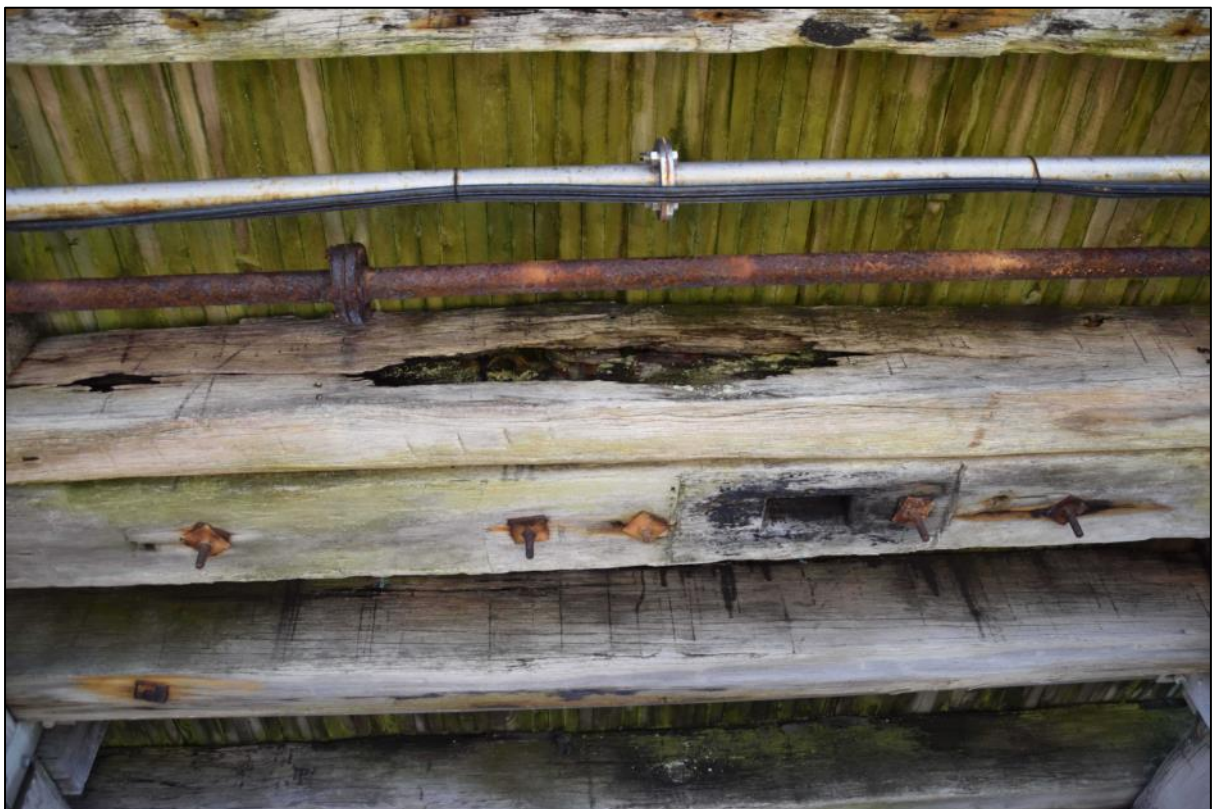
Photo 5 Clear evidence of decay in a timber stringer at the eastern end of the wharf.

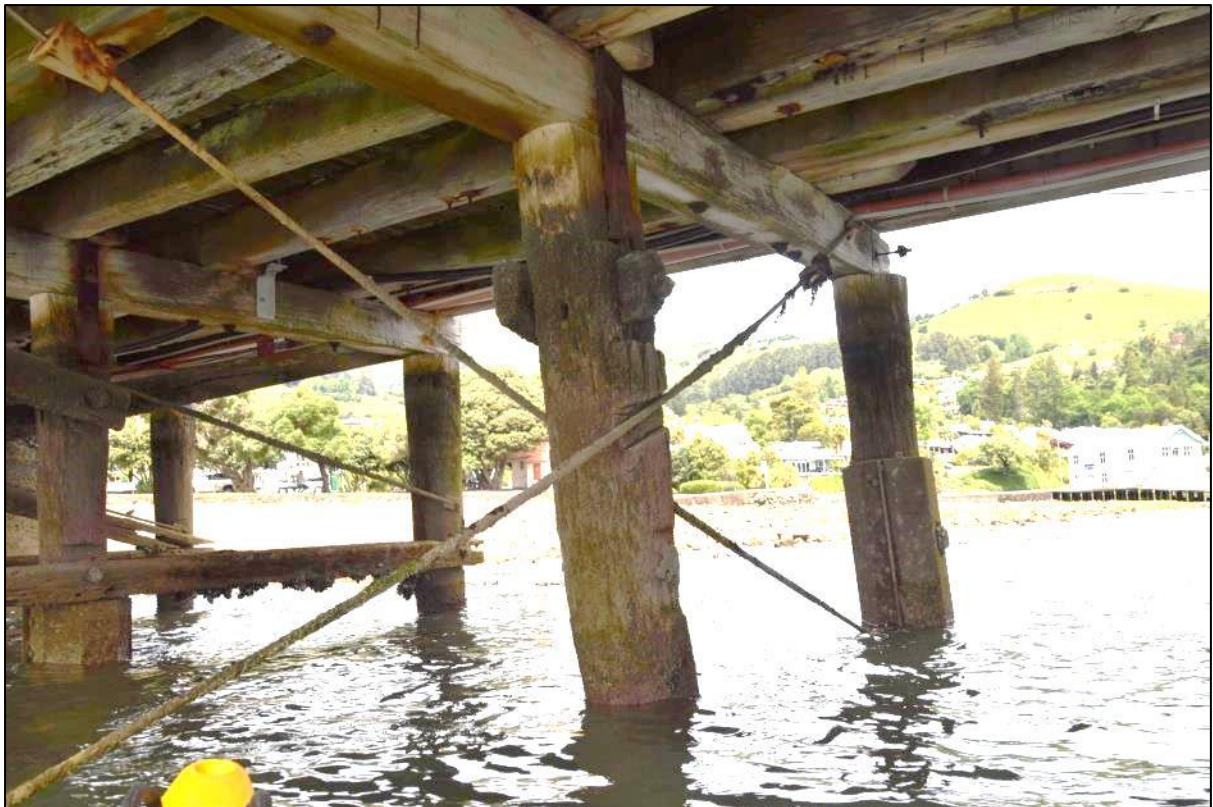
Photo 6 An example of repairs and alterations to a bent – original timber bracing cut off either side of the central pile; diagonal steel braces installed; and a steel jacket added to the right-hand pile.

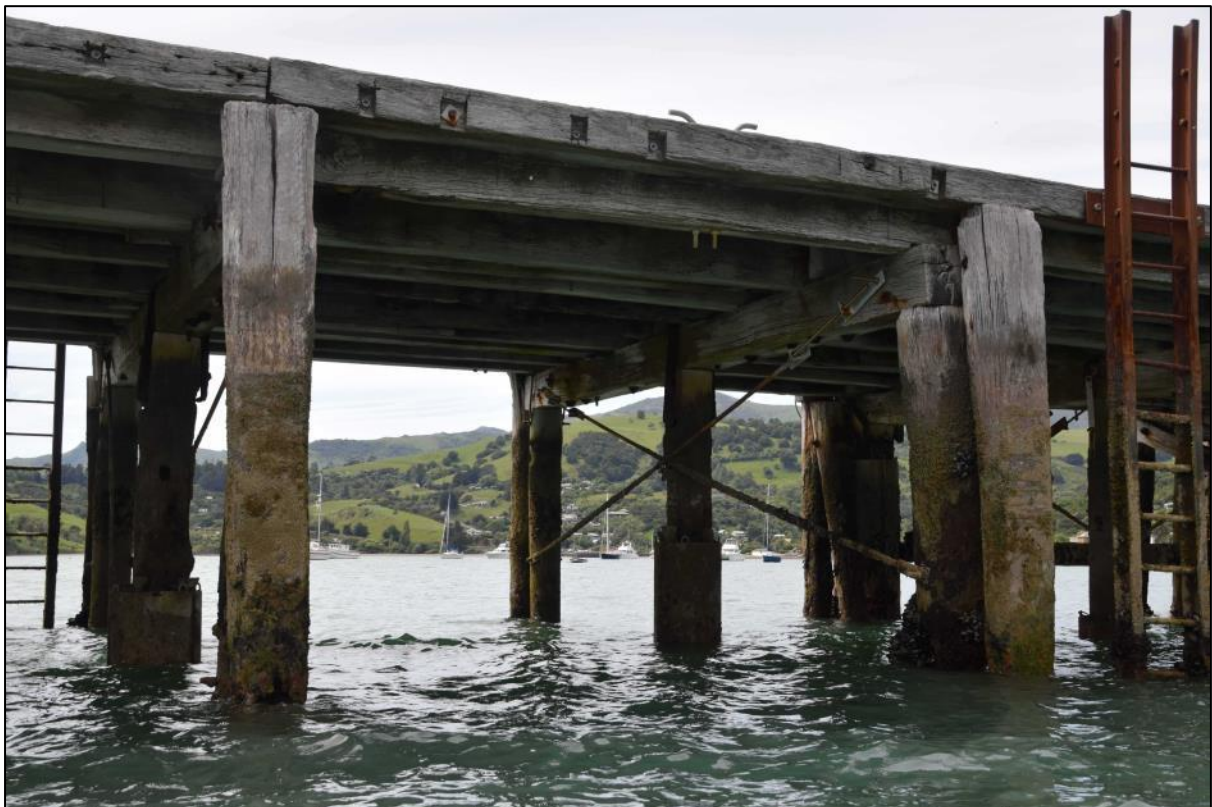
Photo 13 Here the original timber cross-braces to the bents have been replaced with modern steel bracing rods and a number of the piles have had repair 'jackets' encased around their lower sections.

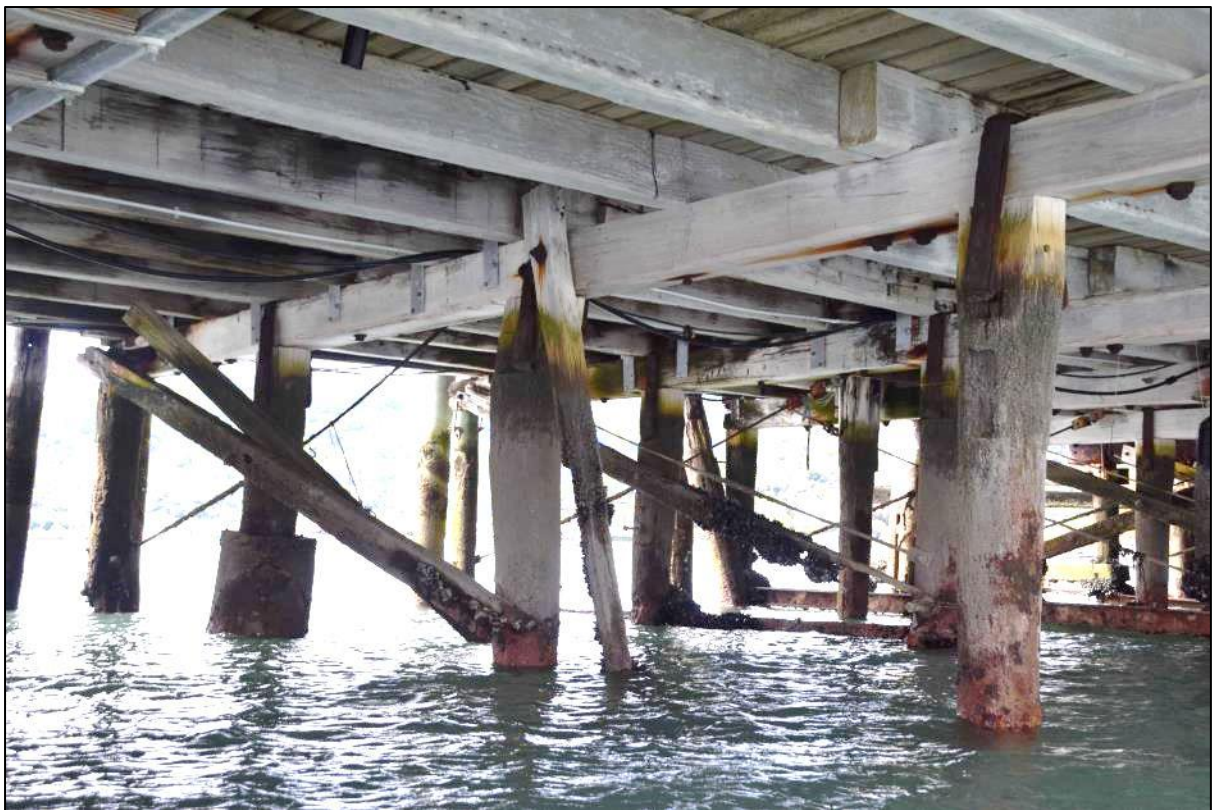
Photo 17 An image 2 bays closer to the shoreline than 16 showing the original widened structure under the original shed –with continuous pile cap spanning over the additional piles and wrought iron straps to the heads of the piles now delaminating and, in places, no longer connected to the piles. The bent in the foreground is missing bracing and one of the piles has a 'jacket' repair.

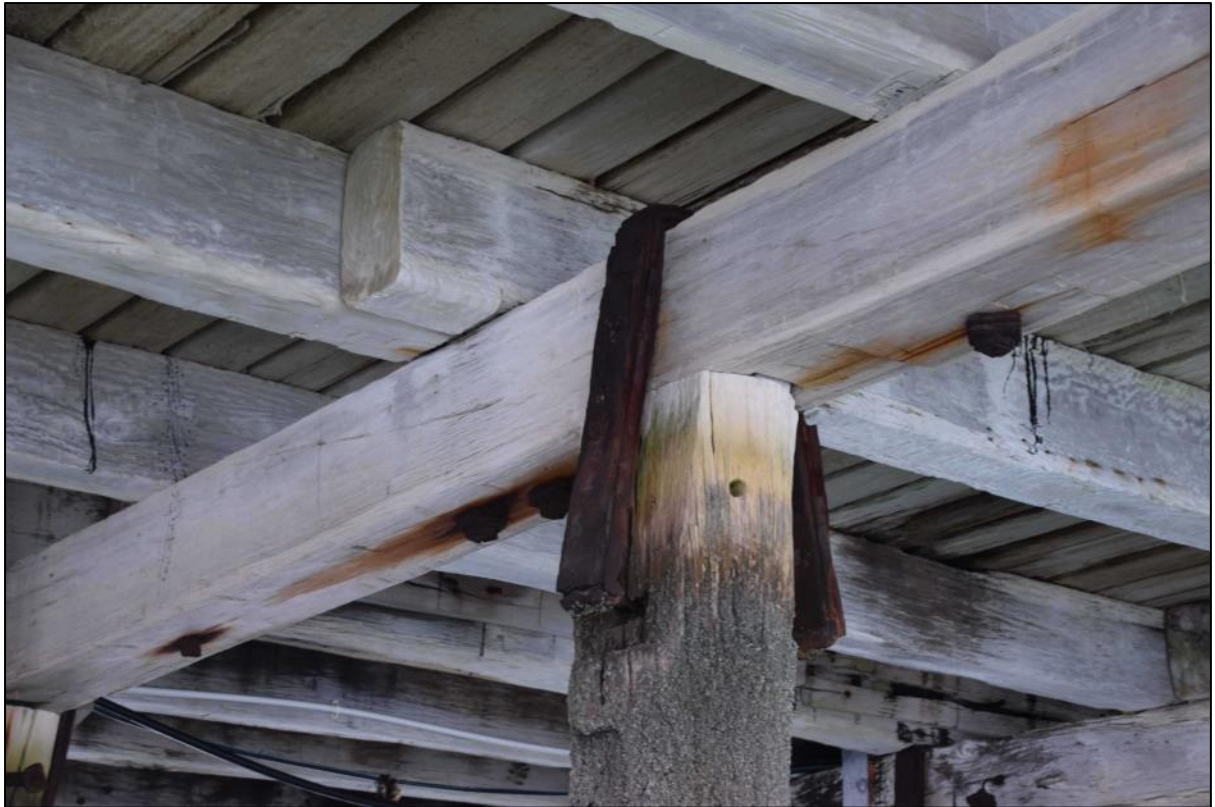
Photo 18 Close-up of the pile head on the right of Photo 17 showing the original wrought iron strap connection with the pile cap beam – now corroding/delaminating and separated from the pile head.

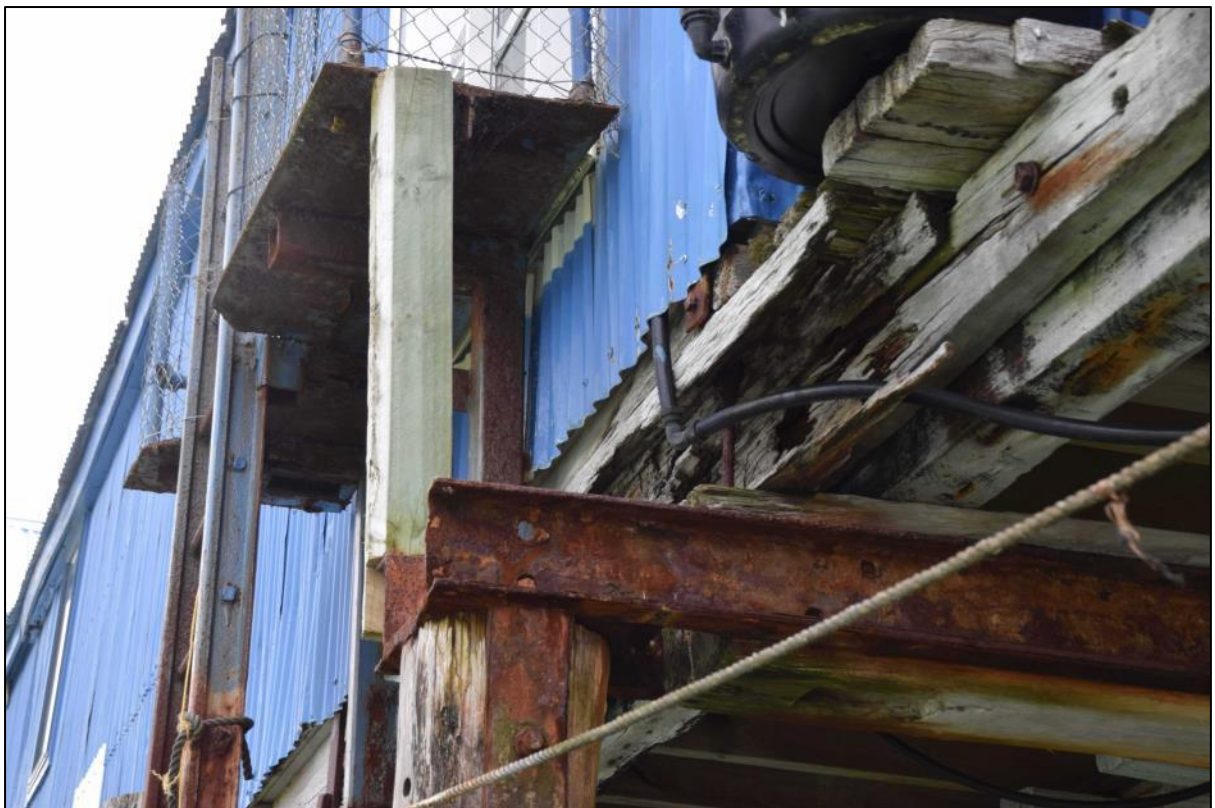
Photo 19 Timber decay and corrosion at the junction of two of the modern sheds (south side approx. 16th bent from the abutment).

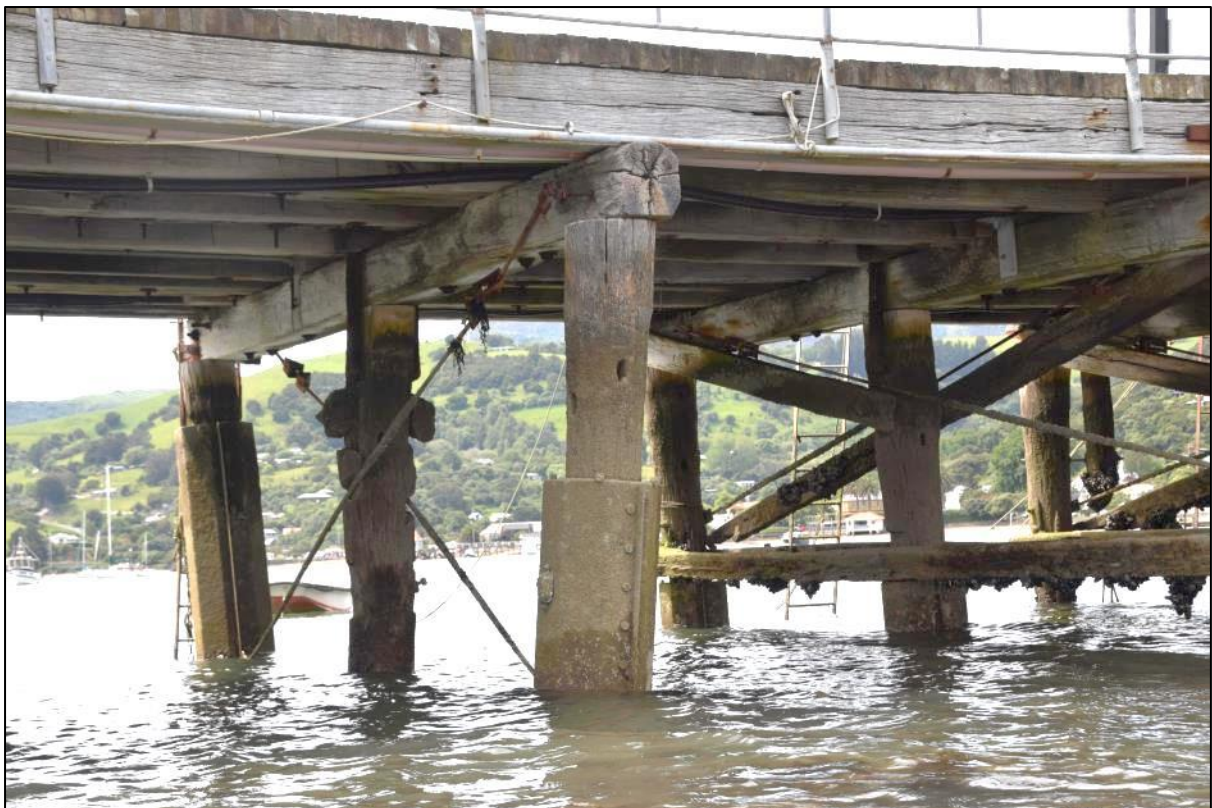
Photo 25 The same bent as in Photo 6, but from the south side. Both outer piles have 'jacket' repairs and the bent is missing its original horizontal brace. The diagonal timber braces have been cut off and replaced by steel rods.

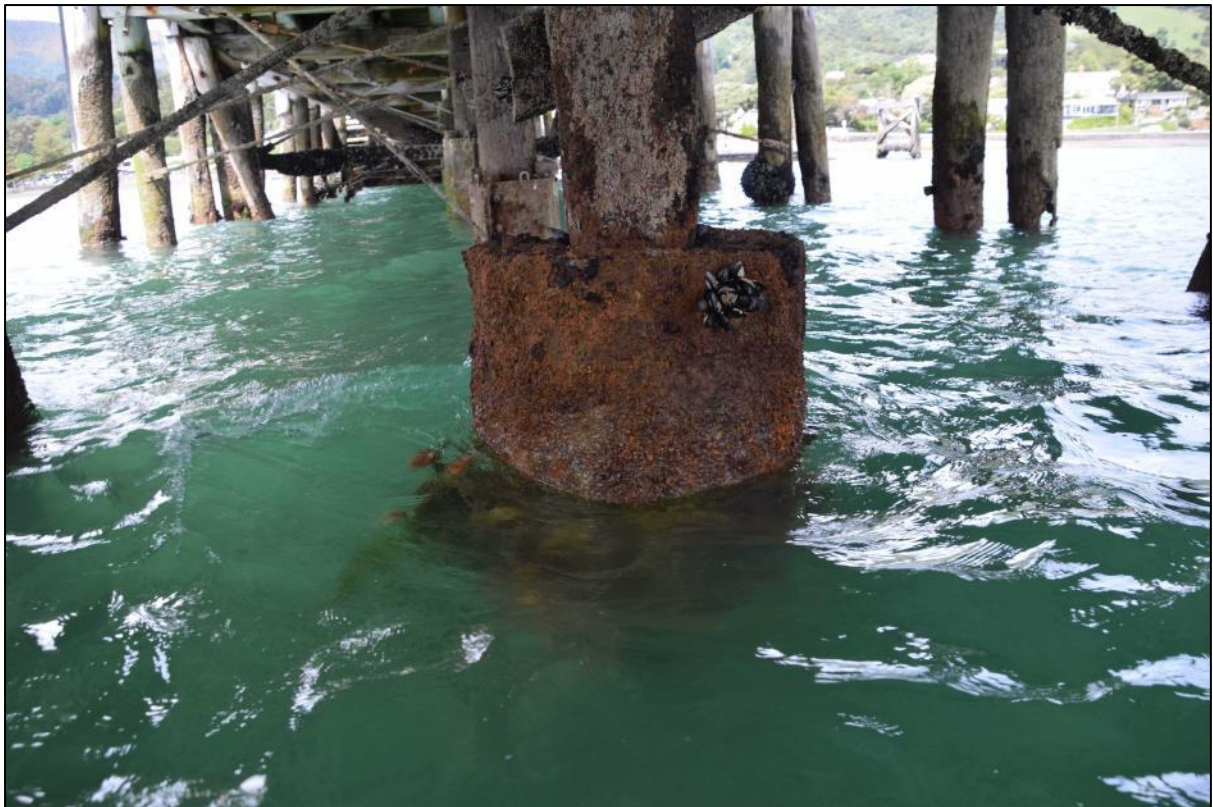
Photo 26 A 'jacket' repair to a central pile under the western end of the wharf. The pile has continued to erode above the jacket.

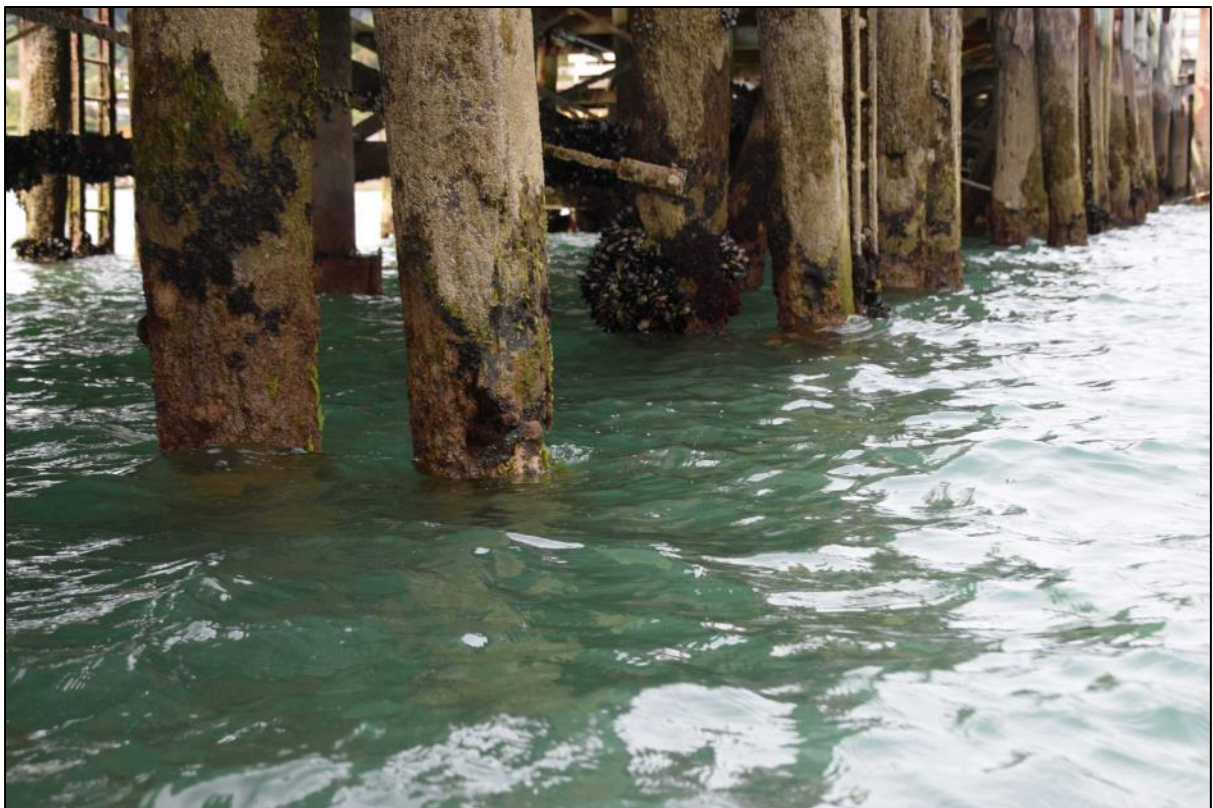
Photo 27 Severe decay at the water line to a fender pile on the south side of the wharf towards the western end. The photograph shows rows of piles and adjacent fender piles, many of which are thought to be original and of Ironbark timber.

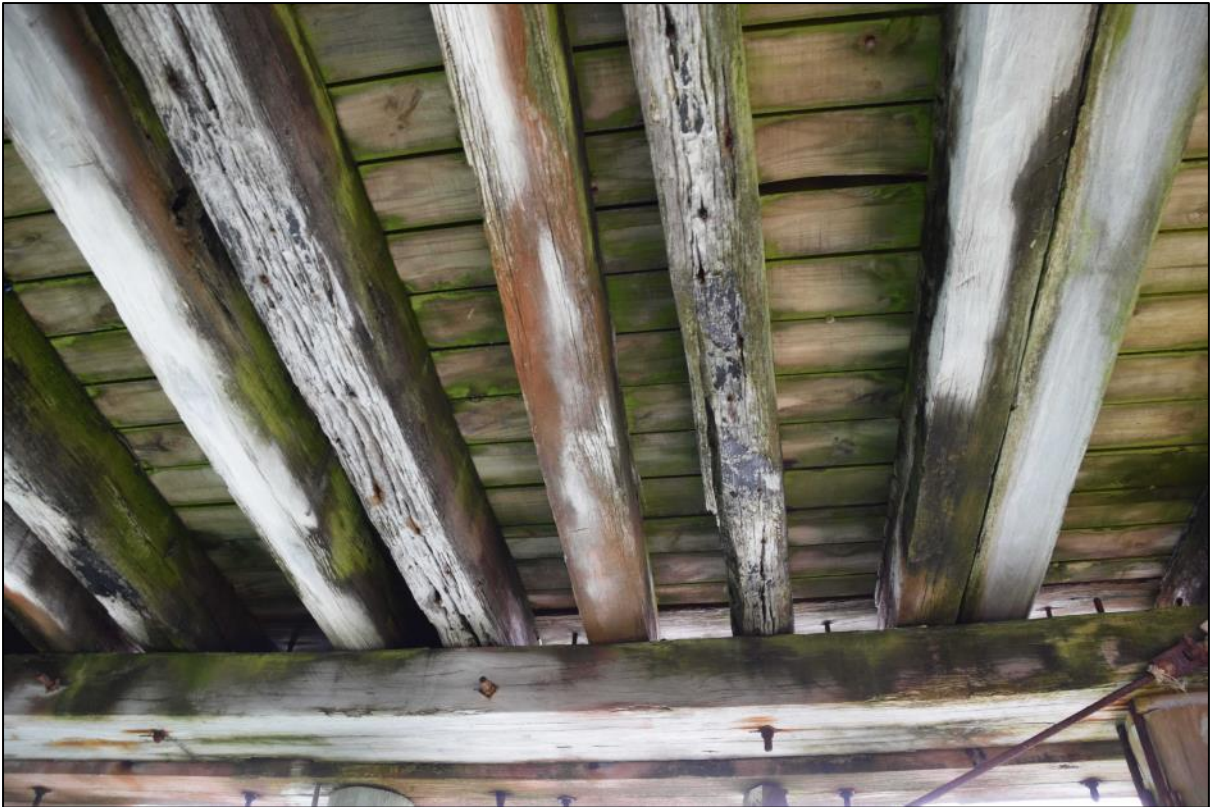
Photo 28 Additional stringers inserted to strengthen the deck at the western end of the wharf. There is considerable erosion and decay in many of the stringers here.

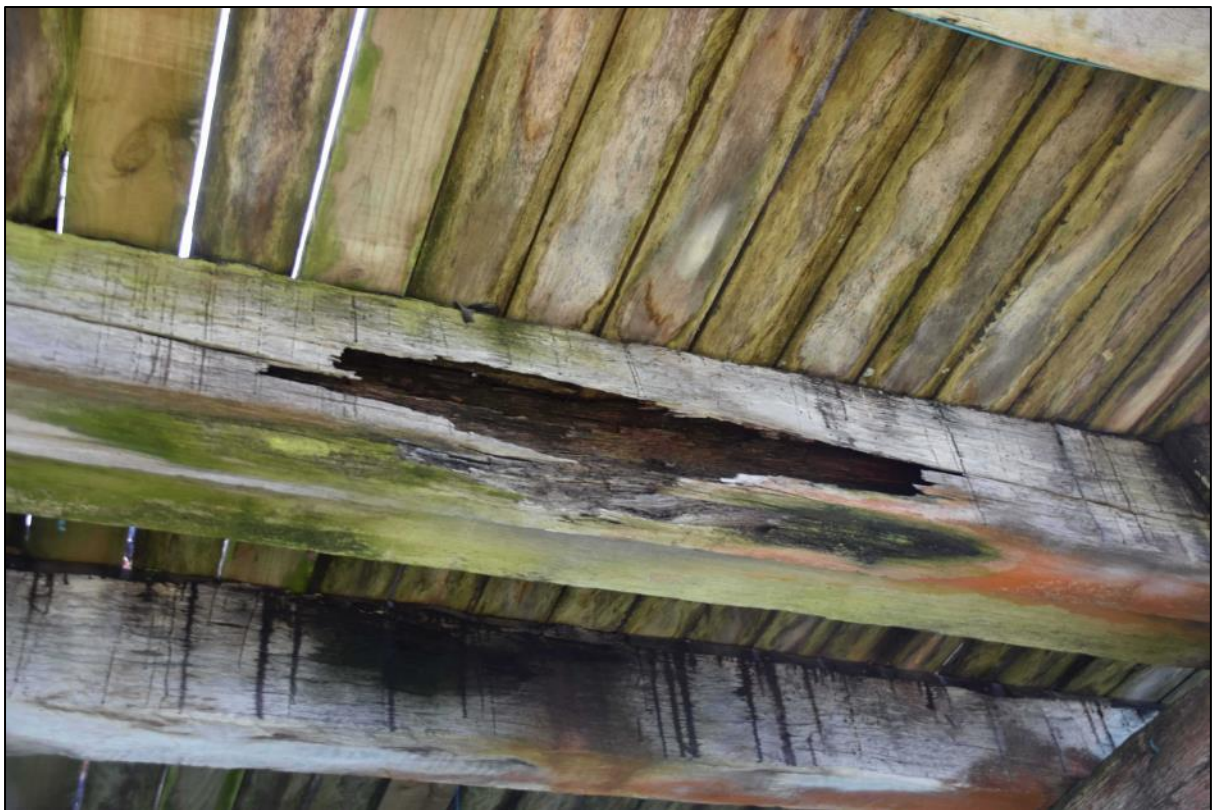
Photo 31 A large area of decay in one of the stringers close to the modern steps toward the western end of the wharf.

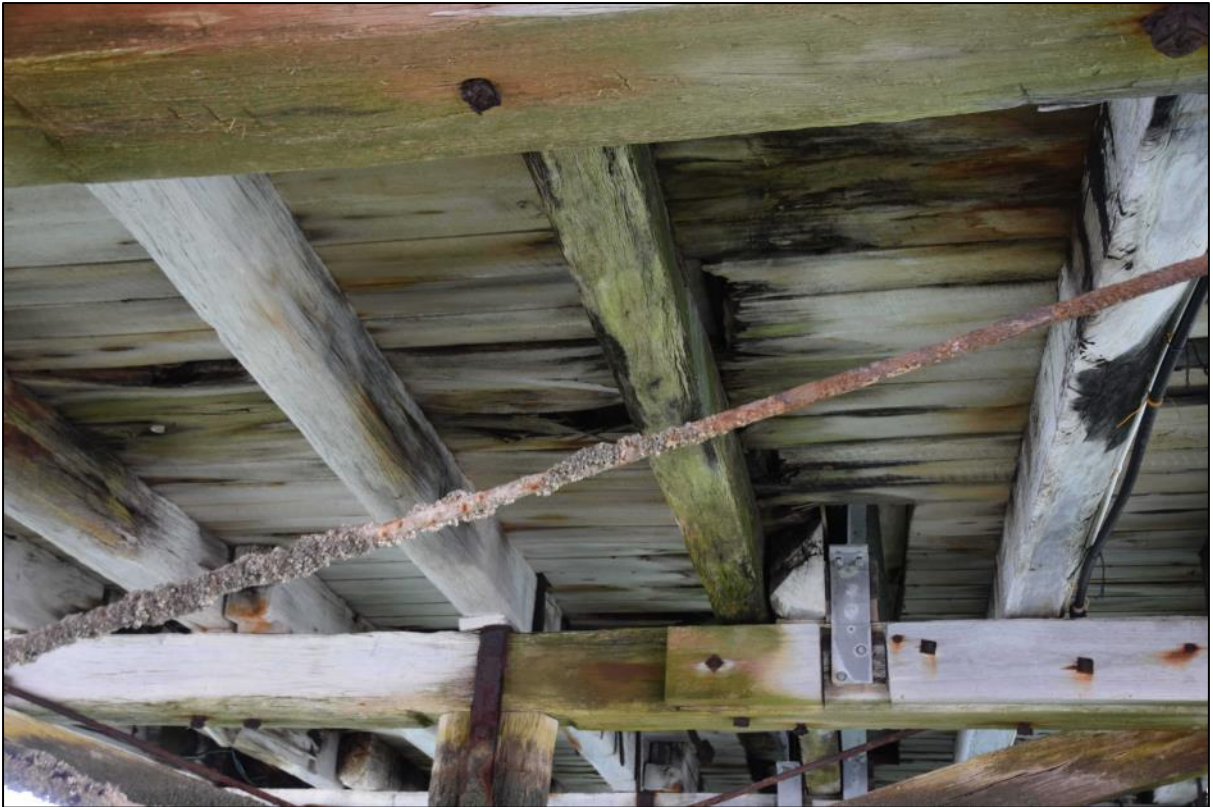
Photo 32 Decay in the decking boards and modern steel straps added.

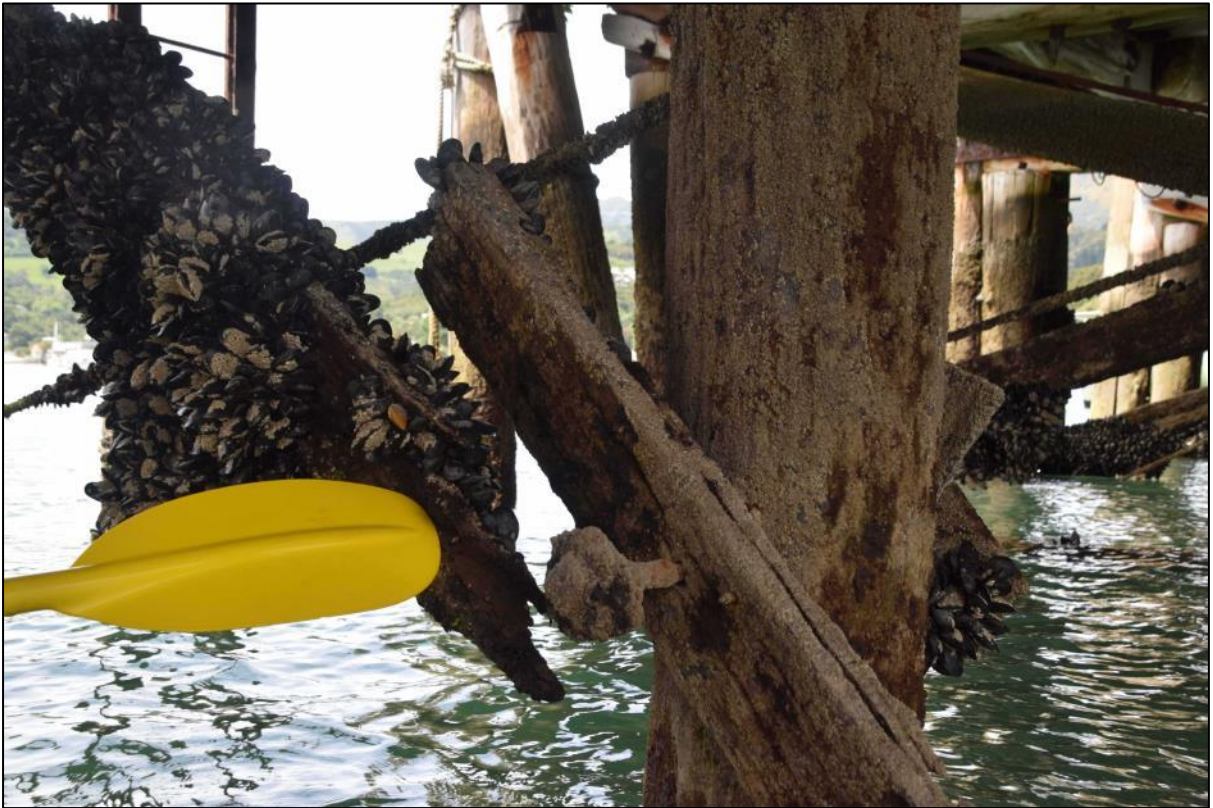
Photo 33 Broken timber brace.

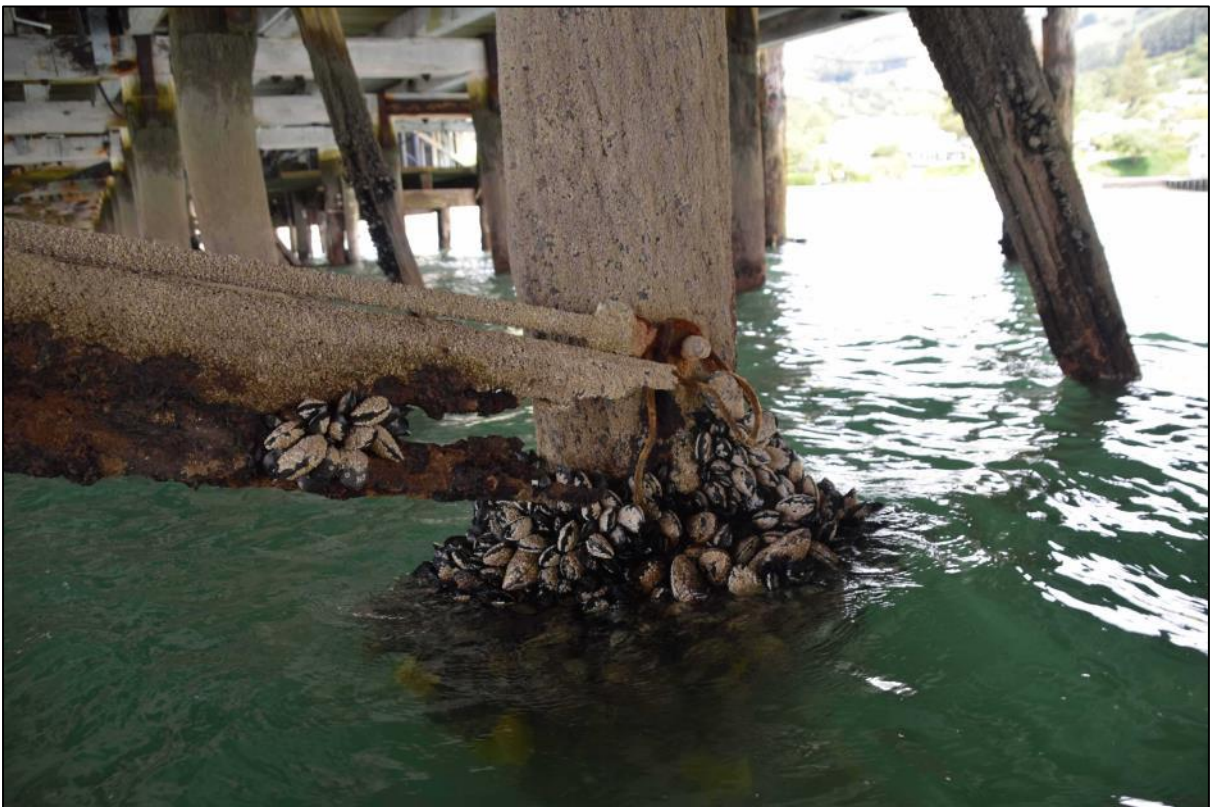
Photo 35 Broken/corroded steel brace.

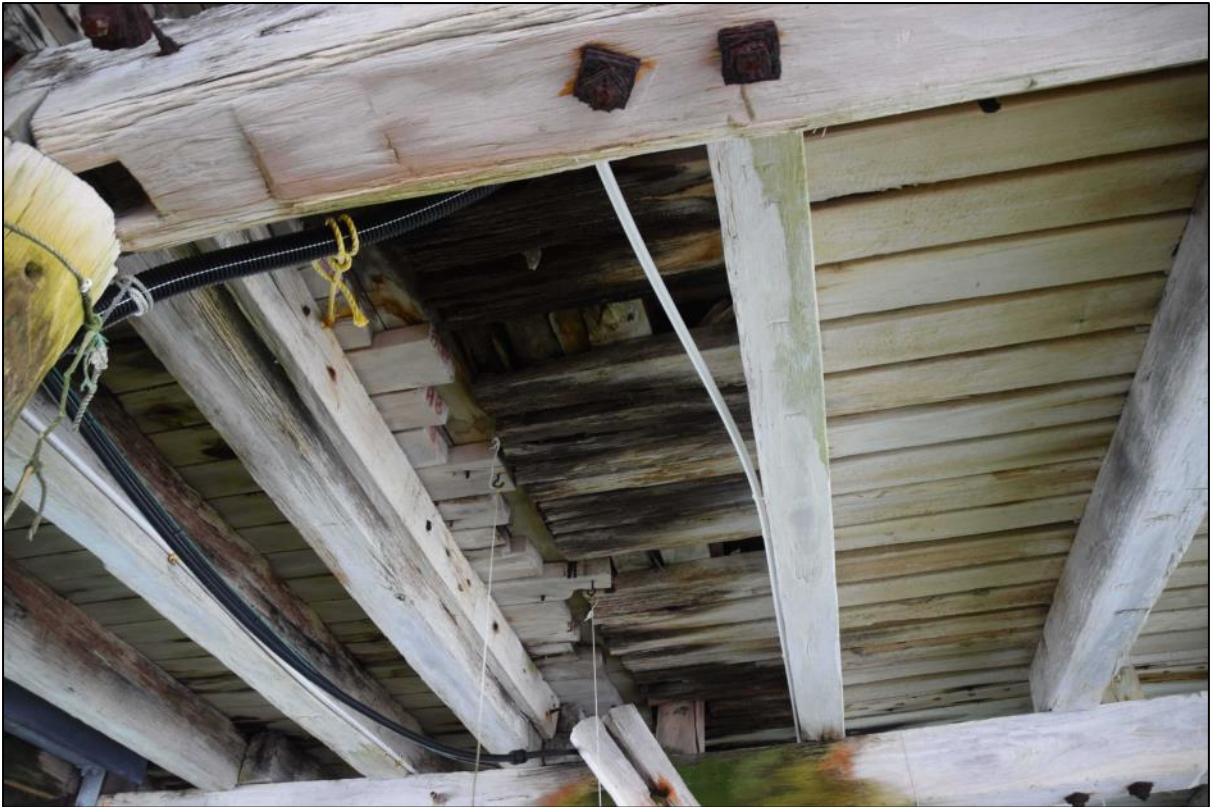
Photo 36 Decay in decking boards beneath the existing deck finish. Corrosion to original iron bolts and nuts.

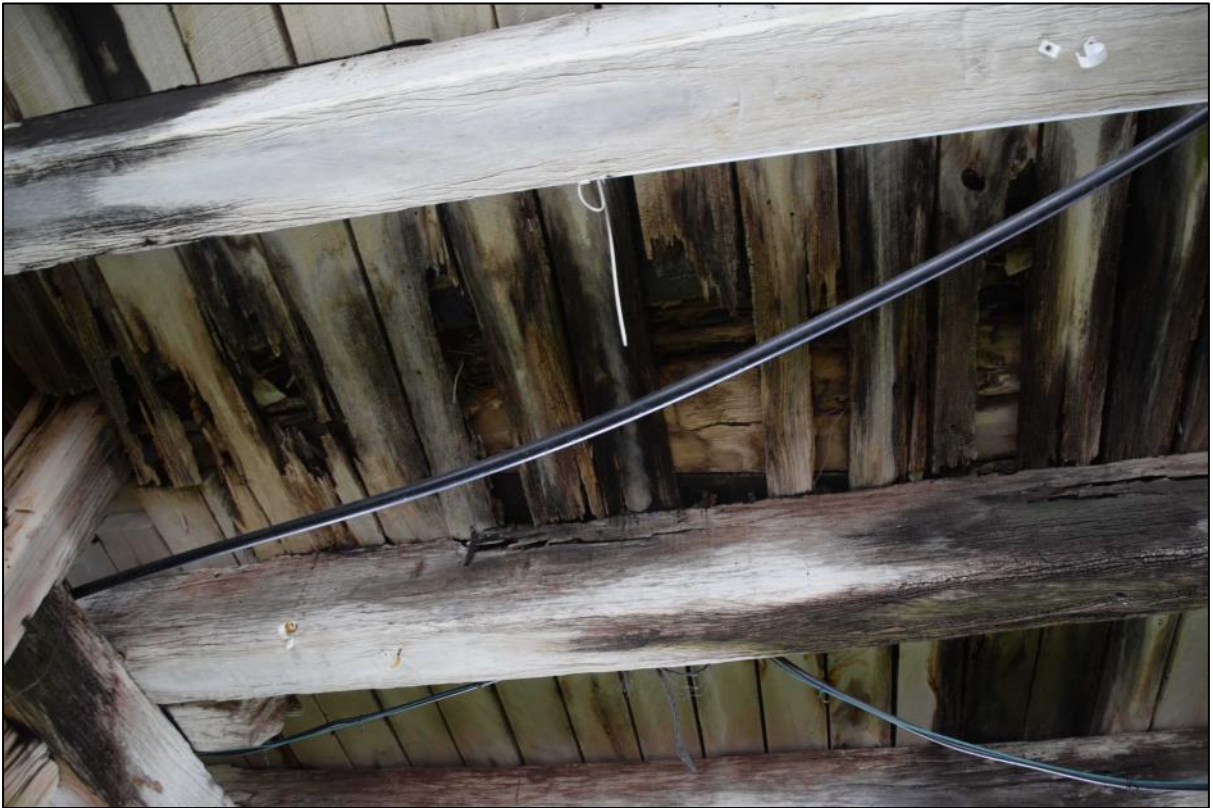
Photo 37 Further decay in decking boards beneath the existing deck finish.

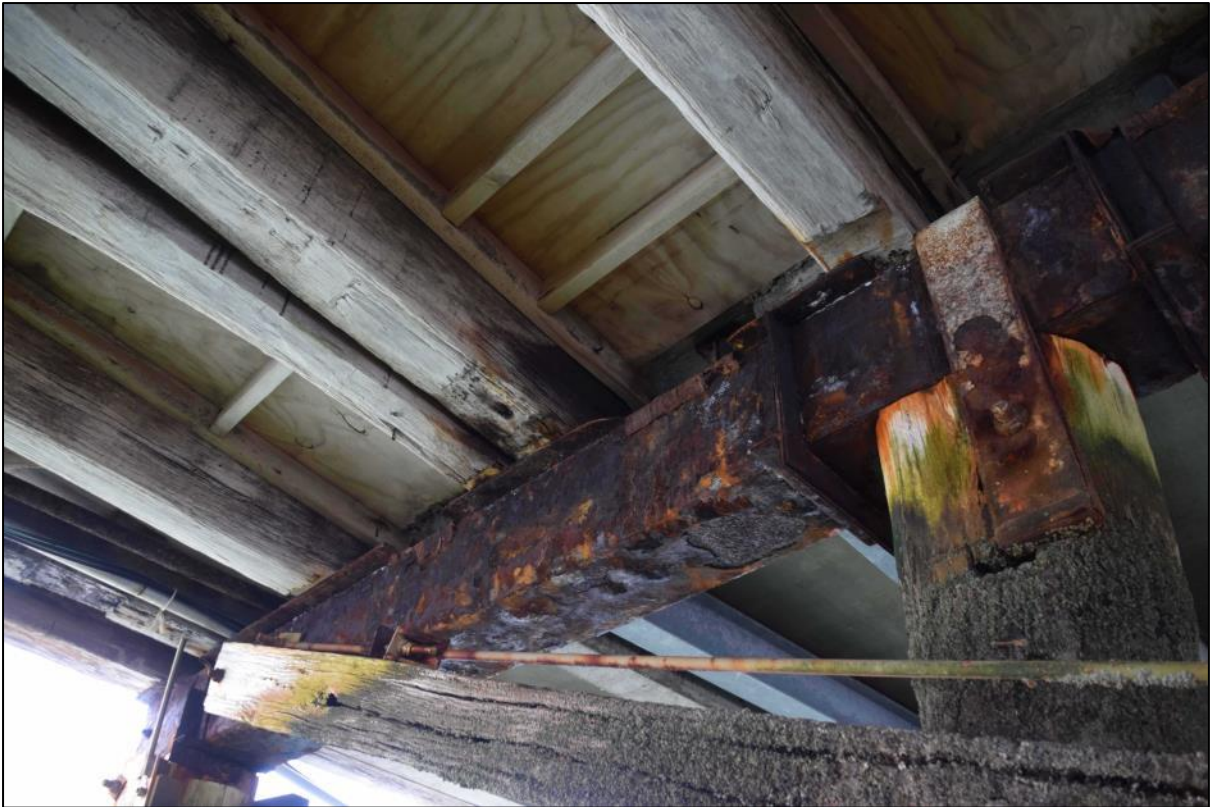
Photo 38 Severe corrosion to a past steel repair.

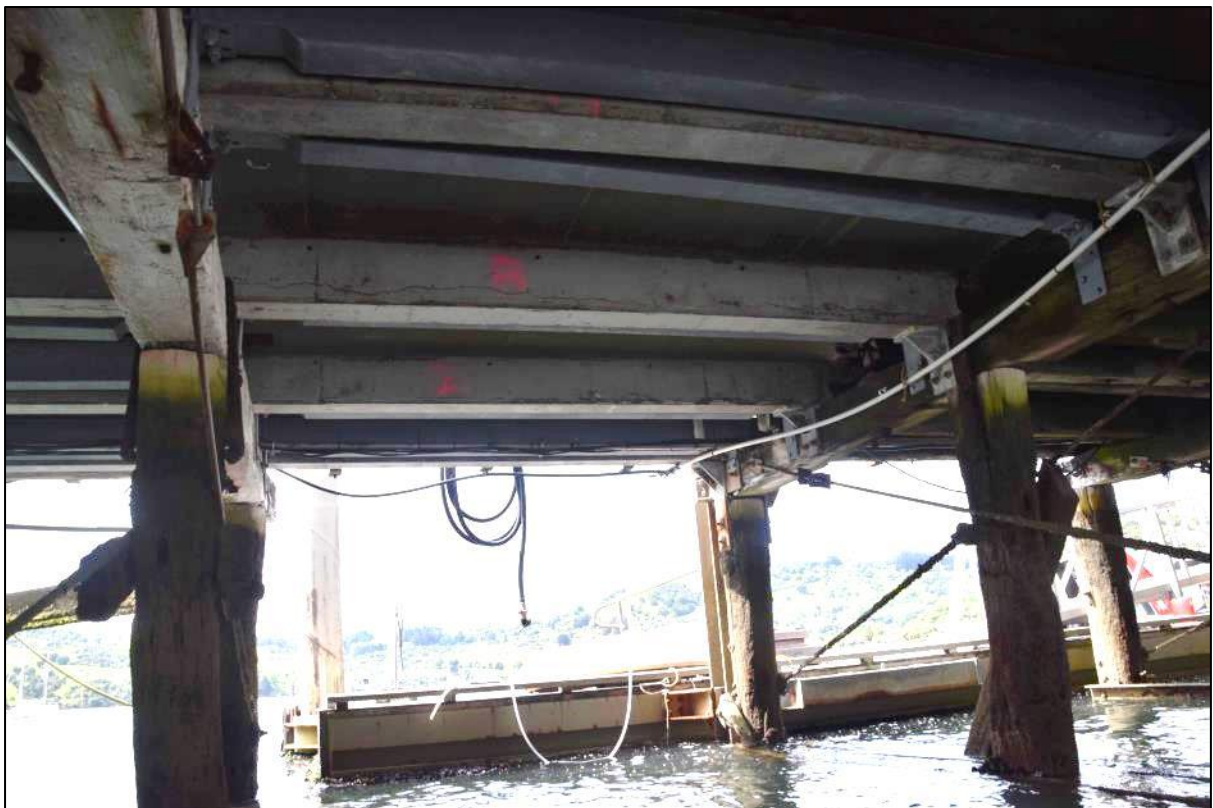
Photo 41 A close-up of inserted concrete and steel beams (Photo 40) – some of the concrete beam are cracked. Poorly restrained and concealed modern conduits.
