# A Conservation Management Plan for the Awa-iti Domain Memorial Gates, Little River.

June 2005

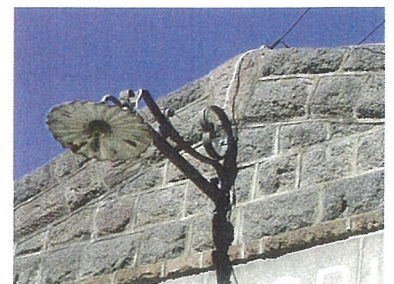
Metal support and fixings into the stonework are showing rust.

*The two lights were installed prior to the 1948 unveiling and are iconic fittings of their time.*

Remove from stonework and remove rust and paint coatings. Refinish and re-fix with stainless bolts into stonework. Adapt and conceal electrical supply cable and underground supply cable from library. Consider replacing energy saver bulbs for a light source that directs light onto stonework only.

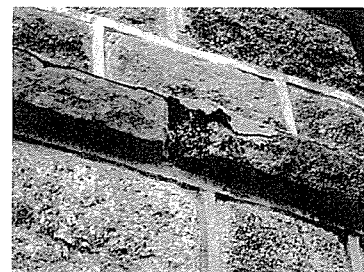
- Several Lyttleton trachyte stones have a delaminated surface.
- Many of the Port Hills "tuff" string course stones have decayed

Previous attempts to repair stonework defects includes the loose application of grout to external faces of stones as a tidy-up measure, re-pointing with incorrect profile and possibly incorrect mix, continuation of plastered cappings over onto damaged "tuff" stonework strings and an inappropriate repair to a granite slab bruise.

Spalling tuff string course & poor plaster repair

(See 2 above for re-pointing). Horizontal "tuff" string course decayed stones to be refaced with new stone facings secured with stainless pins. It may be possible to 'reverse' original stones to expose new face. The trachyte string course stones with delaminated faces to have faces re-fixed with structural adhesive.

Remove previous infill plaster and pointing stone repairs.

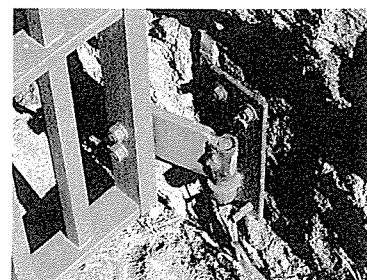
One gate has the original pivot pin removed and a makeshift support installed into the stonework, possibly to raise the opened gate over a raised concrete path built much later than gate installation. Gate latch hardware has parts missing on all gates and is not functional.

Improvised gate hinge replacing original pin.

South west gate missing pin to be reinstated and existing non-original fixing removed and stonework made good. Any subsequent conflict of gate with path height to be remedied by reforming concrete path.

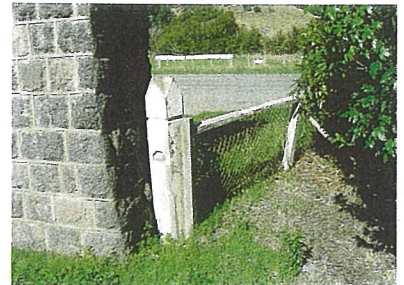
The early timber rail, post and mesh fence either side of the gates is in poor repair. Timber rails and posts are decaying or missing and the fence is out of shape.

Original timber post and fence

The angled fence segments either side of the memorial are an early design and are a significant feature within the memorial's curtilage, and should be retained with the design replicated where damaged or missing. The remaining profiled post could be reused set in a new footing with galvanized fixing, and replicated on the other side. The retained angled fence segments would then join with any new fencing on the Domain east boundary as proposed in the Draft Management Plan.
