# Little River Coronation Library & Awa-iti Domain

CONSERVATION PLAN  
June 2015

CONSERVATION PLAN FOR THE  
LITTLE RIVER CORONATION LIBRARY

PREPARED FOR THE  
CHRISTCHURCH CITY COUNCIL: JUNE 2015

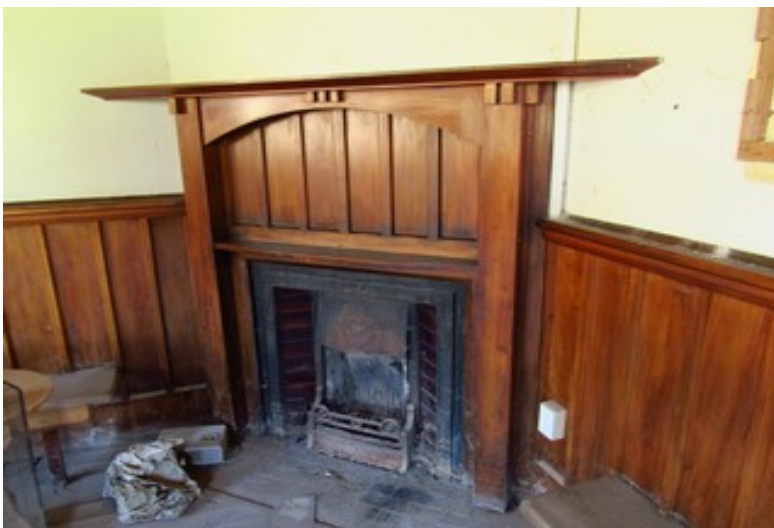
Source: B.Dougan 31/3/2015  
Coal register fireplace in Reading room flanked by glazed tiles and Rimu surround. Note intrusive surface mounted power outlet.

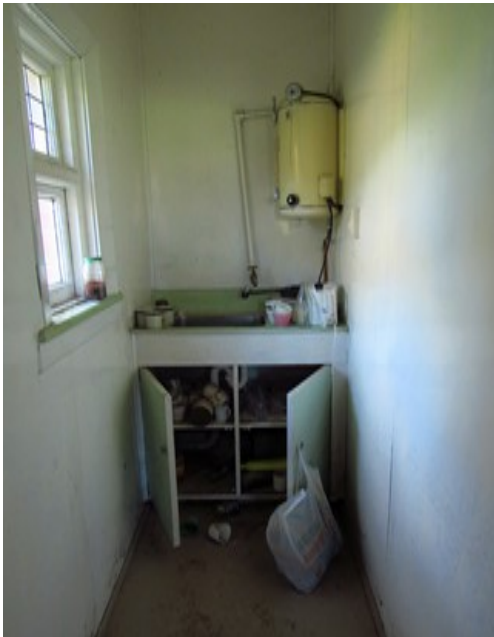
Source: B.Dougan 31/3/2015  
Tearoom showing painted hardboard lining overlay to brickwork walls, crude sink bench and poorly executed plumbing. All of this is non-original fabric or no heritage value.

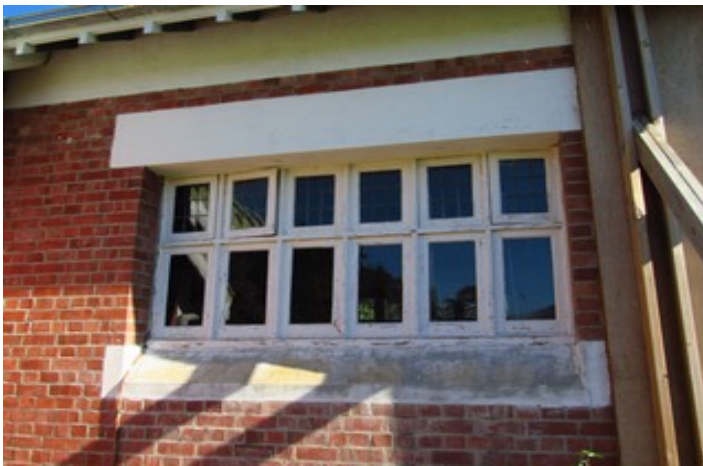
Source: B. Dougan 31/3/15  
The north windows to the Library room showing weathered paint to the plastered sills.  
Note the side hung toplights.

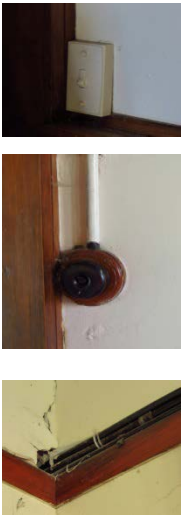
<p>Later heritage fabric. Black cabling and conduit from original electrical installation. White PVC cabling, clips, conduit , switches and power outlets intrusive.</p> <p>Early black bakelite switches.</p> <p>Cabling and conduit not sleeved at wall penetrations</p>	<p>Replace white PVC clips ,conduit, switches and power outlets with black PVC.</p> <p>Black bakelite switches to be retained</p> <p>Sleeve cabling and conduit at wall penetrations. Refer to repair of spalling plasterwork</p>	<p>Necessary</p> <p>Nil</p> <p>Necessary</p>	<p>5,000 sum</p>
<p><b>Electrical Distribution Board</b></p>
