## MEMO

**Memo Title:** Fire Hazard 265 Riccarton Rd

**Date:** 8<sup>th</sup> November 2021

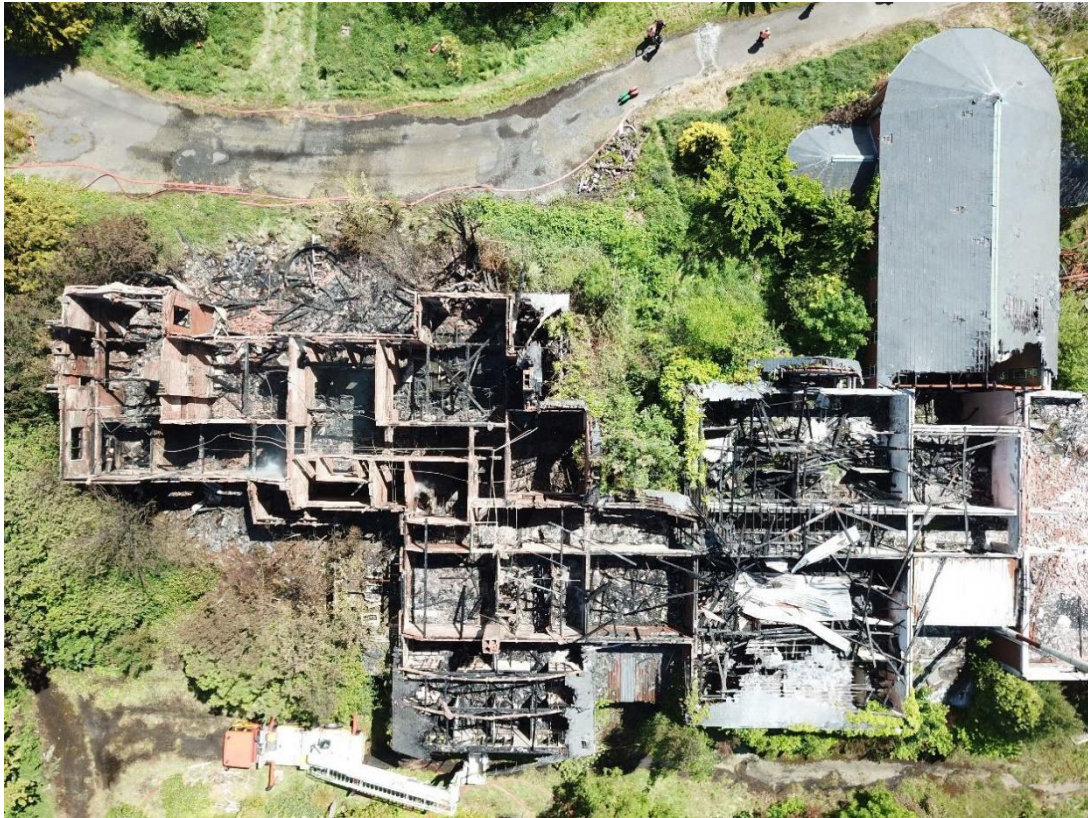
Historic Building section following fire:

FENZ believes that the site is now in a significantly worse condition than in 2019, with the “Historic” element suffering catastrophic damage as a result of the fire on Friday morning.

Total loss of all structural floor and roof elements, across ground and first floor areas.

It is recommended that the owner demolish the remaining structures on the site to avoid further fires on the site and that the site be cleared of unmanaged long grass and vegetation to prevent fire spread beyond the property of origin.

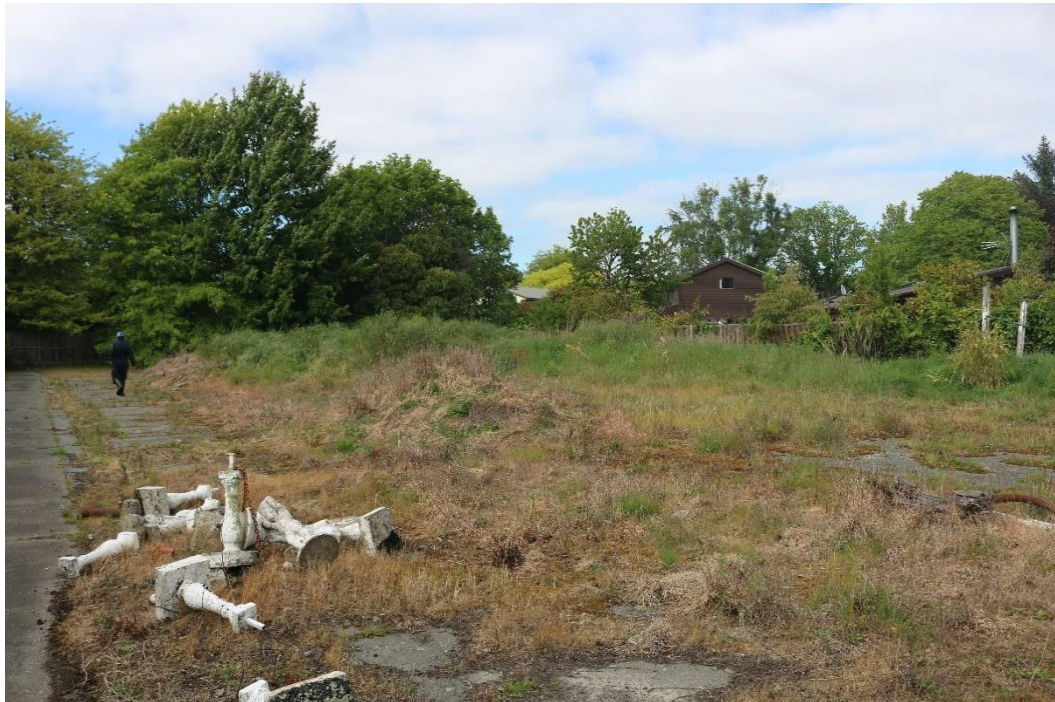
Rear Section with overgrown vegetation:

Section to the south of the main building with long grass to boundary fences.

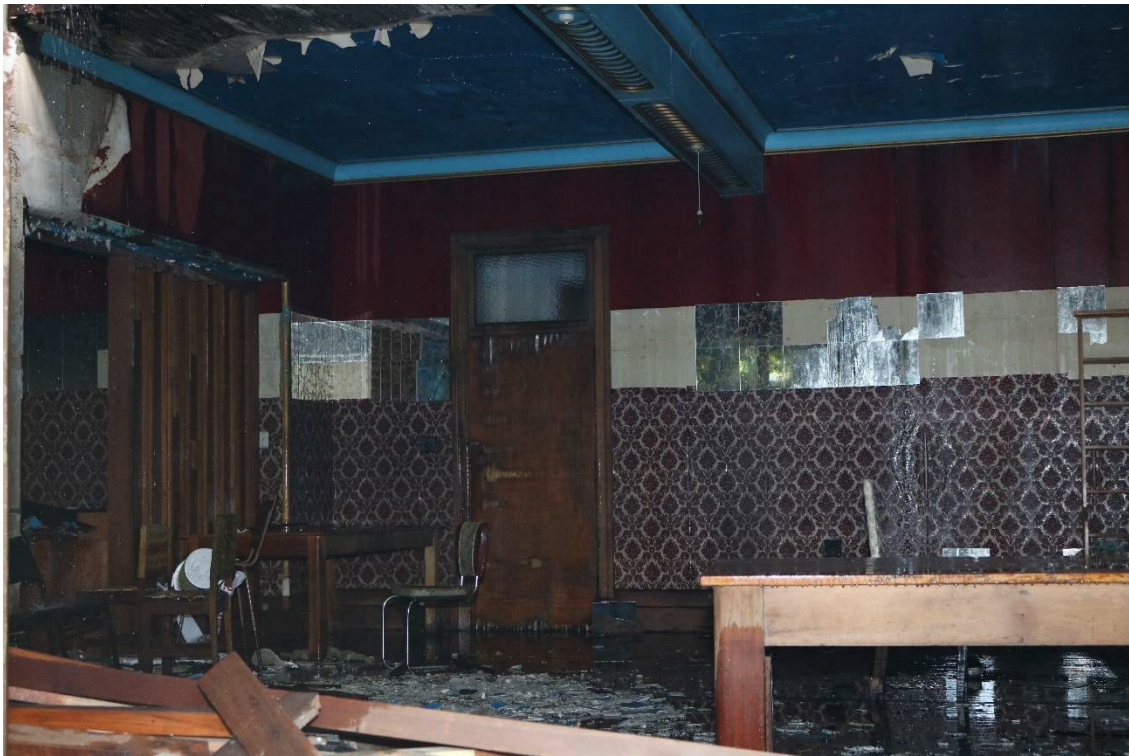
Central Section still with furniture: (Sources of fuel)

Area too dangerous to enter due to structure above.

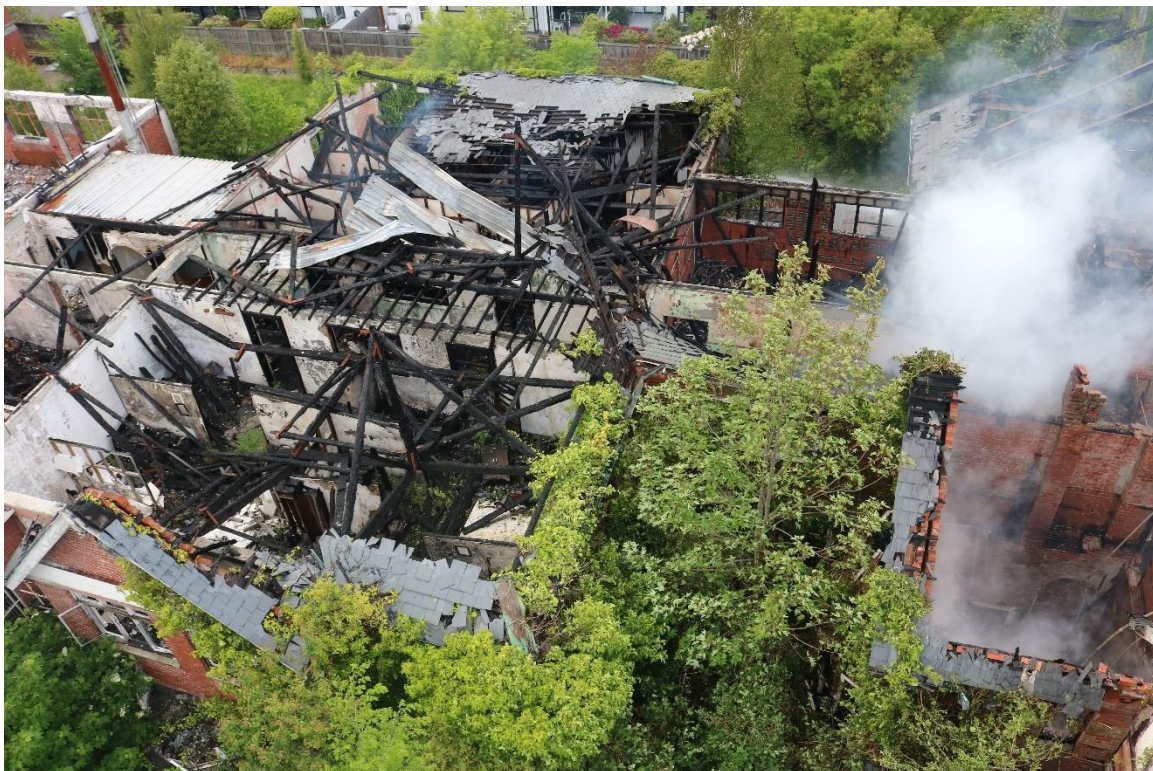
Damage to area above Central Section

Fire connected at first floor level to previous fire. Total loss of supporting roof structures.

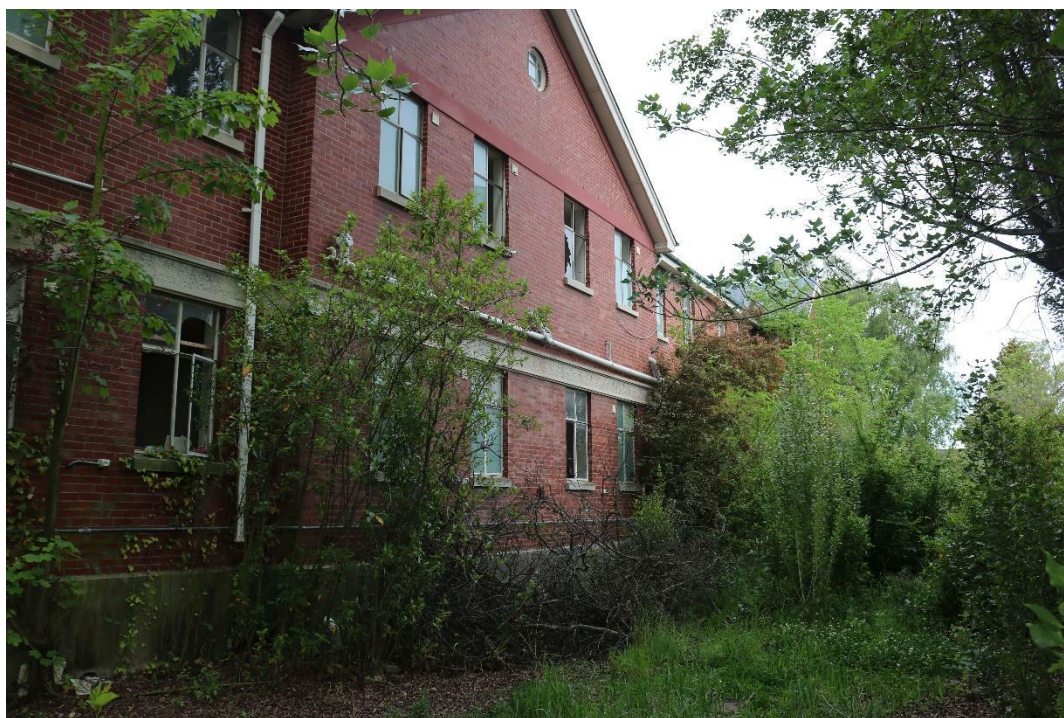
Bedroom Wing (East Wing)

Photo taken 5<sup>th</sup> Nov 2021. Broken windows and unchecked vegetation growth to fence line.

It is FENZ belief that the “East Wing” now presents an almost certain risk of fire, due to the lack of security on the site and the continued storage of materials in the rooms that could be used as items first ignited to create a well-developed fire. This is what occurred in the “Historic Building” for the current fire. (Fire being treated as suspicious)

No windows are intact and there are repeated reports of illegal entry to the property on a daily basis to NZ Police by a locally engaged part time security person.

FENZ recommends to CCC and the building owner to demolish all structures on site, and to clear the site to a manageable level for fire hazard mitigation. (Maintenance of vegetation) Security fences to be re-established. All windows on the East Wing building to be boarded over as an interim security step.

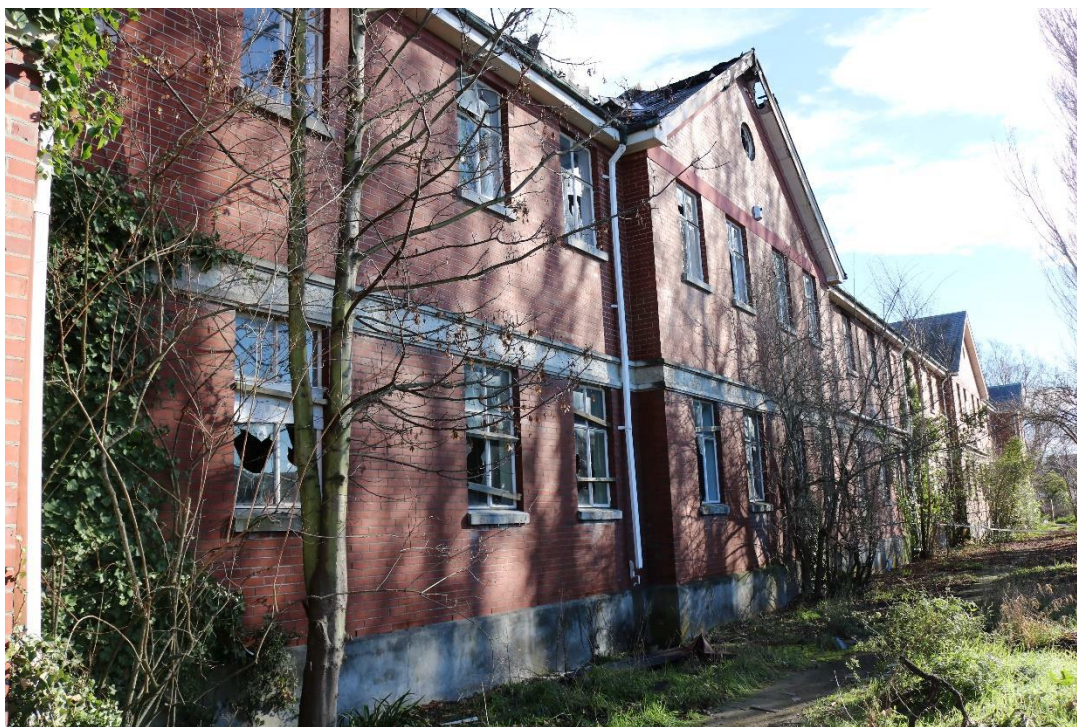
East Wing vegetation growth 2019

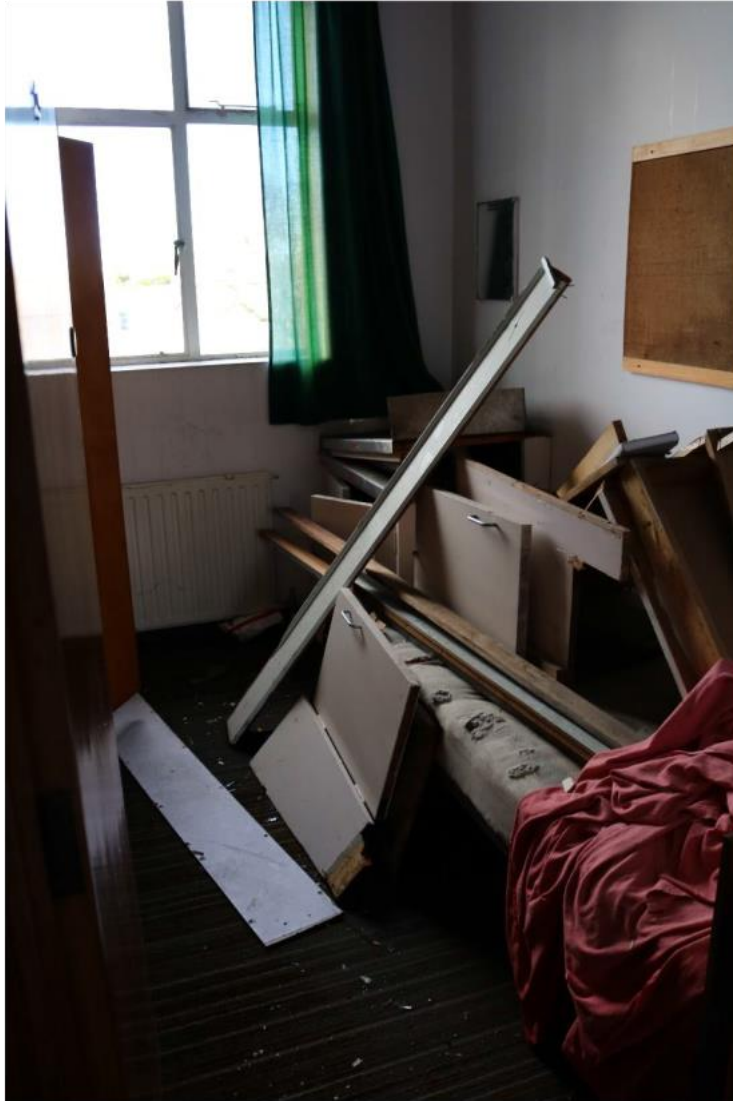
East wing storage in rooms. Photo 2019
