## Appendix R

### Site Inspection Structural Report:

DATE: 04/04/2024

ADDRESS: 265 Riccarton Road, Christchurch Antonio Hall

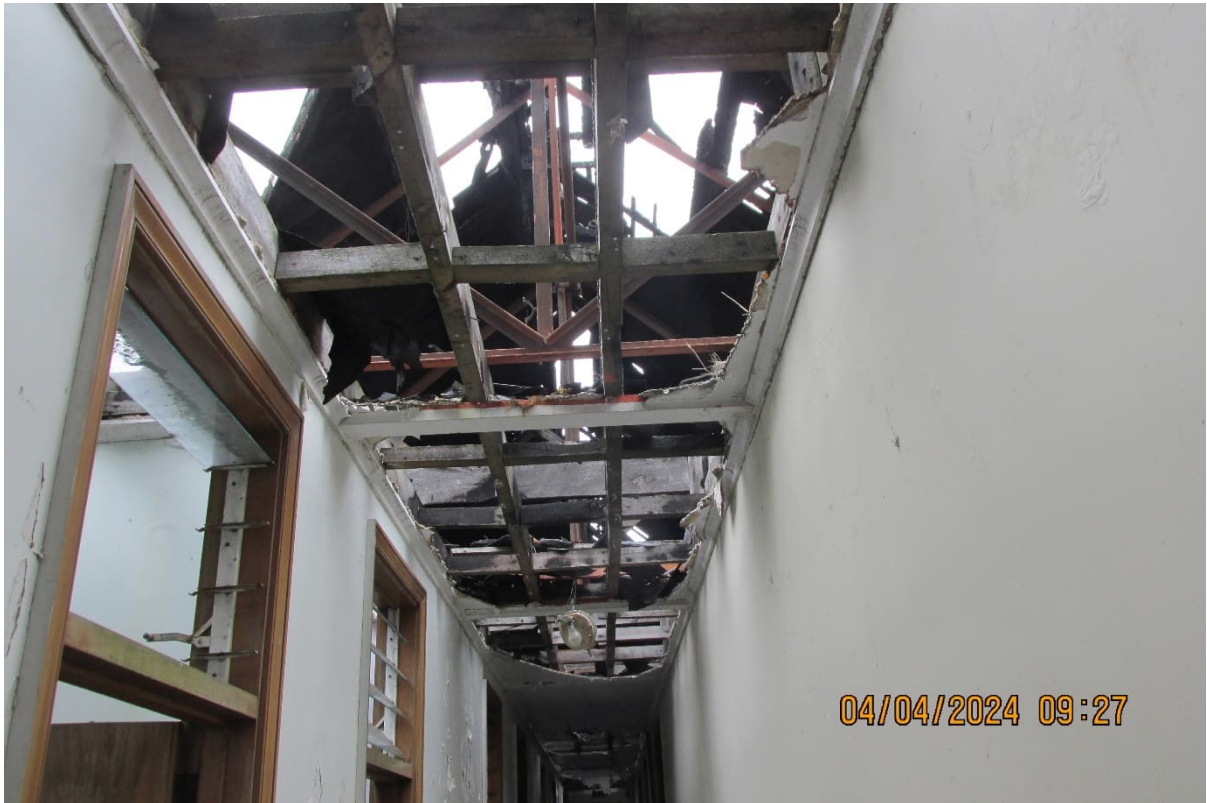
South-East End Roof Structure (fire damage accommodation block)

Remove the roof structure (fire damage) and part gable walls down to the top of the first-floor wall height southeast end as indicated by the below site map (brownish red lines below).

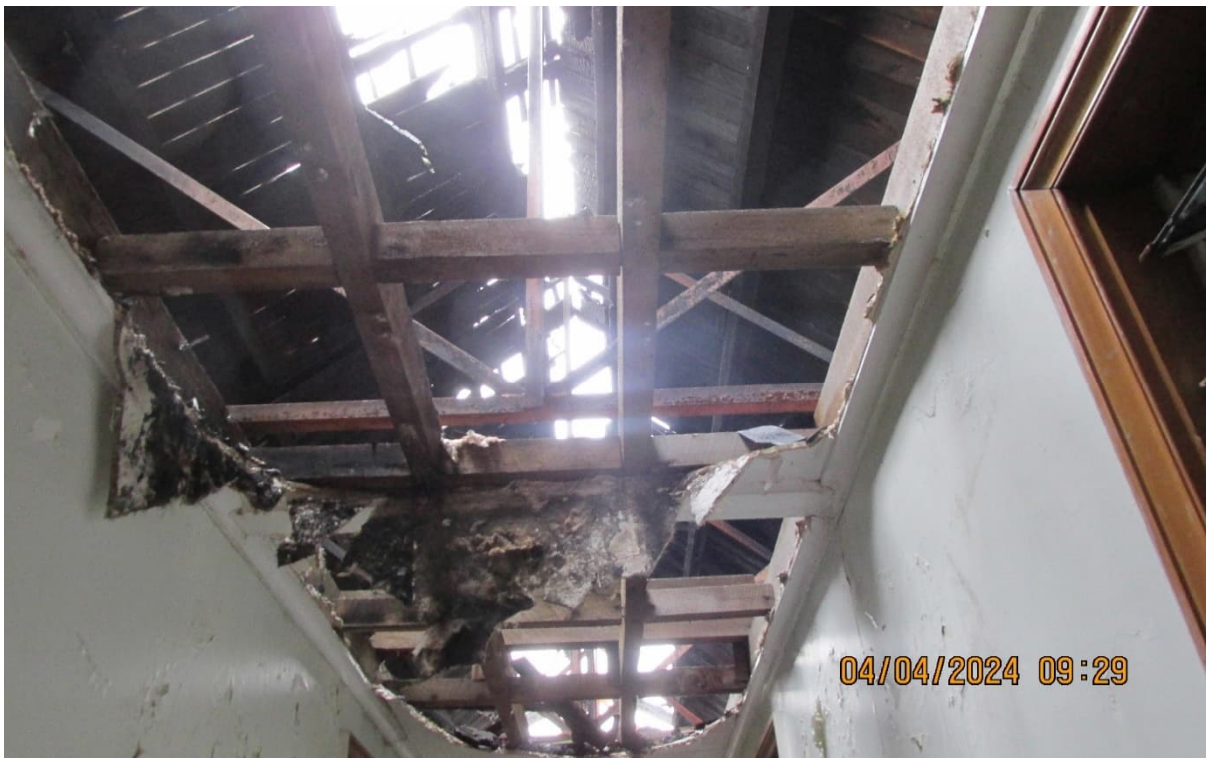
South-East End Roof Structure (fire damage accommodation block)

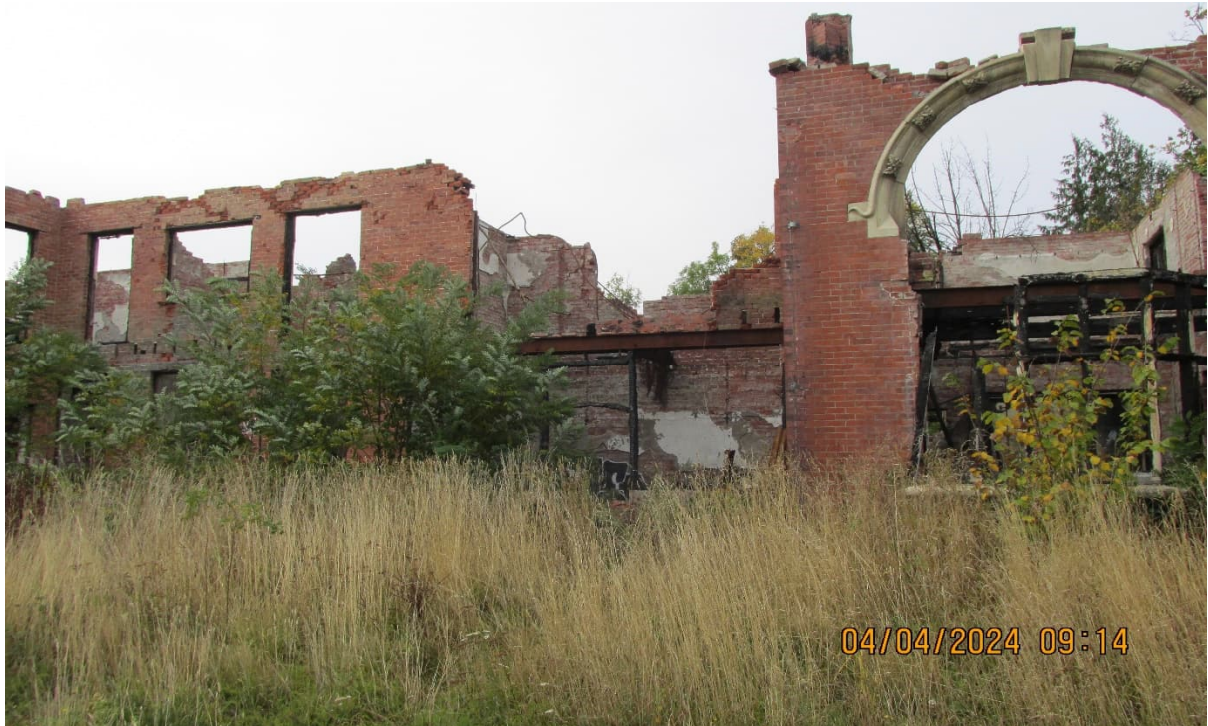
North-West End Building Structure (main homestead)

The Property Manager or Building Owner should remove the west-end building structure (main homestead) completely as indicated by the below site map (red lines - unreinforced masonry two storey high building structure).

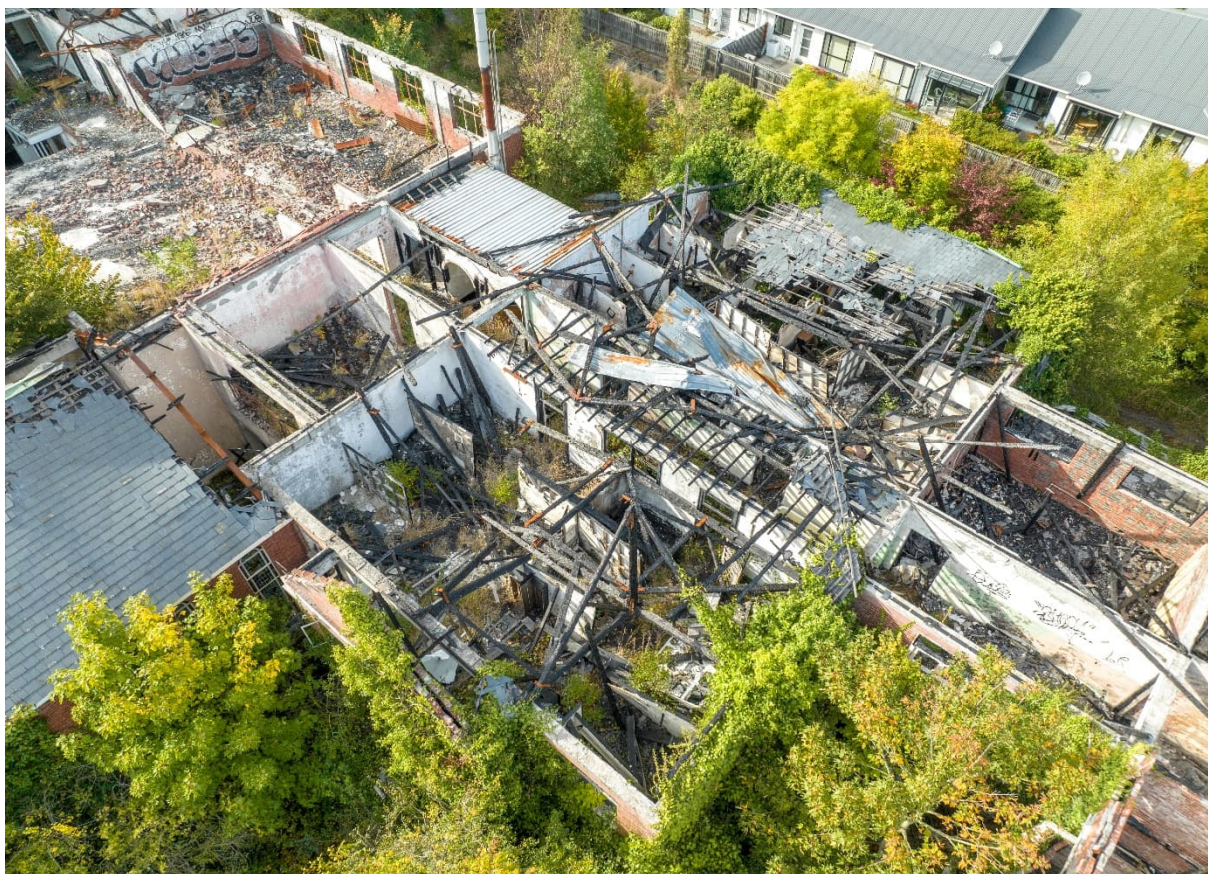
Centre South-East End Roof Structure (unsuitable debris)

Remove all unsuitable debris, centre wing south-end as indicated by the below site map (yellow lines below).
