Housing Health Inspection

HYB 1046743

Photos: 265 Riccarton Rd, Christchurch 8041 – Antonio Hall

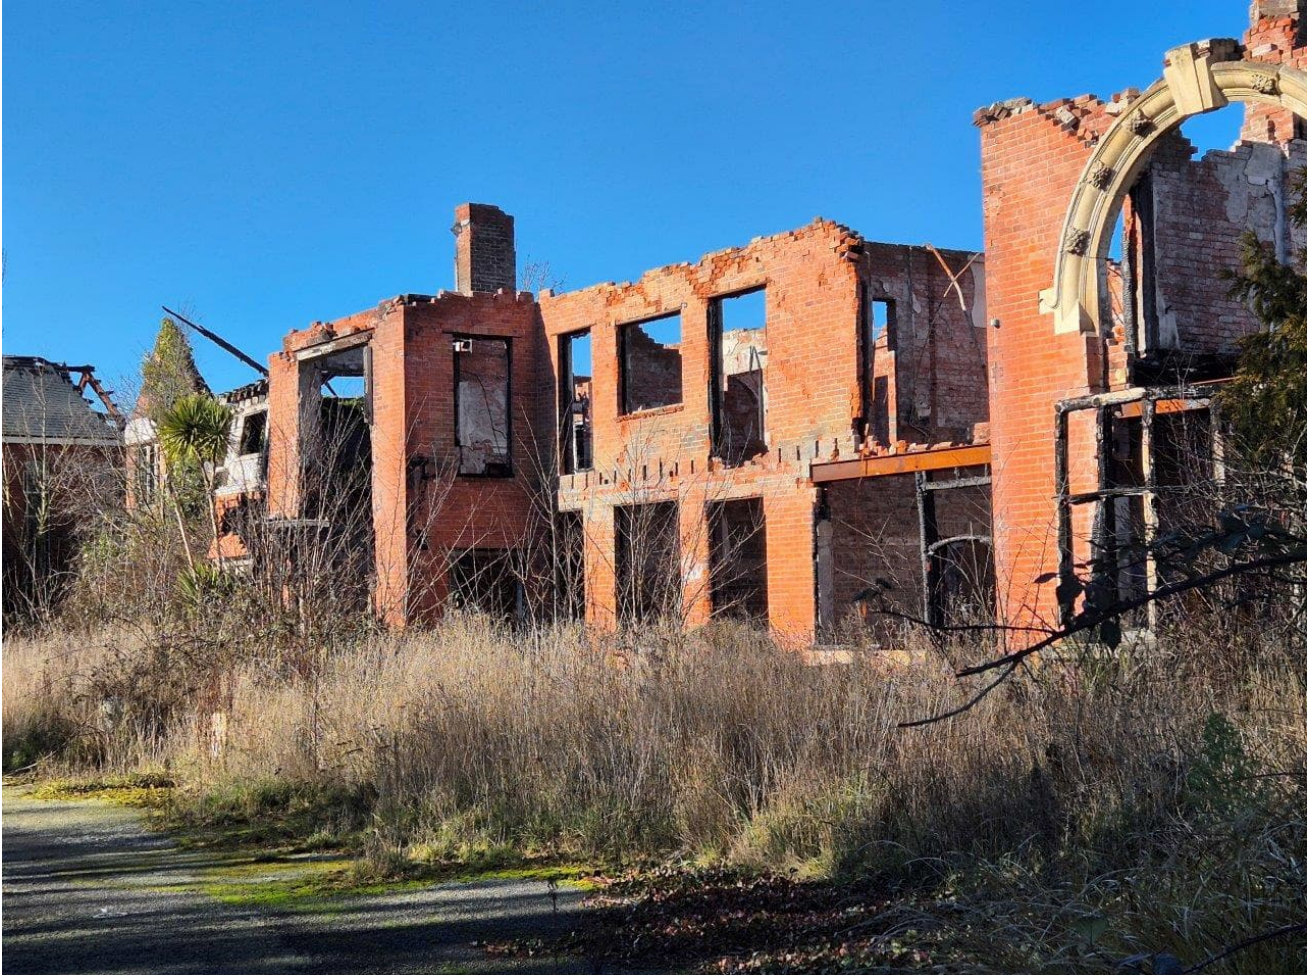
Northside west end exterior

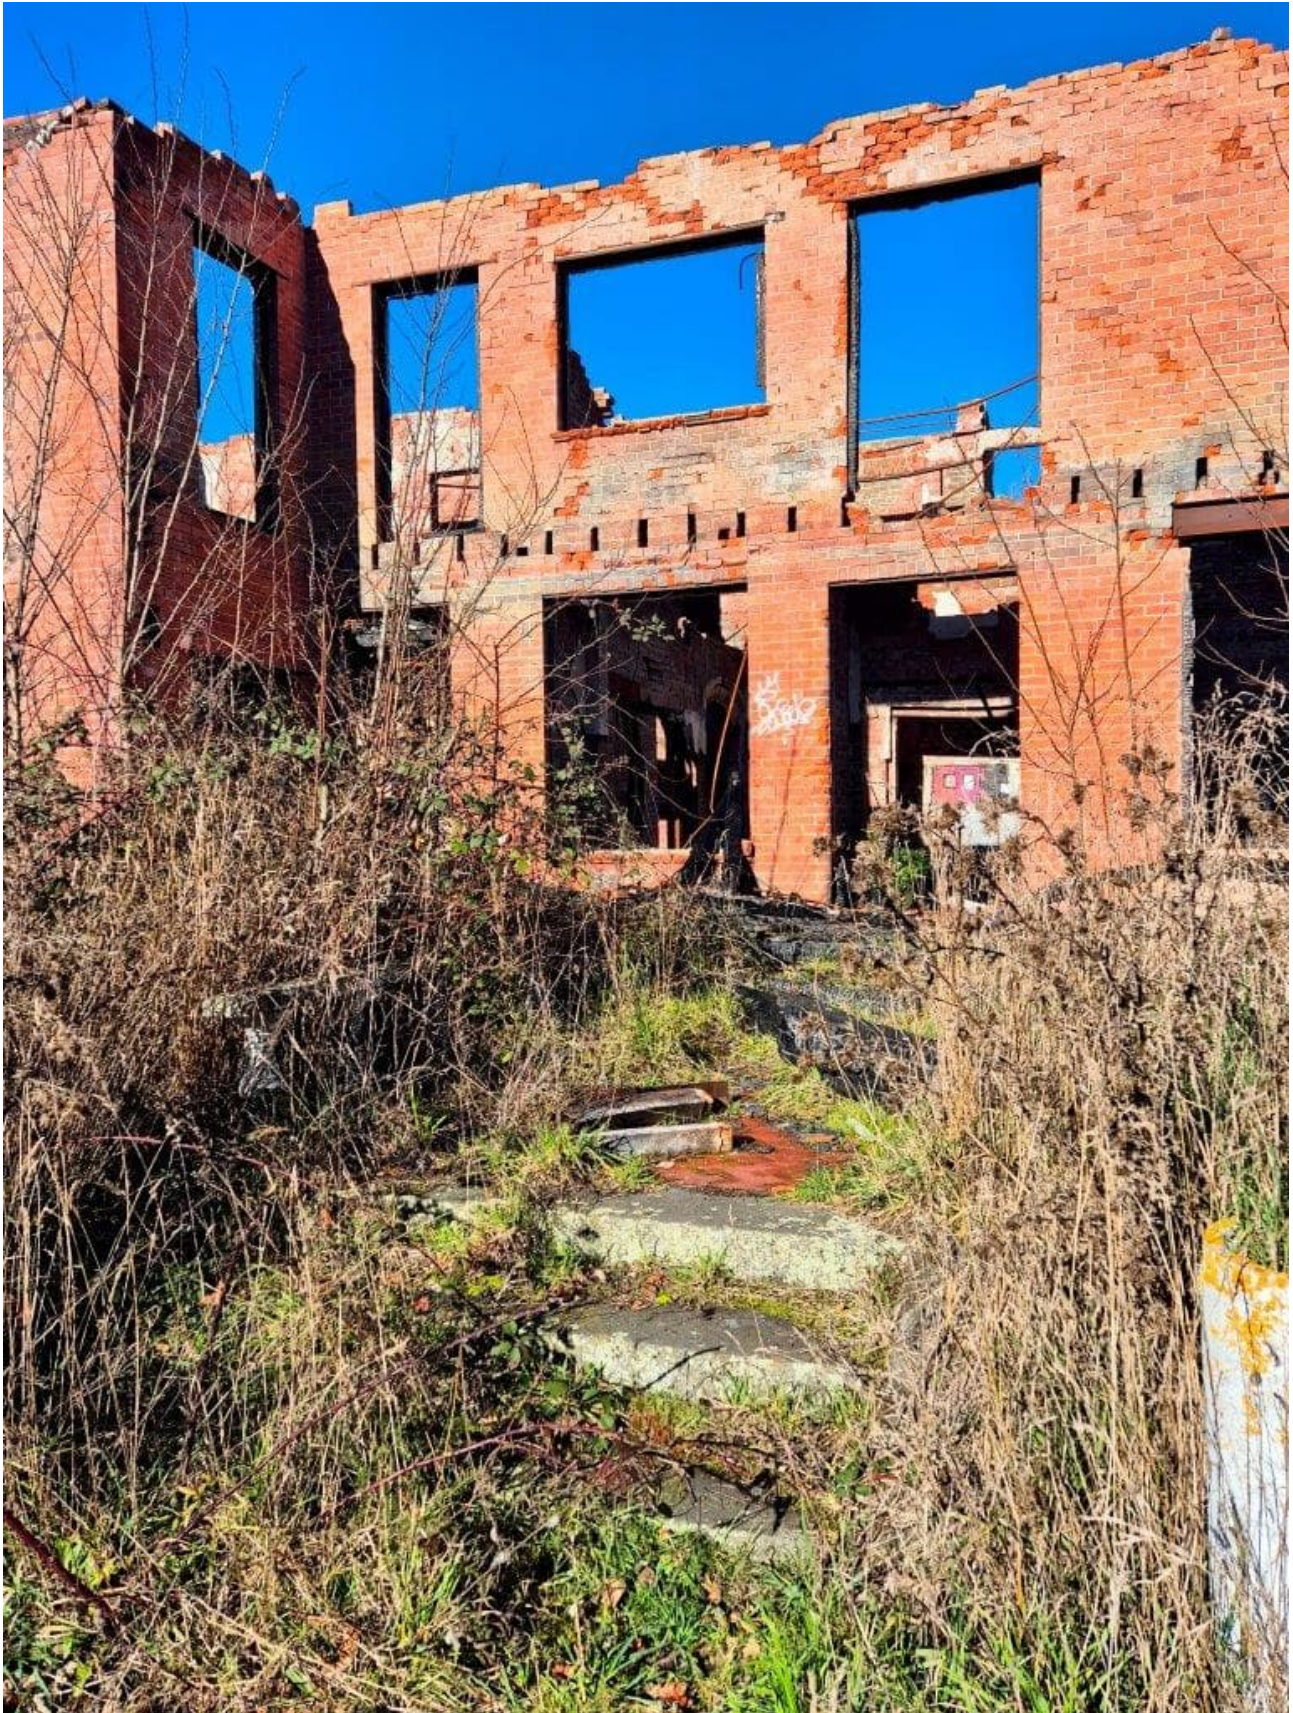
Northside west end exterior – closer view

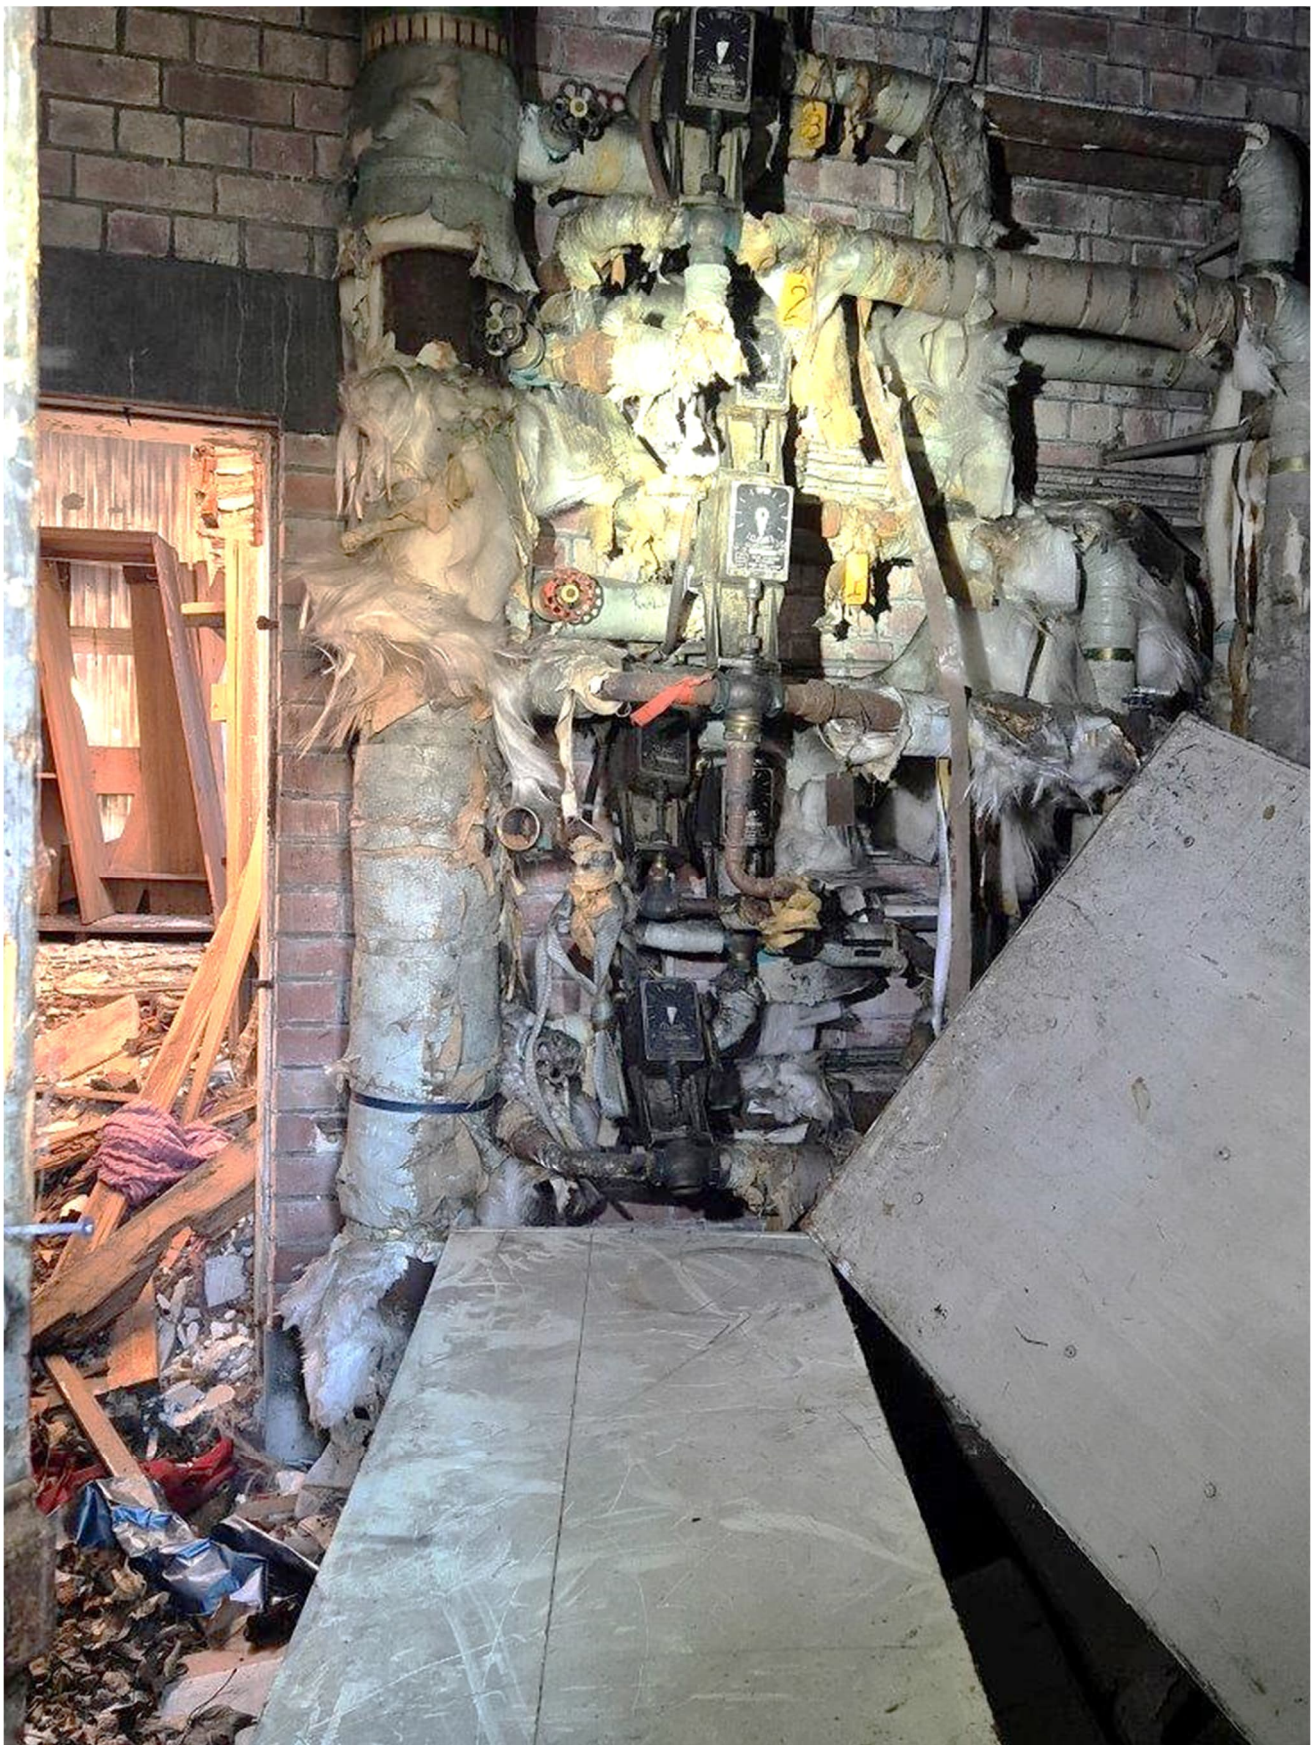
View of boiler room north wall

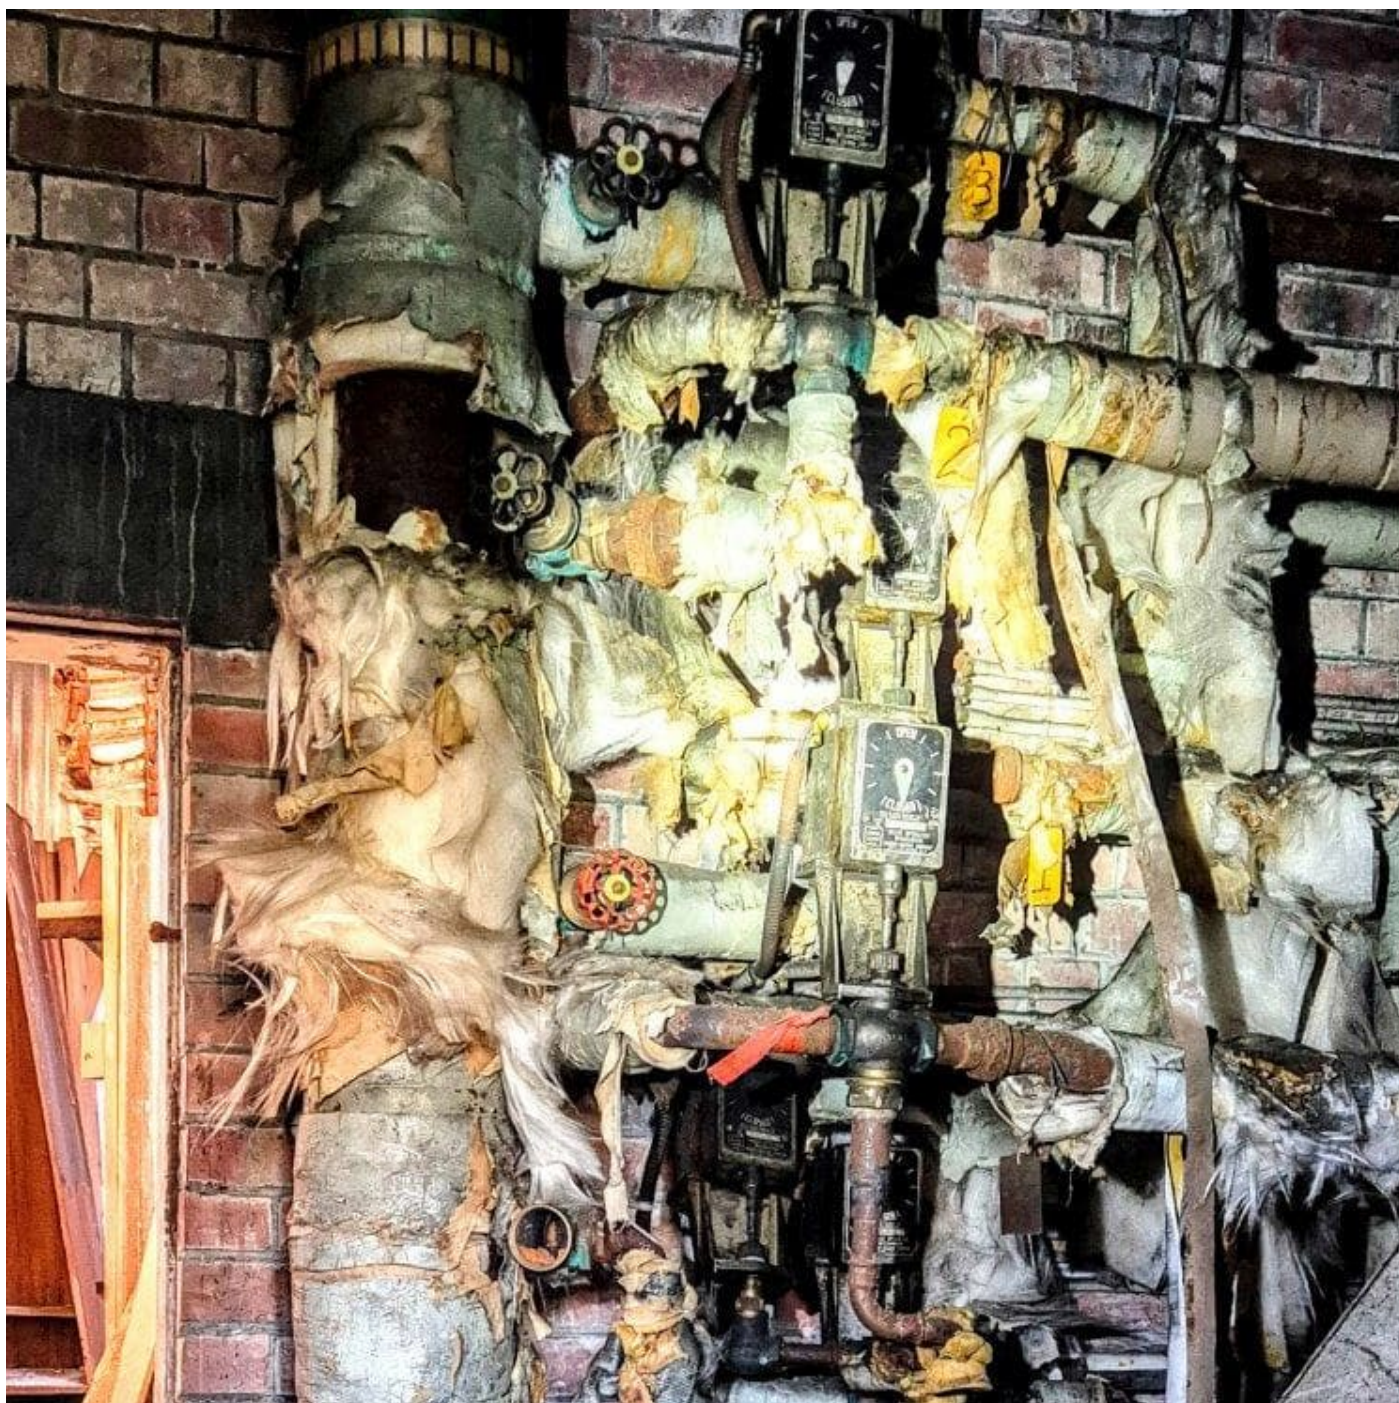
Closer view of boiler room wall

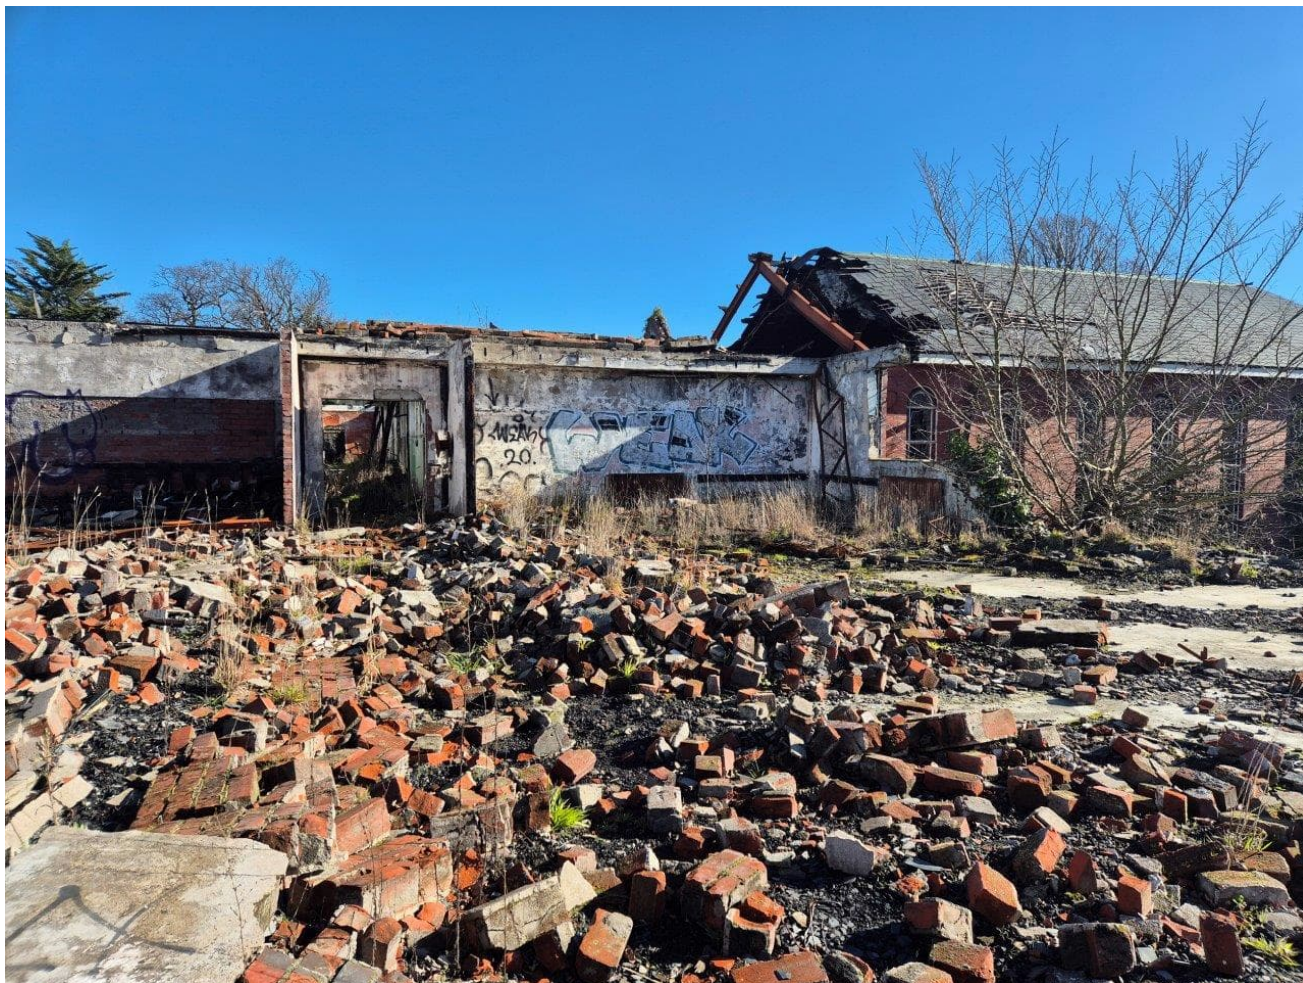
View west of first floor

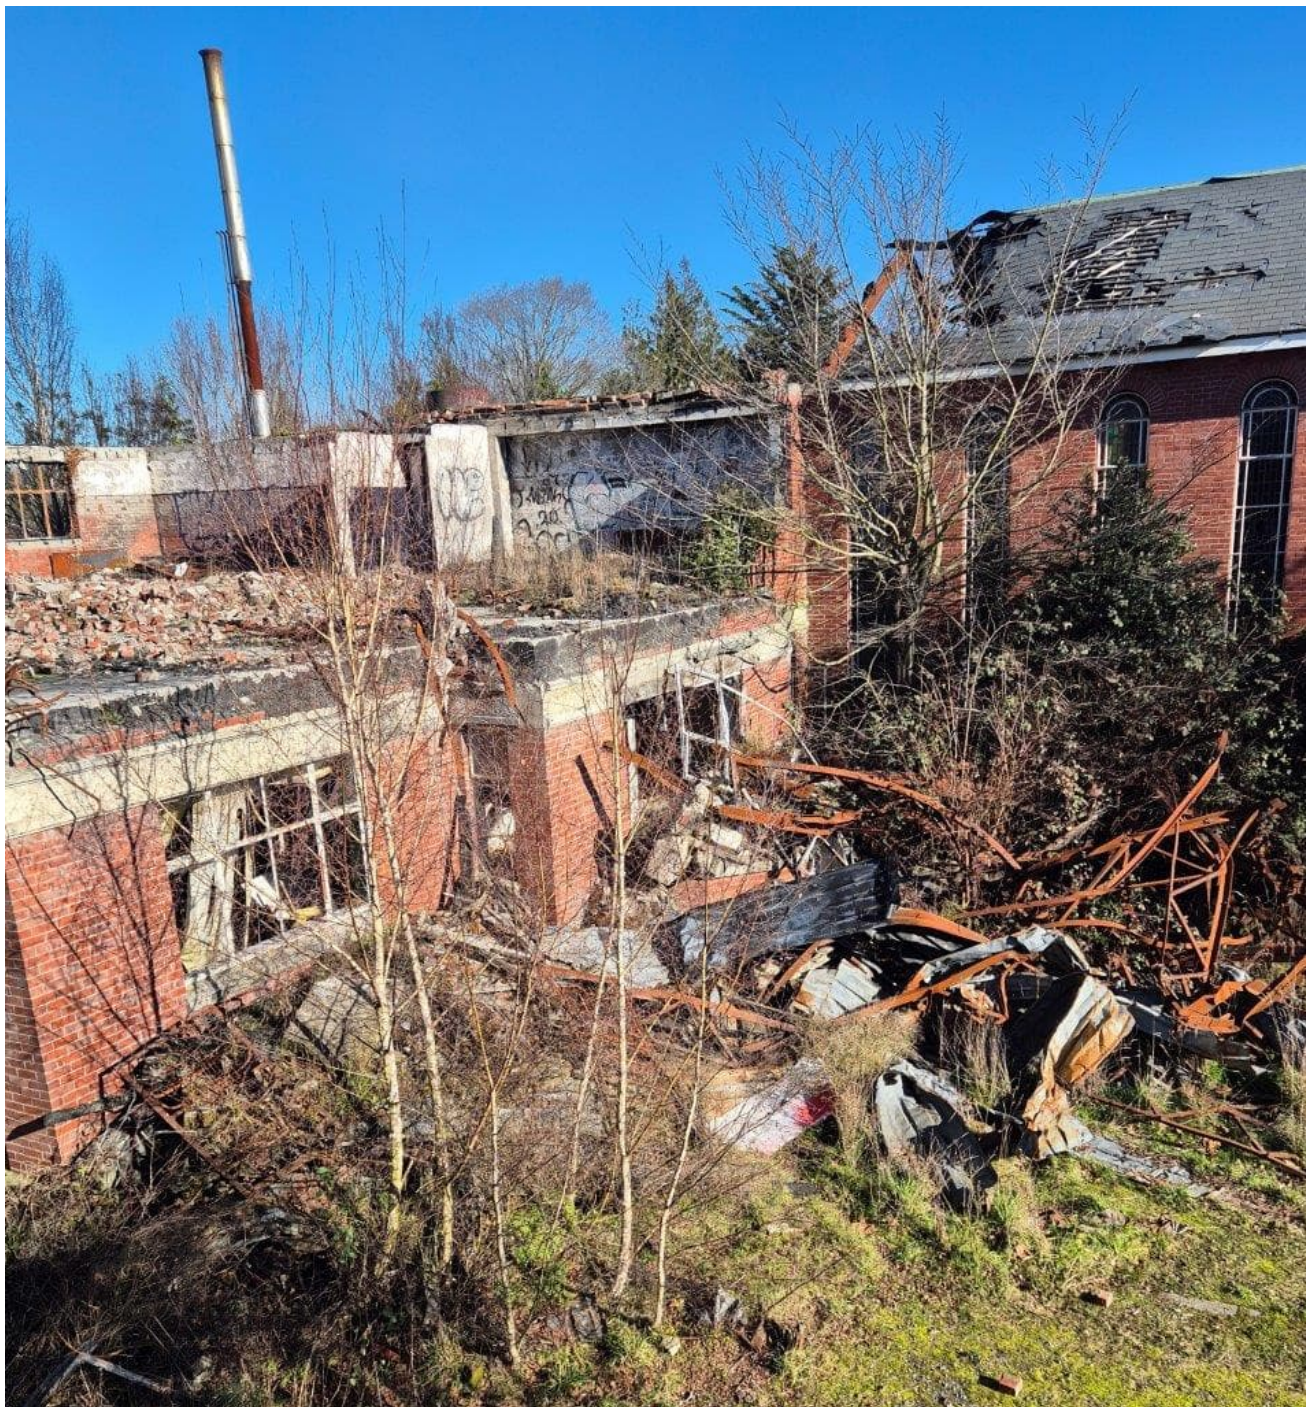
View - first floor

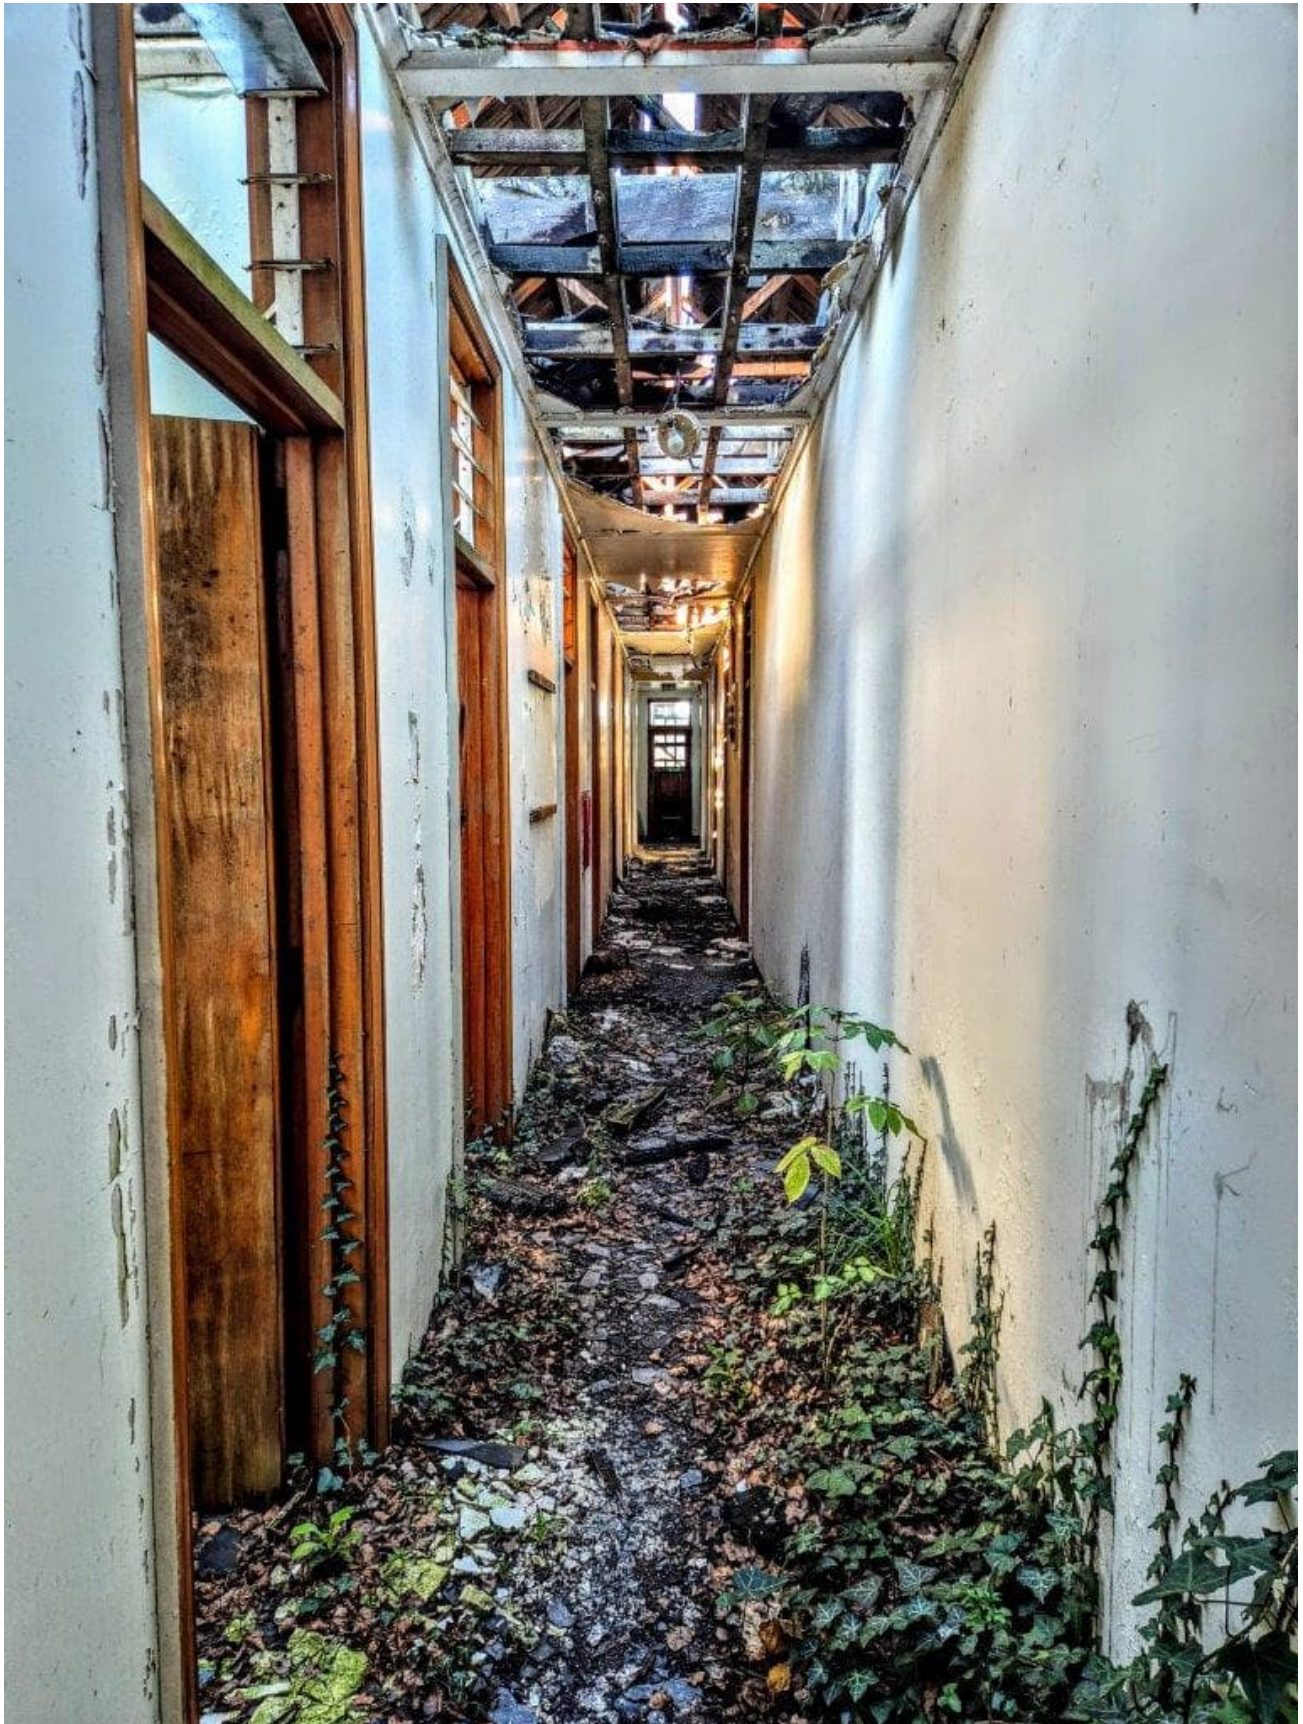
View of east-west corridor (first floor)

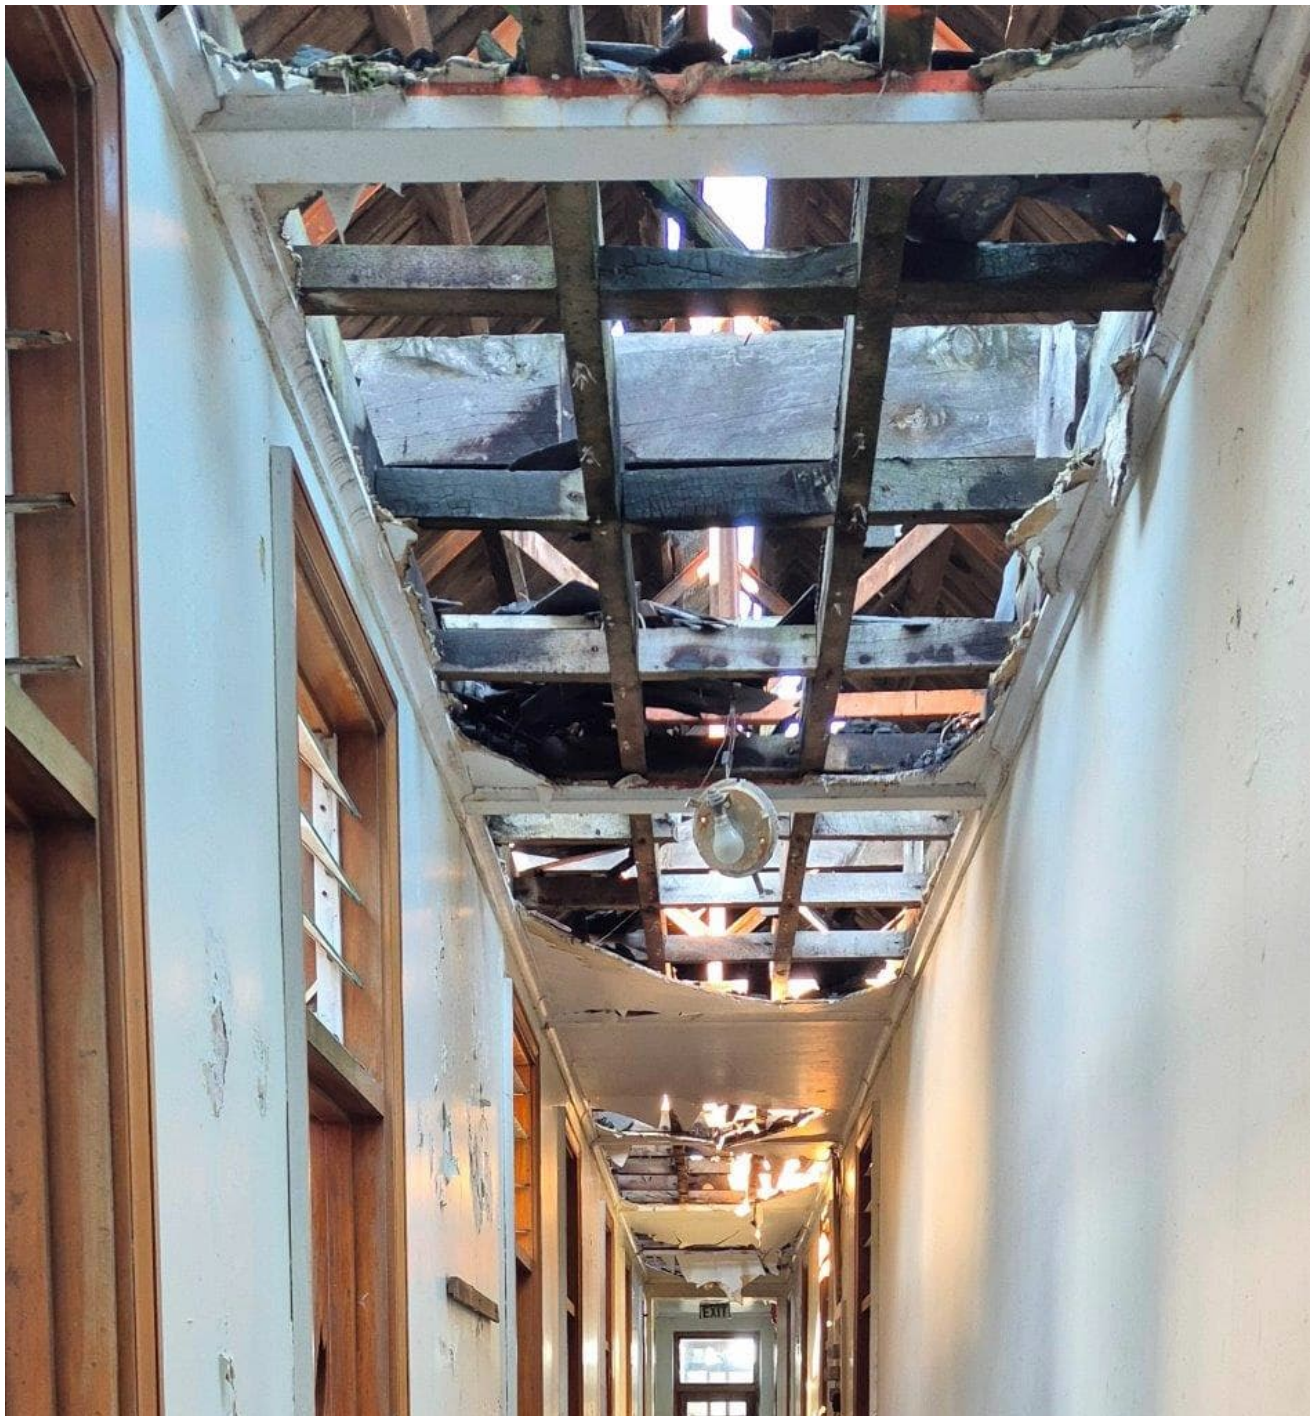
View of east-west corridor (first floor) – ceiling detail

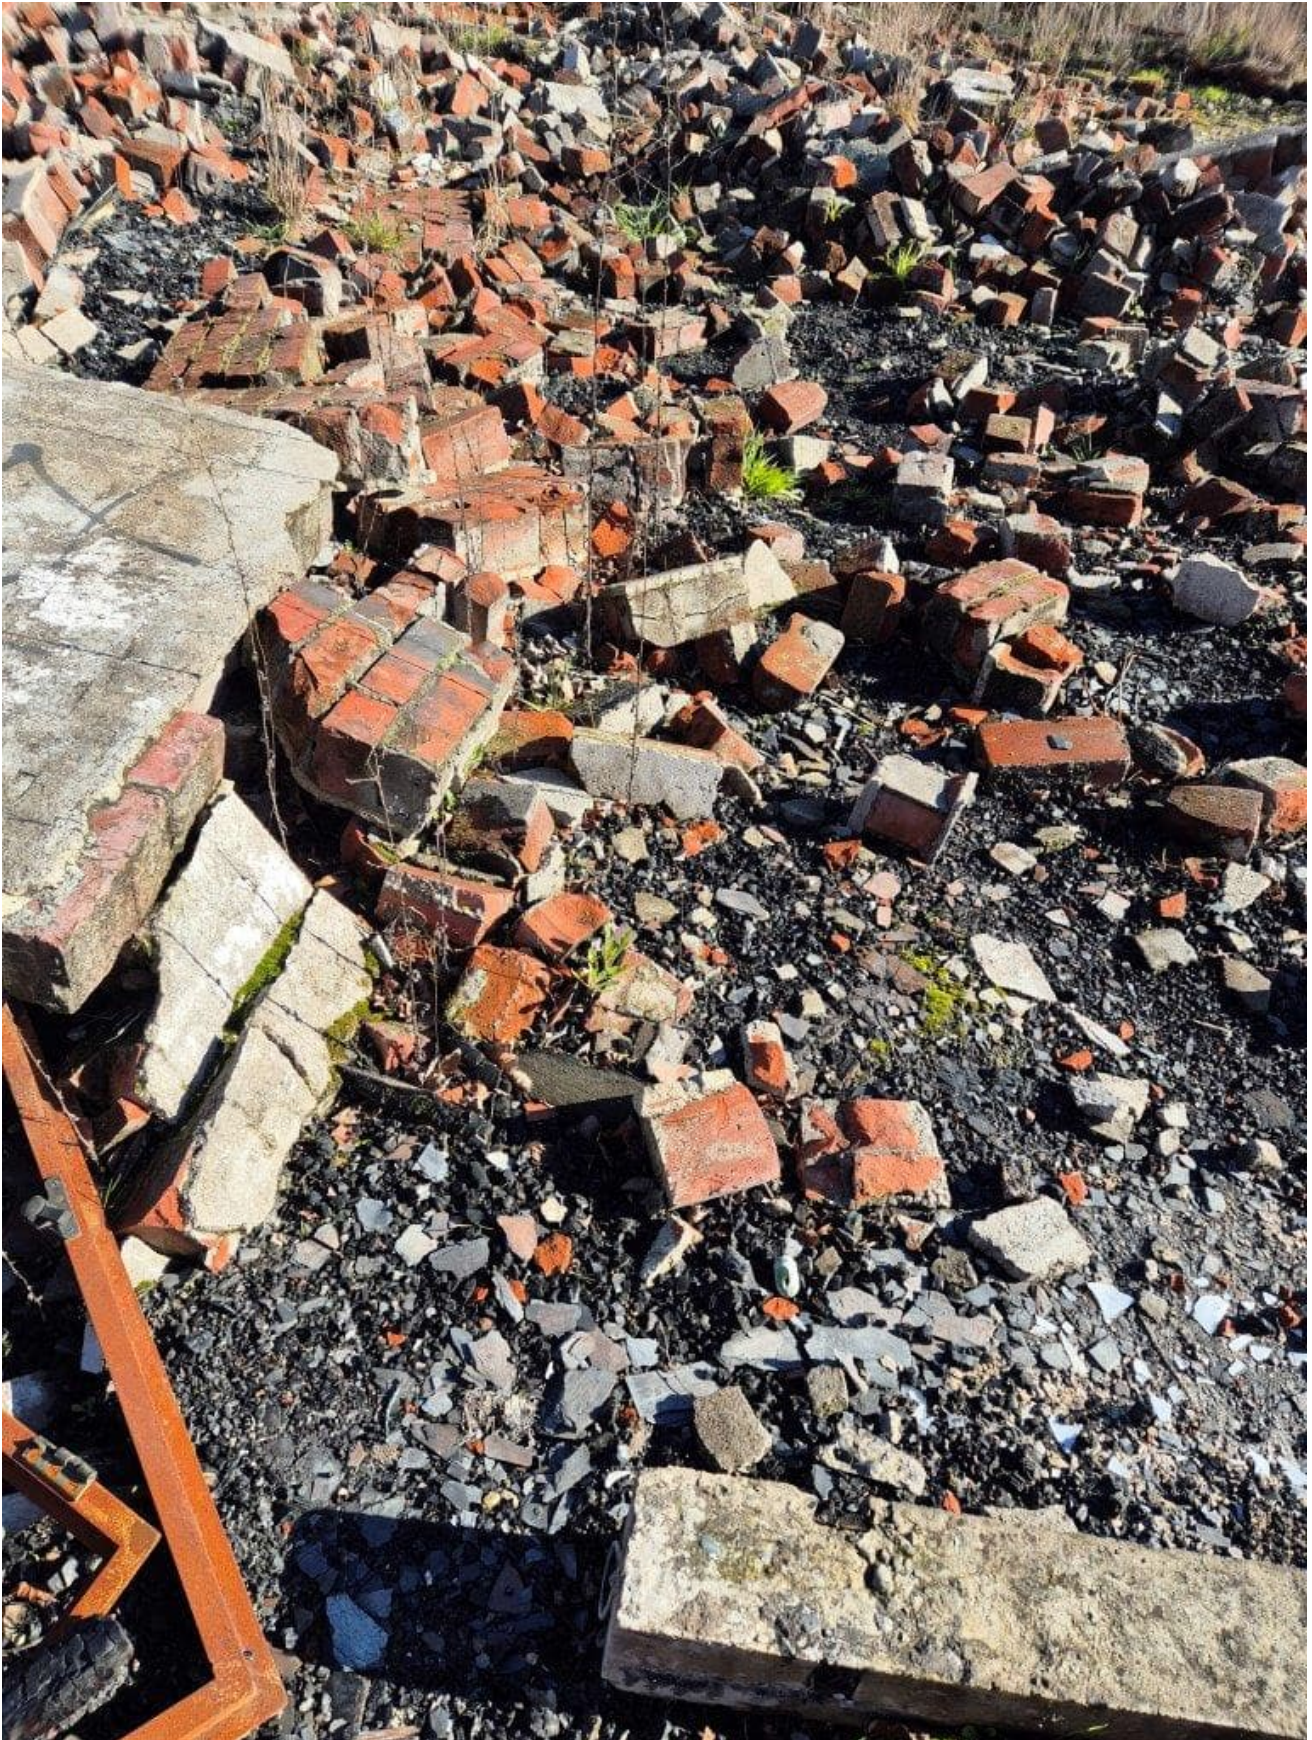
View of first floor debris

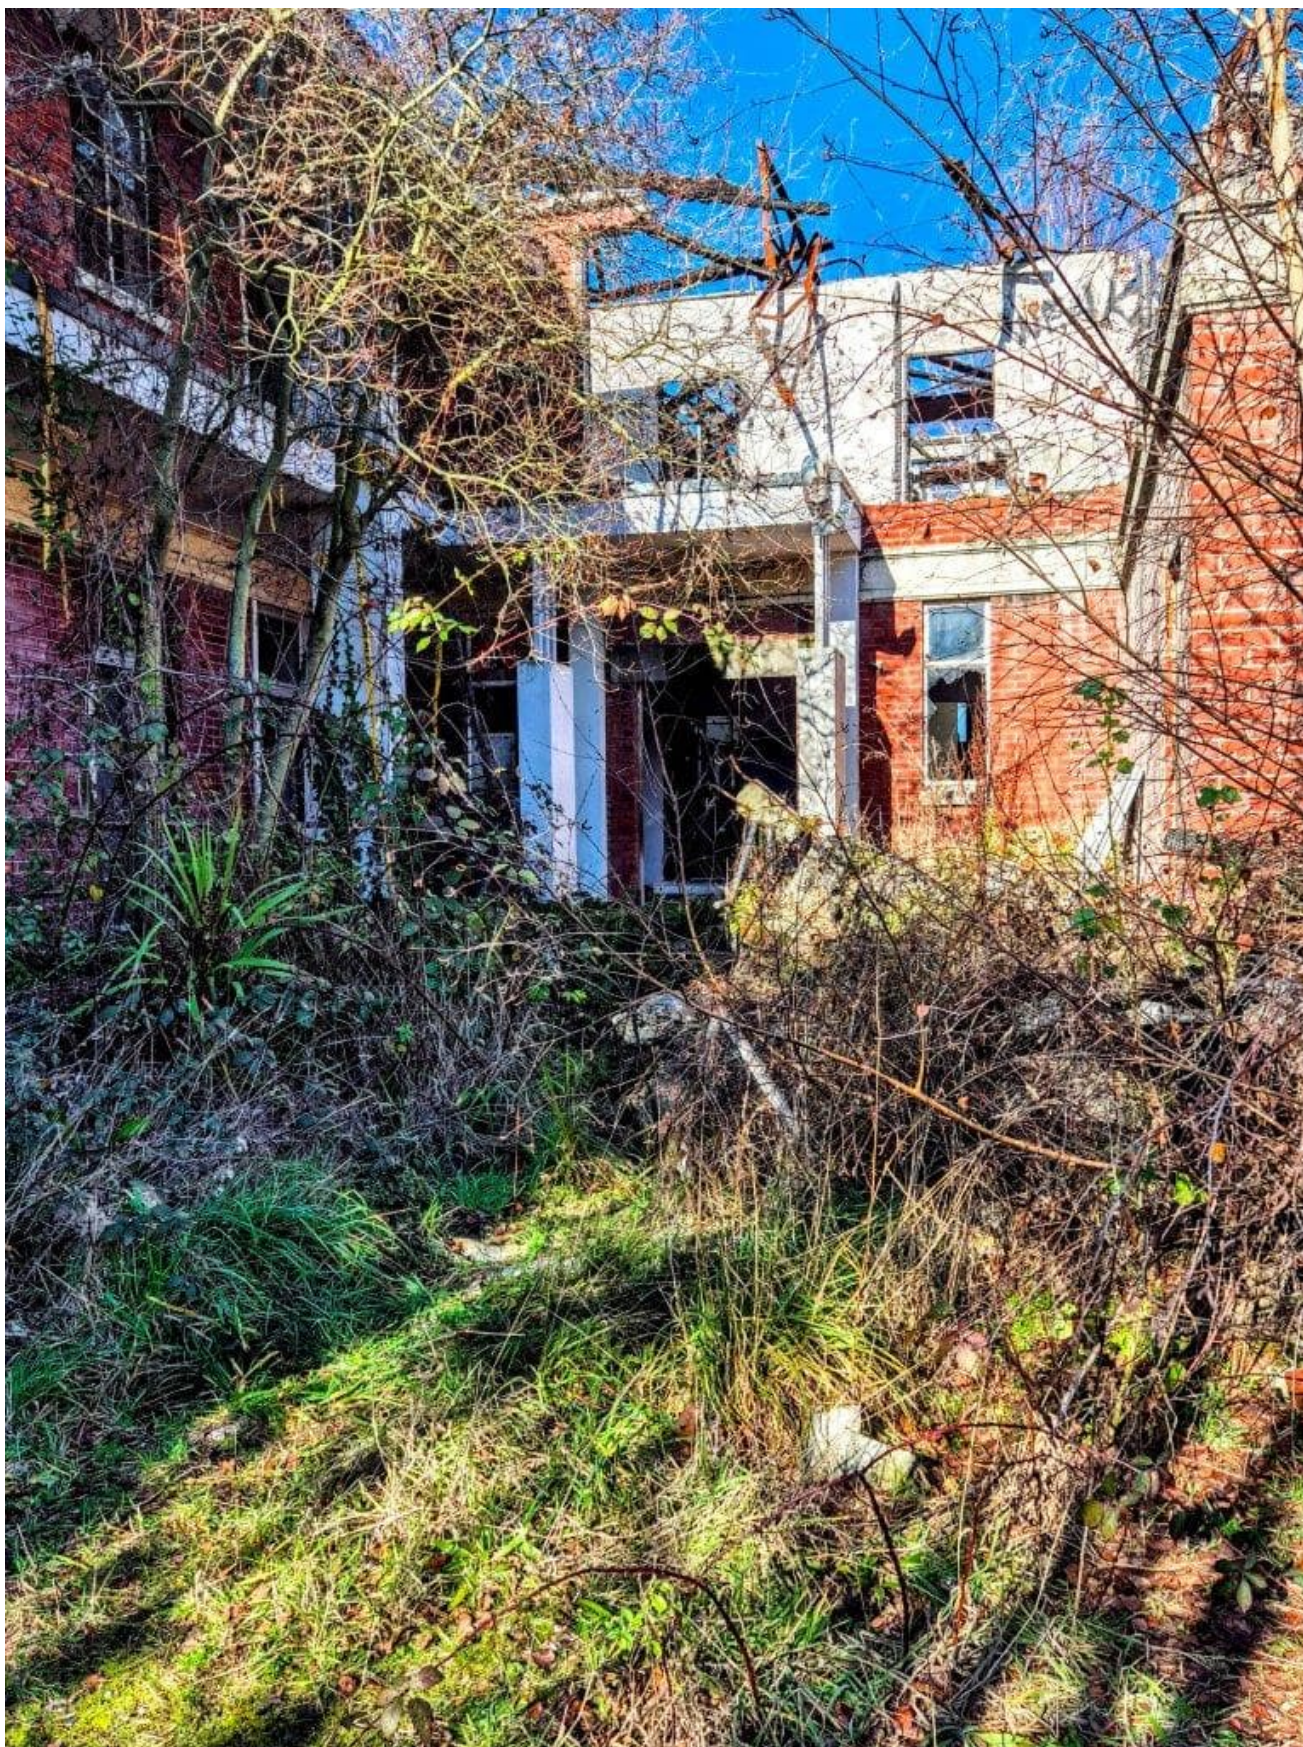
North side entrance

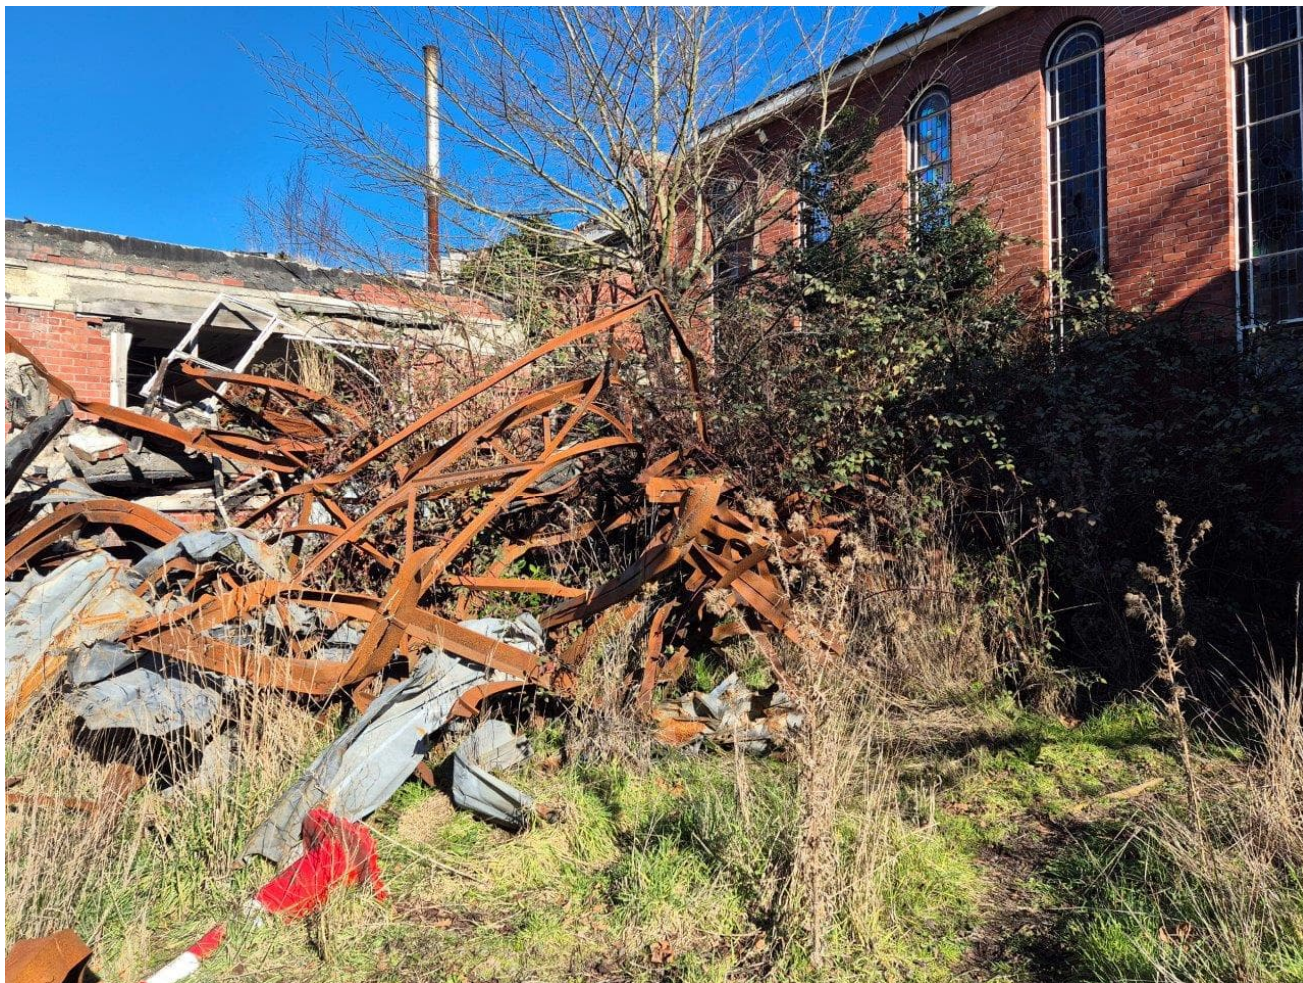
North side – demolition material

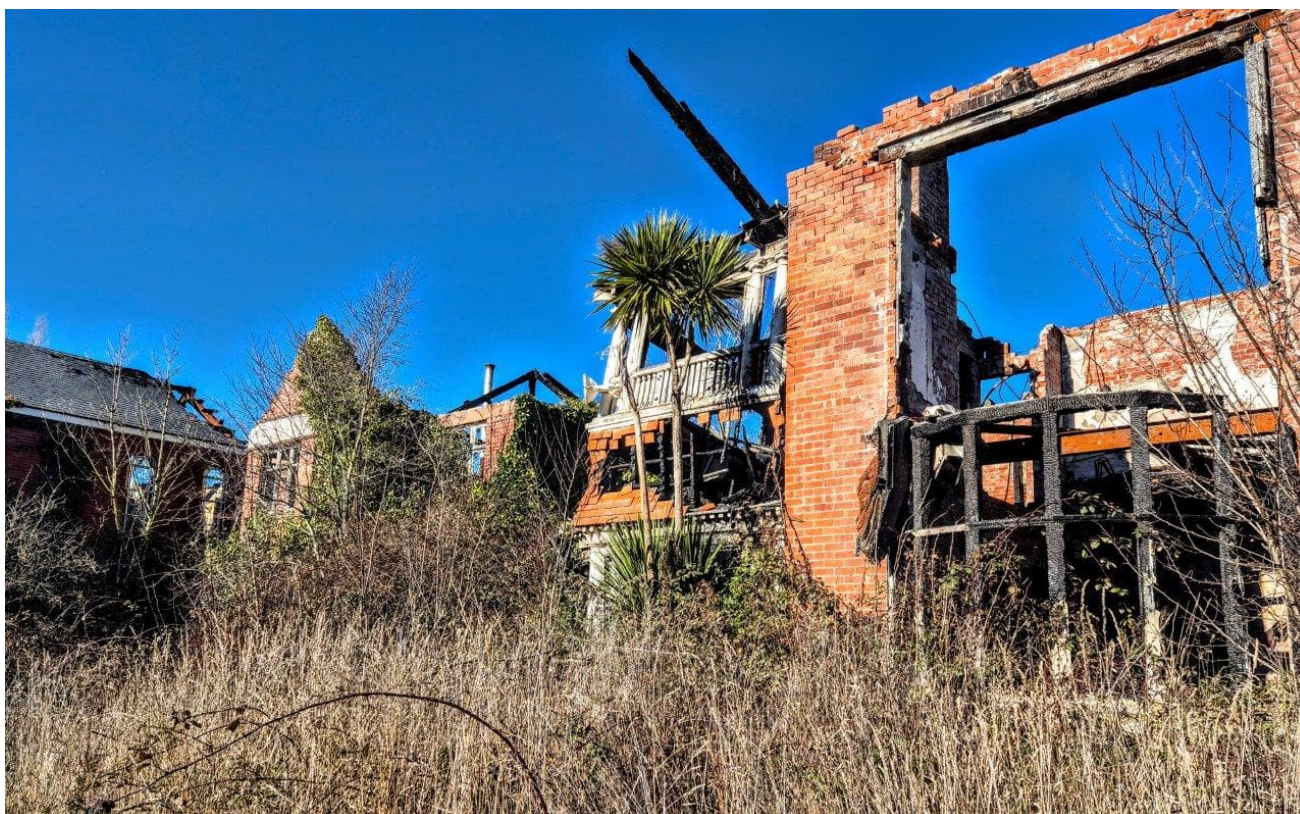
View – North side
