Housing Health Inspection

HYB 1046743

Photos: 265 Riccarton Rd, Christchurch 8041 – Antonio Hall

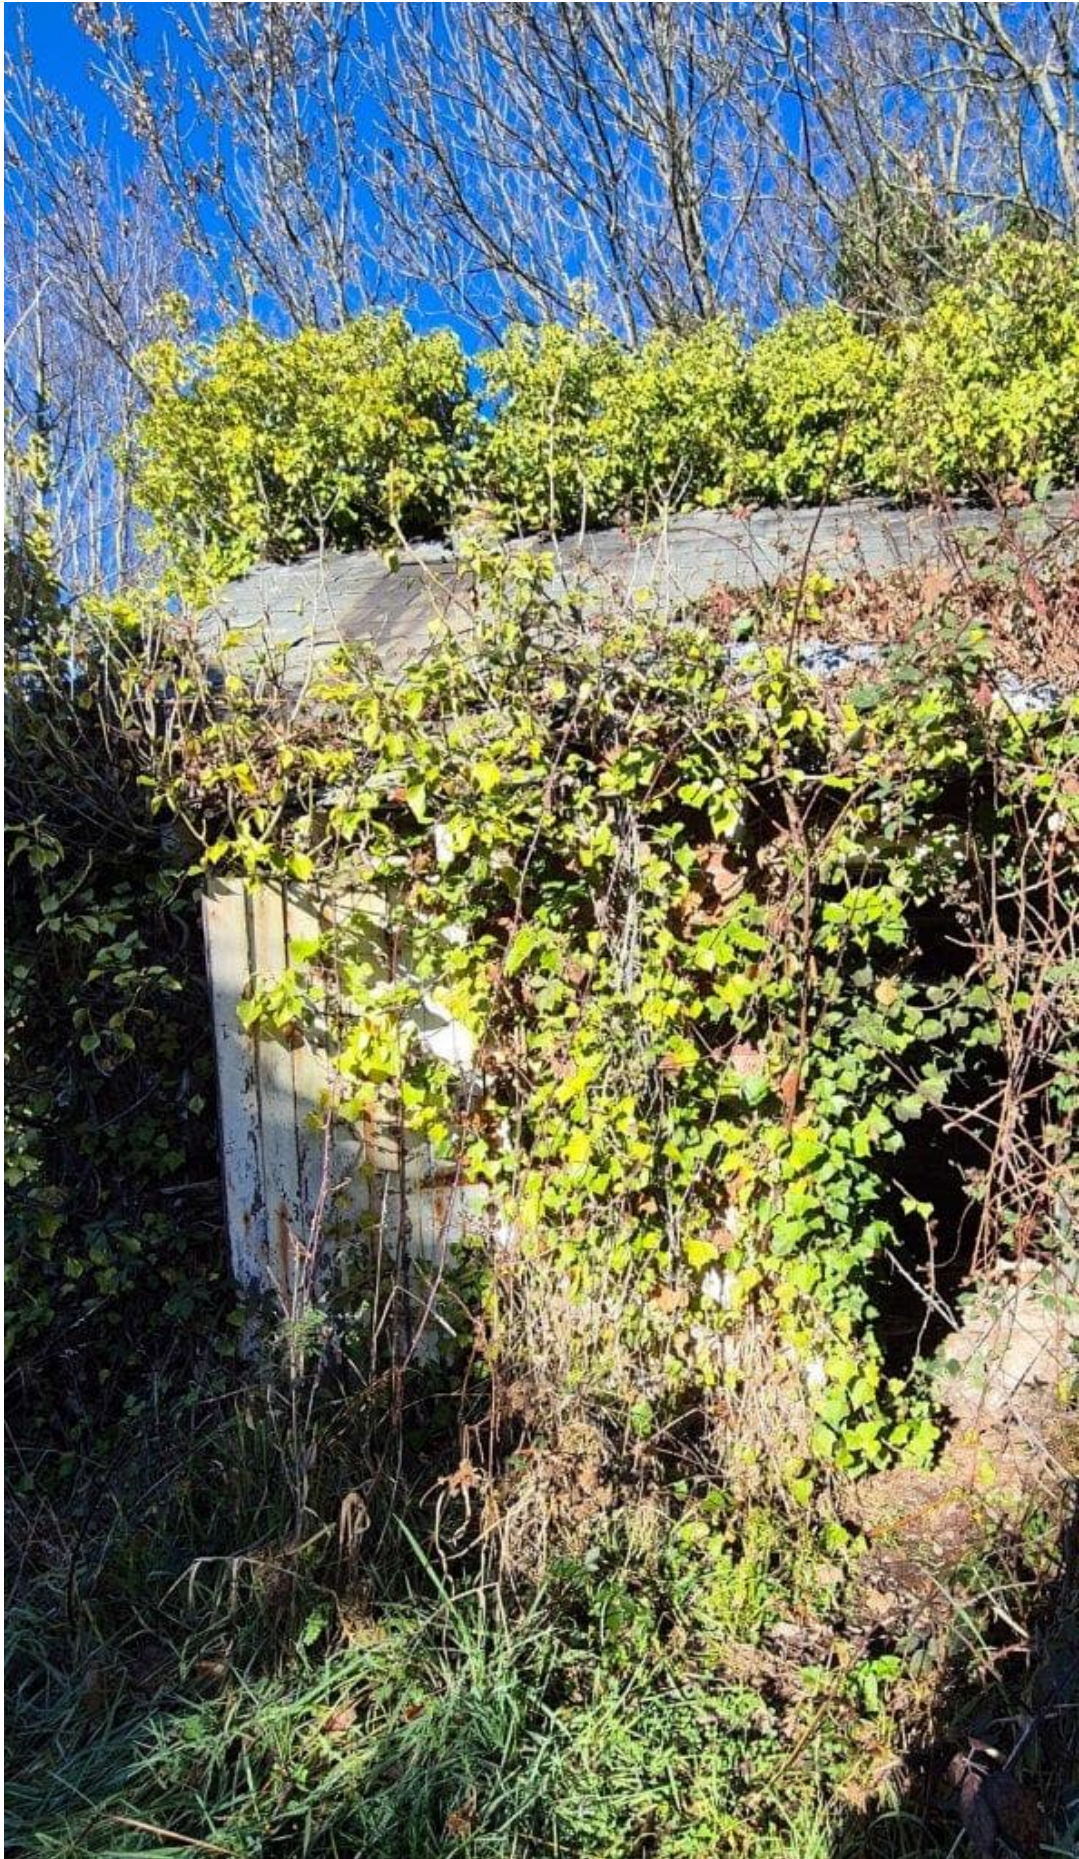
Outbuilding – south side

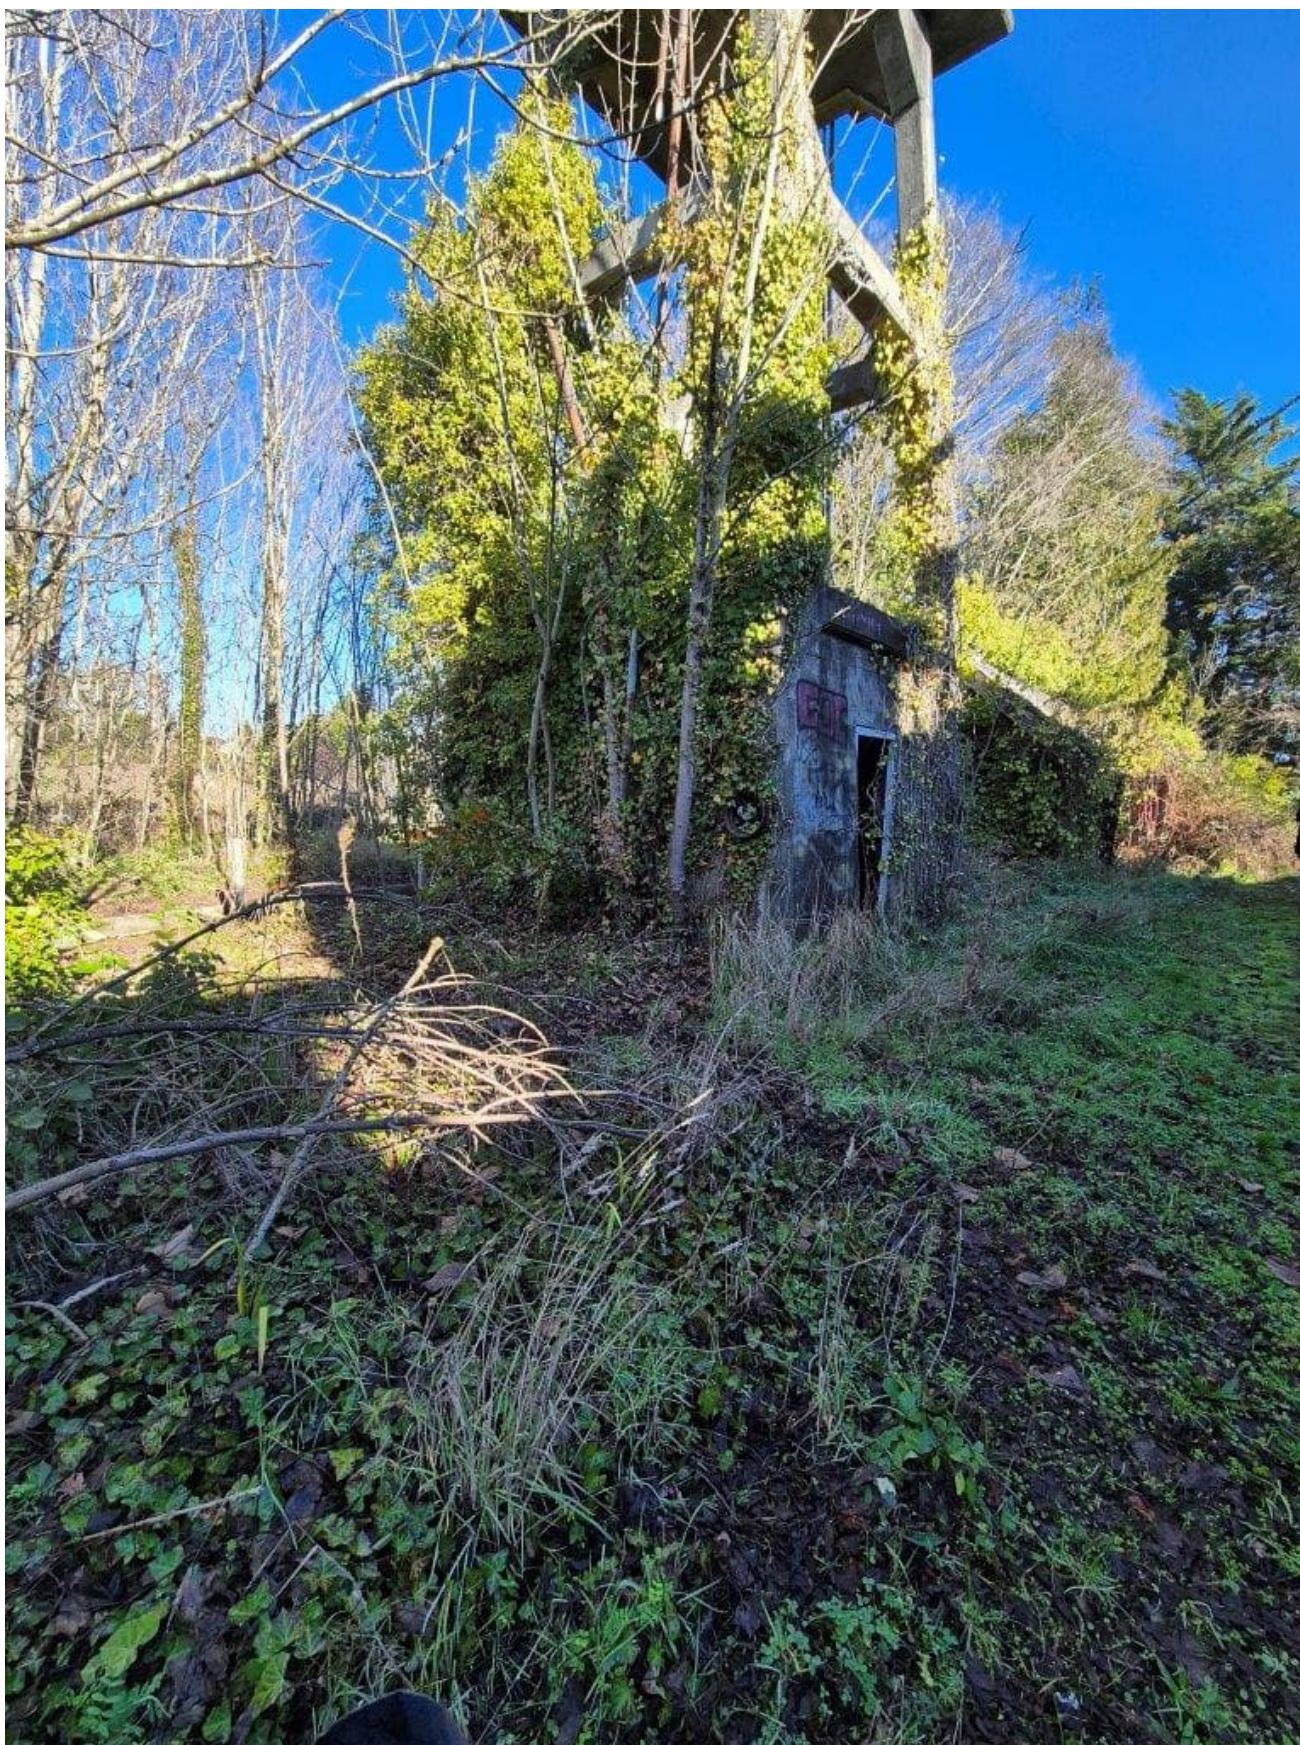
Outbuilding (water supply) – wider view

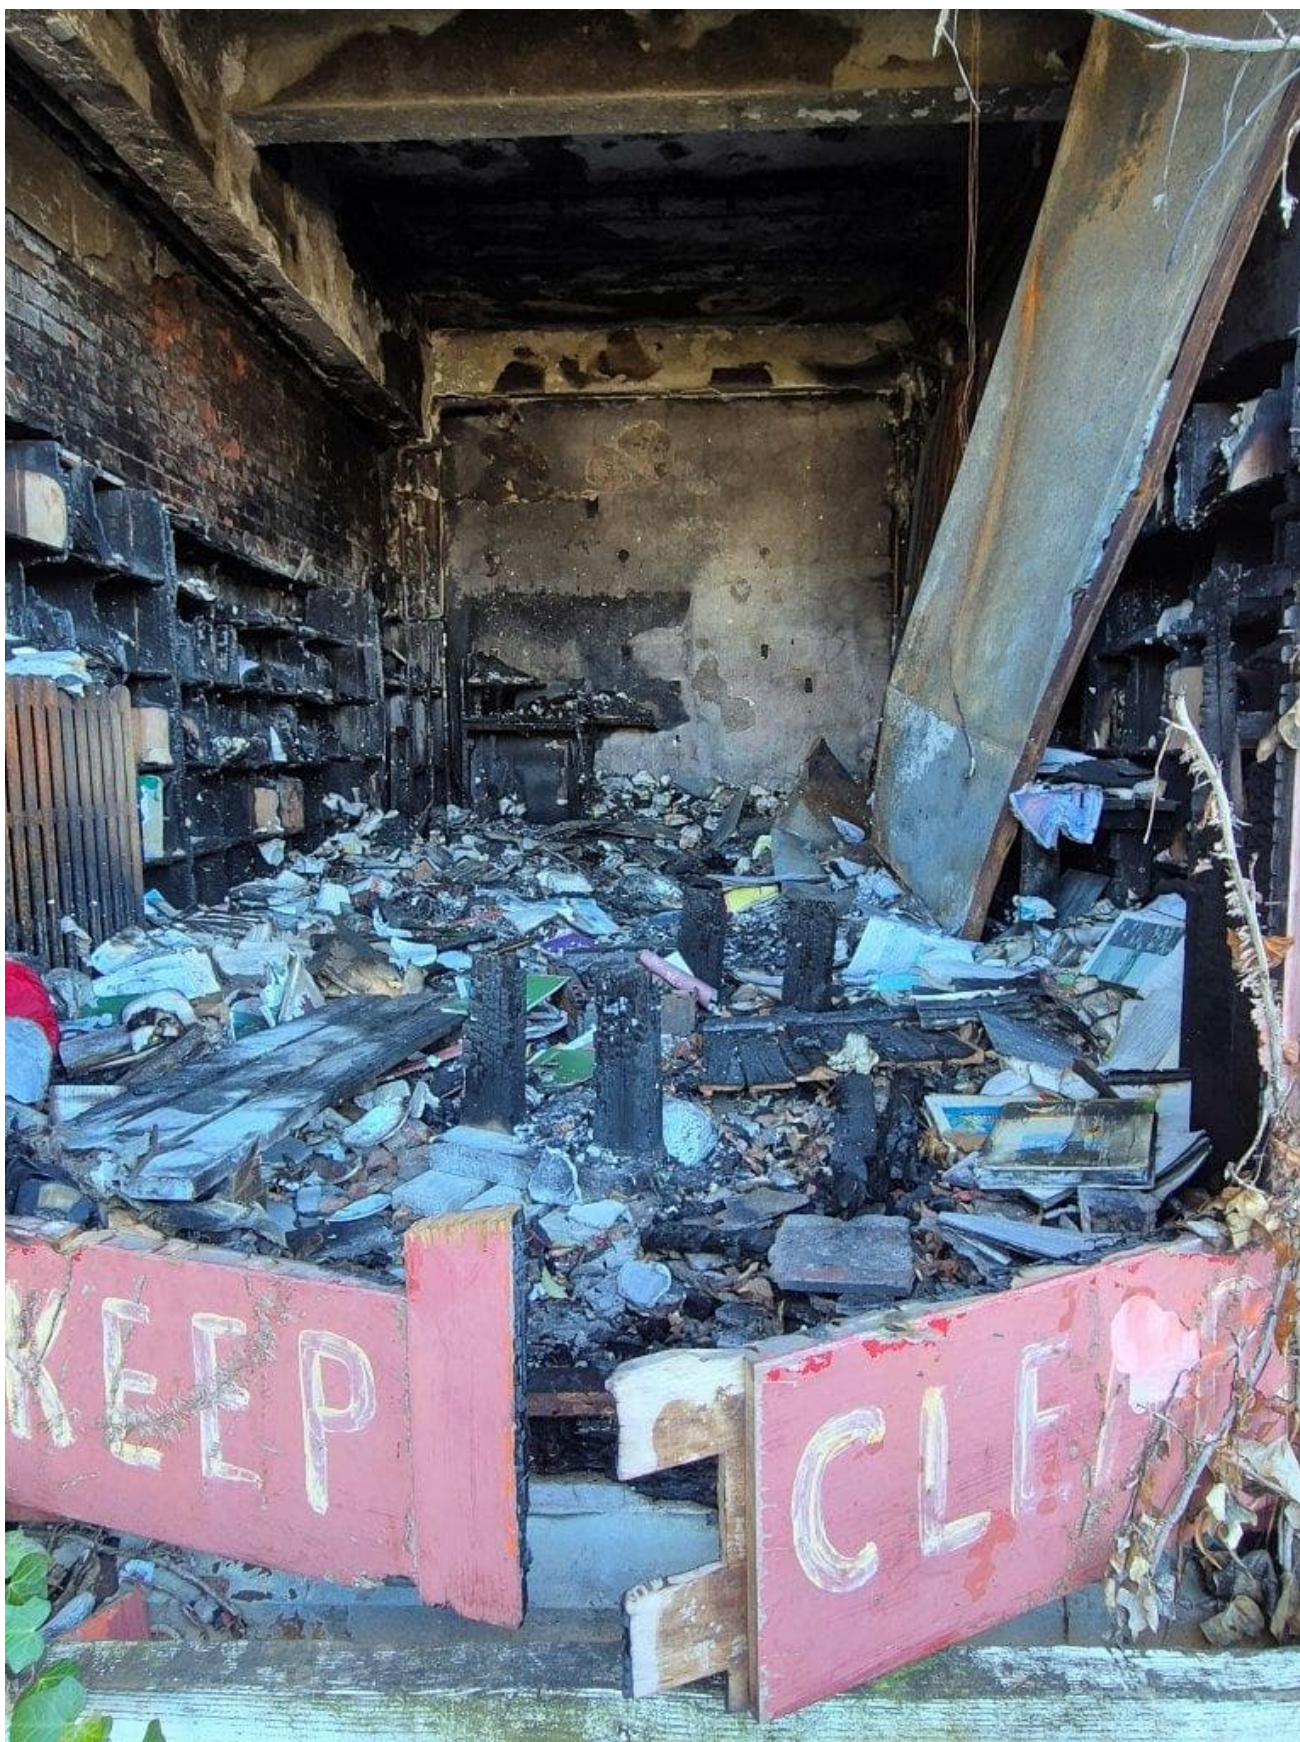
Interior view from south side

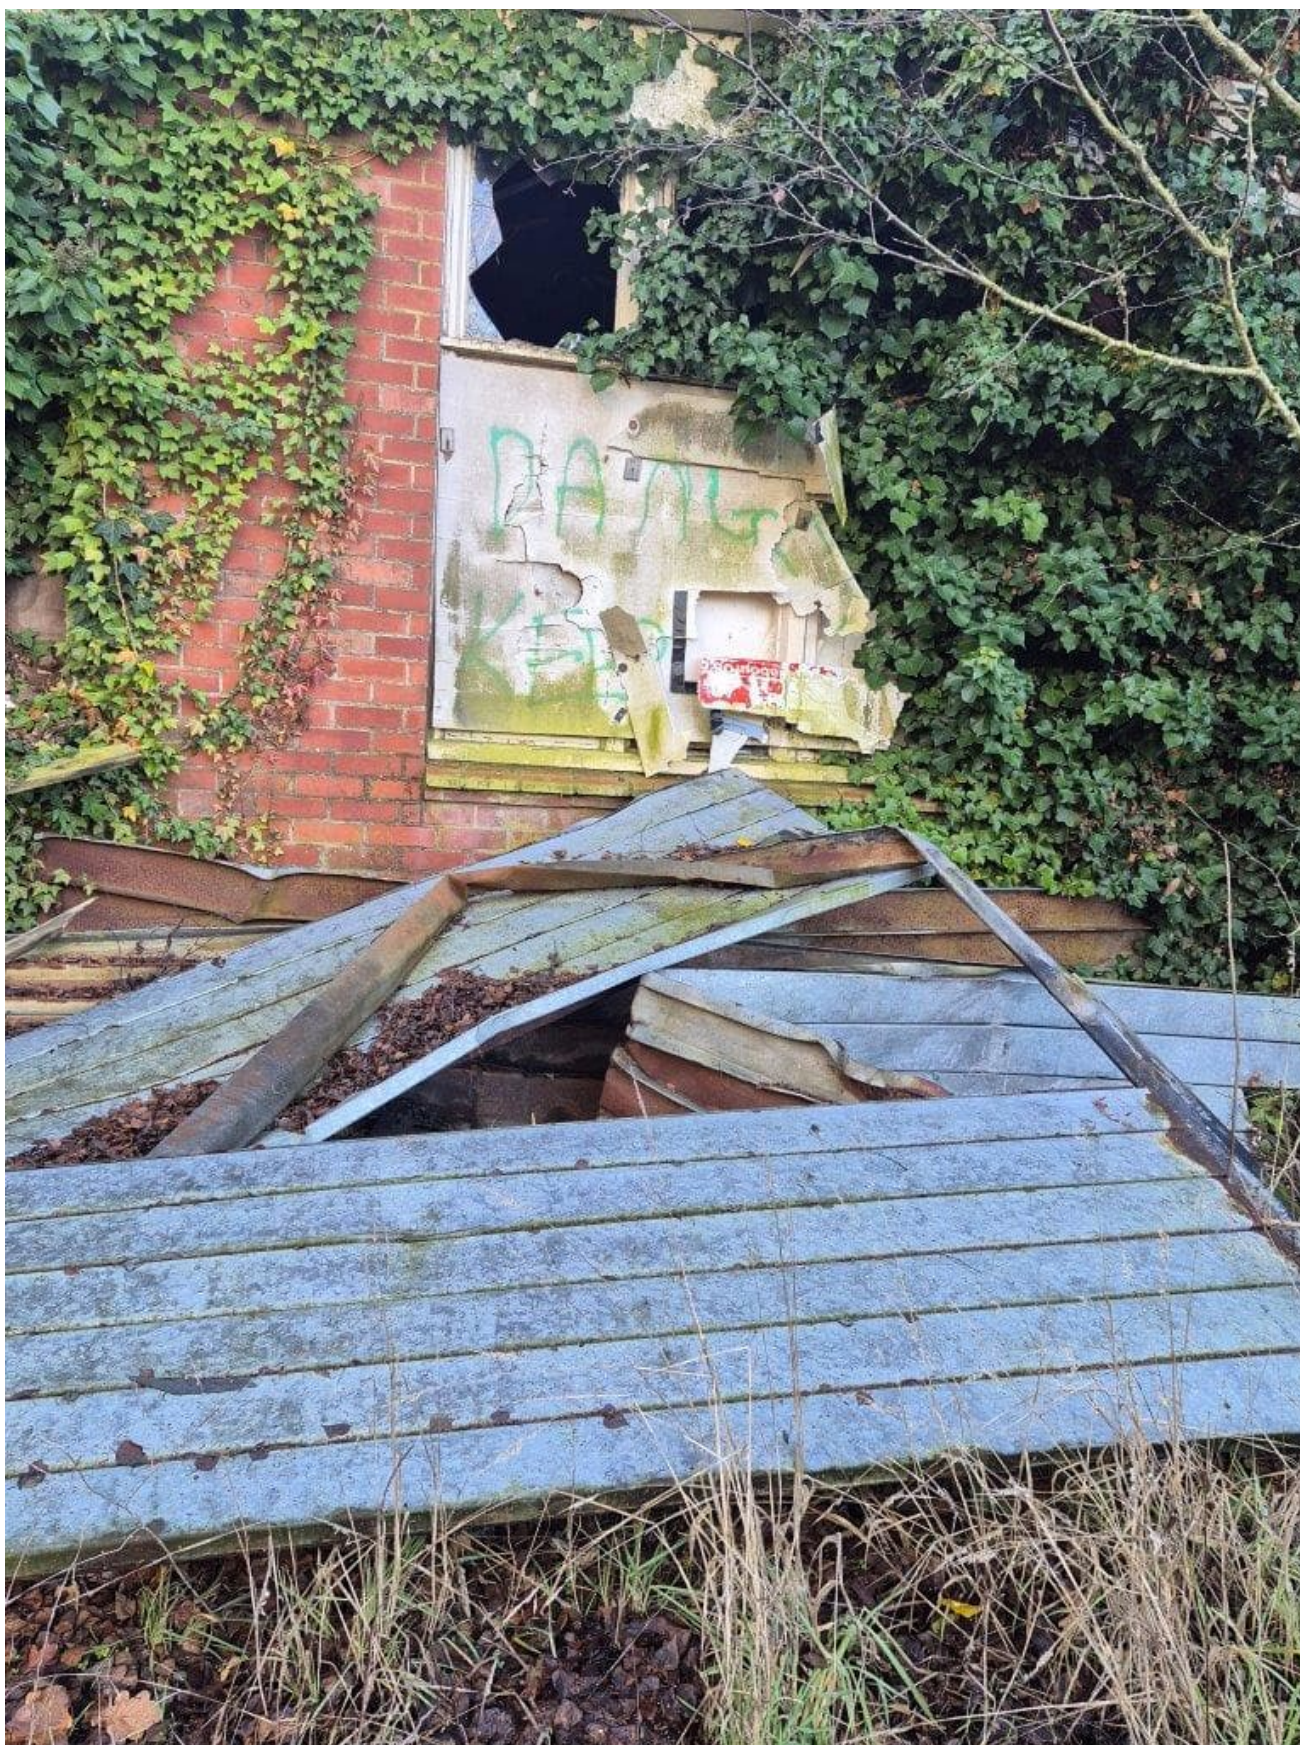
Demolition debris - south side

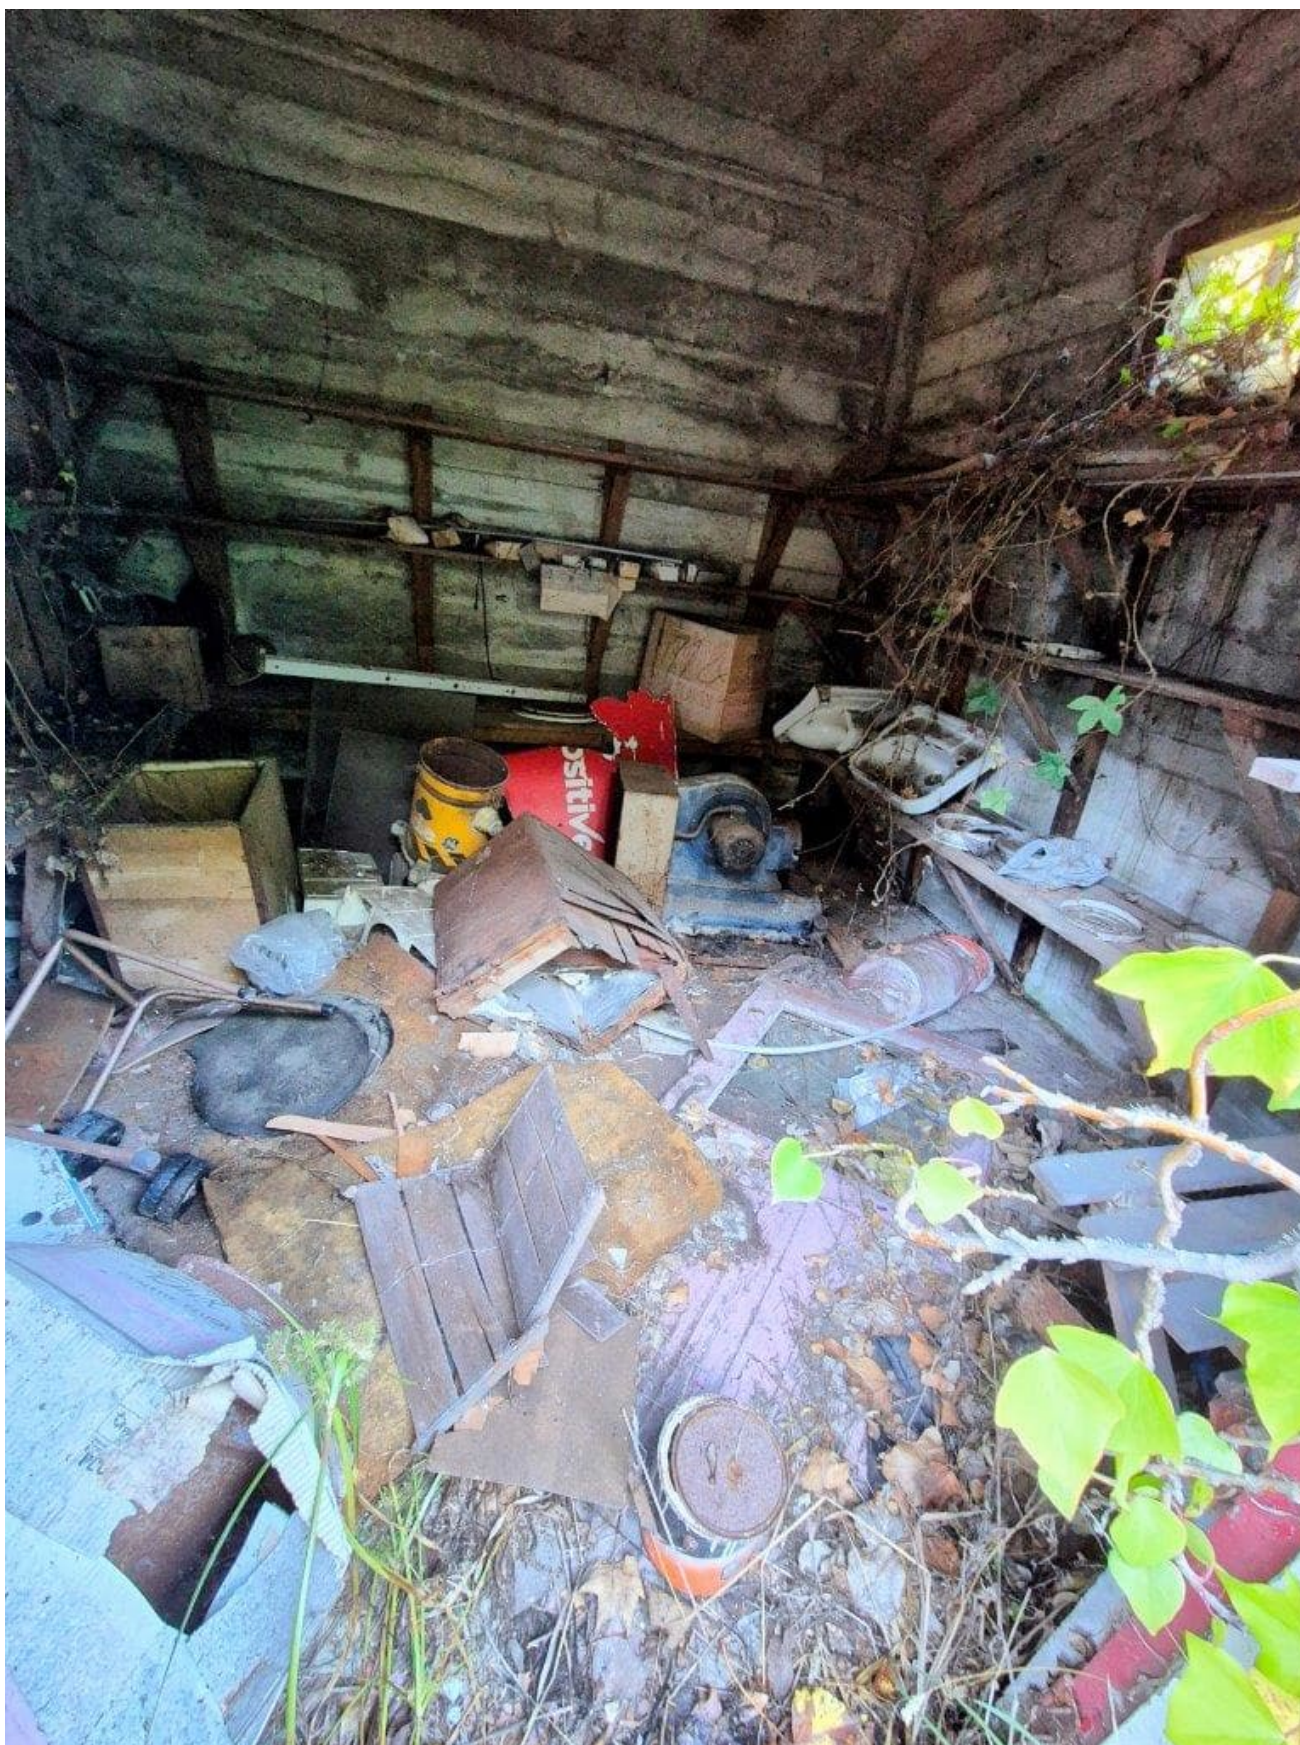
Outbuilding – south side

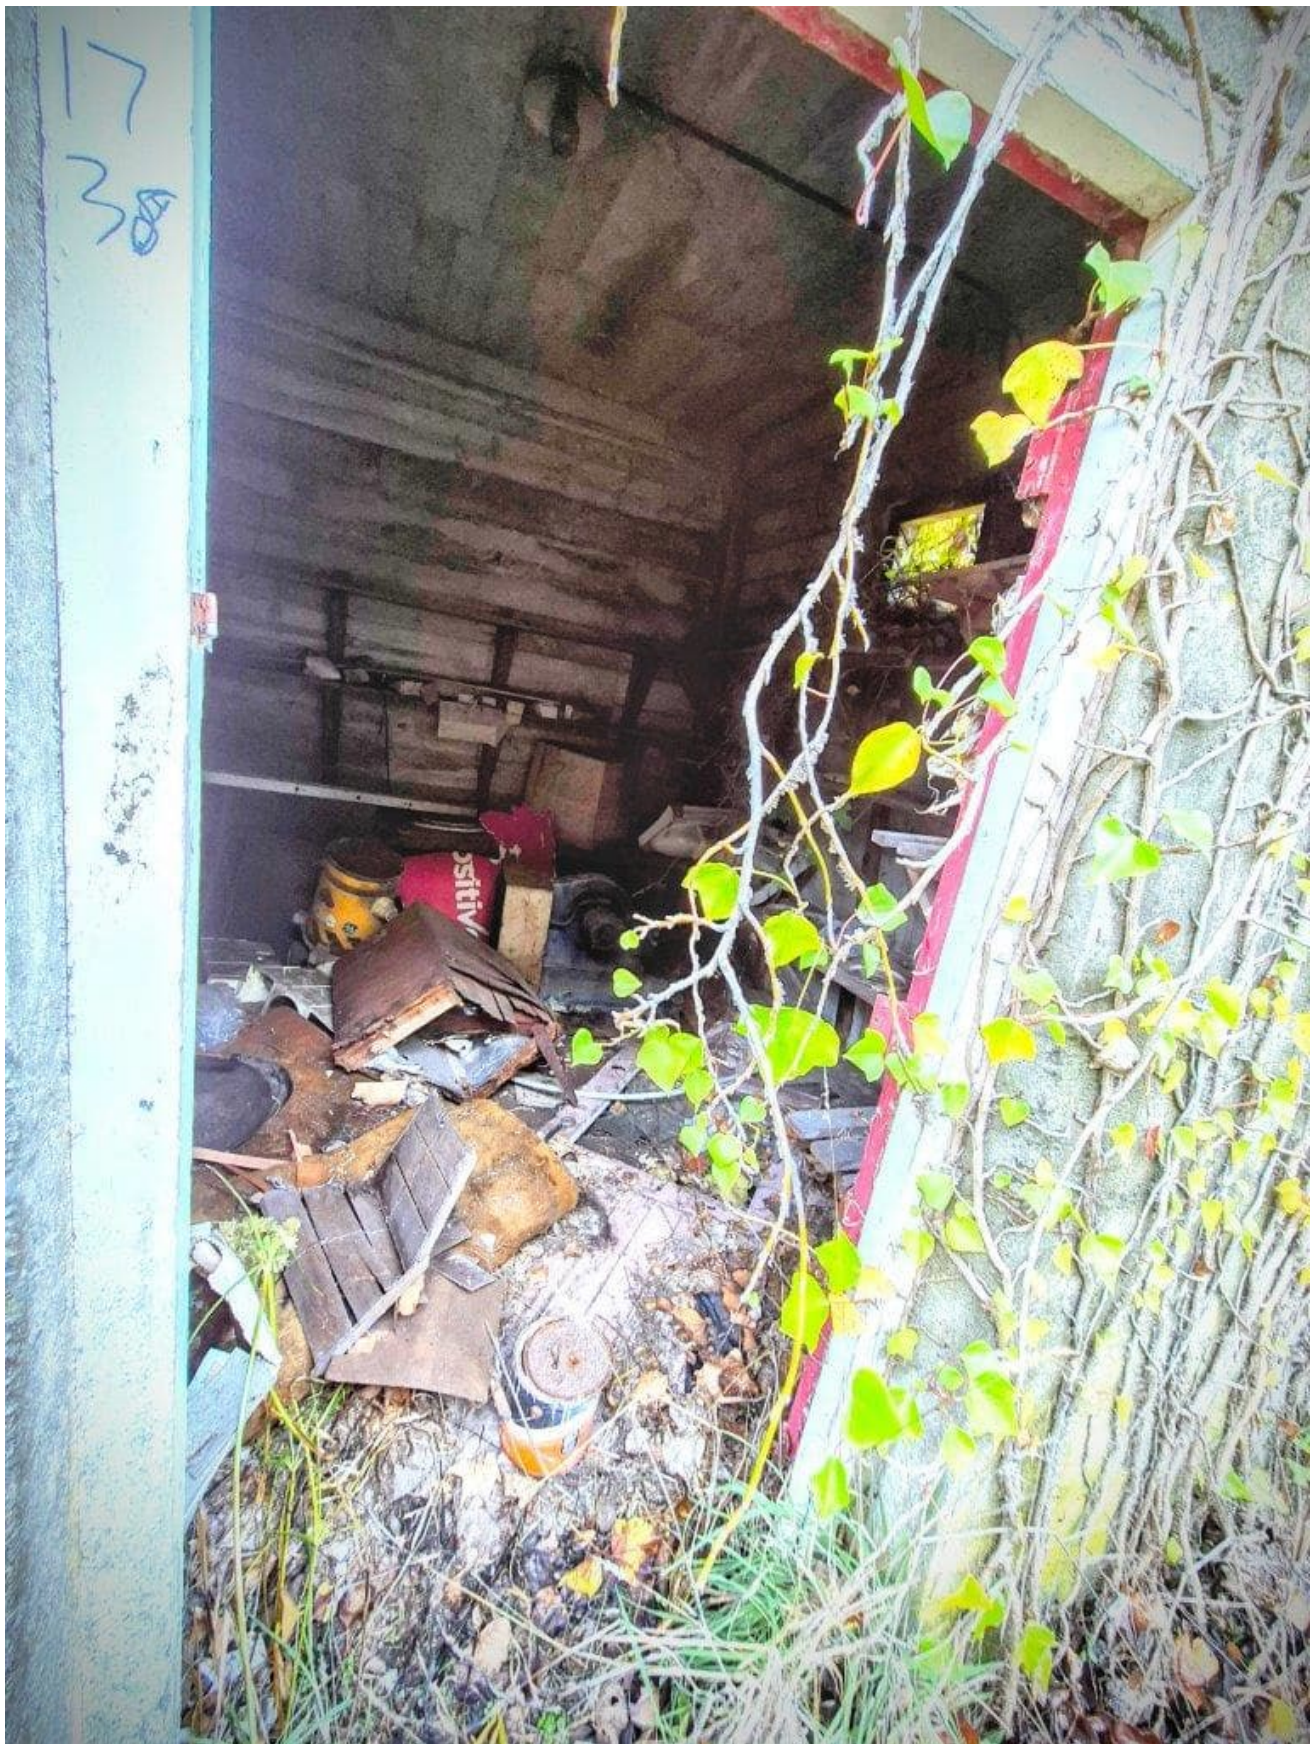
Outbuilding – south side

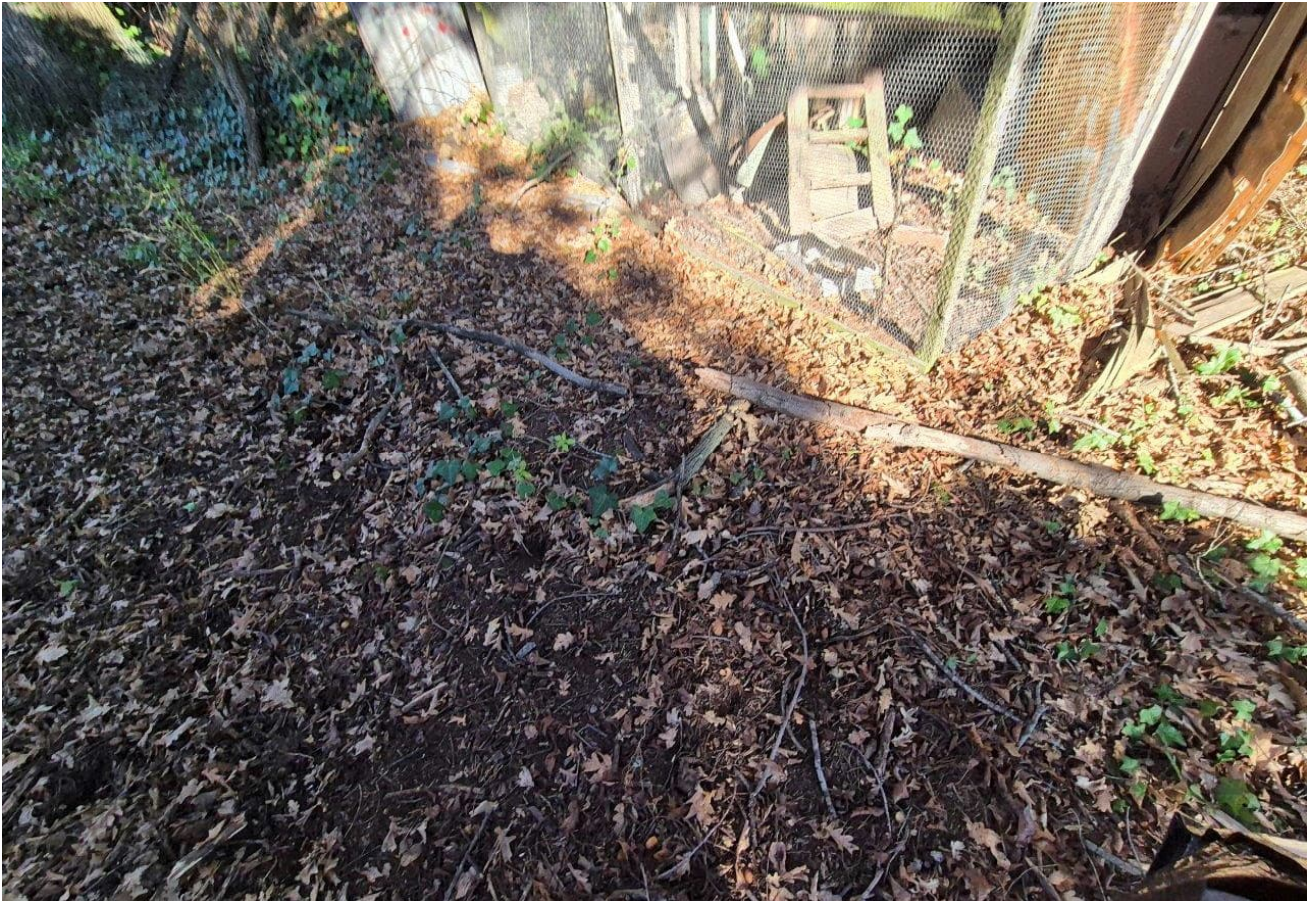
Aviary/coop west side
