## Appendix E

### Site Inspection Structural Report:

ADDRESS: 265 Riccarton Road, Christchurch Antonio Hall

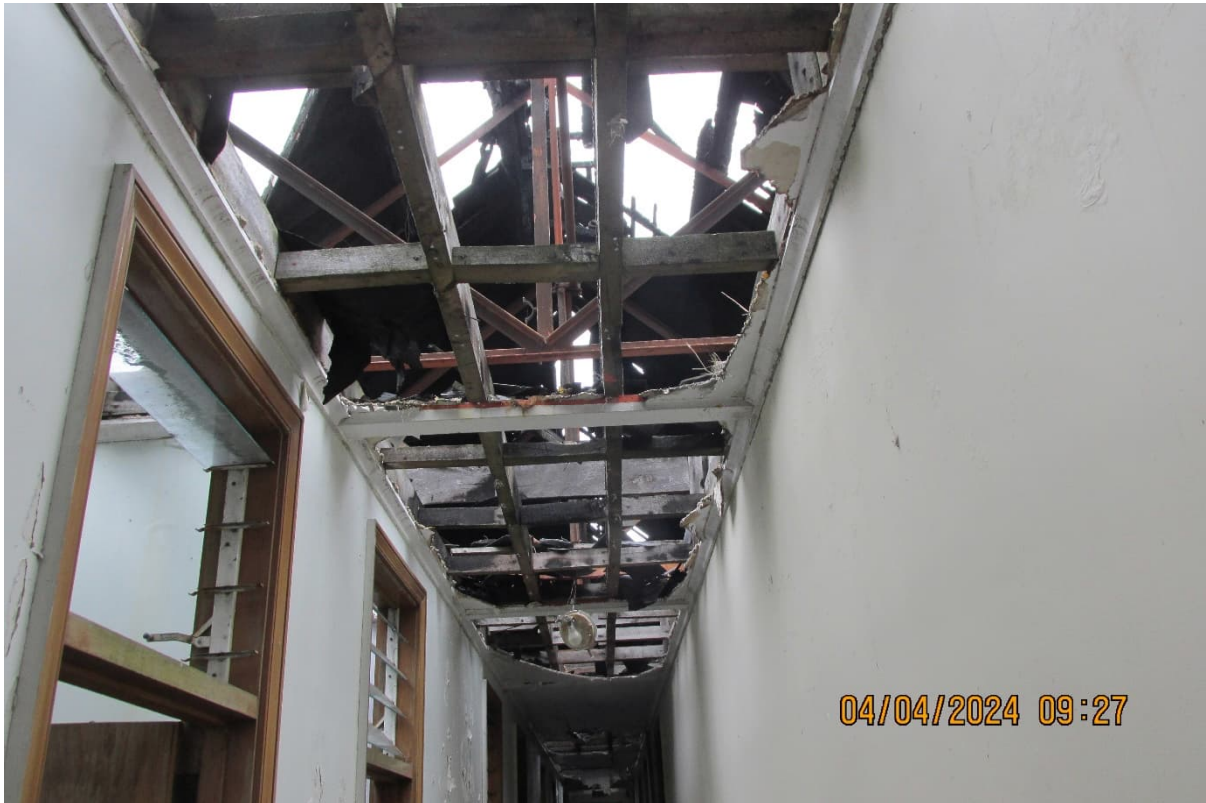
South-East End Roof Structure (fire damage accommodation block)

Remove the roof structure (fire damage) and part gable walls down to the top of the first-floor wall height southeast end as indicated by the below site map (brownish red lines below).

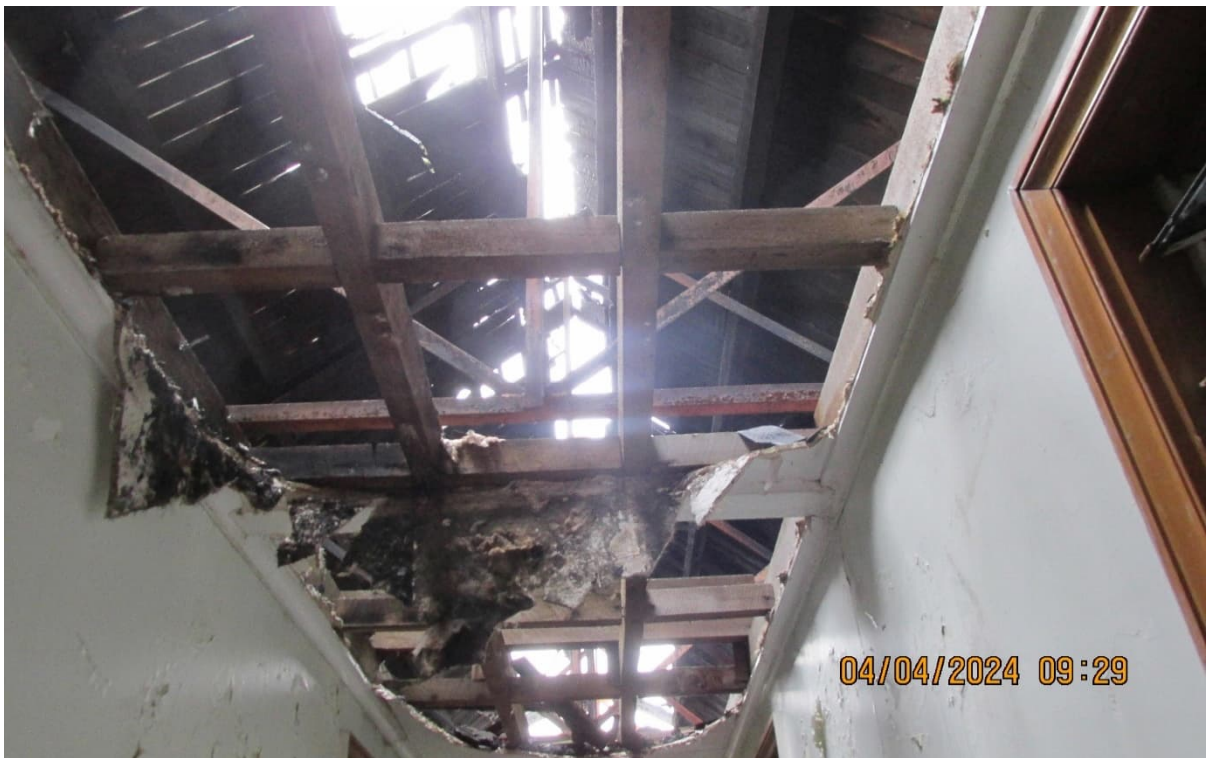
South-East End Roof Structure (fire damage accommodation block)

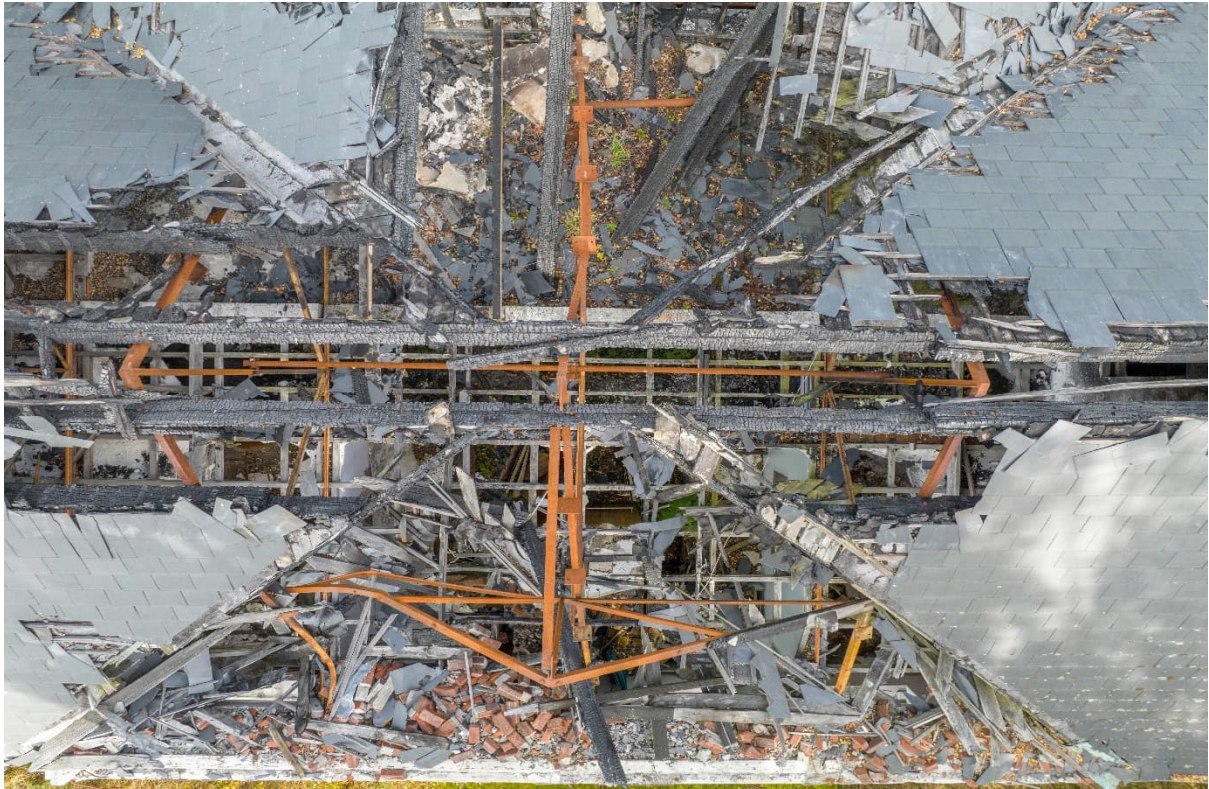
South-East End Centre Roof Structure (fire damaged accommodation block)

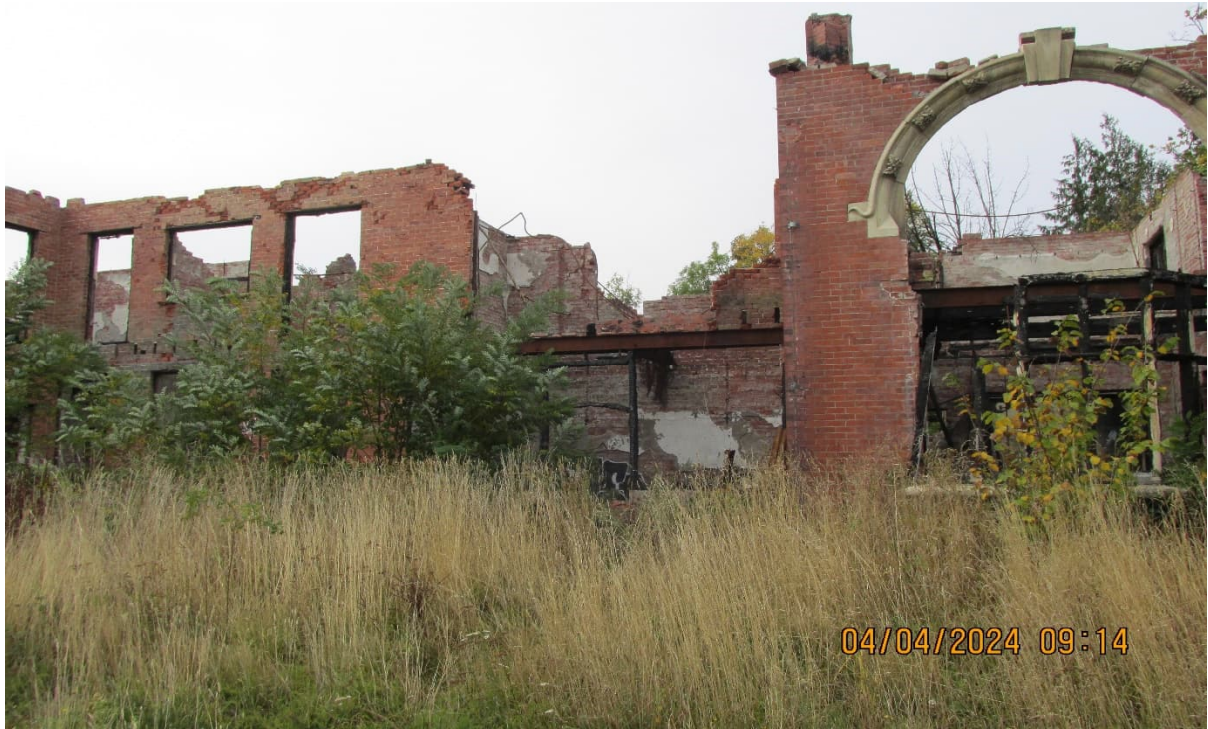
North-West End Building Structure (main homestead)

The Property Manager or Building Owner should remove the west-end building structure (main homestead) completely as indicated by the below site map (red lines - unreinforced masonry two storey high building structure).

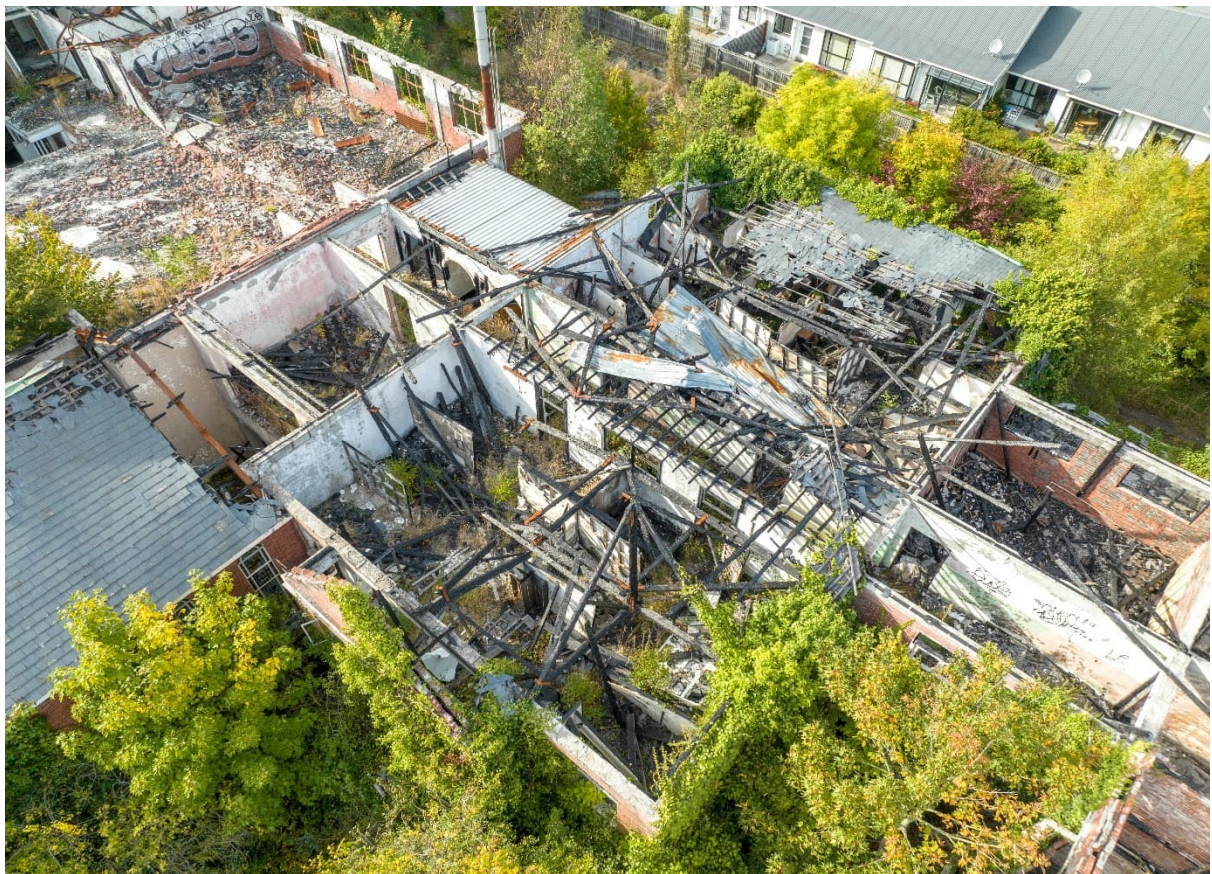
Centre South-East End Roof Structure (unsuitable debris)

Remove all unsuitable debris, centre wing south-end as indicated by the below site map (yellow lines below).
